**A Level 2 Historic Building Recording at
7 King Street,
Sileby,
Leicestershire
NGR: SK 6013 1527**

**ULAS Report No 2021-093
©2021**

Site Name: 7 King Street, Sileby, Leicestershire.

Client: UCR Construction and Development Limited

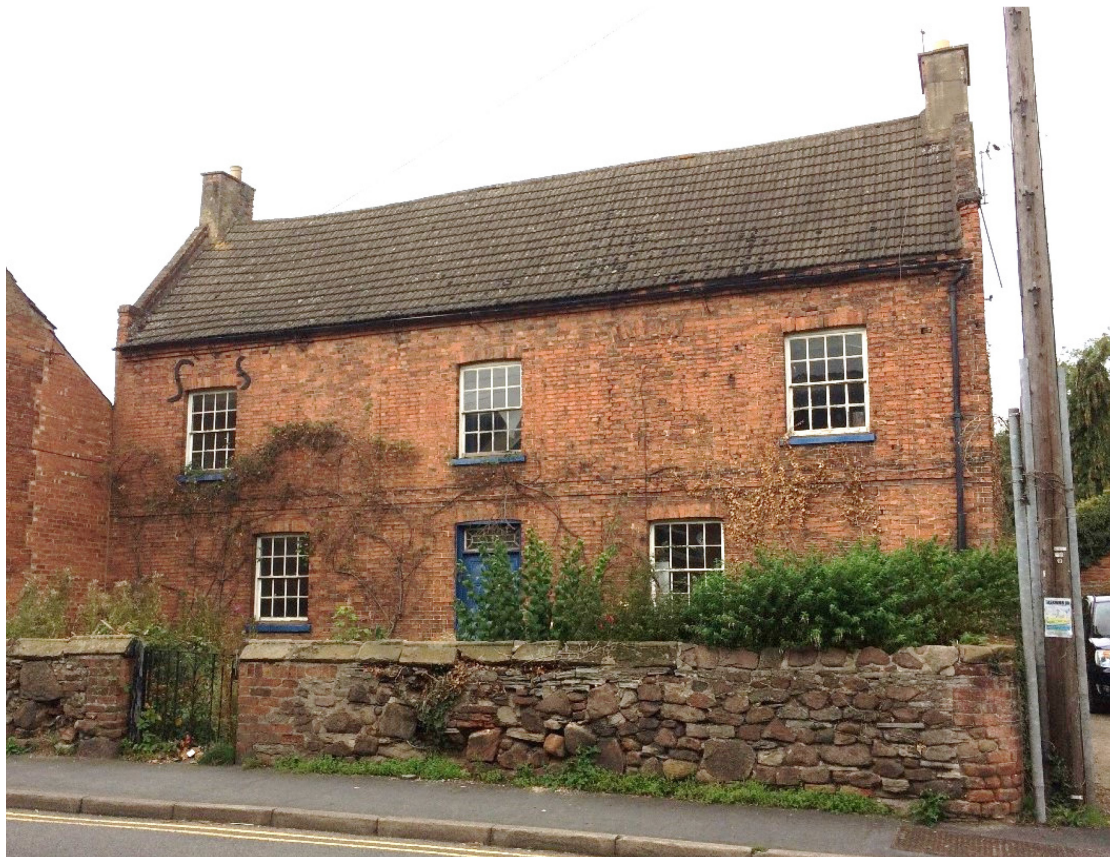
Figure 10 South-east facing elevation of farmhouse
Picture source: Lanpro Services DBA 2017. Photograph taken before erection of hoardings and demolition of boundary wall

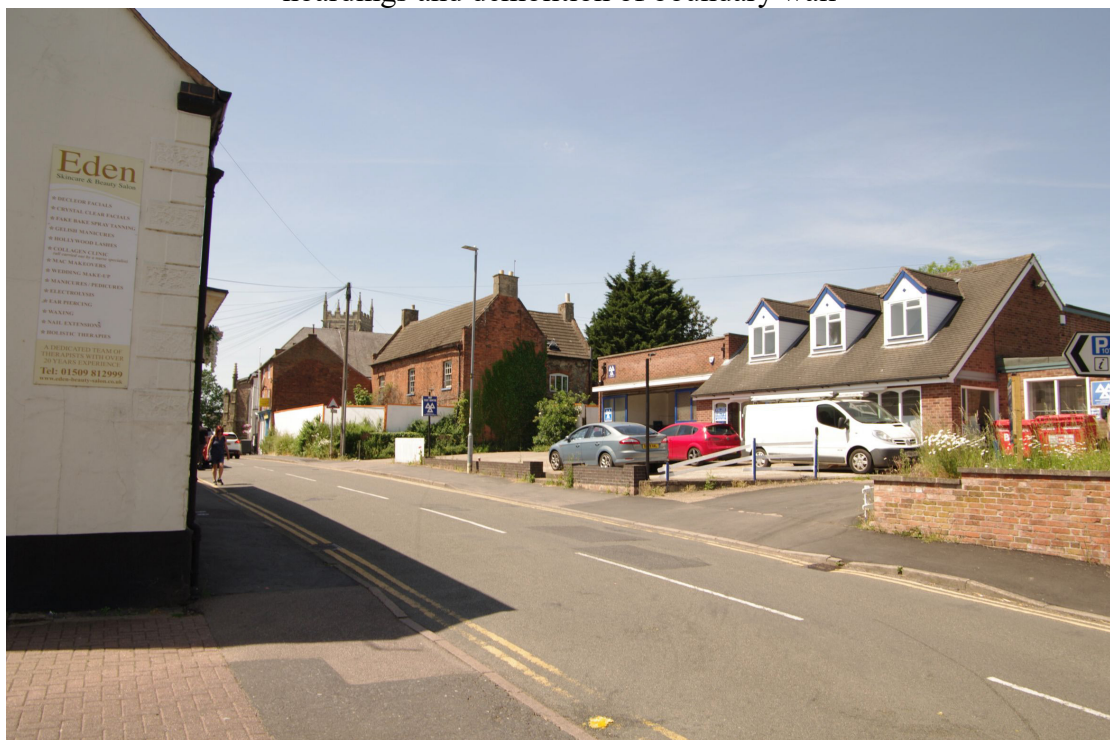
Figure 11 View along King Street looking north-west
Hoardings around building now present. Garage on right is located where the courtyard range of agricultural building were

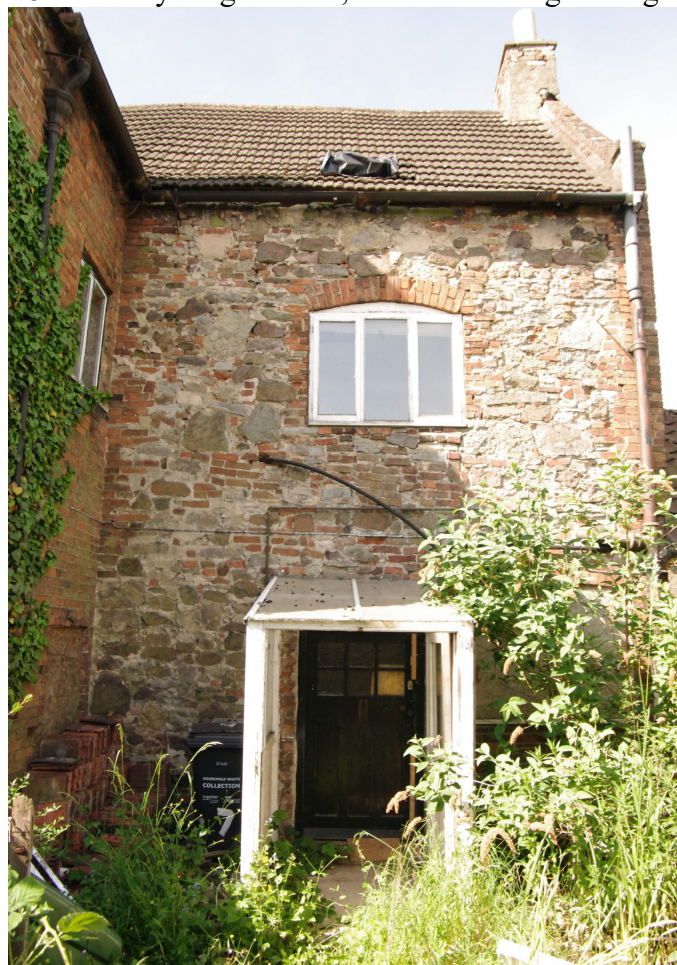
Figure 21 North-east facing elevation of rear range
Note rather haphazard use of uncoursed stones and brick infilling

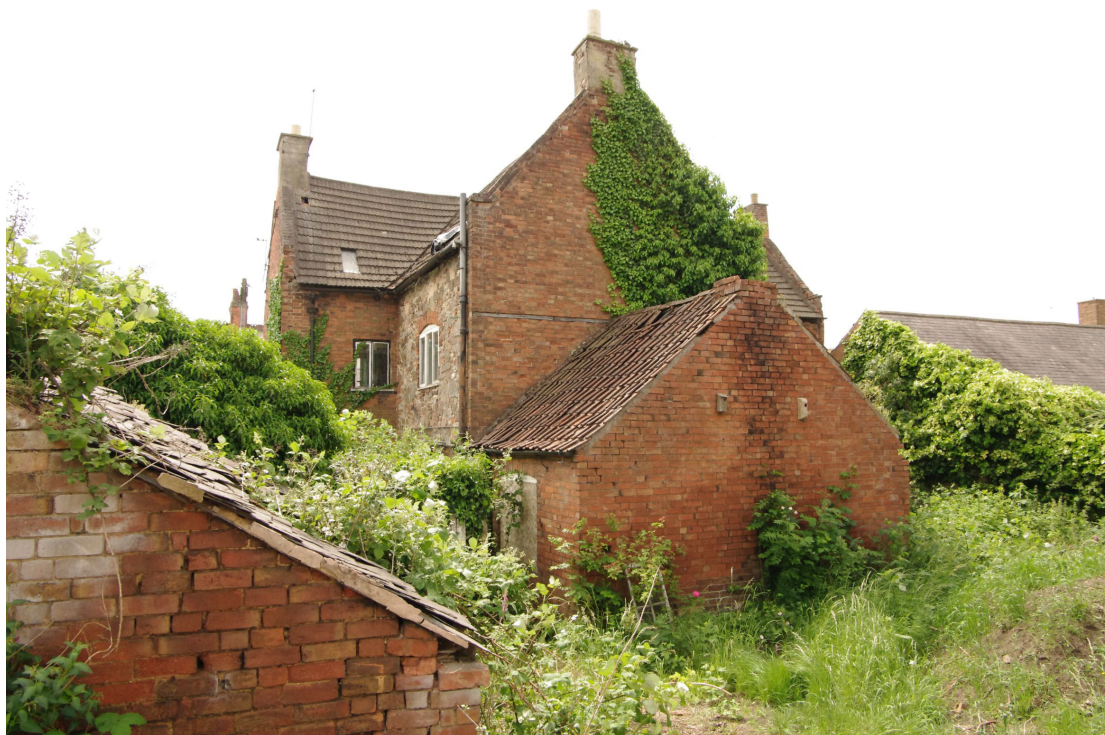
Figure 22 Rear of farmhouse looking south
Note gable end of rear range is of brick suggesting stone range may have extended further. Outbuilding 1 on left

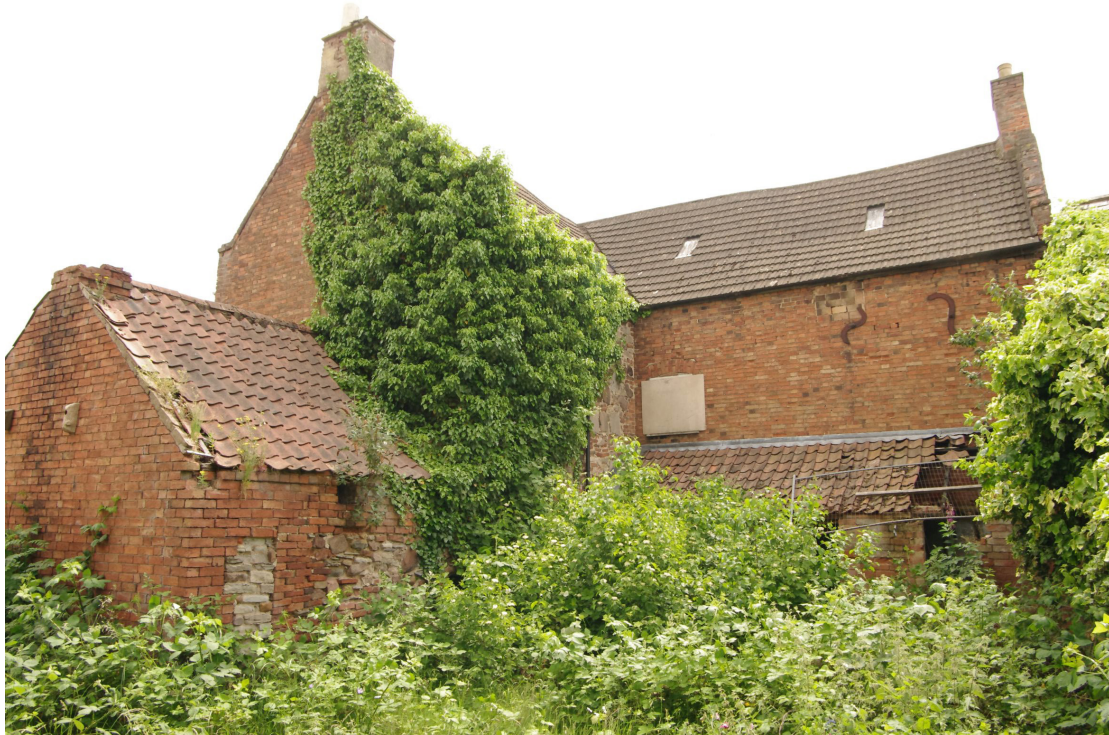
Figure 24 Rear of farmhouse looking south-east
Note remnants of stone walling in the single storey building and the rear two-storey range (see Figs 25 and 26 below)

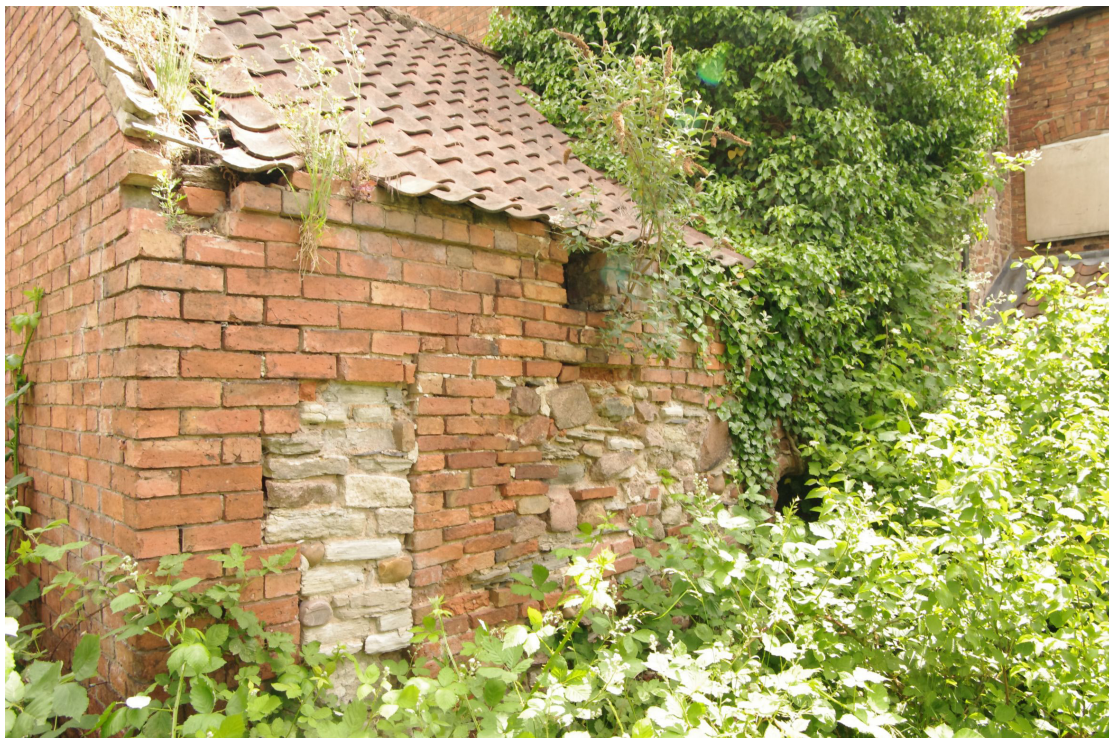
Figure 25 Remnant of stone wall in single storey rear range
Looking south-east

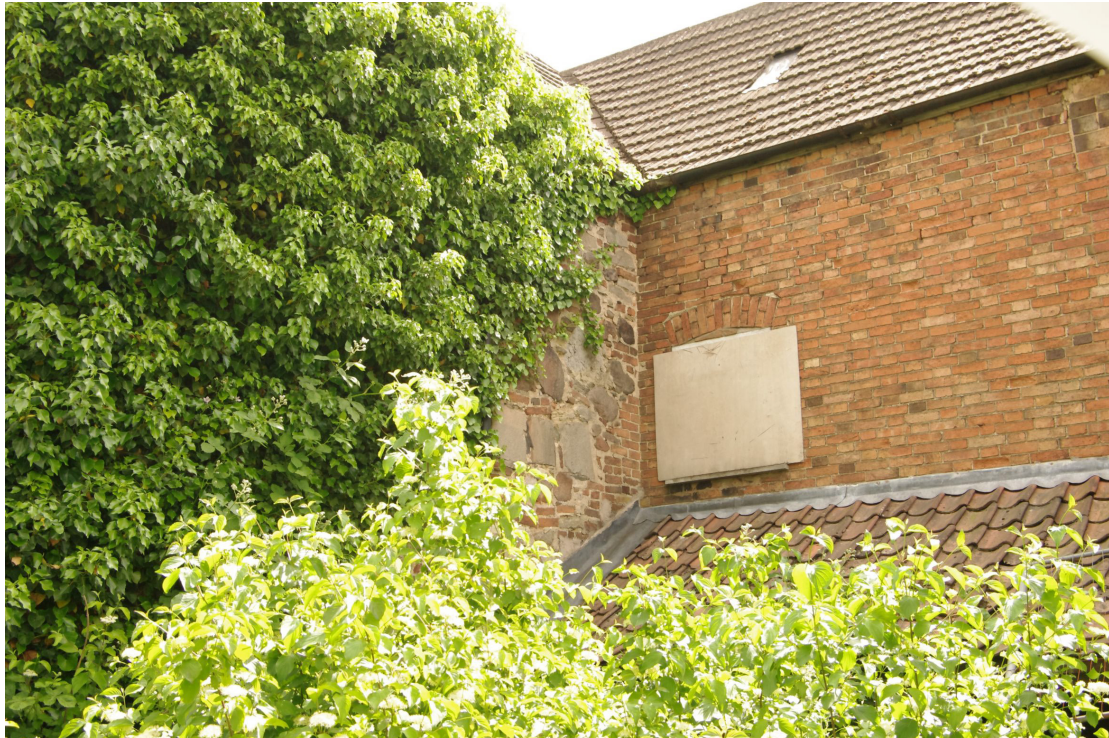
Figure 26 SW facing elevation of rear range and NW facing elevation of 18th century range

Looking south-east. Note mix of stone and brick on rear range

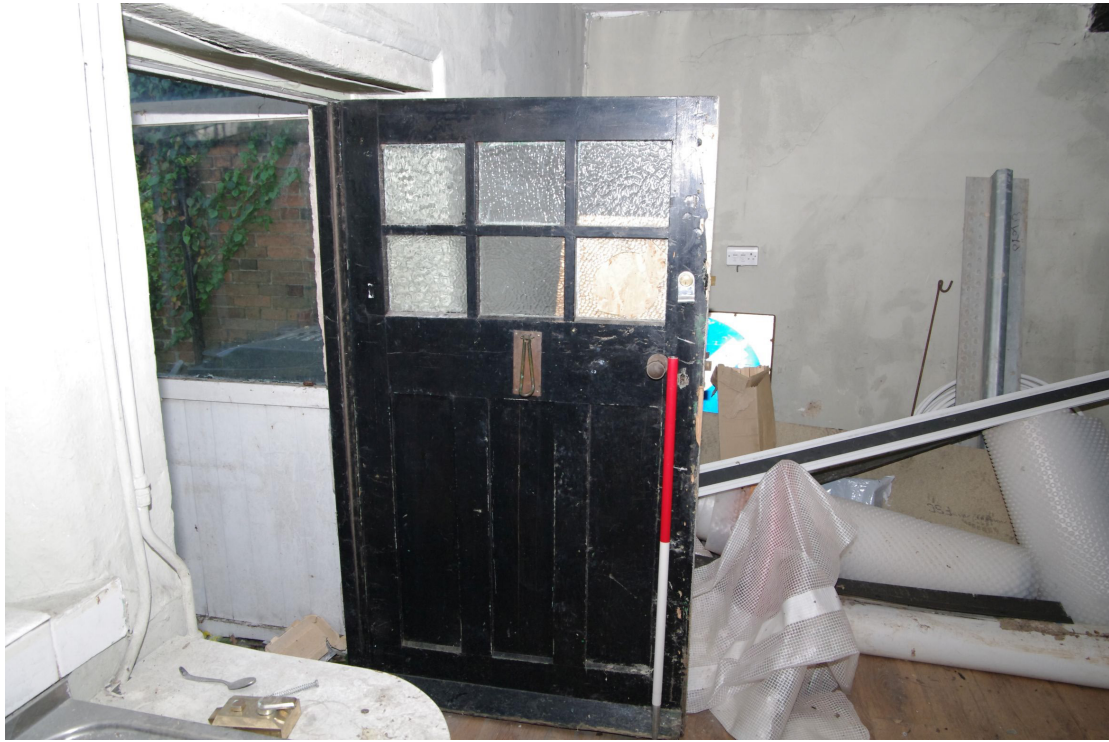
Figure 30 Door detail of rear range door into G1
Note that the earlier staircase was located in the corner behind the door

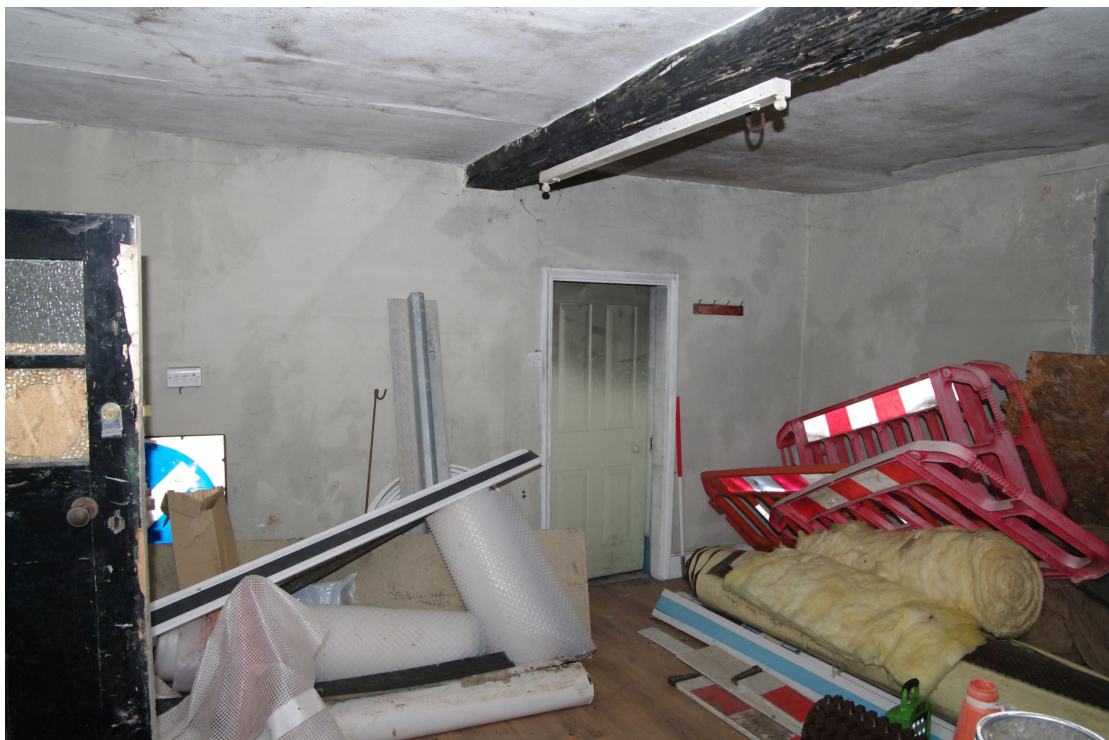
Figure 31 General view of Room G1
Looking south towards doorway to G2 and 18th century range. A blocked doorway from G8 is in the corner behind the safety barriers although no trace is visible here

Figure 51 Room G8 lean-to
Looking north-west. The white rail marks the top of the cellar stairs. Evidence of a blocked doorway on far wall leading into G1 (see Fig. 31)

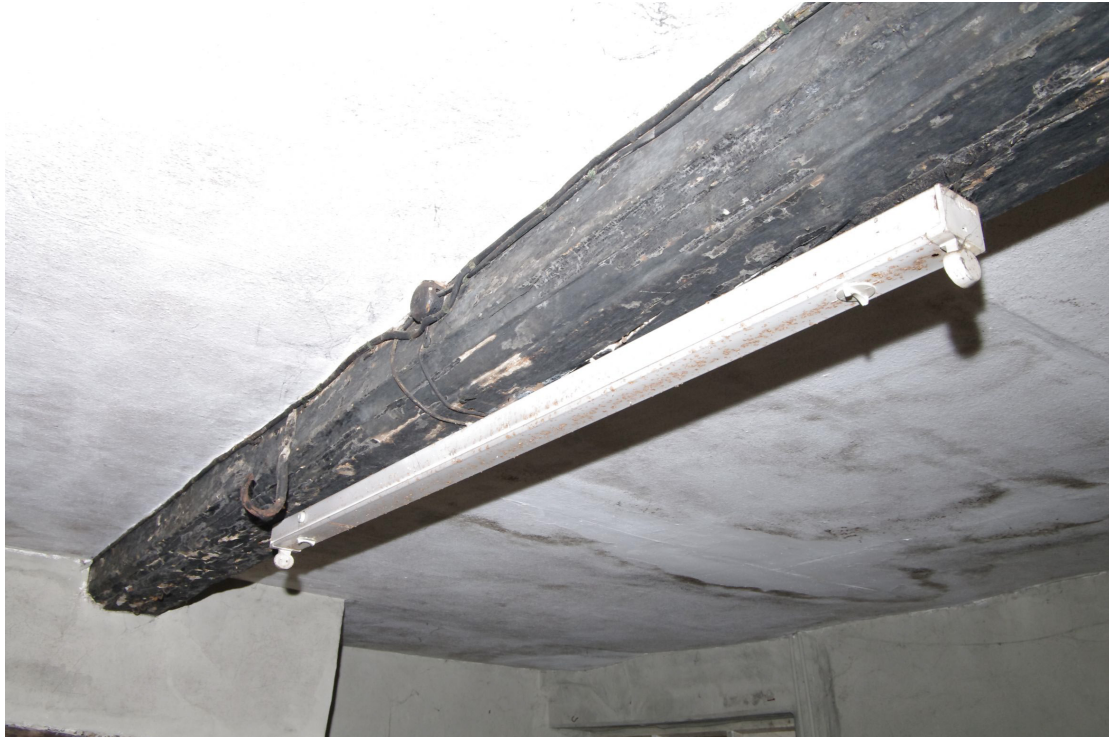
Figure 34 Room G1 beam detail
Looking north. Note hook, also that the chamfer continues into the wall above the fireplace

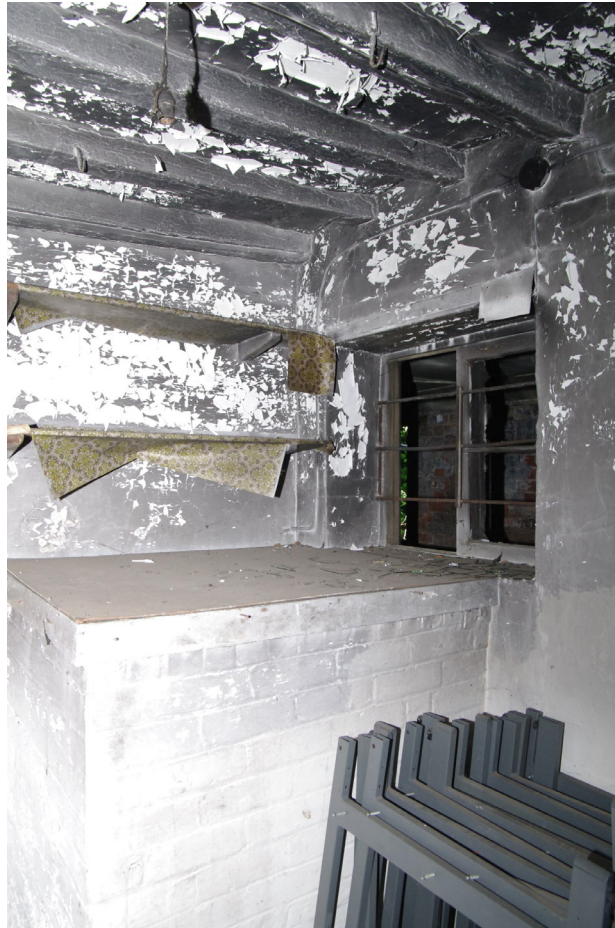
Figure 40 Room G3
Looking north. The brick base forms the roof of the cellar stairs

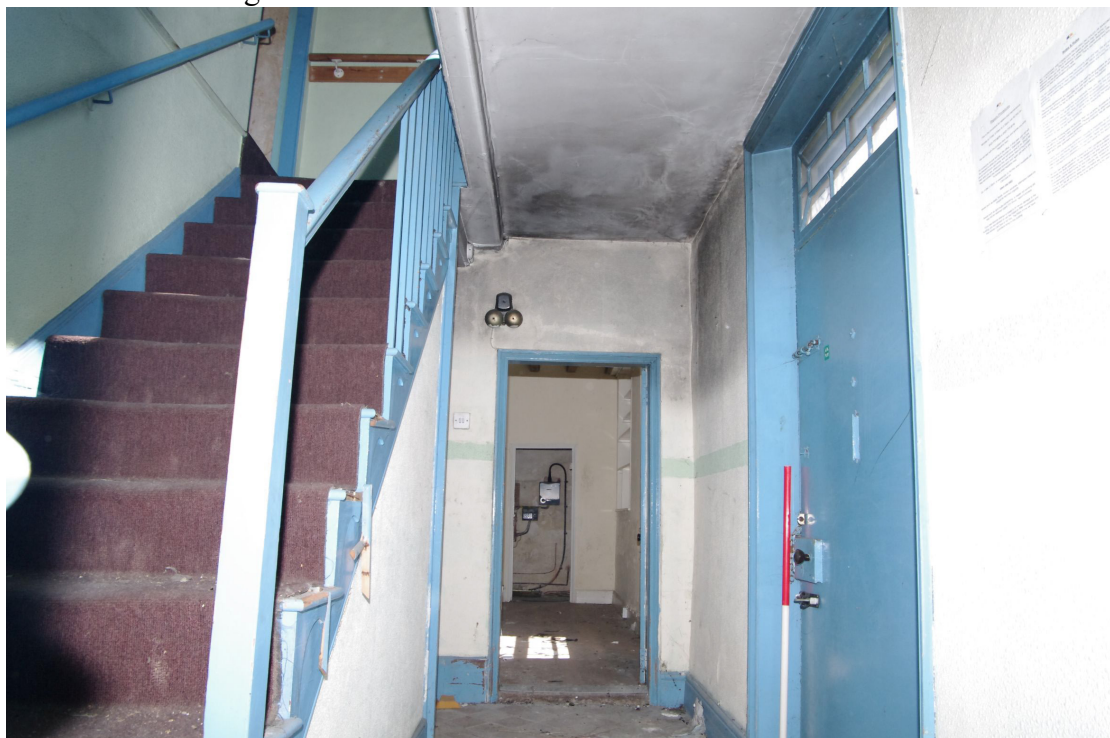
Figure 41 Hallway G4
Looking north-east. Front door on right. Room G5 ahead and corridor G2 left beyond the stairs

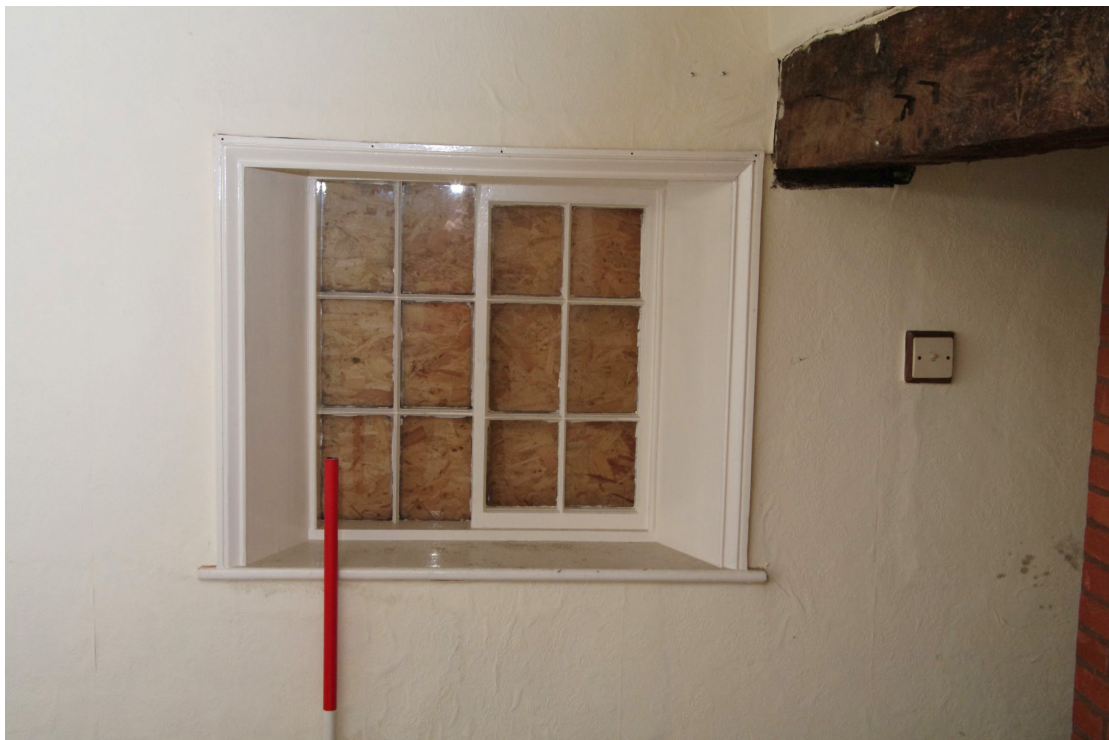
Figure 45 Window detail on north-west wall of Room G5
Horizontal sliding sash

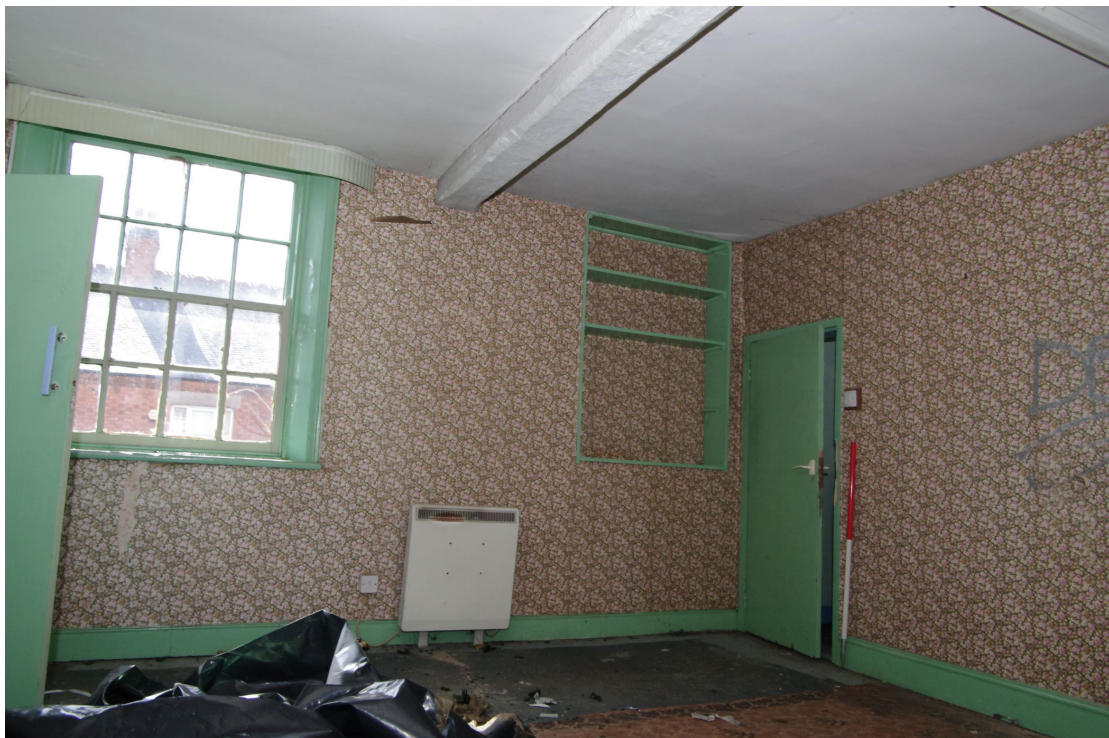
Figure 58 General view of Room F3

Looking north. Doors to right lead to cupboards either side of chimney. Note iron bar added to strengthen the beam where it has cracked at a redundant socket. The repair appears to be quite old. 1m scale

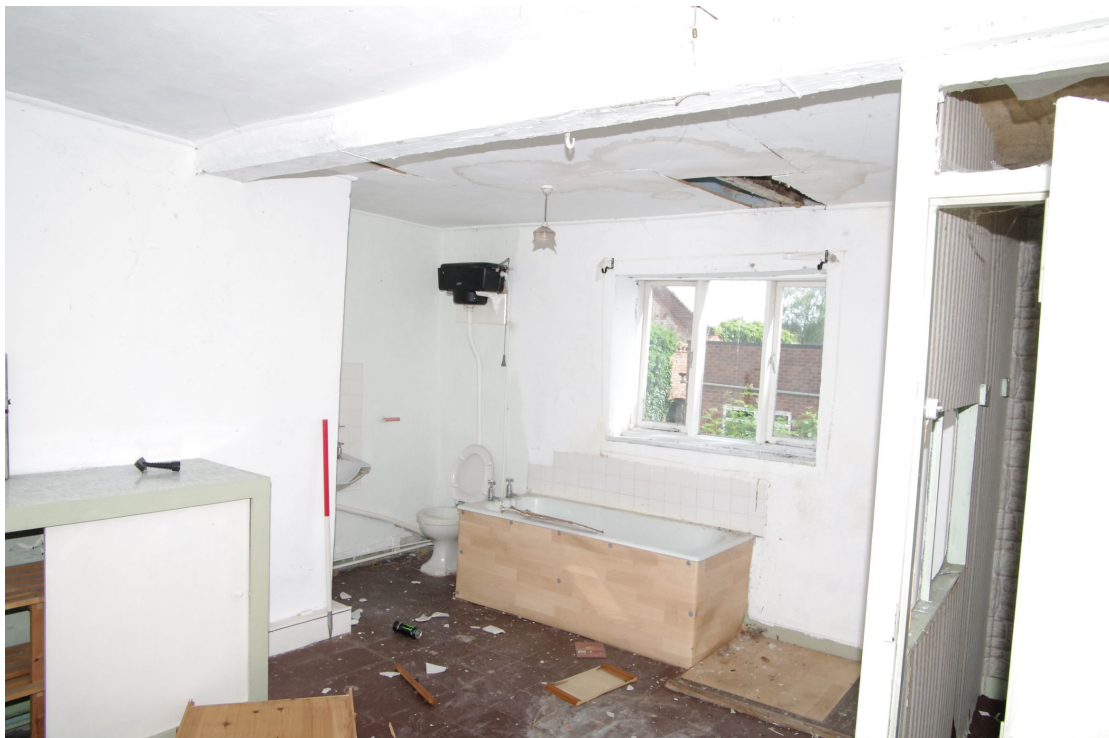
Figure 63 General view of Room F6
Looking north. The raised woodwork to the right of the bath show where the stairs came up from the ground floor. The stairs to the second floor were enclosed by the partition on the right. 1m scale

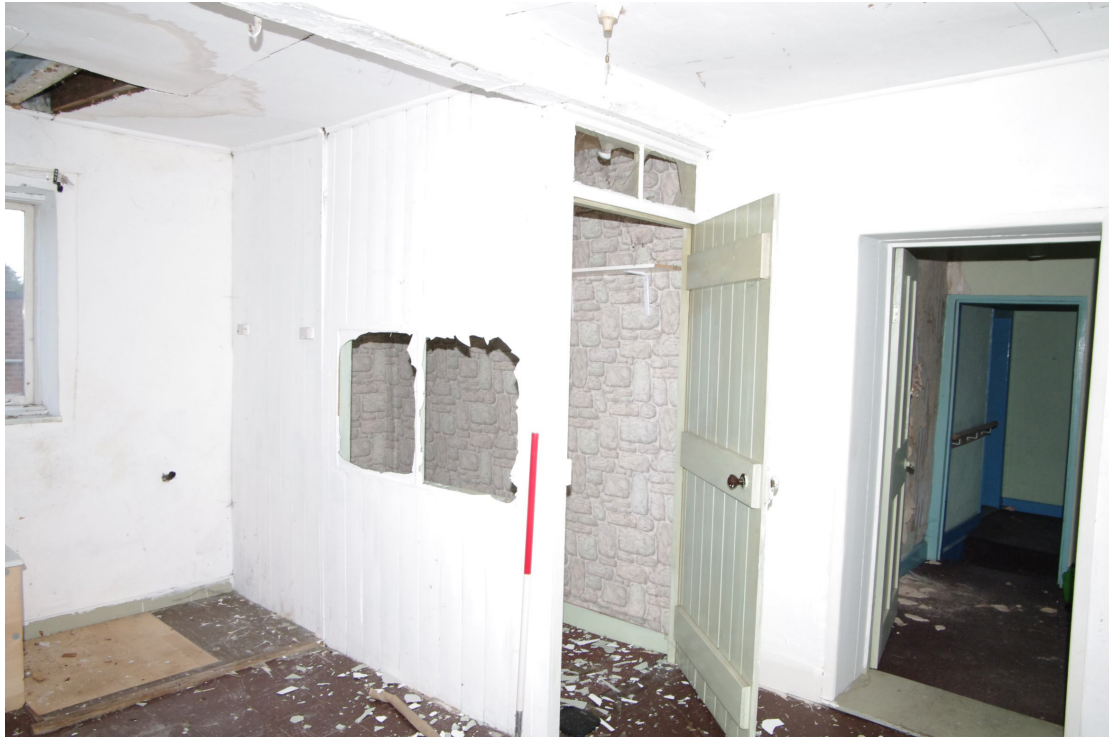
Figure 64 Room F6 and enclosed staircase partition
The stairs are no longer present. Doorway to Room F4 on right

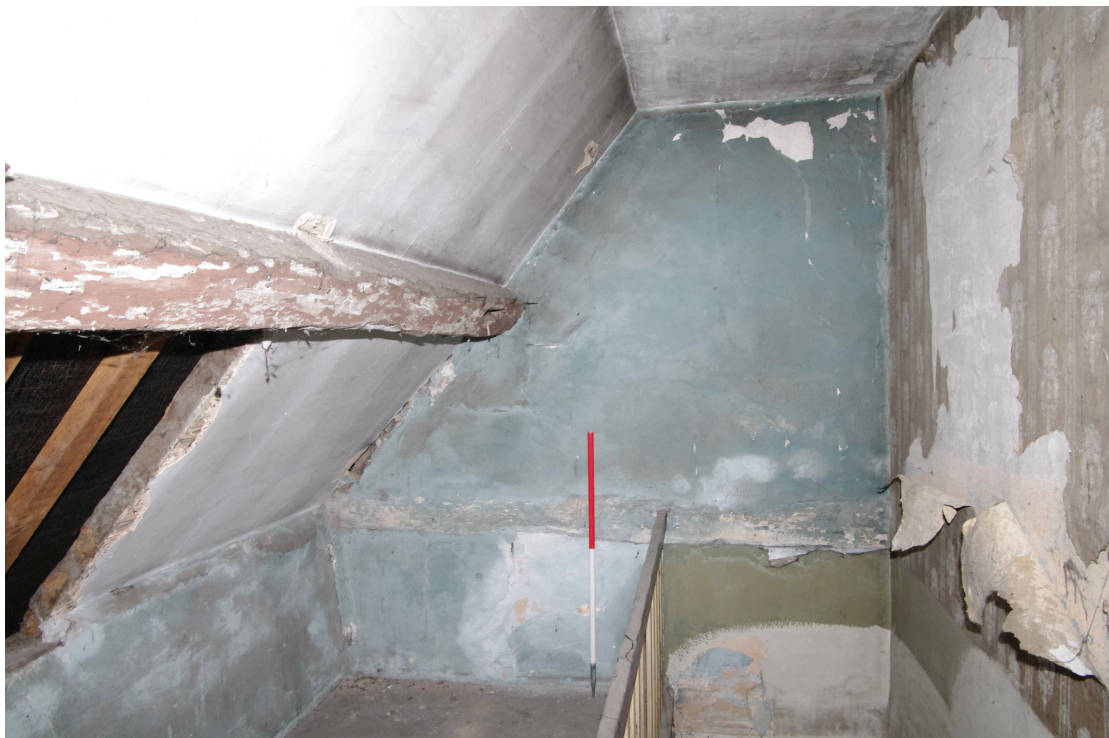
Figure 69 General view of Room S1
Looking south-west. Note redundant socket towards the end of the purlin

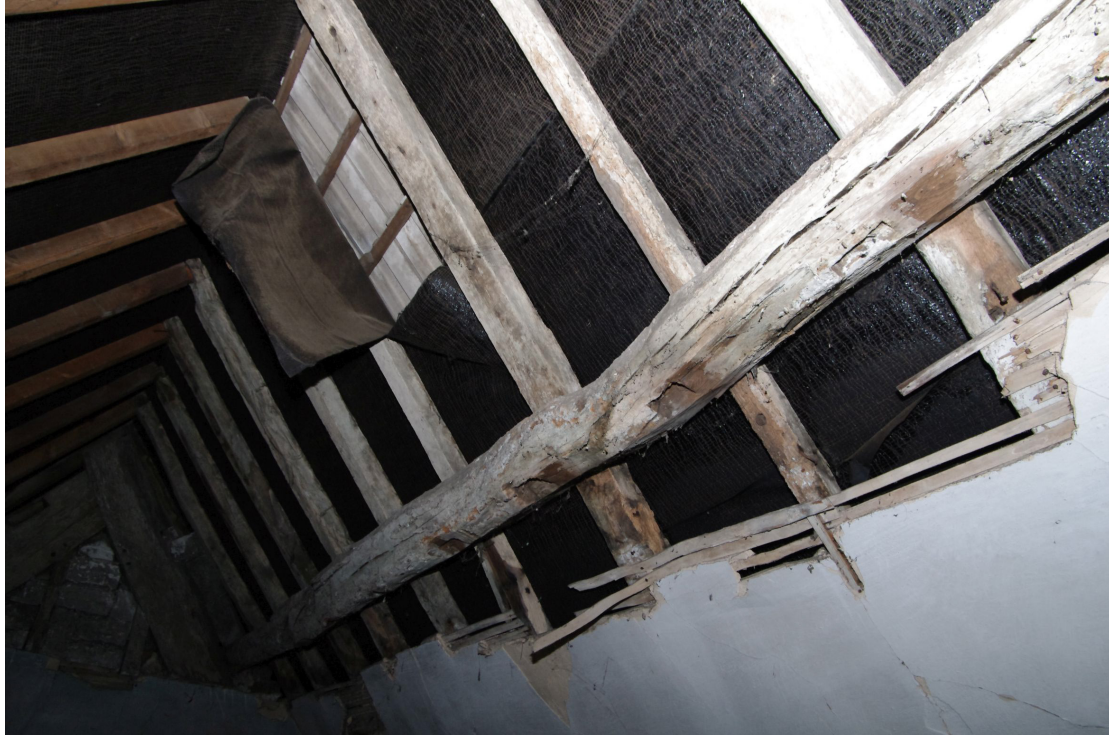
Figure 76 Room S3 upper purlin detail on SE side of roof
This is a re-used timber with many redundant sockets. Looking east

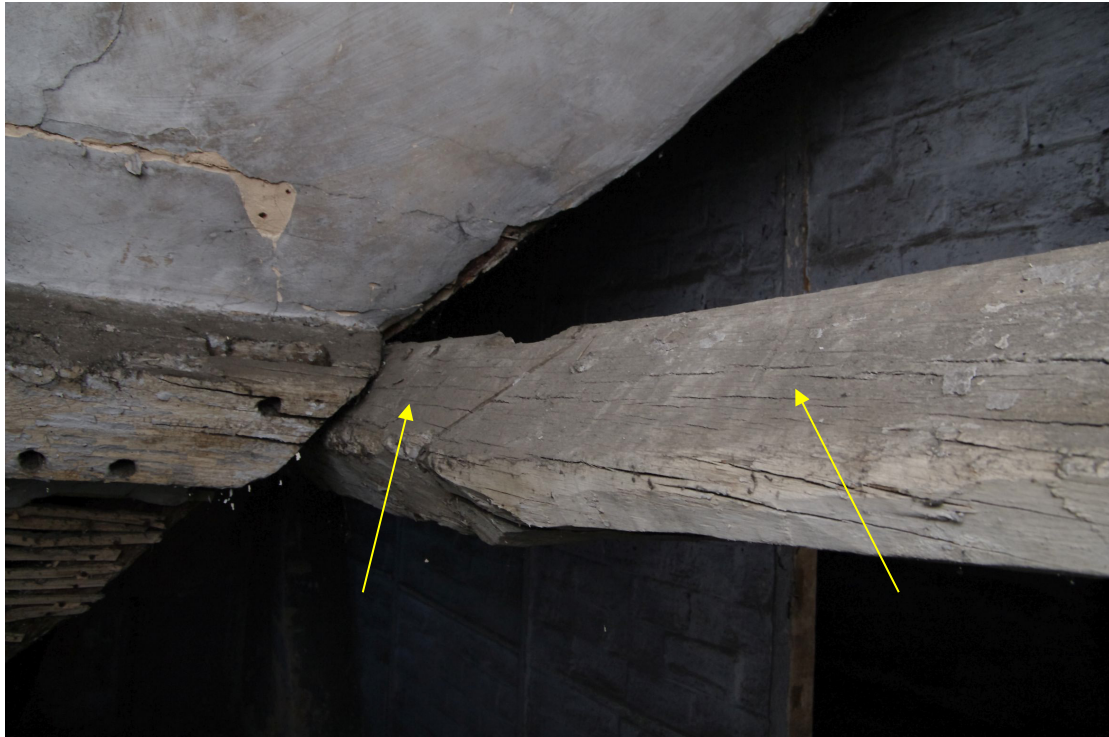
Figure 82 Redundant peg holes and carpenter's marks, Room S5
Looking south-east. The carpenter's marks are seen as Roman numerals II and are highlighted with the arrows

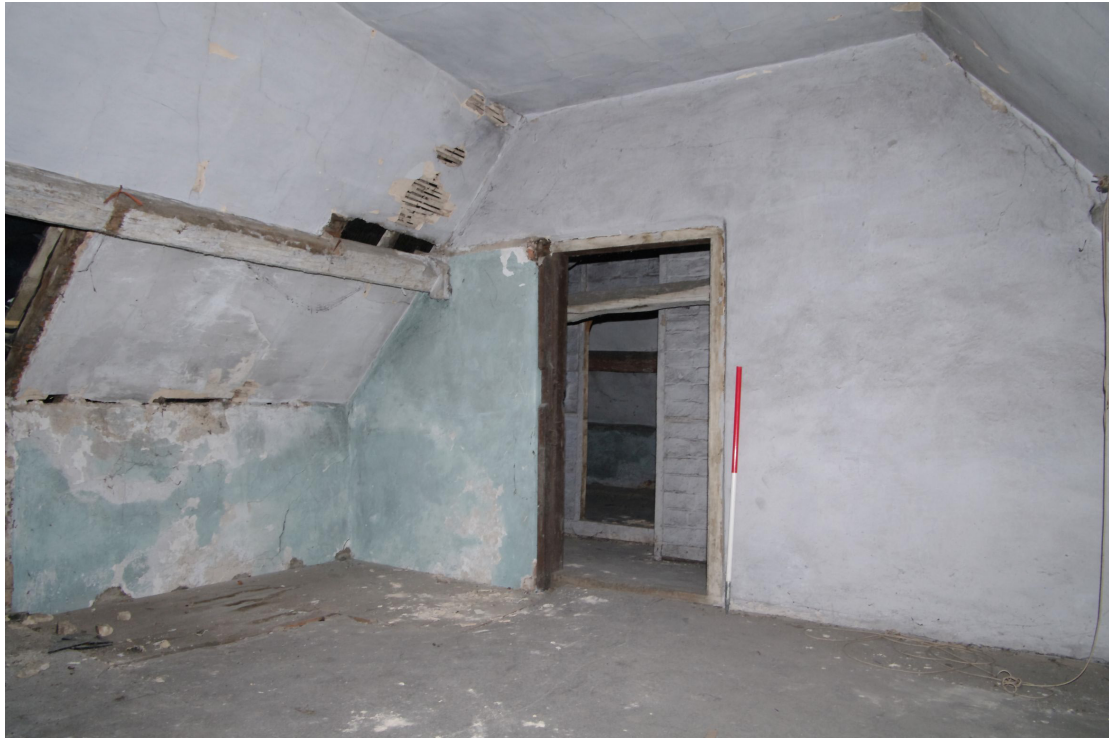
Figure 84 General view of Room S6

Looking south-east towards doorway to Room S5. Note the timber floor area in the left hand corner which marks to location of the earlier stairs these led down to Room F6 – see Figs 63 to 65. 1m scale

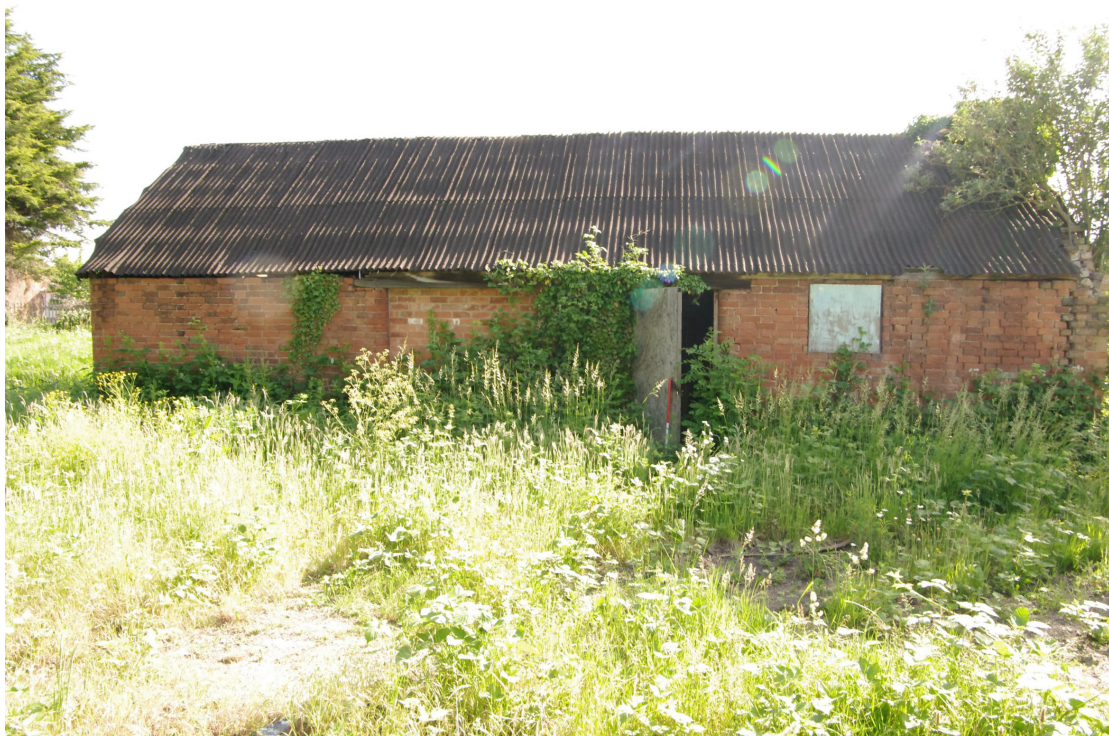
Figure 85 Barn 1, south-west facing elevation

Looking north-east. Modern blocking to entrance to left of 1m scale. The corrugated sheeting is probably mid-20th century or later

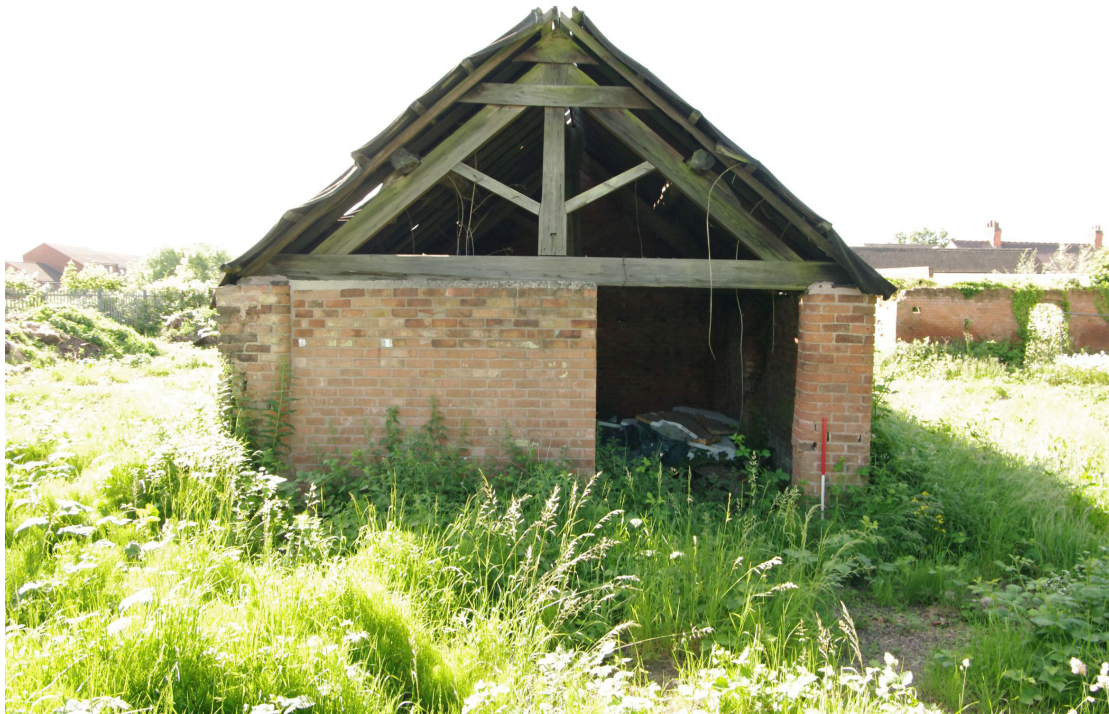
Figure 88 Barn 1, north-west facing elevation
Looking south-east. The bolted roof structure suggests a later 19th century date although the purlins inside are re-used and earlier. Barn 2 to right.

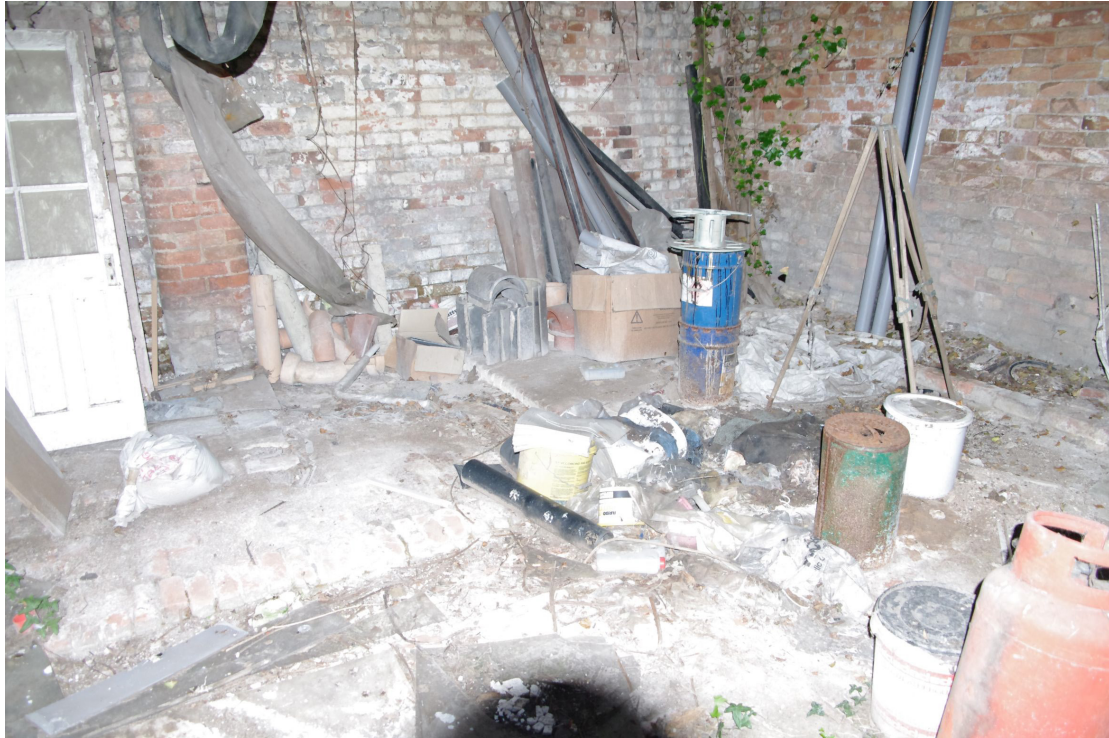
Figure 90 Barn 1, southern room
Looking east at raised brick stands for cattle and byers

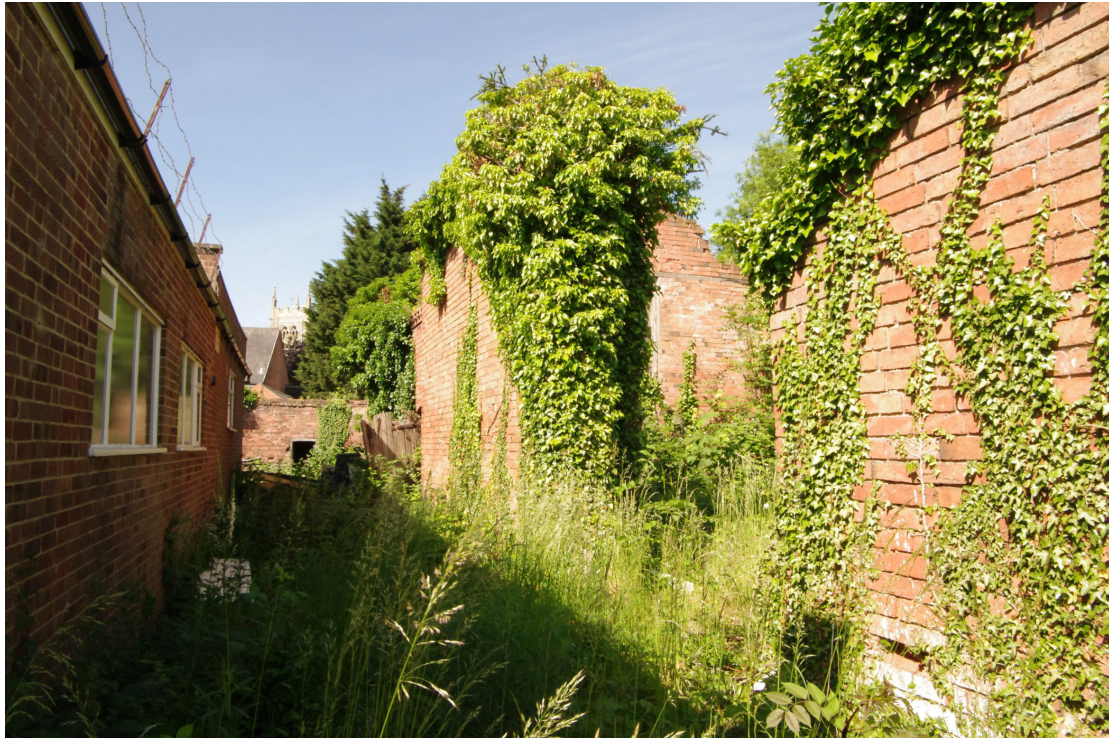
Figure 94 Barn 2, south-east facing elevation
Looking west. This elevation originally faced into the courtyard hence the wide opening. The modern garage is on the left

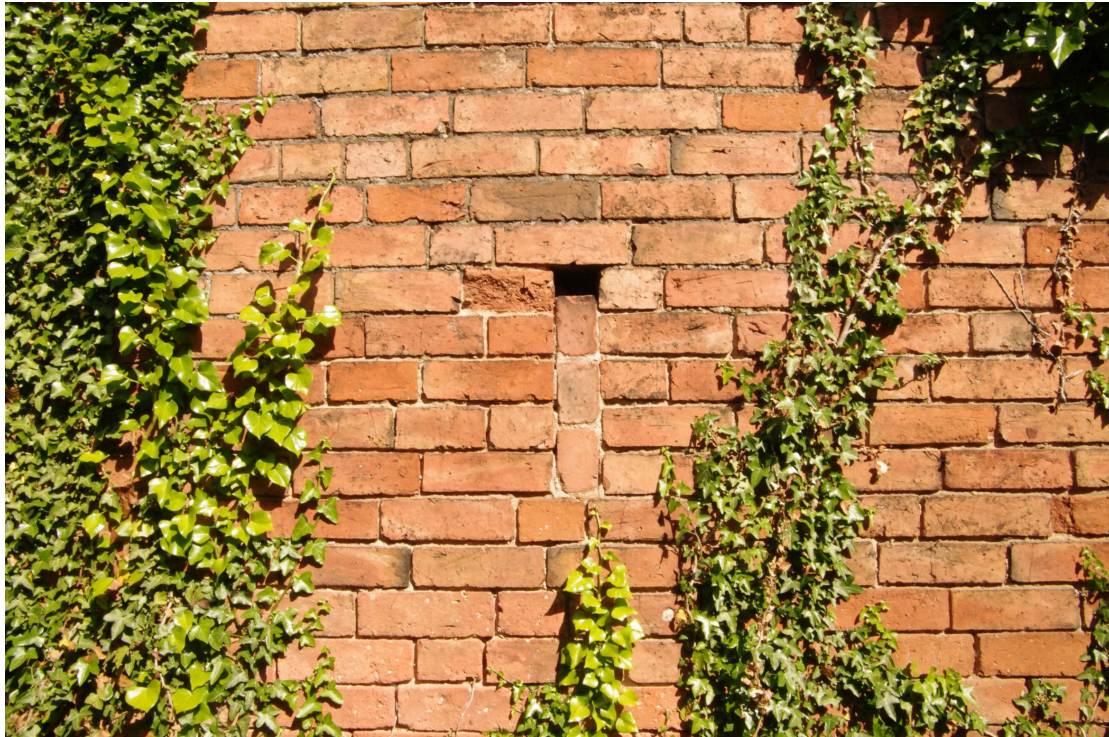
Figure 96 Barn 2, south-east facing elevation blocked ventilation slit
Looking north-west

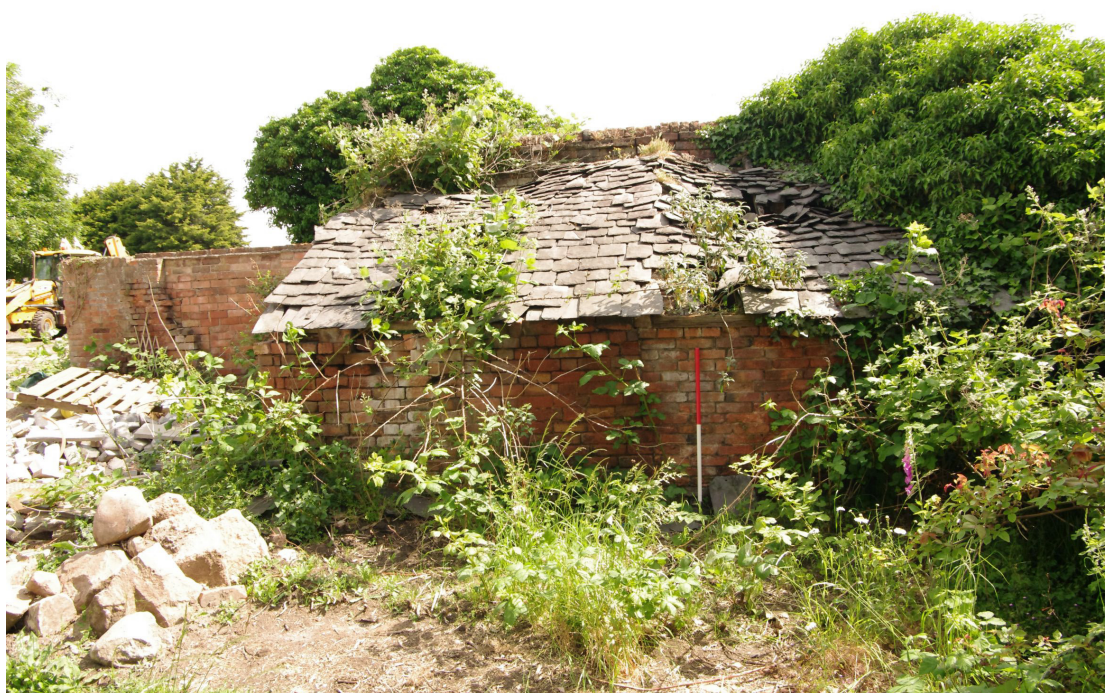
Figure 101 Outbuilding 1, south-west facing elevation
Looking north-east. The roof uses graded slates which have been drilled suggesting a
19th century date

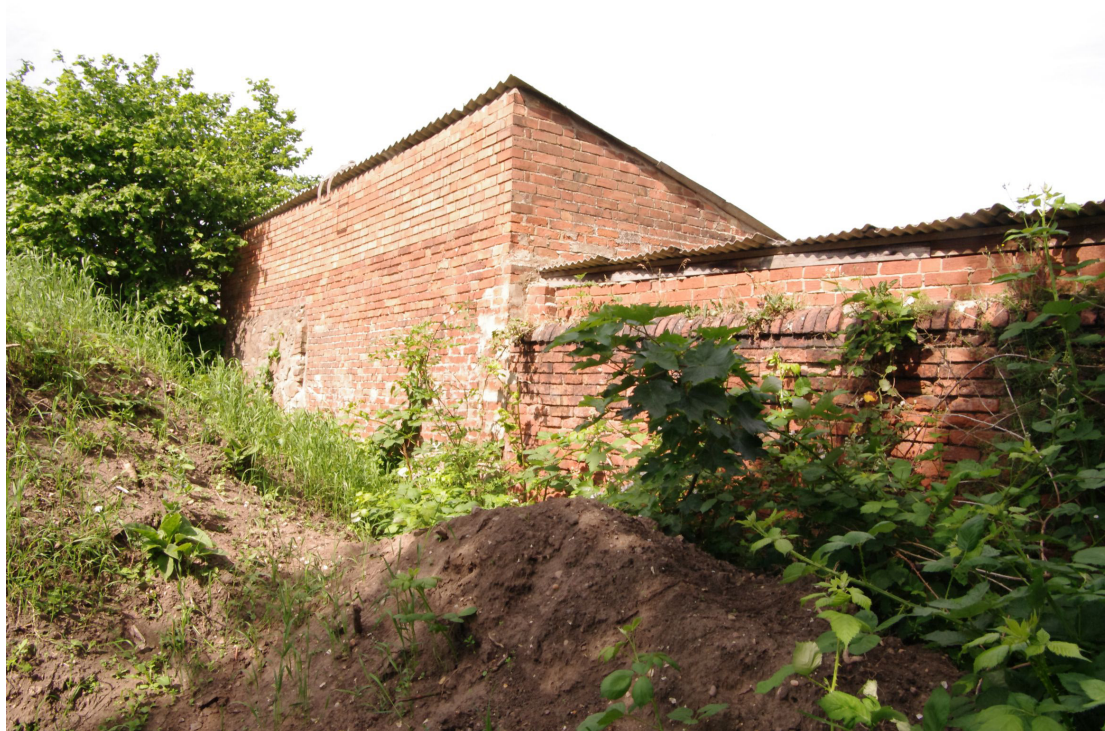
Figure 105 Boundary wall close to north-western corner of the site
Looking west. Note the area of stone towards the left of the picture which has been incorporated into the building. The capped brick wall runs towards Outbuilding 2 (see Fig. 103 above)
