**A Level 2 Historic Building Recording at
7 King Street,
Sileby,
Leicestershire
NGR: SK 6013 1527**

**ULAS Report No 2021-093
©2021**

Site Name: 7 King Street, Sileby, Leicestershire.

Client: UCR Construction and Development Limited

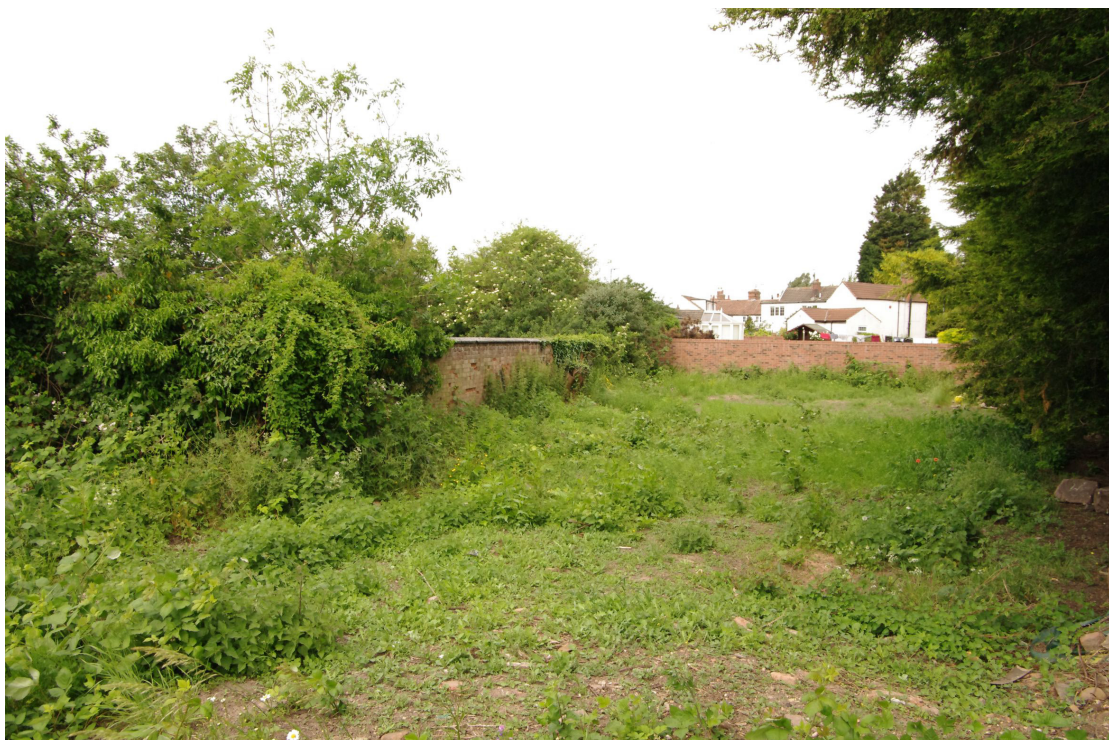
Figure 107 Boundary wall in north-eastern corner of site
The wall is completely brick-built at this point. The eastern boundary alongside the railway is a modern steel fence
