**A Level 2 Historic Building Survey at  
Limes Farmhouse Barns,  
22 Main Street,  
Breedon on the Hill,  
Leicestershire  
NGR: SK 40569 22848**

**ULAS Report No 2021-156  
©2021**

**Site Name:** Limes Farmhouse Barns, 22 Main Street, Breedon on the Hill, Leicestershire.

**Author:** Andrew Hyam

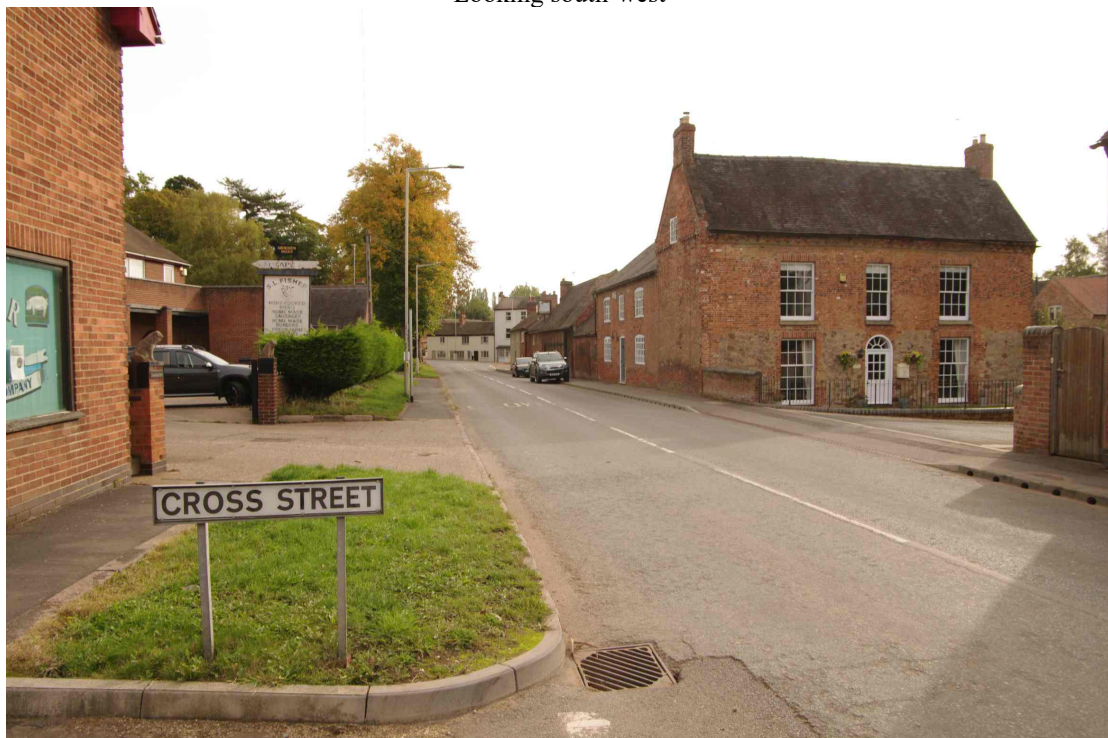
Figure 10 View of site from Main Street  
Looking east. Limes Farmhouse on right

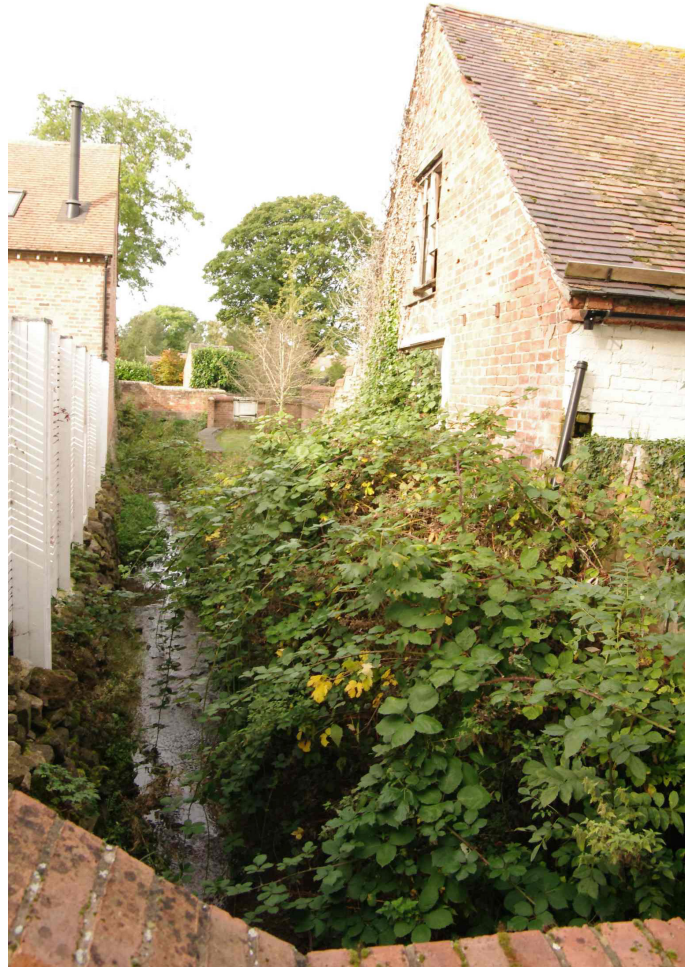
Figure 11 Rear, south, of the site seen from across the brook  
Looking west. Modern houses on left

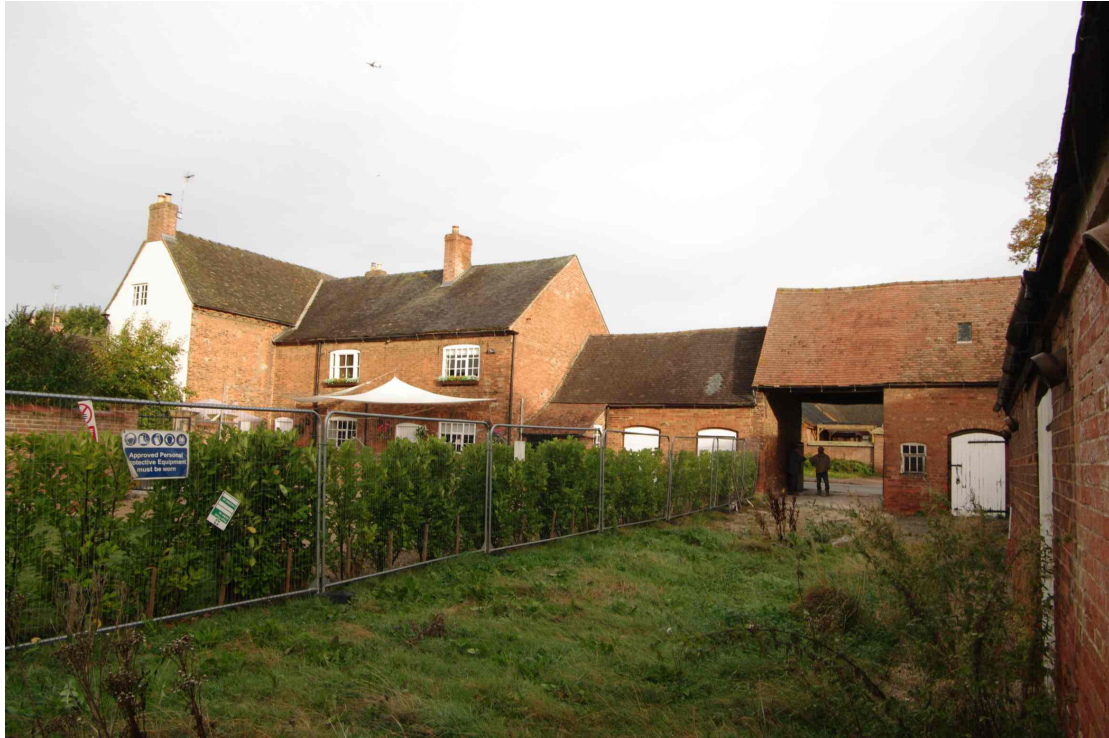
Figure 13 Limes Farmhouse seen from the south  
Looking north-west. Barns on right of picture

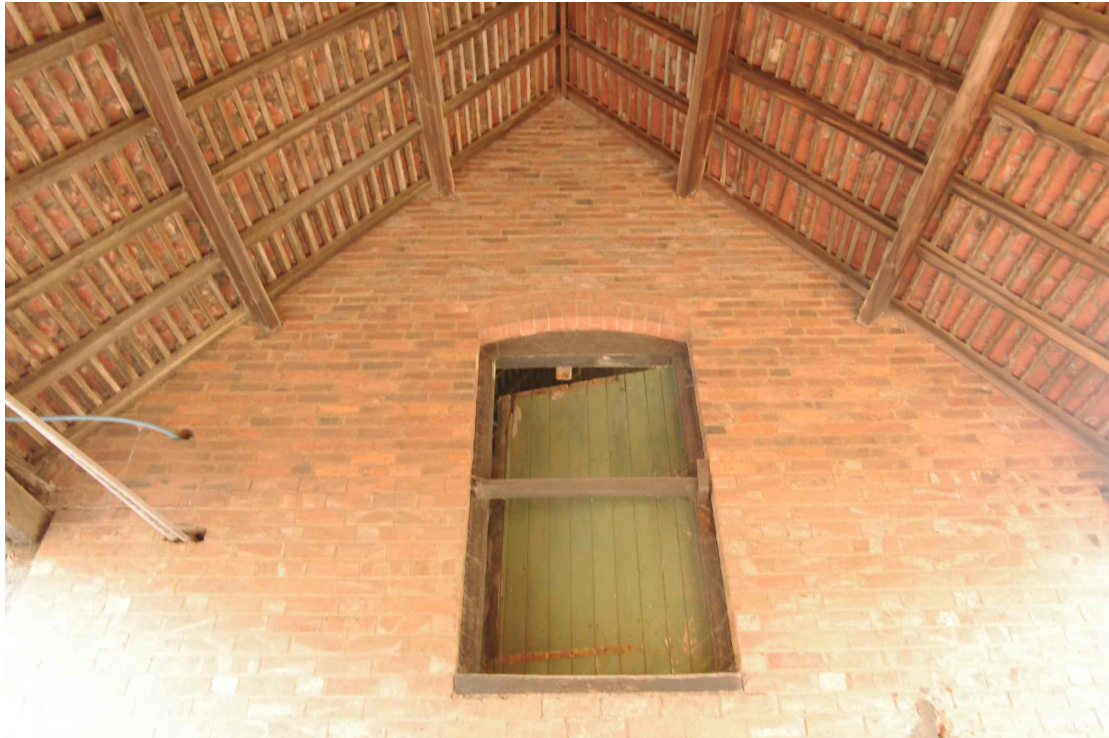
Figure 21 Hayloft door on west facing gable under covered entrance  
Looking east

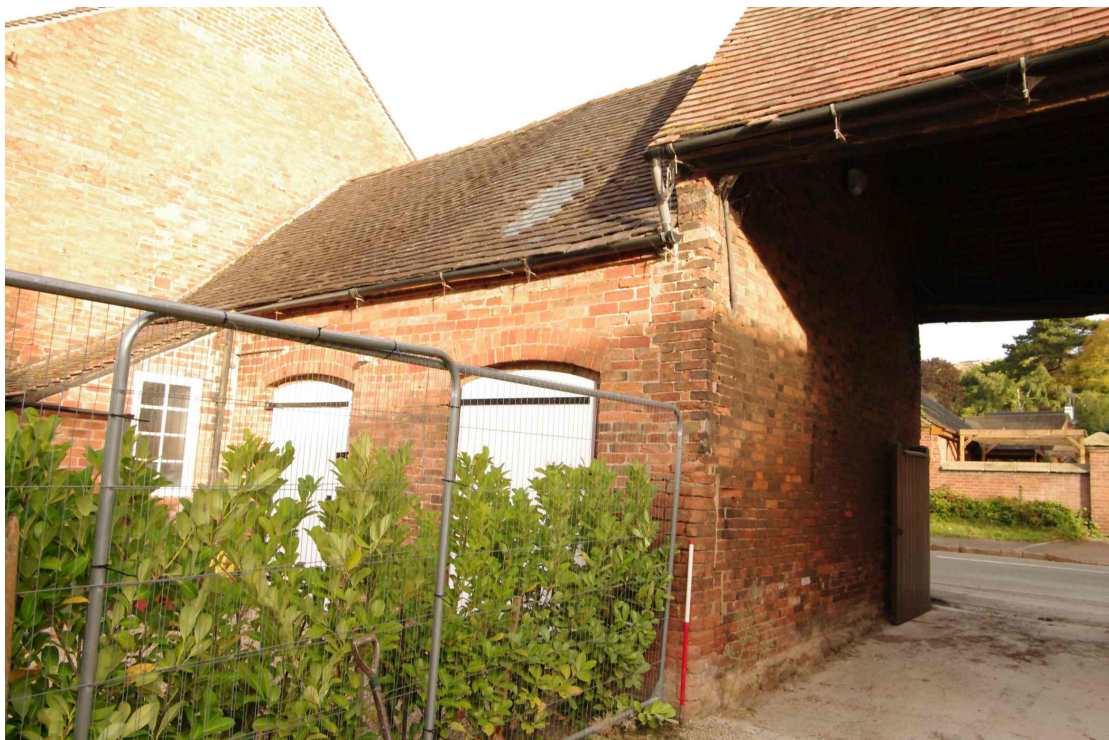
Figure 22 West side of covered entrance  
Looking north-west towards the Limes Farmhouse buildings. 1m scale. Main Street through entrance

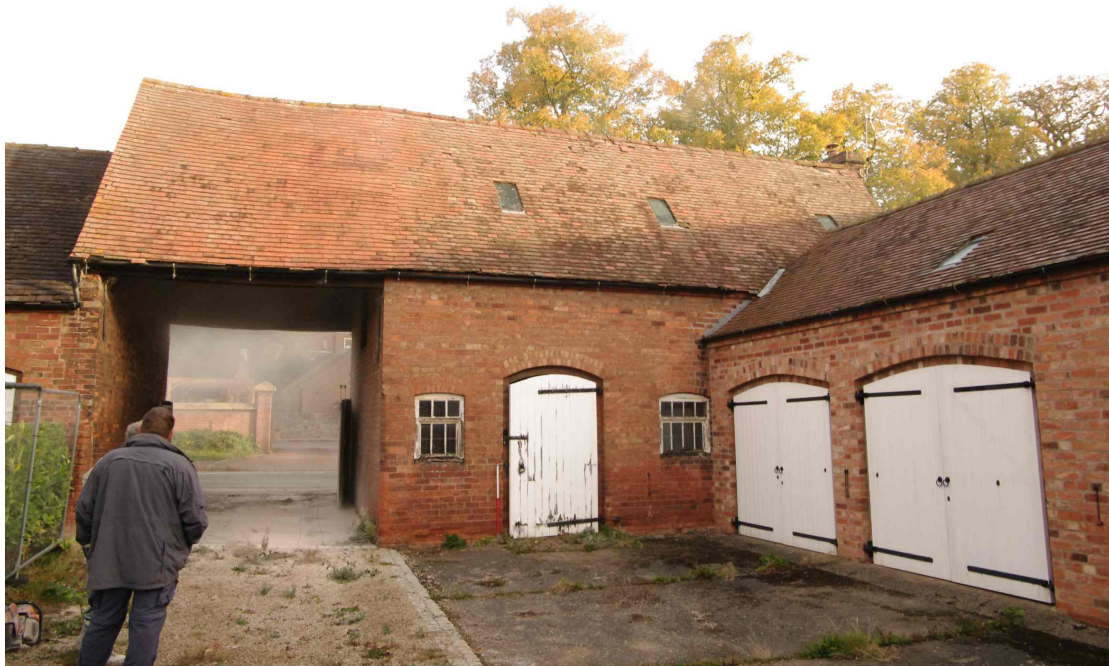
Figure 23 South facing elevation of northern barn  
Looking north. 1m scale. Main Street through entrance

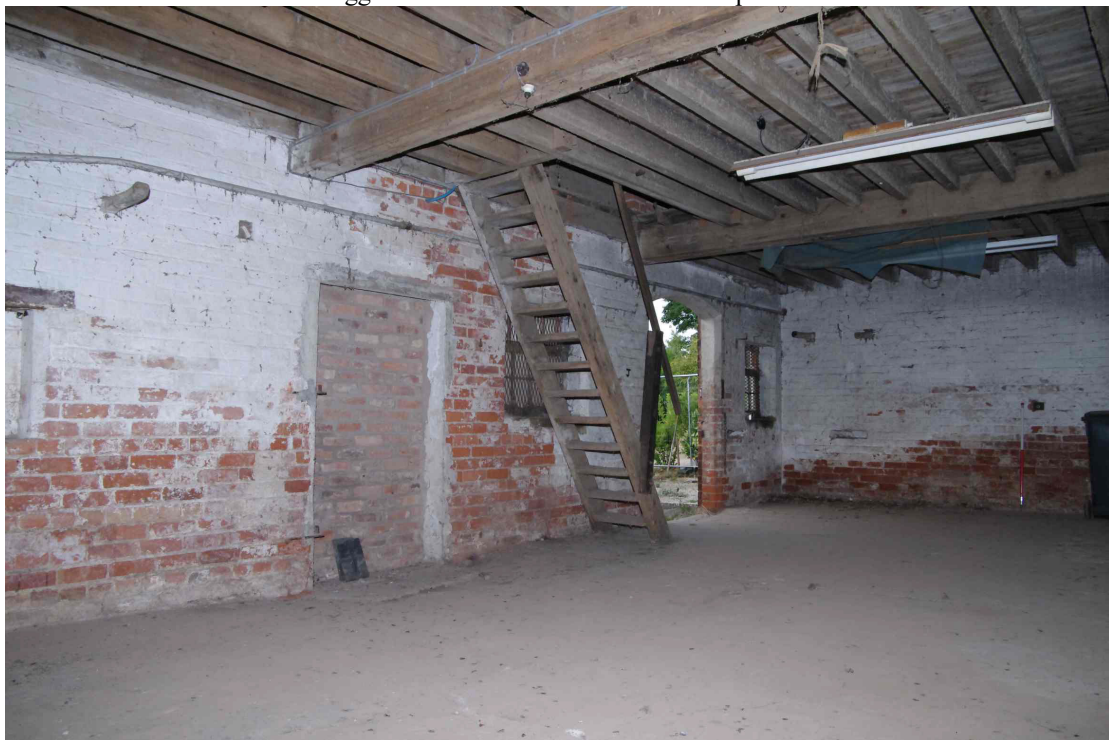
Figure 28 General view of north barn ground floor  
Looking south-west

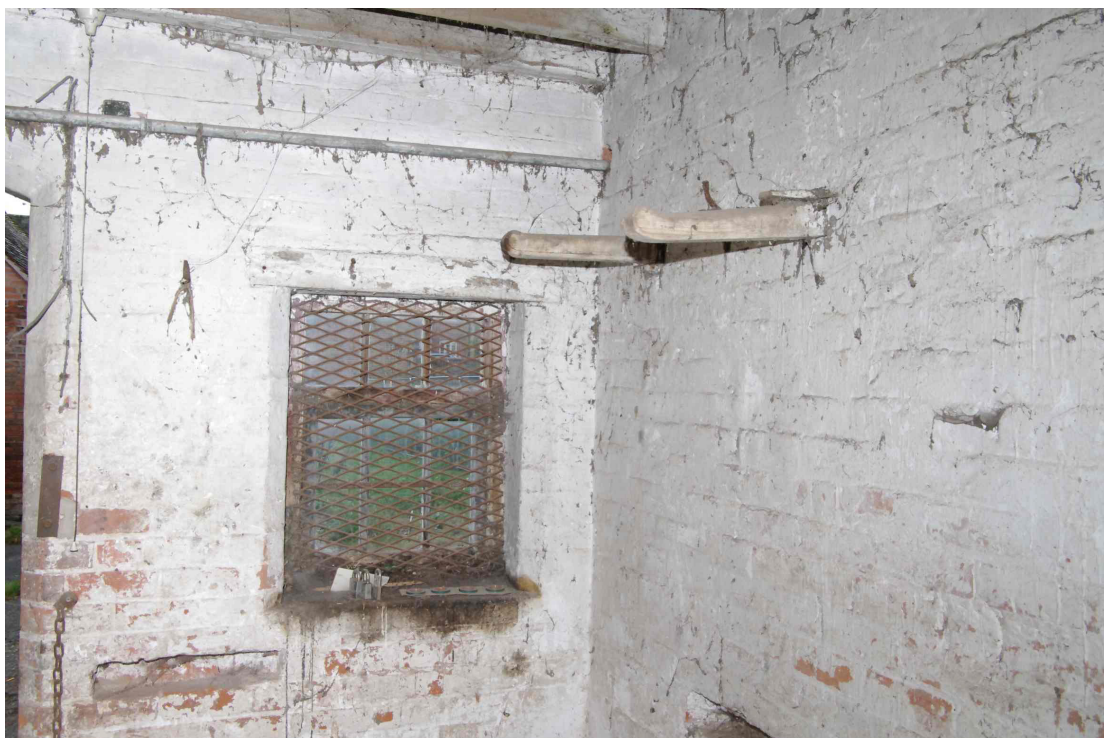
Figure 30 North barn, ground floor. Window detail  
Looking south-west. Note saddle trees

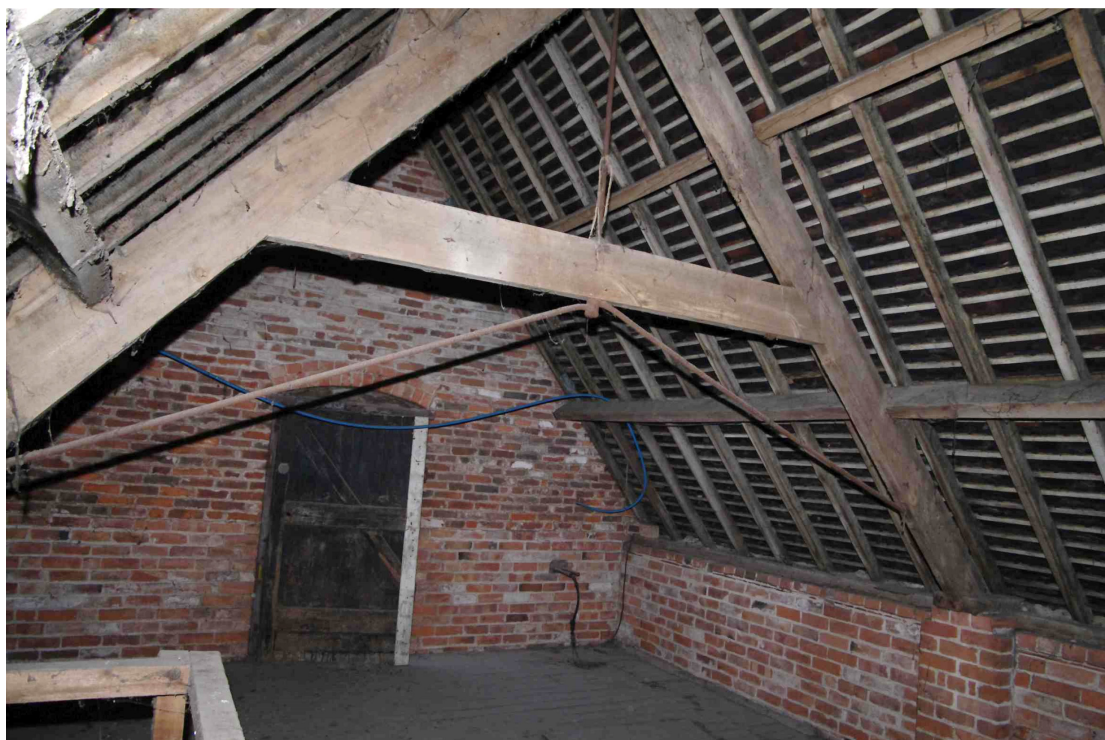
Figure 33 North barn, first floor  
Looking north-west towards hayloft door

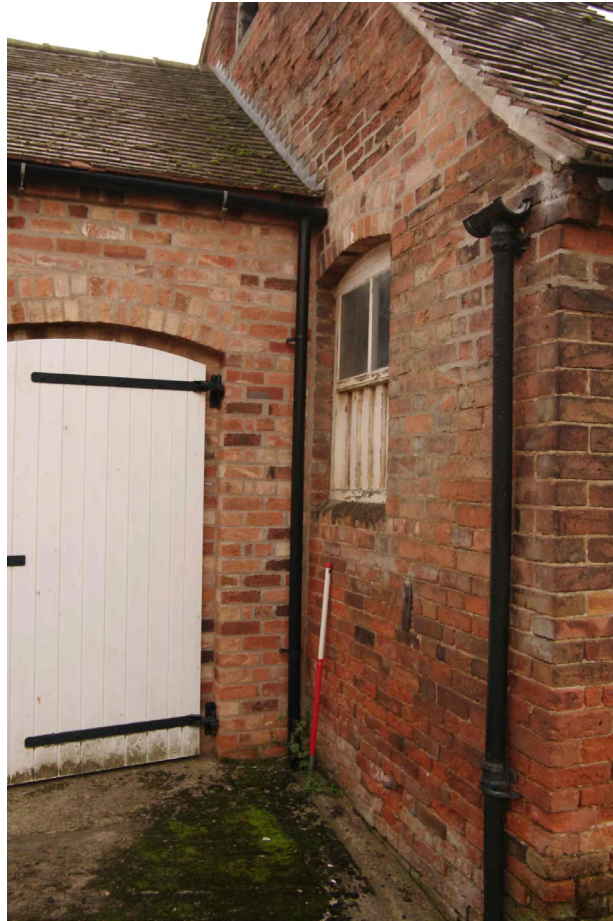
Figure 37 Junction of middle and south barns  
Looking south-east. 1m scale

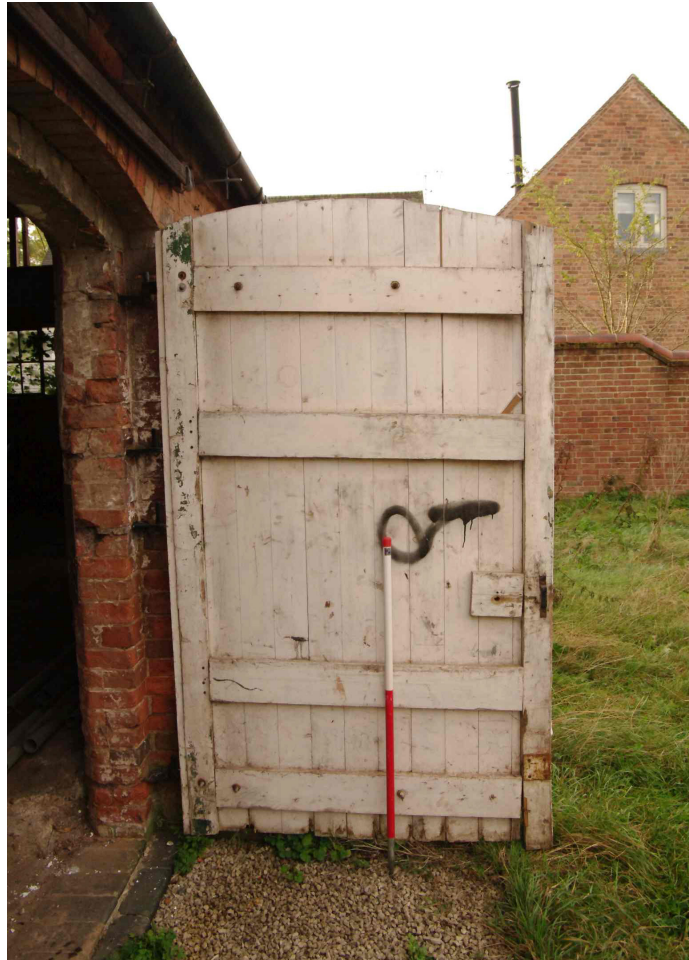
Figure 45 South barn door detail  
Door located on the west facing elevation. 1m scale

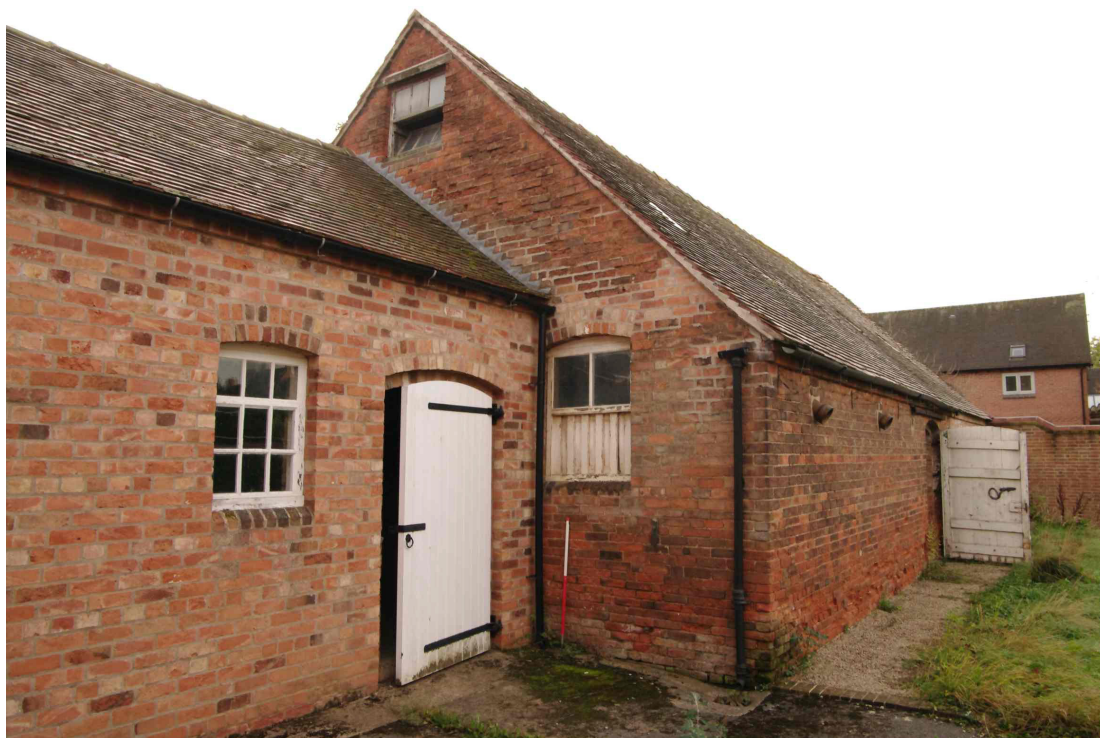
Figure 48 North facing gable end of south barn  
Looking south-east. 1m scale. Middle barn on left. Modern houses on right beyond the brook

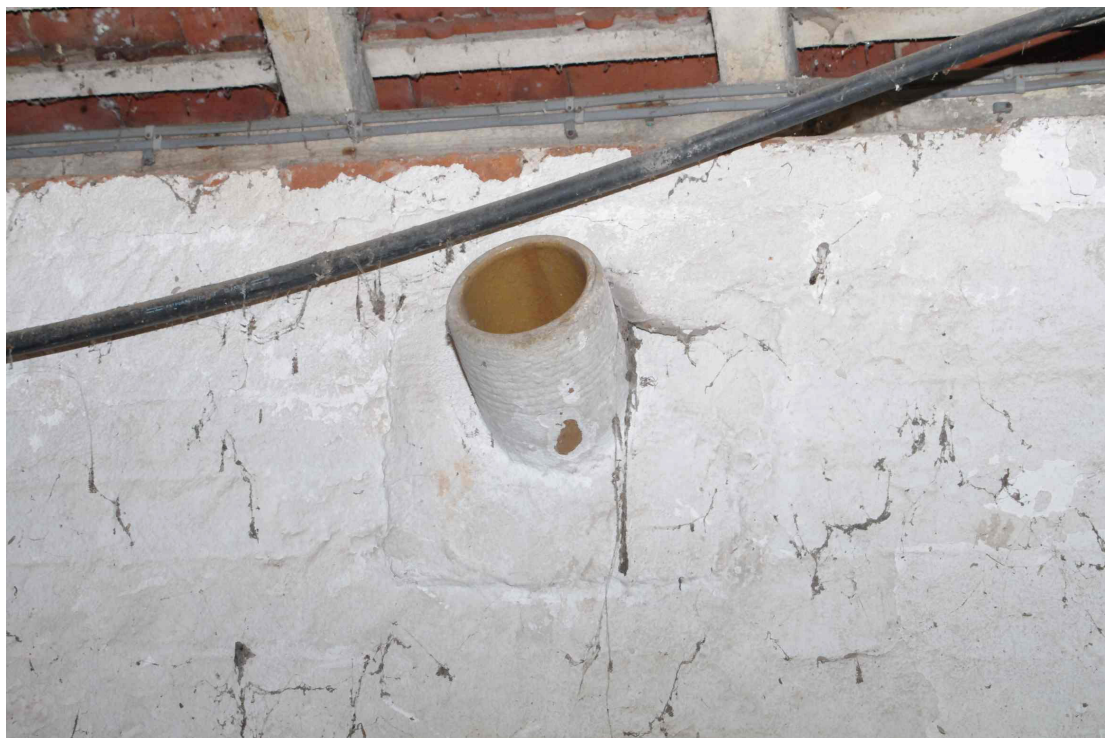
**Figure 44 West facing elevation of the south barn. Vent detail**  
The vents are made from ceramic drain sections and are likely to be mid to late 20th century replacements

Figure 55 South barn, internal vent detail  
See also Figure 44
