**A Level 2 Historic Building Survey at
Winfrey Farm,
Dadlington Lane,
Stapleton,
Leicestershire
NGR: SP 4234 9844**

Client: David Granger Architectural Design Limited

ULAS Report Number: 2021-158

A Level 2 historic building survey at Winfrey Farm, Dadlington Lane, Stapleton, Leicestershire (SP 4234 9844)

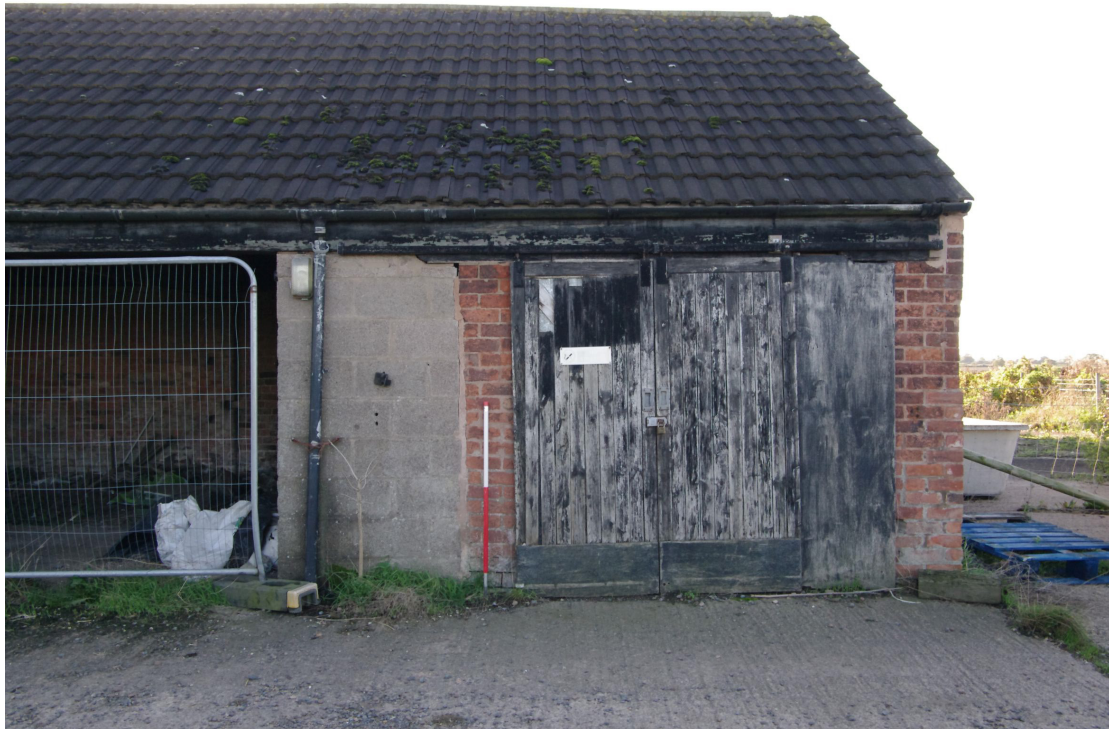
Figure 11 Enclosed western end of Building 1
Looking south-east. The concrete blockwork to the left of the 1m scale is modern and has extended the size of the end room

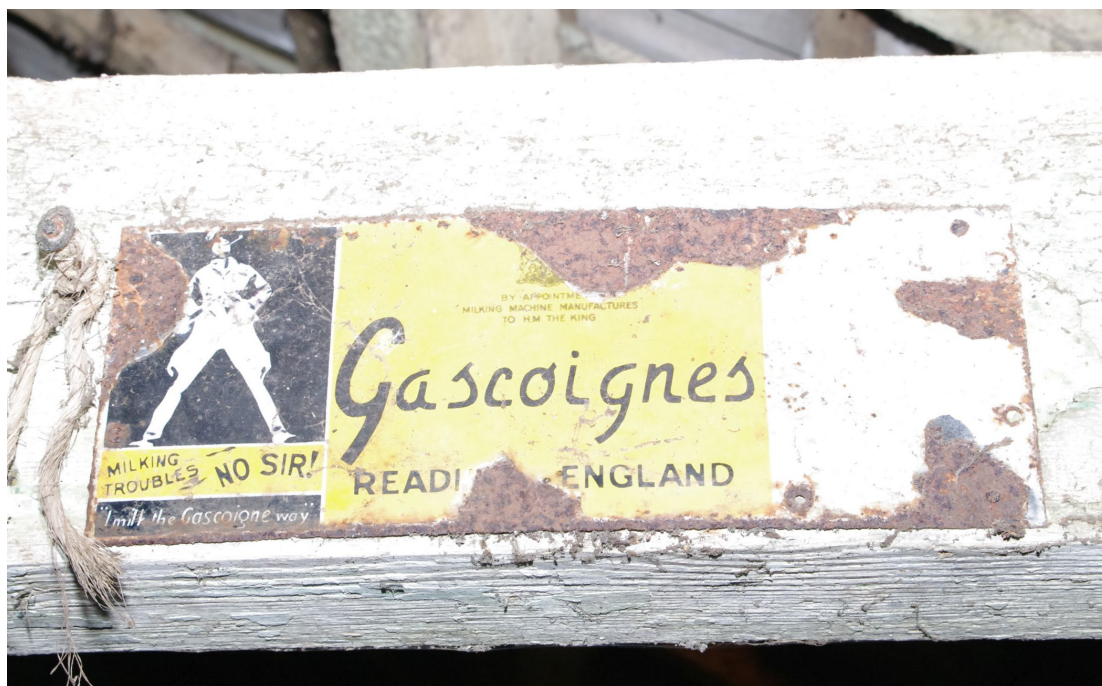
Figure 41 Enamel sign in the northern room of Building 5
The sign notes that it is by appointment to HM The King so is pre-1952 at least. The milking reference also points to its use as a dairy farm (Gascoignes produced milking equipment)

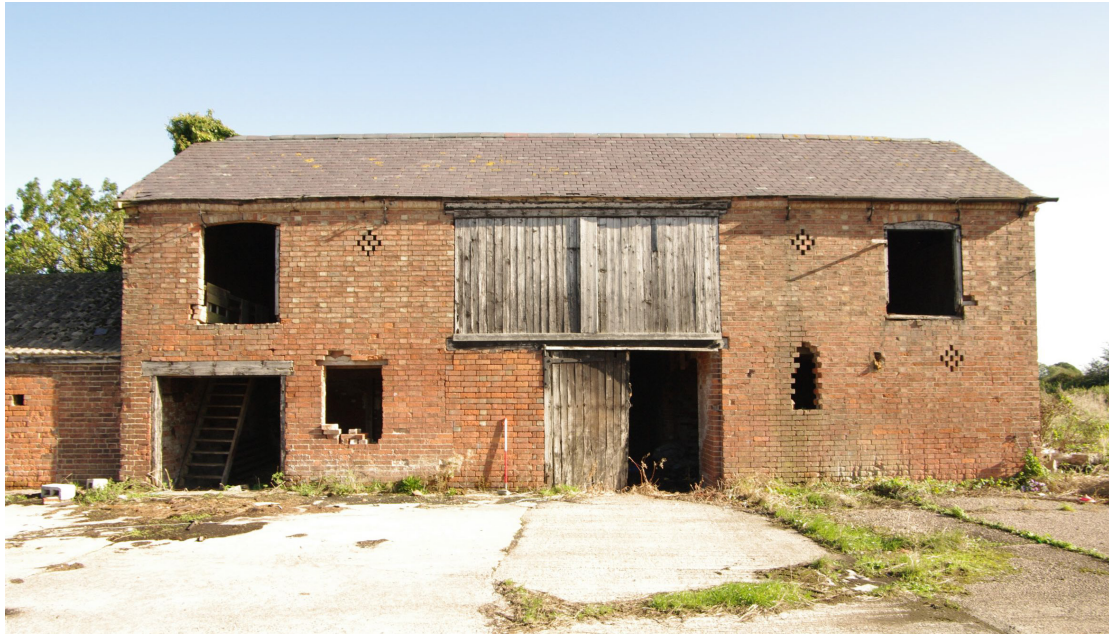
Figure 51 Building 6 south-west facing elevation

Looking north-east. The original full-height central threshing doors have been partially blocked with brick at ground floor level and timberwork at first floor. The two ground floor openings to the left are probably later modifications. 1m scale

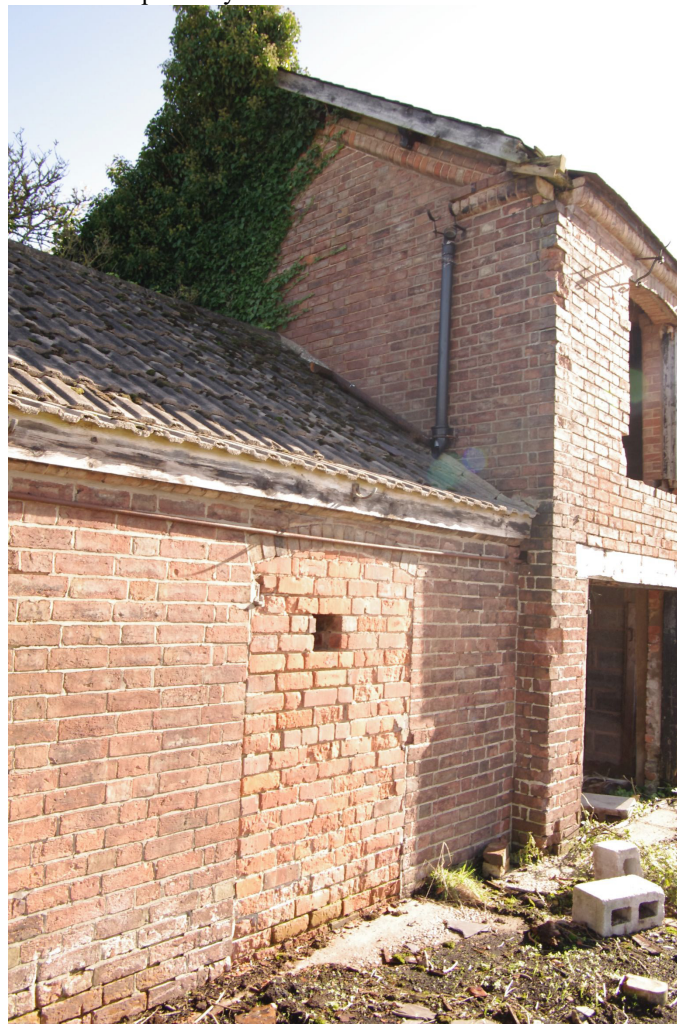
Figure 52 Building 6 north-west facing gable

Building 5 to left. The same brick eaves detail is seen on Building 4 and 5 but not 1 or 7

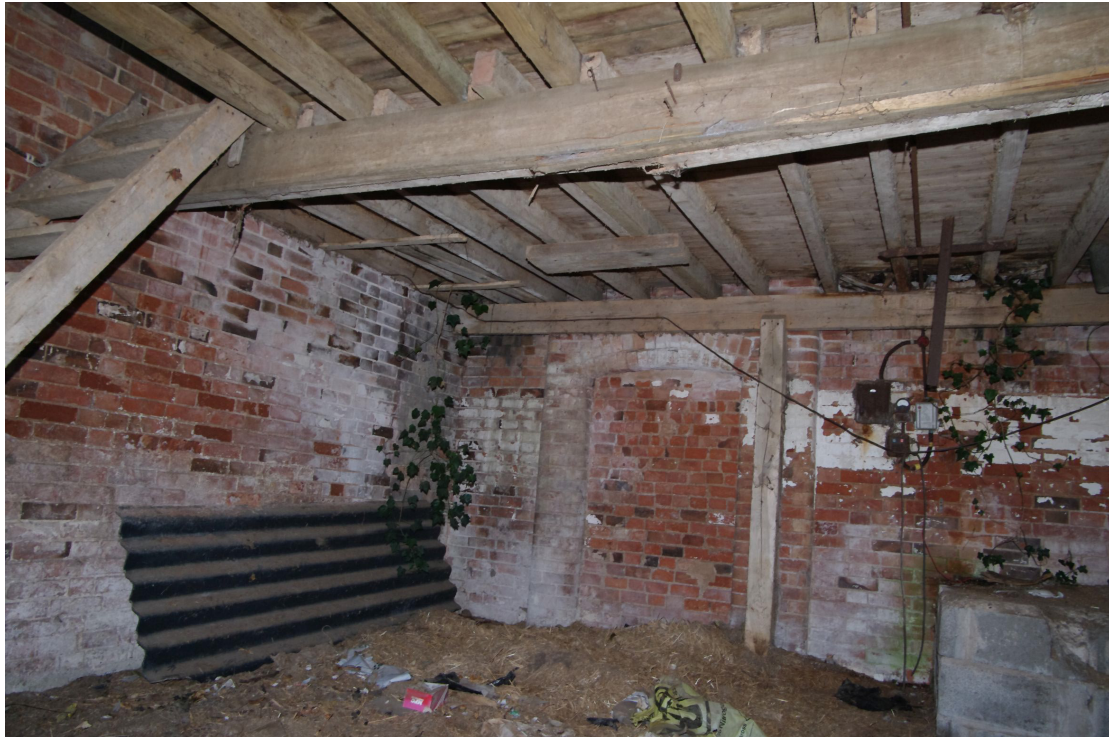
Figure 57 Building 6. Ground floor room on north side
Looking north-east towards blocked doorway on north-east facing elevation

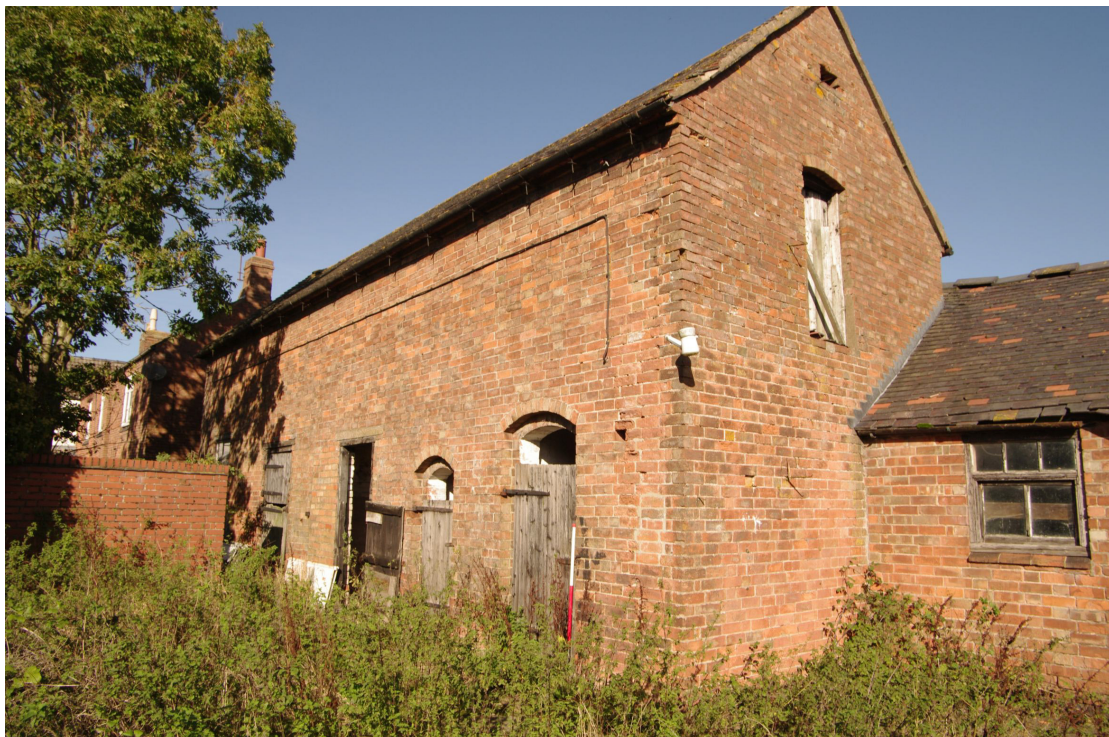
Figure 67 Building 7 south-west facing elevation of two storey range
Looking north-east

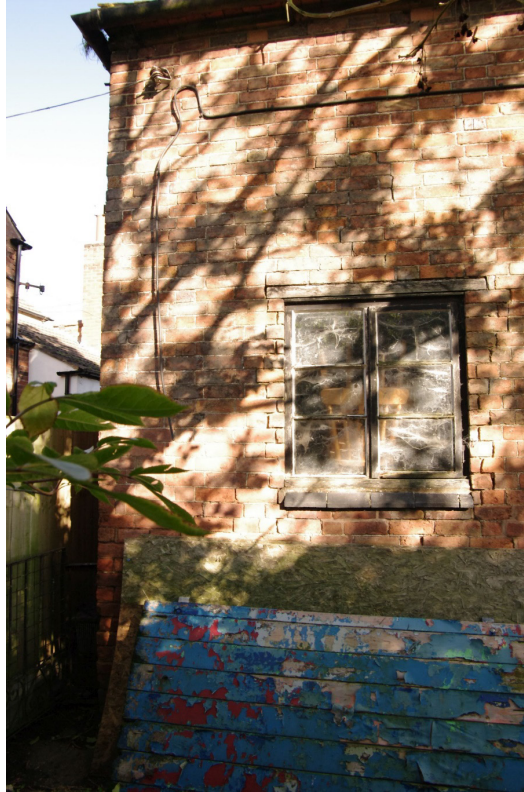
Figure 68 Building 7 south-west facing elevation of two storey range
Looking north-east at ground floor window at northern end of building

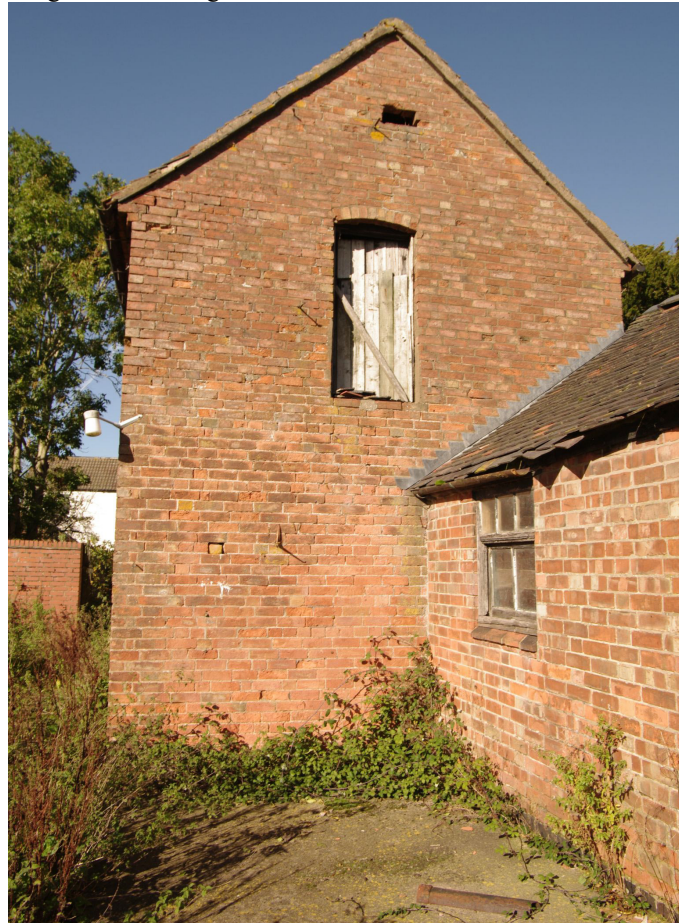
Figure 69 Building 7. South-east facing gable end of two storey range
Looking north-west

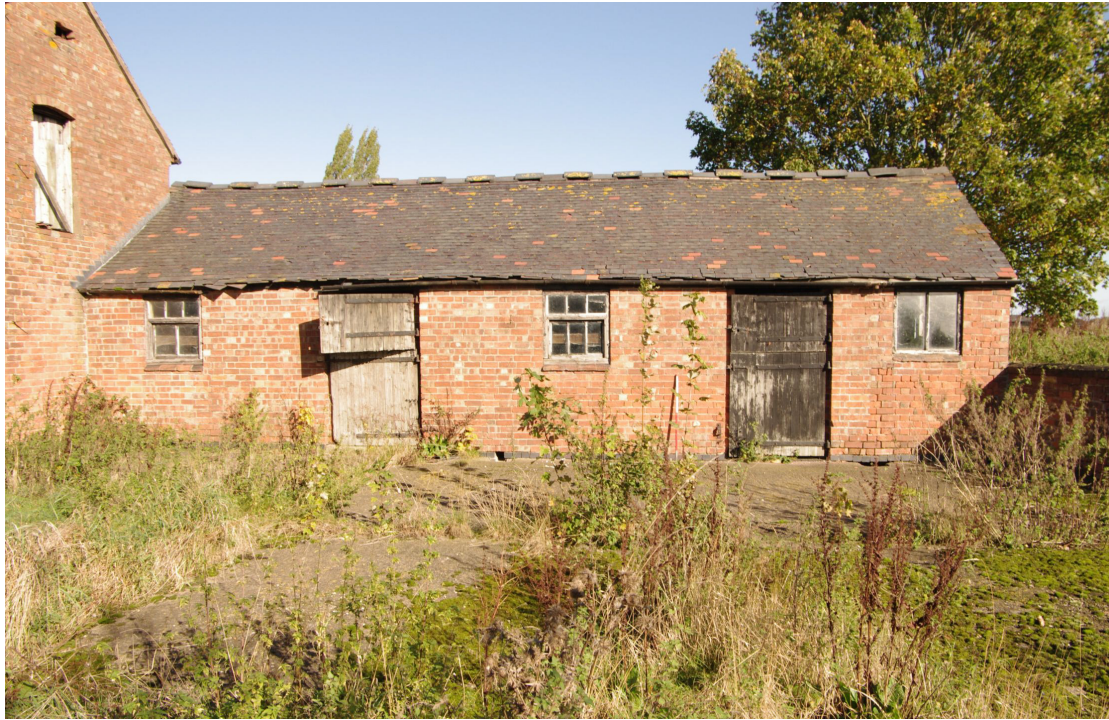
Figure 70 Building 7 south-west facing elevation of single storey range
Looking north-east. 1m scale

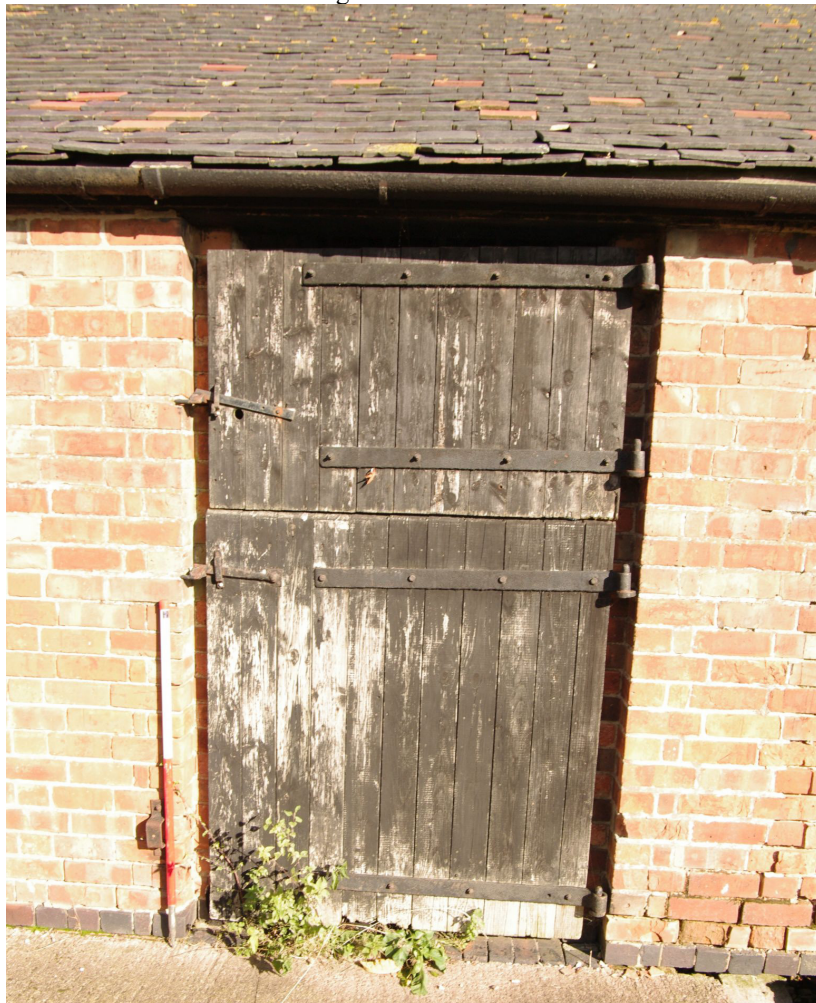
Figure 71 Building 7 south-west facing elevation of single storey range
Door detail. Looking north-east. 1m scale

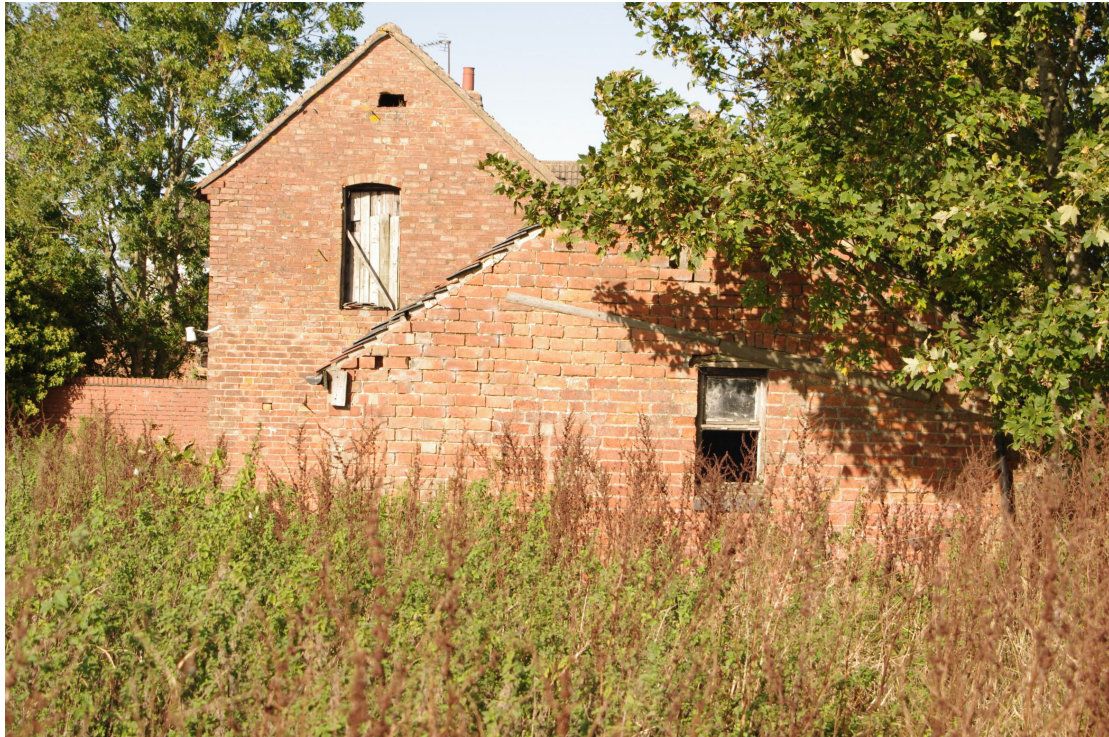
Figure 72 Building 7 south-east facing gable ends
Looking north-west

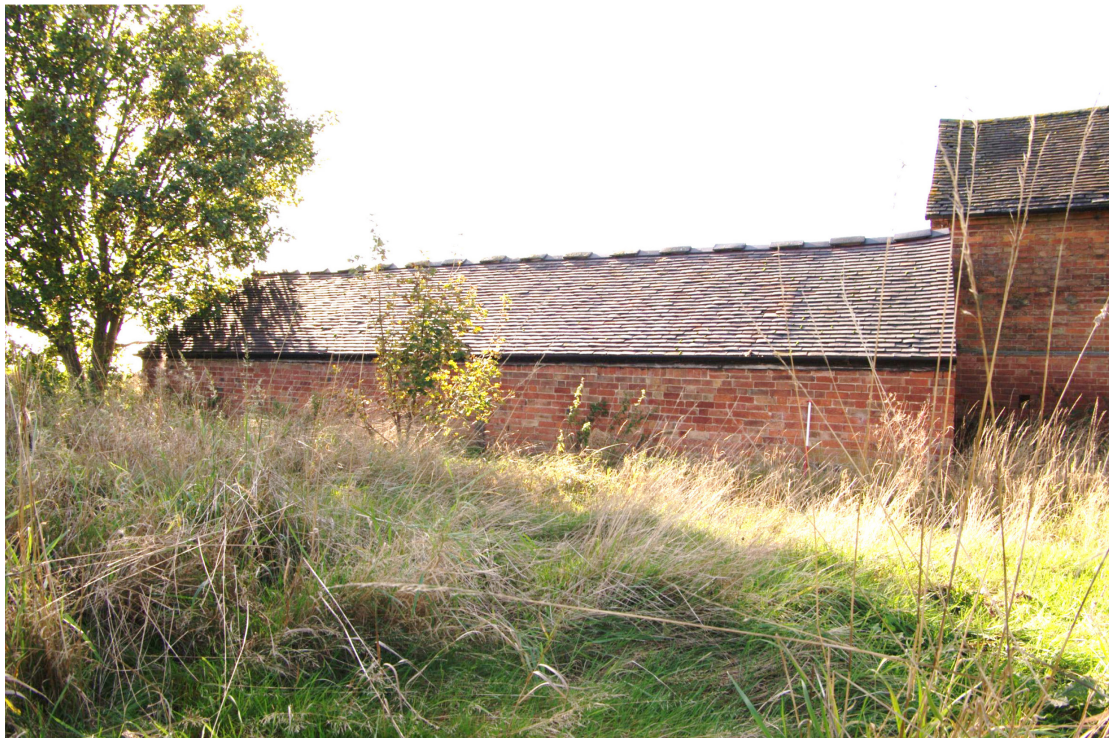
Figure 73 Building 7 north-east facing elevation of single storey range
Looking south-west. 1m scale

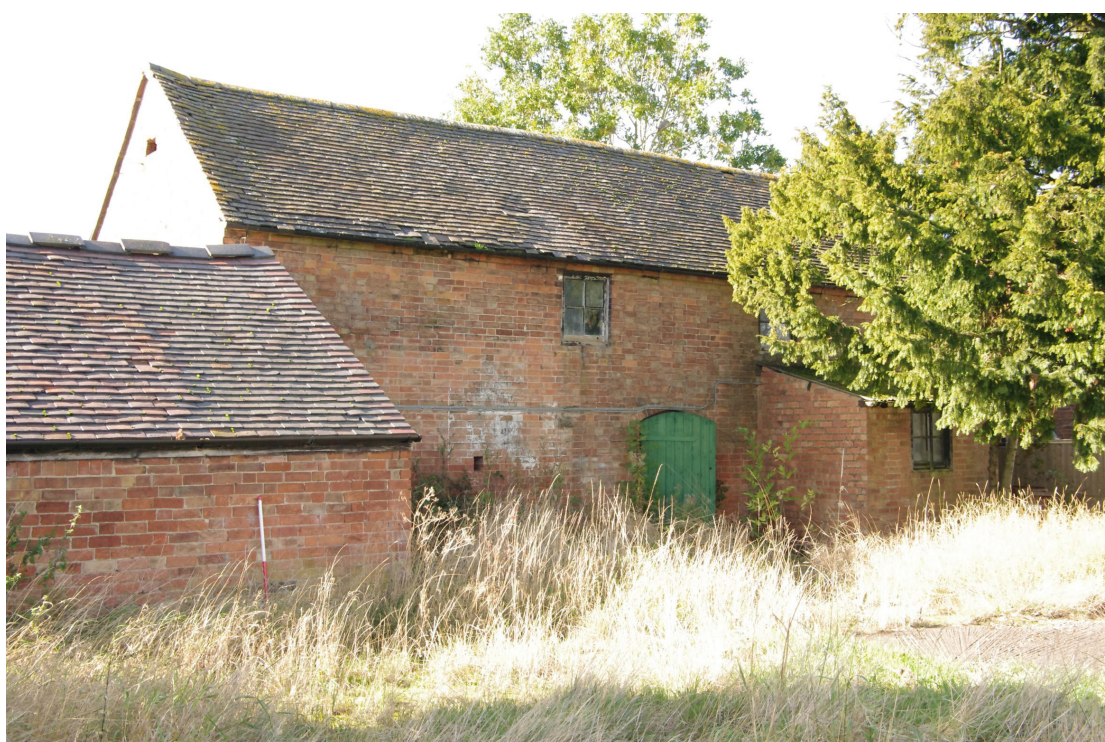
Figure 75 Building 7 north-east facing elevation of two storey range
Looking north-west. 1m scale

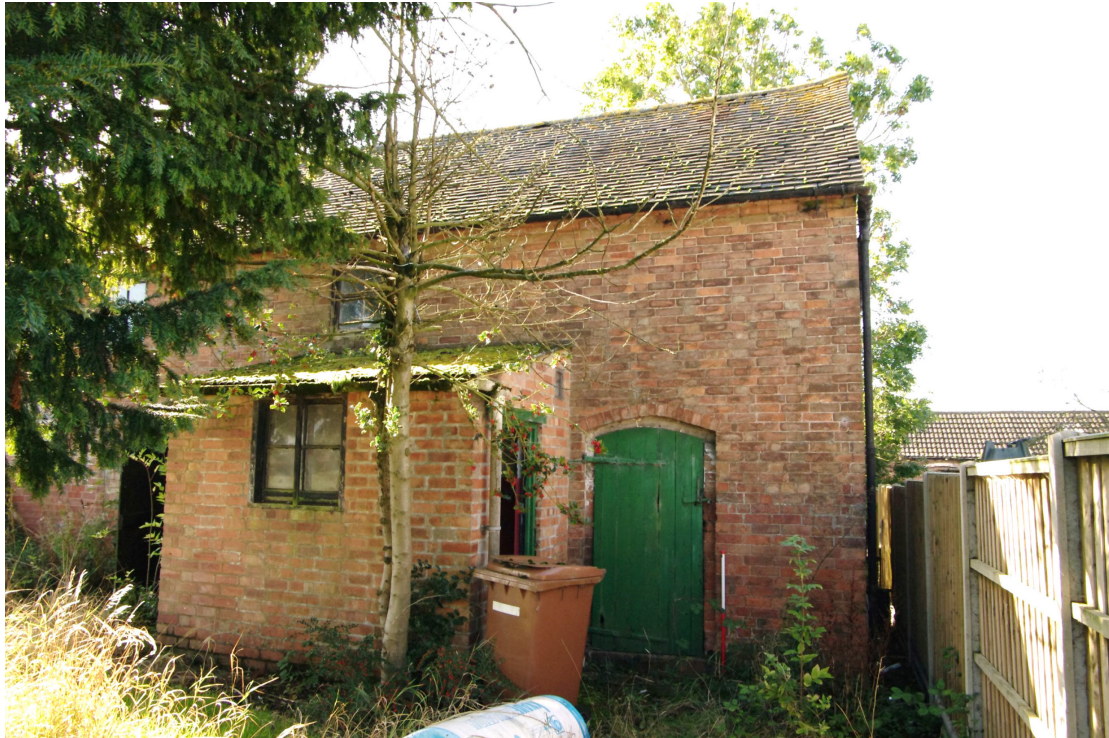
Figure 76 Building 7 north-east facing elevation of two storey range. Northern end
Looking south-west. 1m scale

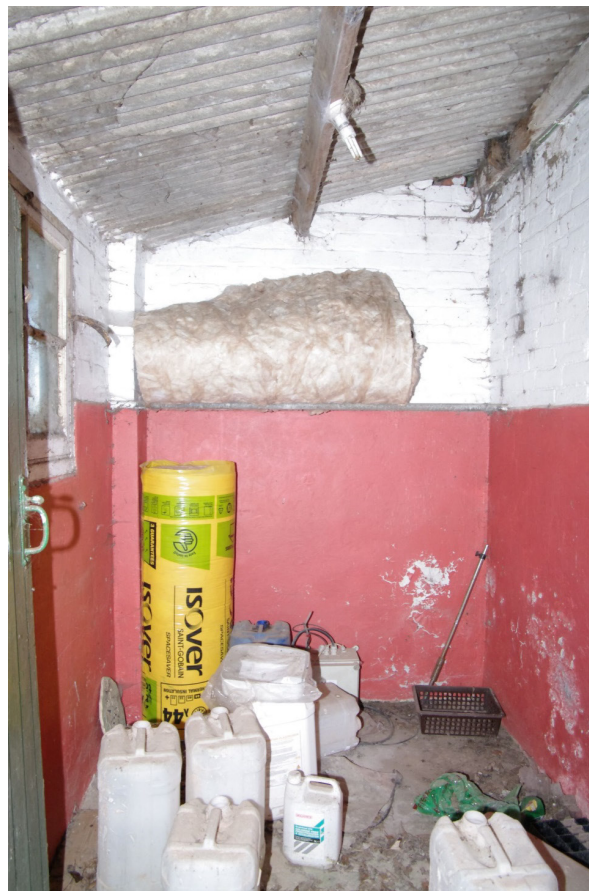
Figure 77 Building 7. Room 1
Looking south-east. This room is a small added-on lean-to structure

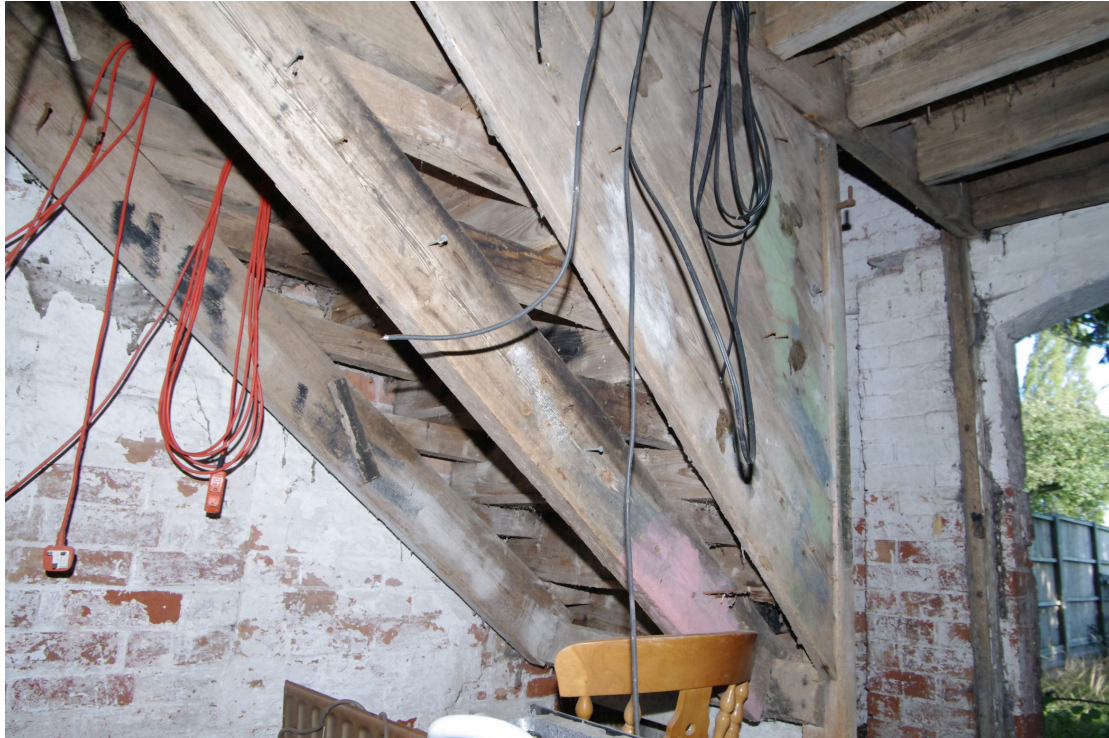
Figure 80 Building 7. Room 2 stair detail
Looking north-east

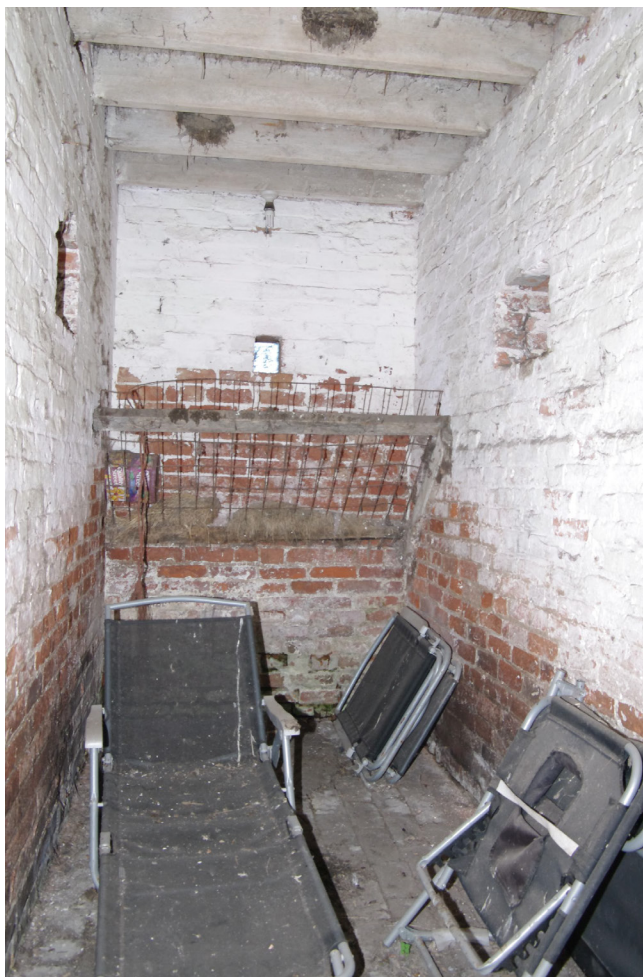
Figure 84 Building 7. Room 6
Looking north-east. The byre suggests use for horses. Note brick floor

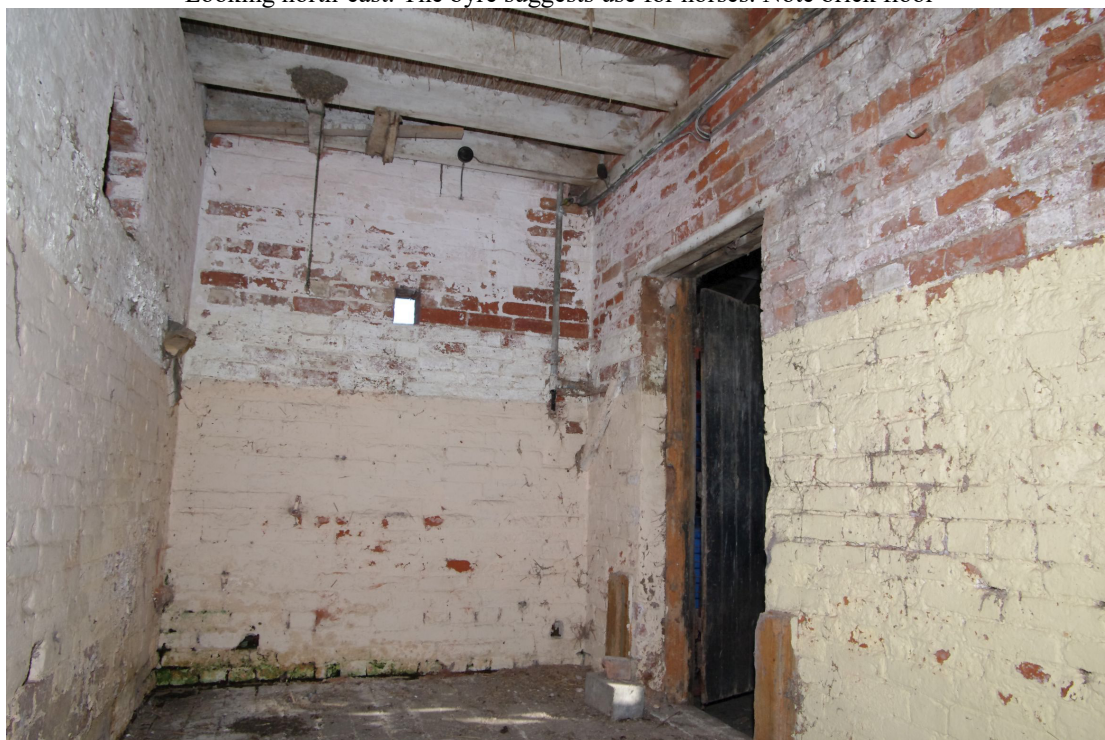
Figure 85 Building 7. Room 7
Looking north-east. The doorway leads into the single storey range

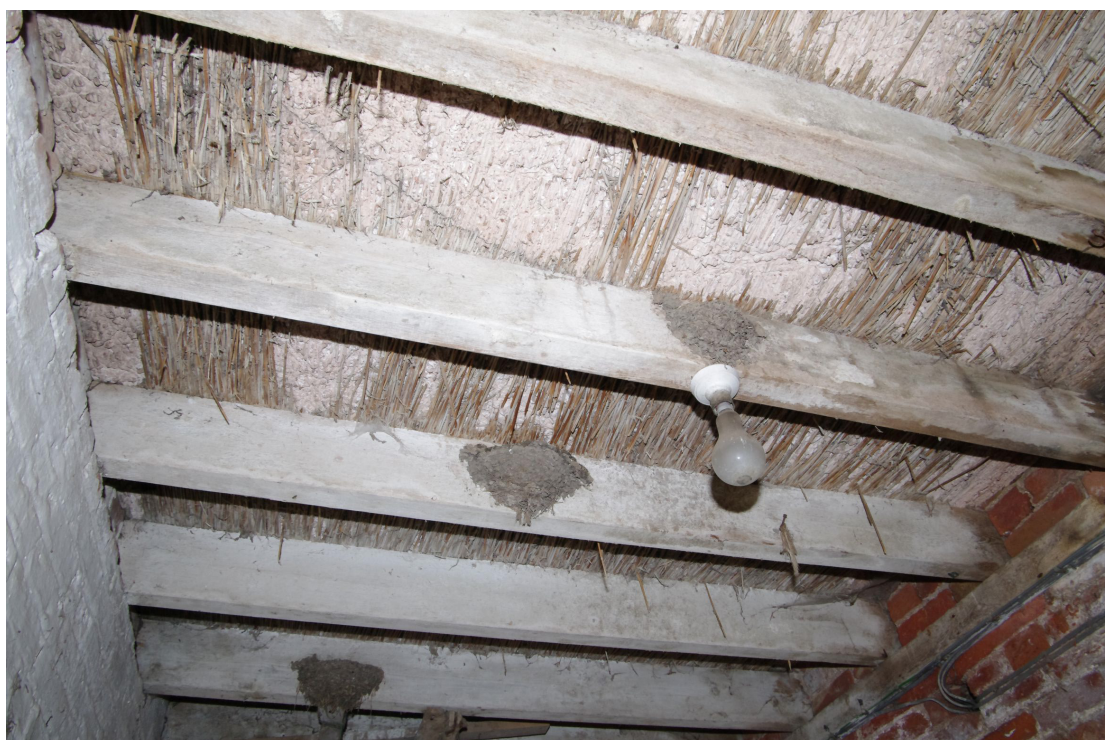
Figure 86 Building 7. Room 7 ceiling detail

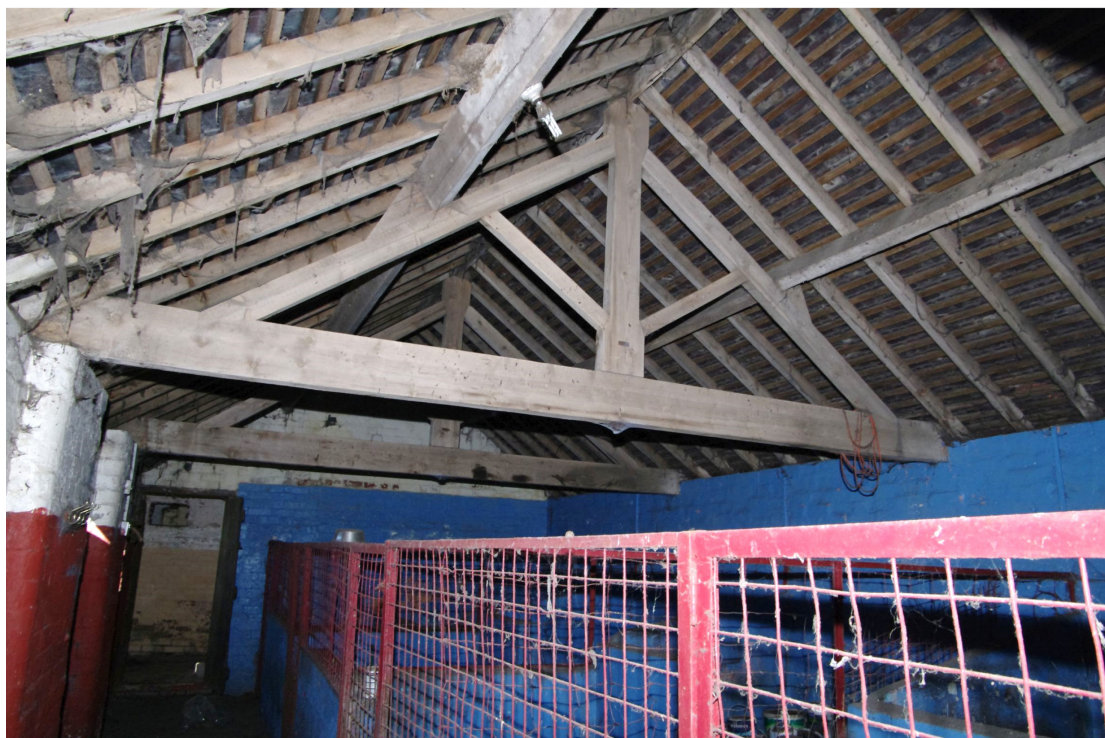
Figure 88 Building 7. Room 8 roof structure
Looking north-west. The doorway to the far left leads into Room 7

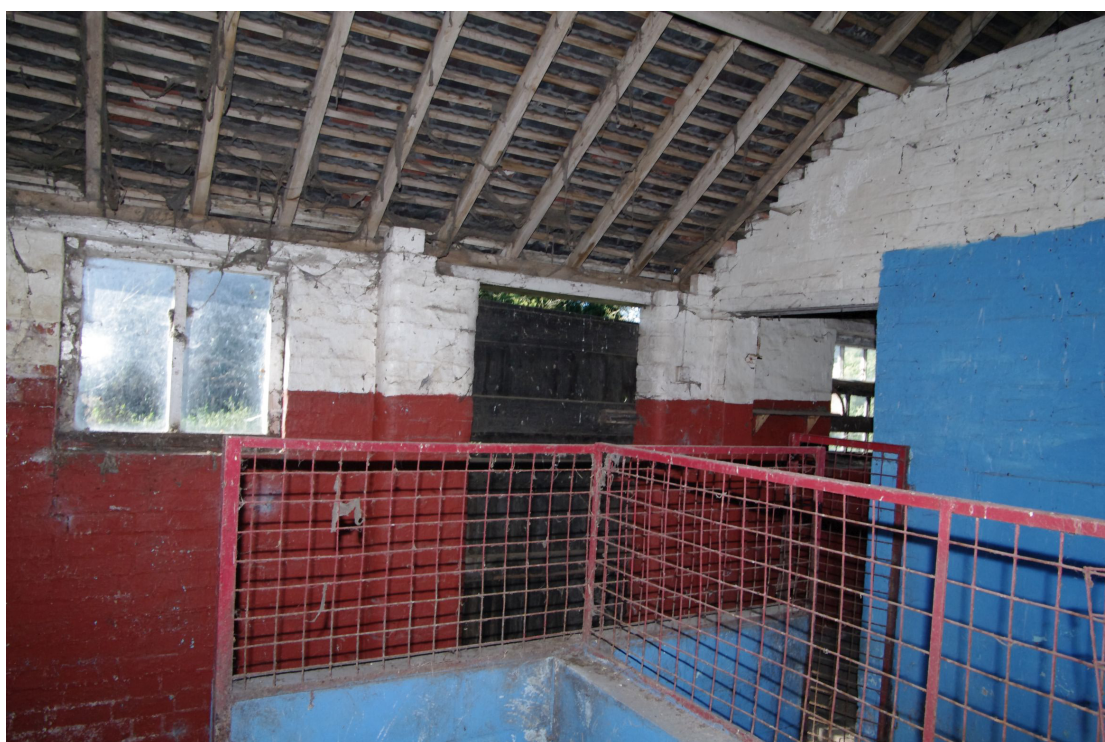
Figure 89 Building 7. Room 9
Looking west. The door to the right leads into Room 8

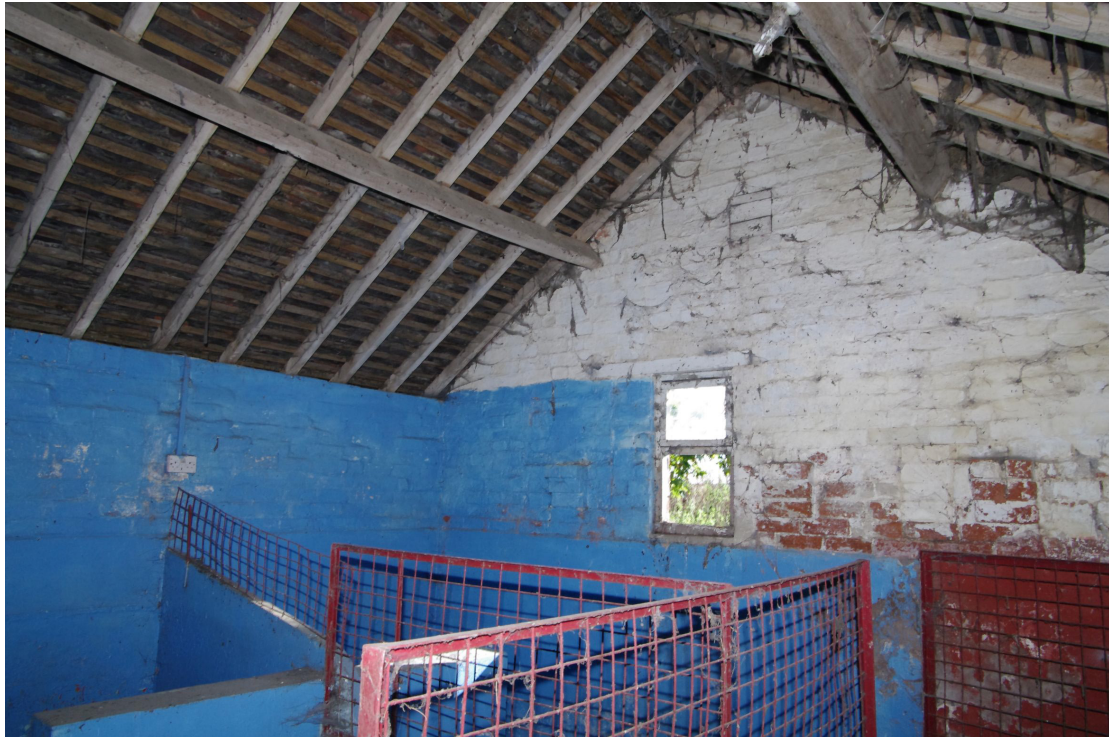
Figure 90 Building 7. Room 9
Looking south-east

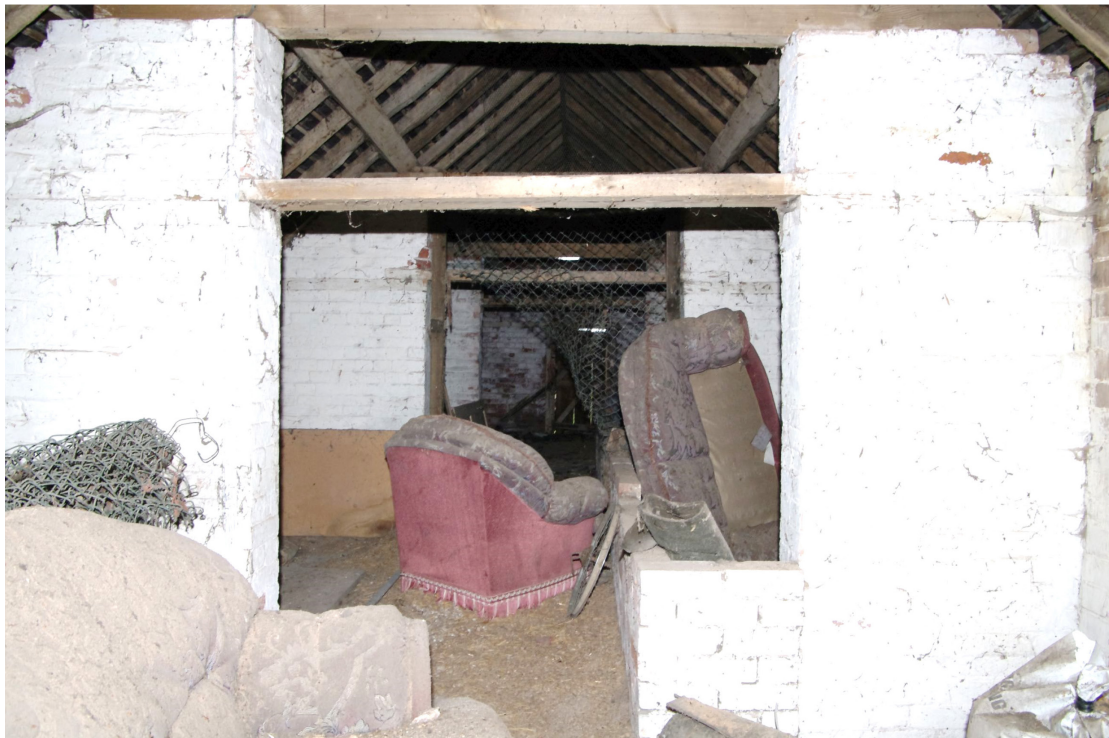
Figure 91 Building 7. Room 10
Looking south-east along the first floor of the two storey range

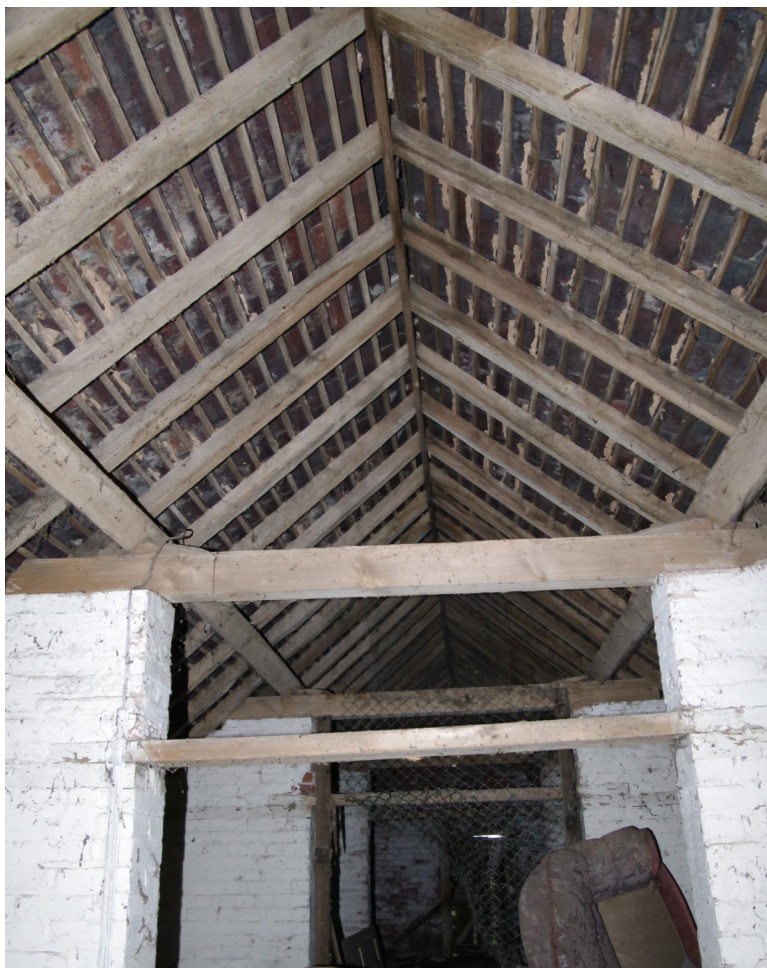
Figure 92 Building 7. Room 10 roof structure
Looking south-east

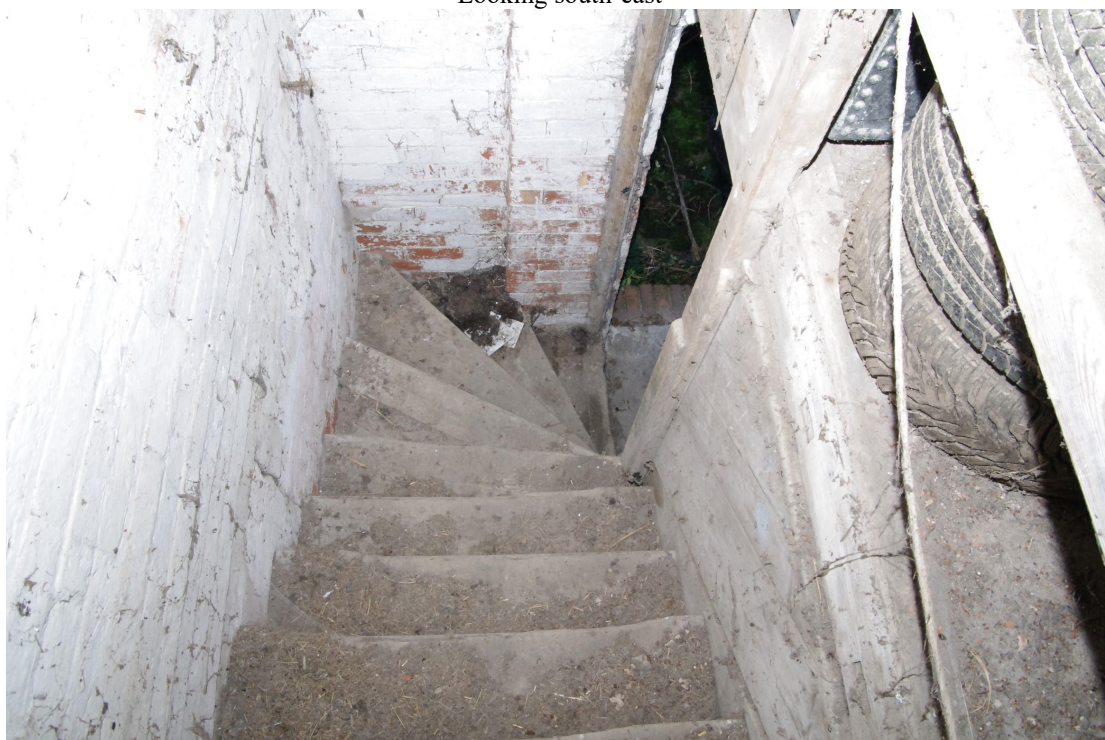
Figure 93 Building 7. Room 10
Looking south-west down the stairs to Room 2
