**Historic Building Photographic Survey
Lodge Farm, Stathern Road,
Eastwell, Leicestershire.**

ULAS Report Number 2009-014

An Historic Building Photographic Survey at Lodge Farm, Stathern Road, Eastwell, Leicestershire. SK 774 295

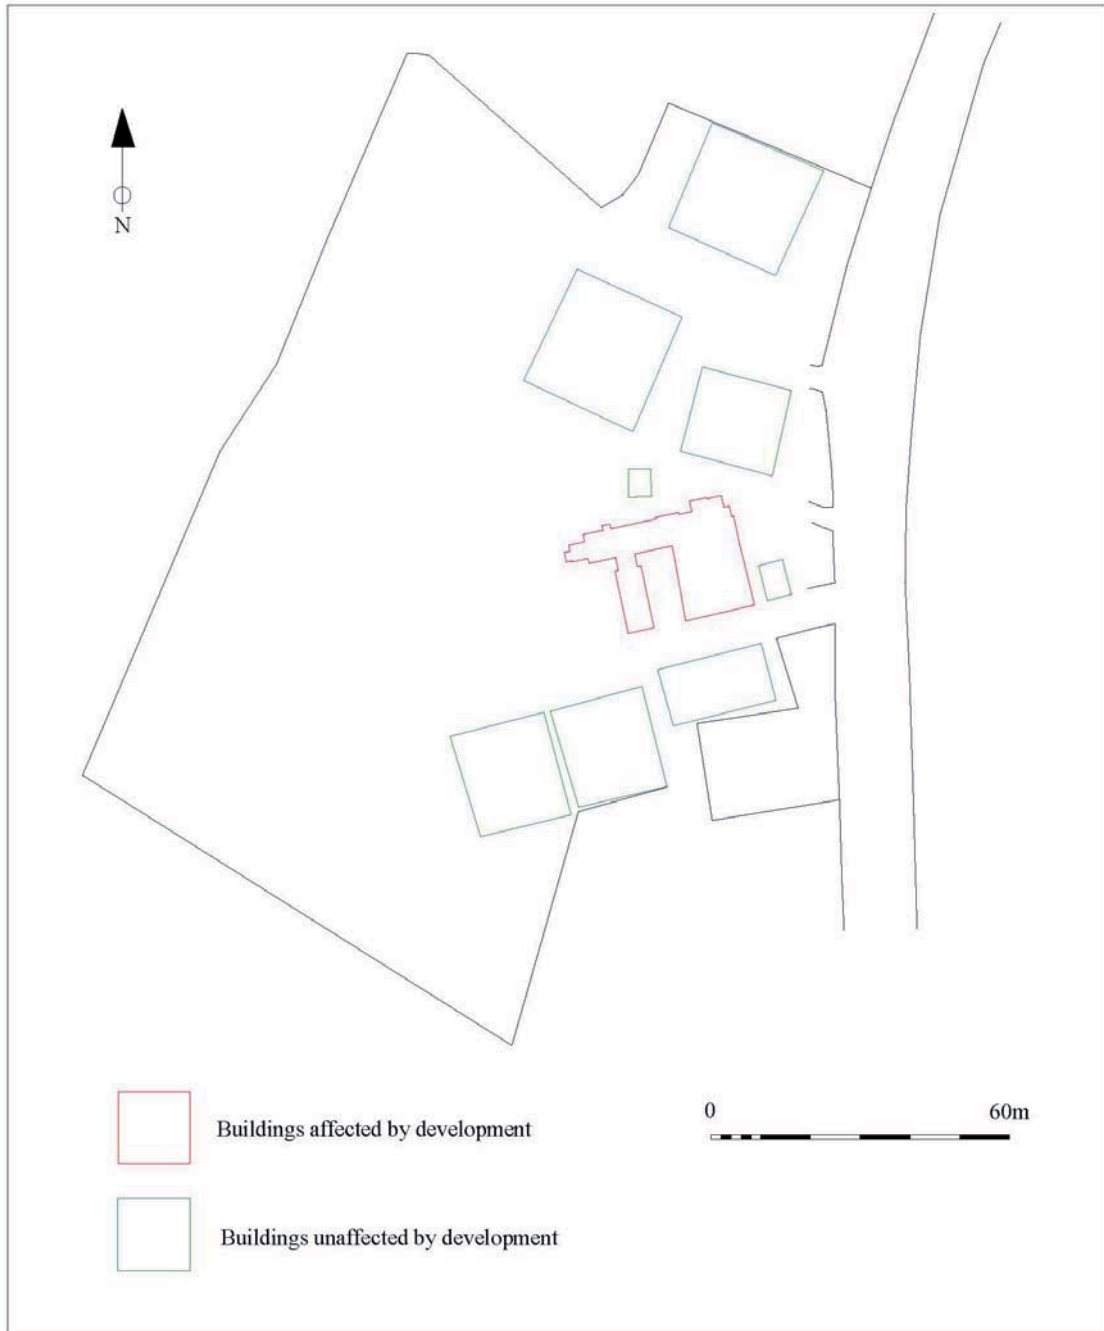
Figure 3 Layout of farm buildings.

As mentioned the main components of the survey are a threshing barn and a farmhouse laid out on an east to west alignment roughly perpendicular to the nearby Stathern Road. Measured drawings have been produced by Francis W Keyworth Architects which show the key components of the buildings. These drawings have been used as the basis of the survey and are shown in figures 4, 5 and 6. The farmhouse has been extended to the west with a full width extension which includes a new staircase and end room. Attached to the western wall of this is a small wash house and toilet block. Another gabled extension has been built on the south side of the farmhouse to accommodate a kitchen and an upstairs bathroom. To the south of this gabled extension a stable block has been added, part of which is presently used as a utility room. To the south of the threshing barn are two parallel barns one of which has been used as a milking parlour which is to be removed as part of this scheme. A number of brick outhouses and lean-to's are grouped around the northern and eastern corners of the threshing barn.

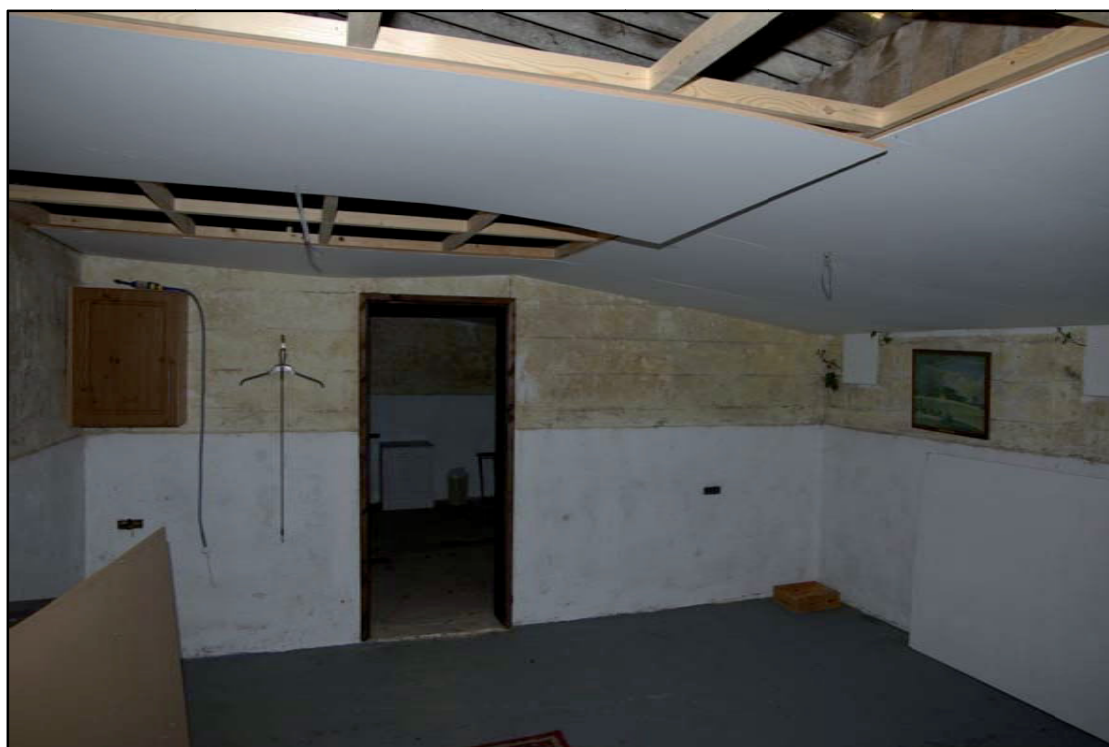
Figure 19 Stable converted to utility room. Facing south.

The stable is constructed to the rear of the farmhouse gable extension creating a small yard between it and the milking parlour (fig. 34). It is constructed of modern concrete blocks with a corrugated pitched roof and concrete floor (fig. 35). Much of the northern end has been converted to use as a utility room for the farmhouse as already noted above. Only the southern end remains as a stable although this is currently in use as a wood store.

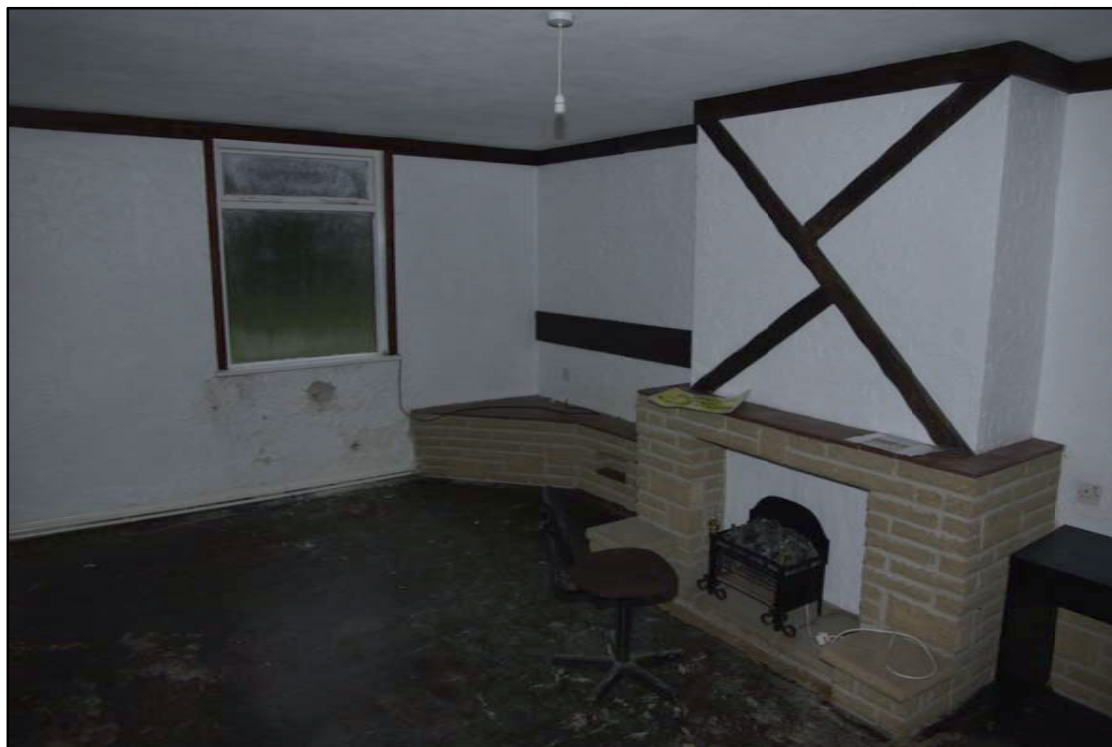
Figure 20 Extension, ground floor room. Facing south west.

16). The floor has 6" square quarry tiles, as has the lobby and adjacent hall. The fireplace is quite modern with a skin of brick which may mask an earlier construction beneath (fig. 17). A door to the east leads to a pantry which would formerly have been beneath the stairs. The door to the south leads out into the modern gable extension kitchen with little visible of historical value (fig. 18). This leads through into the stable, currently being used as a utility room and storeroom (fig. 19). The western extension is entered from an inserted doorway to the side of the chimney breast in the main room. The new stairs are immediately on the south side with the outside door, with the modern porch are to the north. Beyond this is a large sitting room with probable 1970s fittings masking anything earlier (fig. 20). The fireplace appears to be blocked as no chimney is visible outside at roof height.

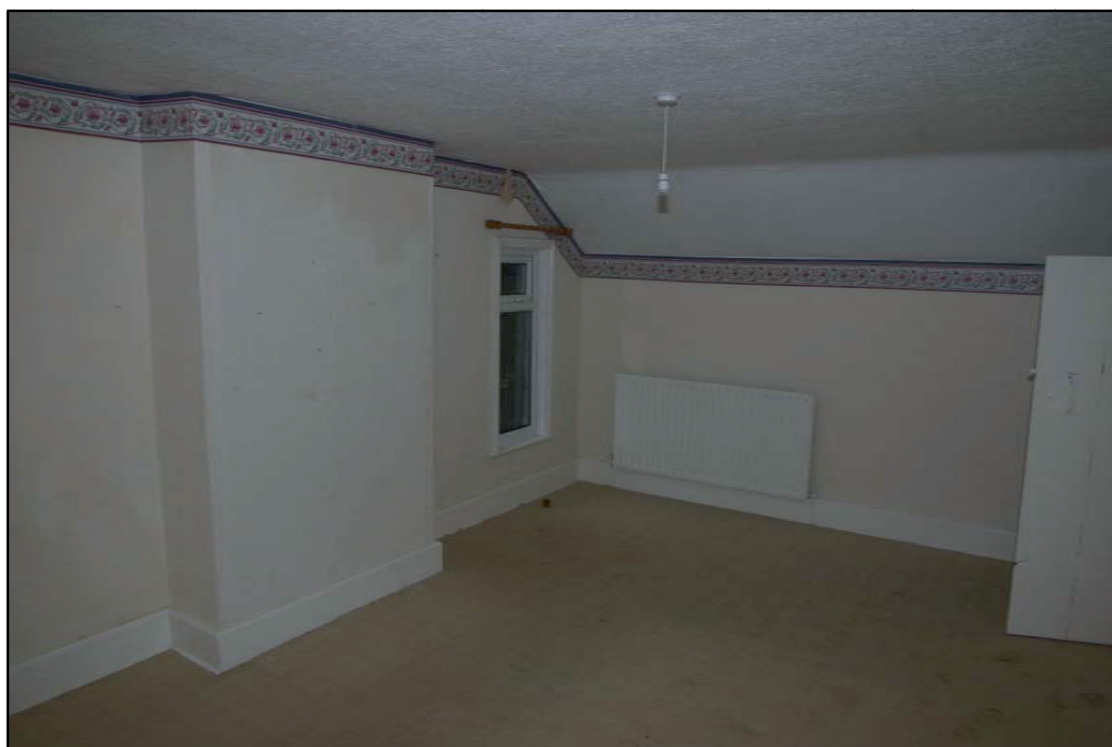
Figure 21 Extension, first floor. Facing north west.

Upstairs, the room in the western extension is completely underdrawn which hides any architectural details. The ceiling height is above the eaves level creating a small angle in the ceiling to the north and south to accommodate the slope of the roof (fig. 21). The door is wooden with four panels and the original lock mechanism (fig. 22) and is the same pattern as the other doors on this floor. A door to a cupboard over the stairs has three wide butted boards fitted together and what look like hand made strap hinges and latch mechanism (fig. 23). The remaining rooms are accessed from a landing running along the southern wall of the original part of the farmhouse. The bathroom in the gable extension is decorated and plastered to hide anything of interest (fig. 24). The largest room, over the main downstairs room, is fairly plain but has a cement floor hidden beneath the carpet (fig. 25). Bricks have been laid around the chimney breast which extends into this room although it is not clear if these are original or part of a patching of the cement floor, it is certainly not an old hearth (fig. 26). The walls of this room appear to be fairly insubstantial, possibly even stud walls. The eastern end room also has a cement floor but has a boarded section in the south eastern corner presumably where the stairs entered the room from below (fig. 27). A small hole has been made by the owner to inspect the roof structure hoping to find a similar structure to that seen in the barn. The hole reveals a relatively modern and lightweight roof with no trace of the original structure apart from sawn off purlins at the eastern end (fig. 28).

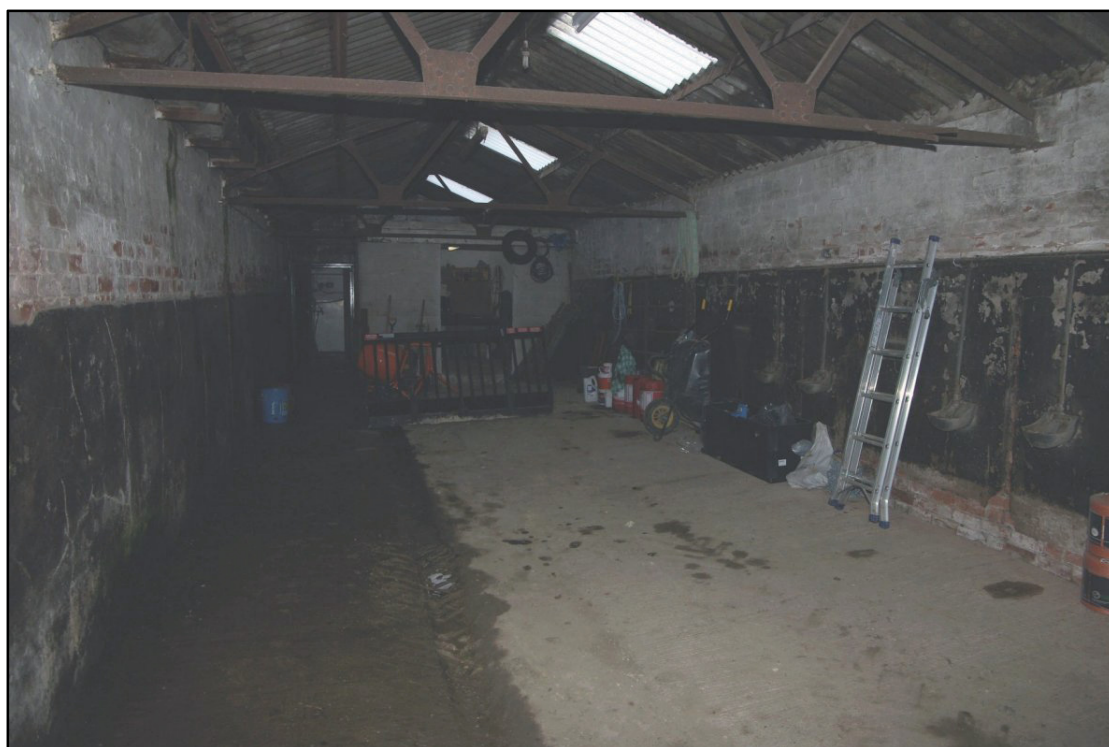
Figure 33 Inside shed. Facing north.

Built along the eastern side of the milking parlour, and using the same central wall is another similarly constructed cattle shed. This is of the same length and height but is not as wide (figs. 32 and 33). Attached to the eastern wall are a series of cast iron
