**An Historic Building Analytical Survey (Level 2)
of the Bothy; Walled Kitchen Garden,
Belvoir Castle, Belvoir, Leicestershire**

Andrew Hyam

For: The Duchess of Rutland

ULAS Report Number 2009-020

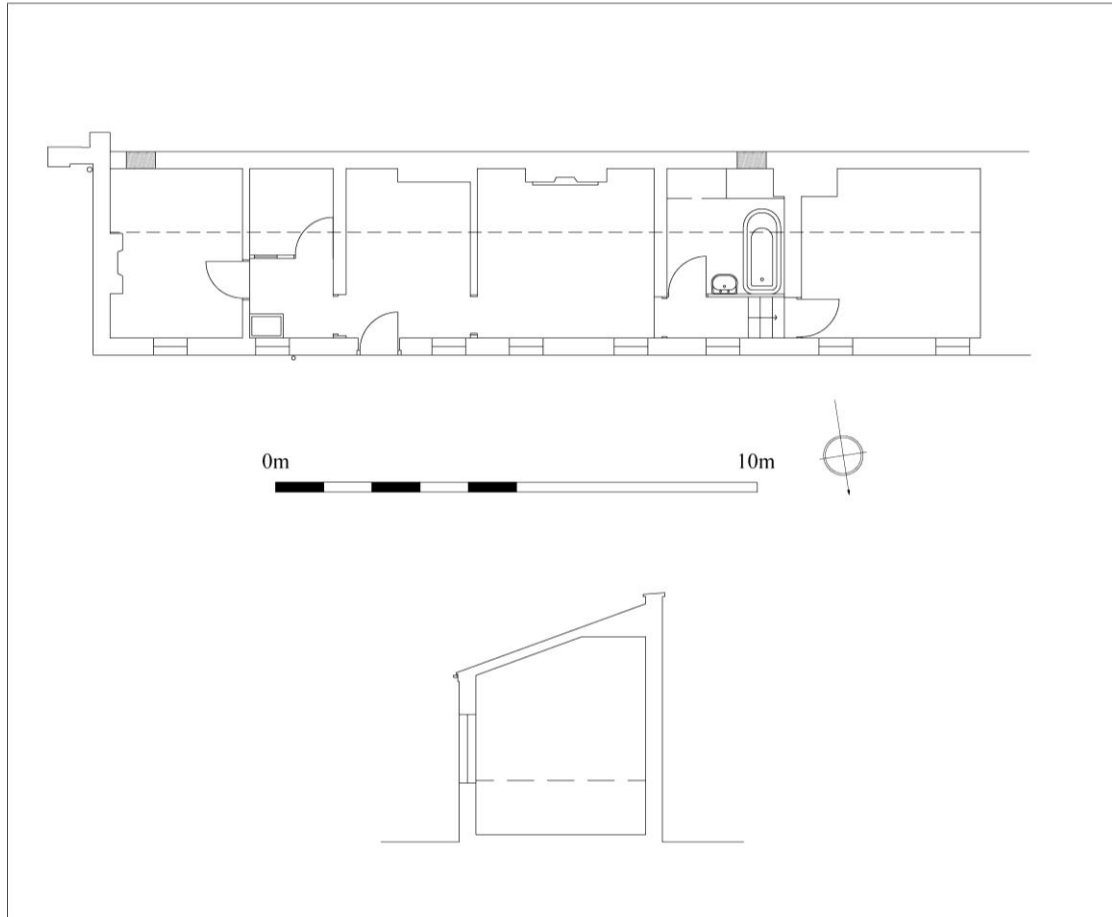
Figure 3 Plan and section of bothy.
Modified from plans supplied by David Todd Architecture.

which all of the other rooms are reached by passing through each consecutive room. Masonry walls of varying thickness (see fig. 3) divide the rooms. The only visible form of lighting is via a single suspended electric light fitting in each room with a small junction box in room one labelled 250V.AC. None of the internal roof detail is visible with the plaster continuing from the wall straight up to the sloping ceiling.
