**Old Star Cottage, 1, Main Street,  
Frisby-on-the-Wreake, Leicestershire:  
Historic Building Survey**

ULAS Report No 2009-173  
©2009

**Planning & Listed Building Applications: 09/00305/FUL, 09/00305/LBC**

**For: Mr J. Mensley, Country House Limited**

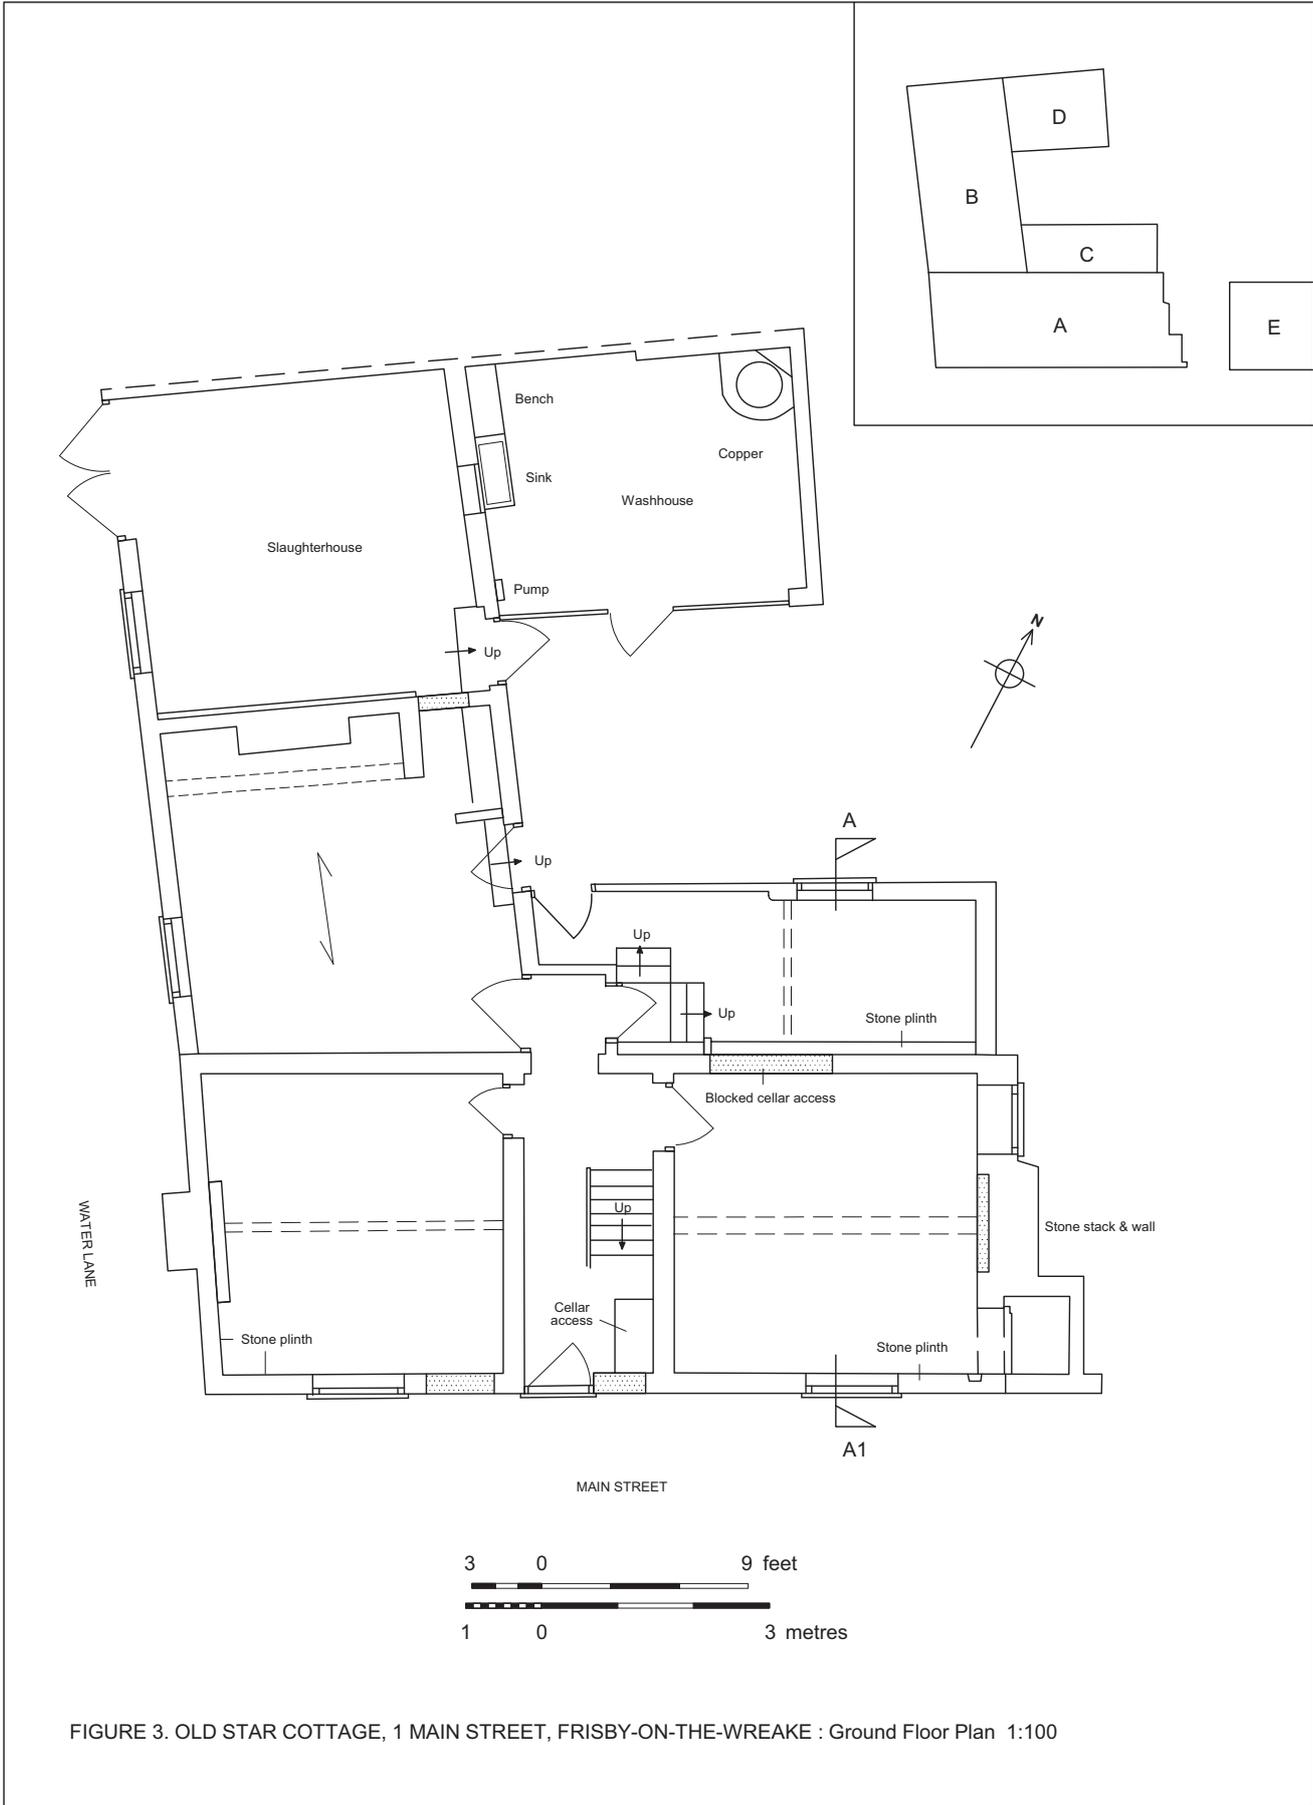
FIGURE 3. OLD STAR COTTAGE, 1 MAIN STREET, FRISBY-ON-THE-WREAKE : Ground Floor Plan 1:100

Doorways at the north end of the hallway open into the two principal rooms to the east and west and a third doorway to the north gives access to the later ranges B and C. The room to the east has in its gable wall a four-centred arched limestone fireplace (Figure 5, Photo 3). This has simple chamfered decoration and a fairly depressed arch and is broadly attributable to the 16<sup>th</sup> or 17<sup>th</sup> century; it is in a poor state of repair and had until recently been covered by a large Victorian gothic fire surround. The east gable wall appears originally to have been constructed of ironstone rubble at this level, though subsequently much altered with the insertion of a late 20<sup>th</sup> century window north of the fireplace and a doorway to its south. This doorway, which is clearly broken through the stonework of the wall, opens onto a small cupboard housed in an awkward external lean-to addition; it is possible that this was at one time an external doorway.

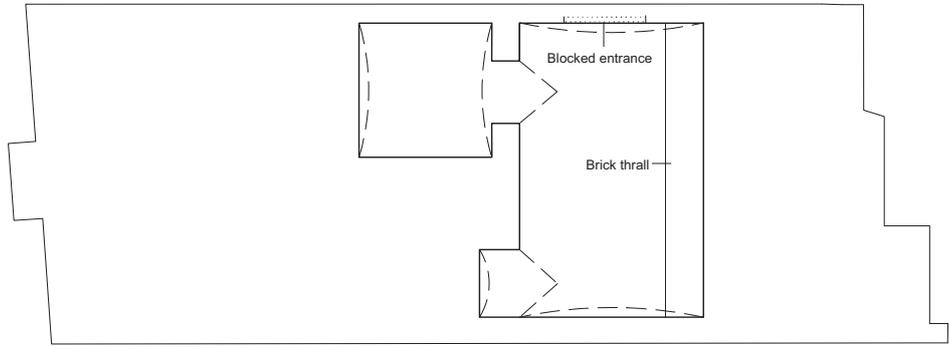
CELLAR

Beneath part of the east room and hallway of this range is a cellar constructed from roughly squared ironstone blocks laid to courses (Figure 4). This has a vaulted brick ceiling and the floor is paved in brick. There is a low brick thrall along the east wall. The original access to the cellar was in the north wall and is now blocked (Photo 5). The present access is via a small recess off the main room at the south end which has its own brick vault. There is another room off the main room, under the hallway, again with a brick vault and floor.

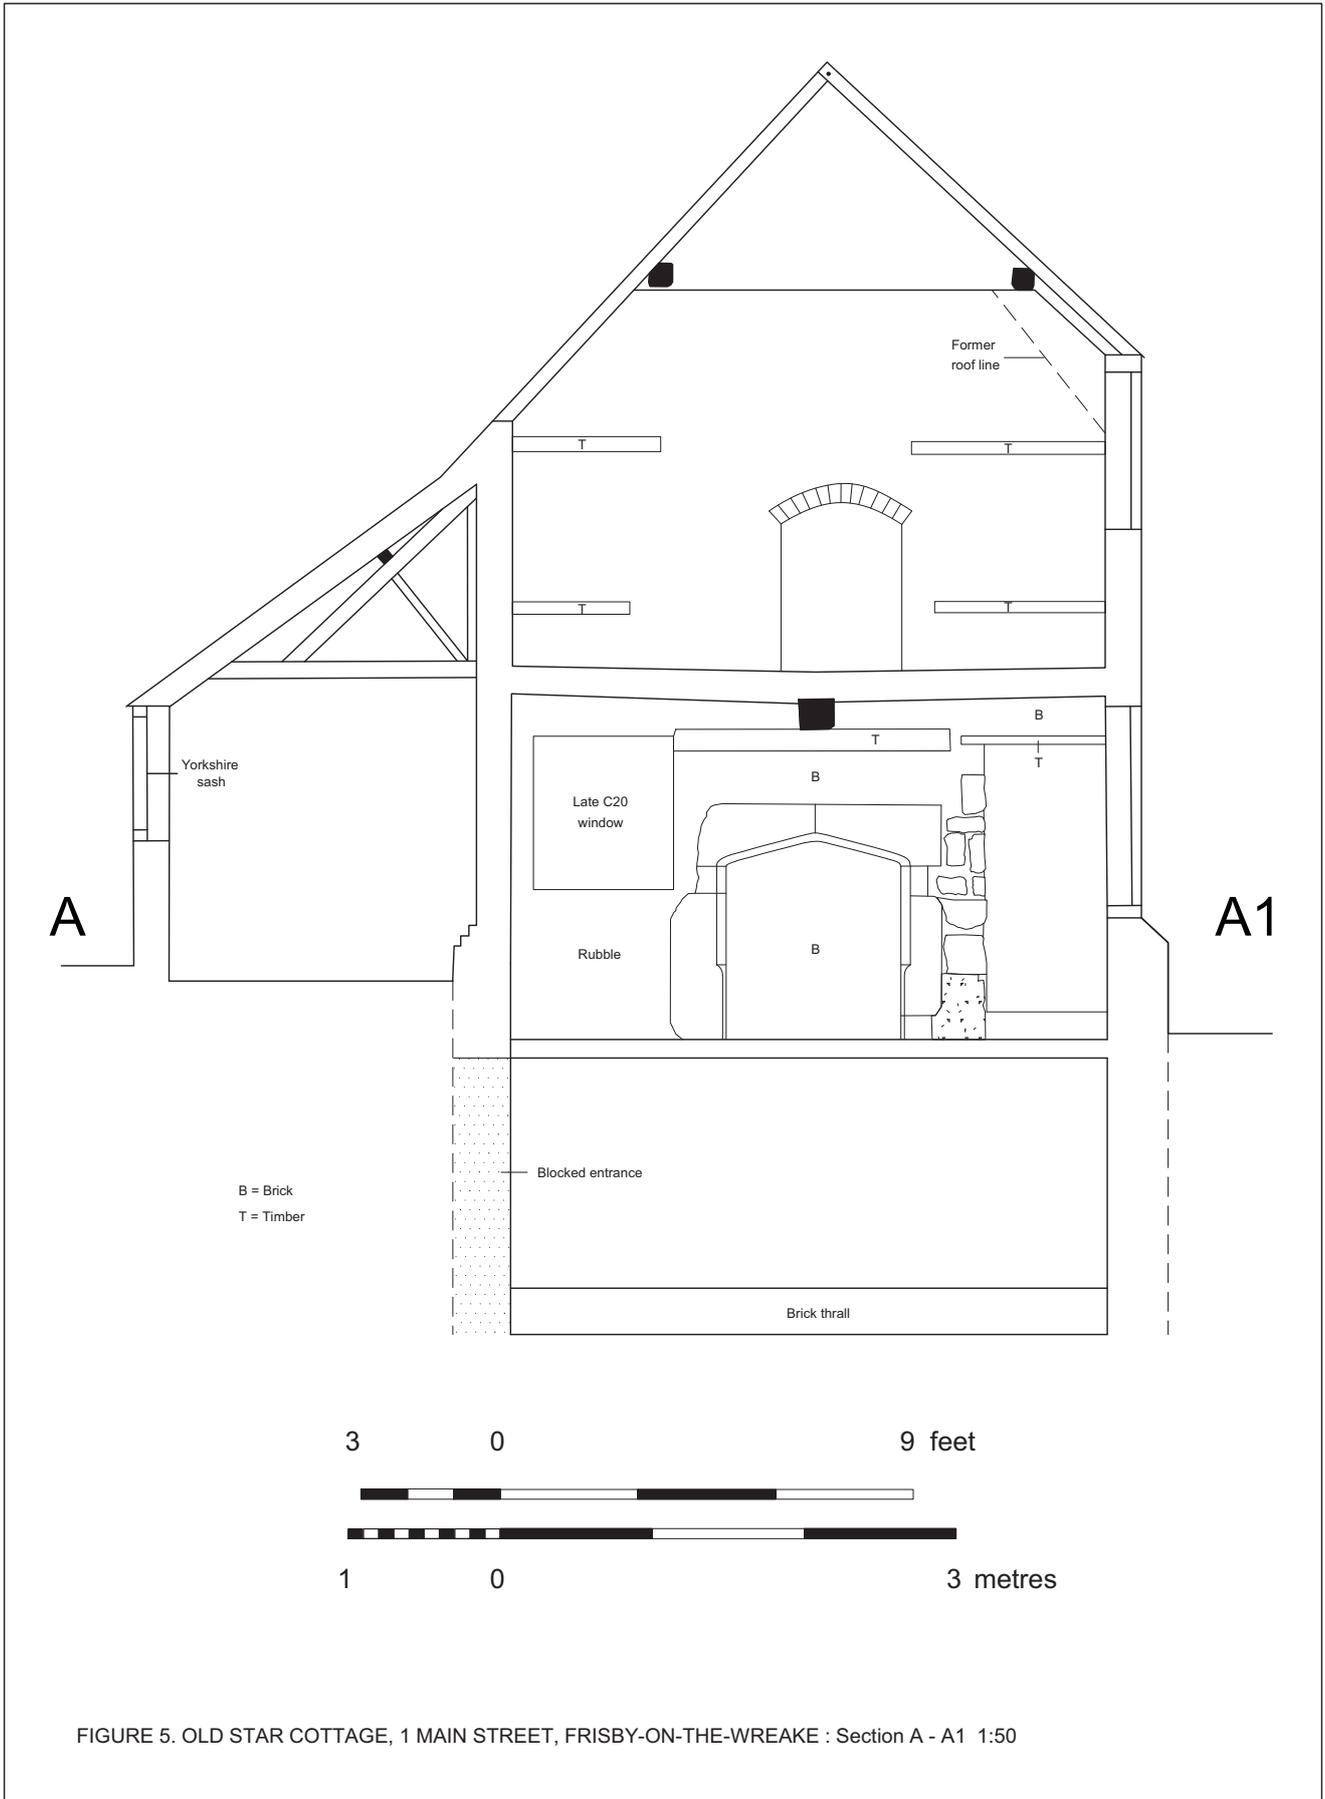
FIGURE 5. OLD STAR COTTAGE, 1 MAIN STREET, FRISBY-ON-THE-WREAKE : Section A - A1 1:50

The two principal first floor rooms have 4-panelled doors with L hinges. These rooms have also been partly stripped of plaster and the scar of the original roofline is apparent in both gable walls (Figure 5; Photo 7). In the east room there is a blocked fireplace opening with segmental arch head in the gable wall. At first floor level this east gable wall is of 18<sup>th</sup> century brick. The west room was unheated. In both rooms the rough finish to the brickwork of the window reveals indicates that these have been altered and enlarged. The upper floors throughout this range are of solid gypsum or lime plaster type.
