**An Archaeological Historic
Building Assessment for
The Laundry, Belvoir Castle,
Belvoir, Leicestershire.
NGR: SK 823 338**

ULAS Report No. 2009-171
©2009

For: The Duchess of Rutland

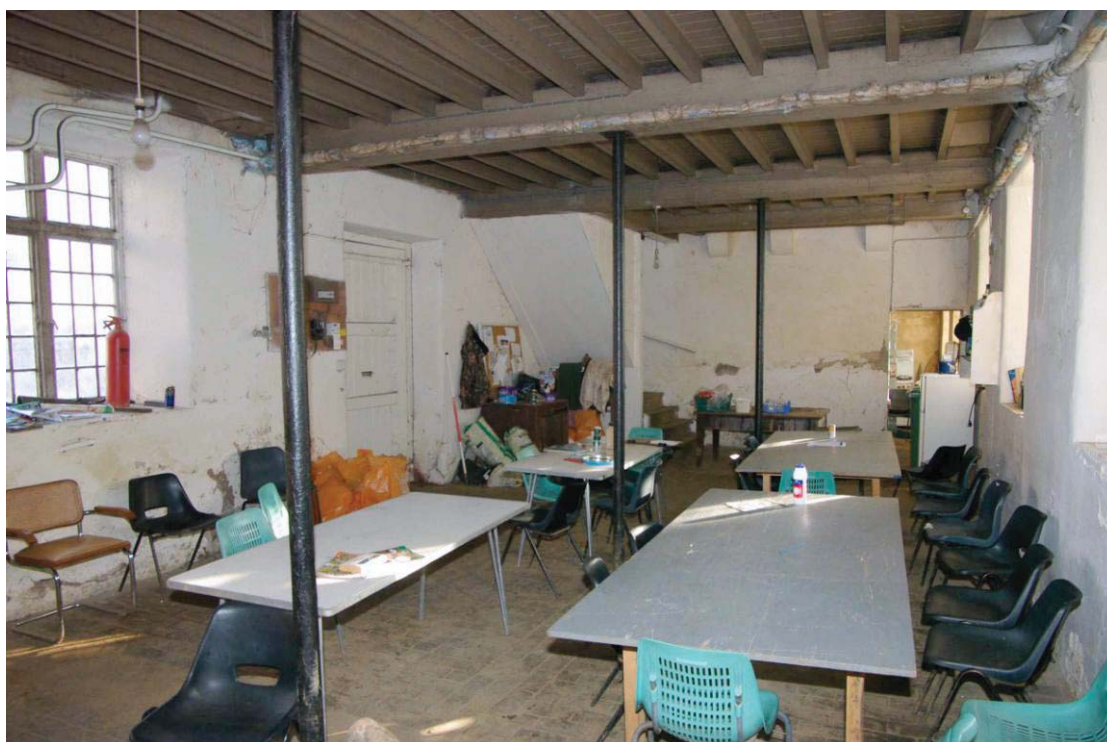
Figure 9 Ground floor
Looking north-west

The ground floor of the main building forms a single large open room (figs. 9 and 10). Under the proposed works the room will be divided to create a large living room and a

smaller kitchen across the western end. Three large stop-chamfered beams run from north-east to south-west across the room and are supported by three 75mm (3 inch) diameter cast iron columns. The columns are badly corroded possibly indicating that the atmosphere in the room has been quite damp, which is consistent with it having been a laundry. These do not appear to be original as they have been wedged between the beams and floor rather than properly fitted. Two additional shorter wooden beams run across to the base of the stairs. The floor joists are lap jointed onto the tops of the beams and support the beaded floor boards (fig. 11). Running along each long wall are a series of inverted boxes set into the ceiling (see fig. 11). There are two of these on the north side and four on the south. It is not clear what these were for but in the floor on the first floor it can be seen that a circular attachment has been removed and the hole blanked off with a piece of flat metal (fig.12). The floor is laid with blue bricks, measuring 235mm by 115mm, with a drainage channel running down the centre leading to a covered drain. A modern sewage pipe has cut through this floor on the western side of the room. A large stone slab covers what appears to be a well near to the south-eastern corner of the room. Extending a hand-tape through a small hole in this cover indicates that there is water approximately 2m below floor level.

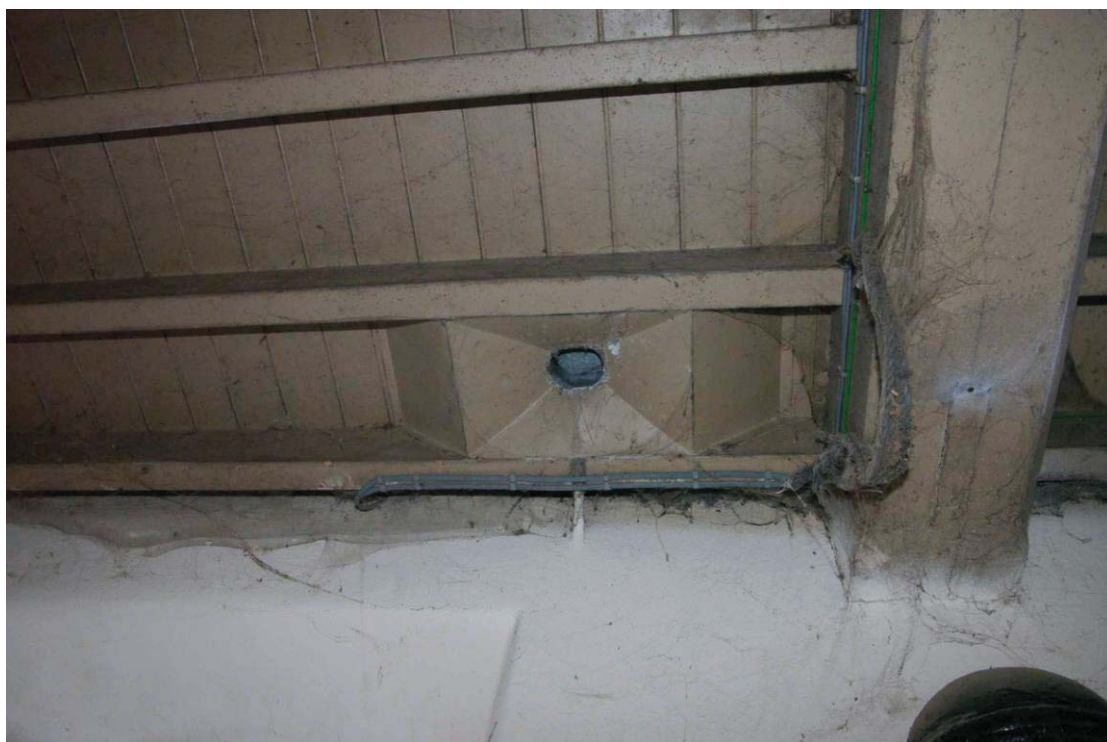
Figure 10 Ground floor
Looking east

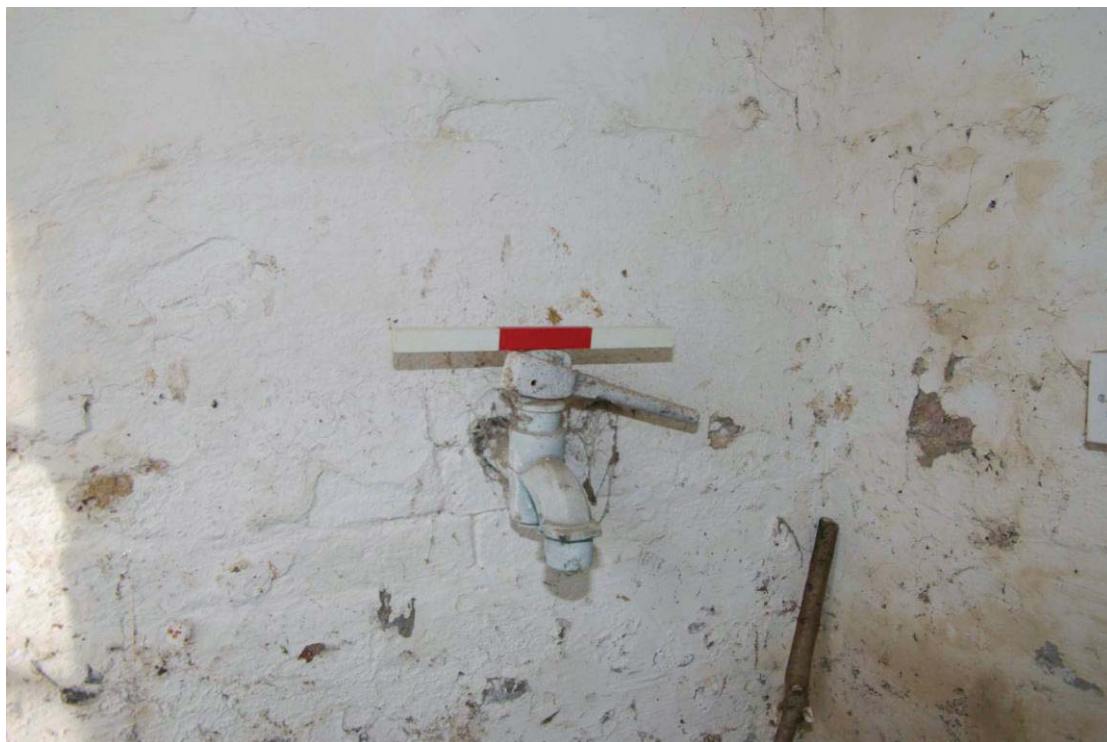
A chimney breast is located on the western gable end and is constructed of whitewashed bricks measuring 235mm long by 75mm high by 125mm deep (fig. 13). The same sized bricks are also used as the internal skin of this end wall. The fireplace is in a fairly poor condition and the stove or grate has been removed leaving a rough hole. A large stone above the fireplace has three incised circles each of 85mm diameter in what seems likely to be an apotropaic mark (fig. 14). To the side of the fireplace is a copper built from modern bricks which must date from the second half of the 20th century although a small grate and ashpan built into the base appear to be earlier. A large angular tap is attached to the wall to the south-west of the chimney breast (fig. 15).

Figure 15 Tap on gable end wall
30cm scale

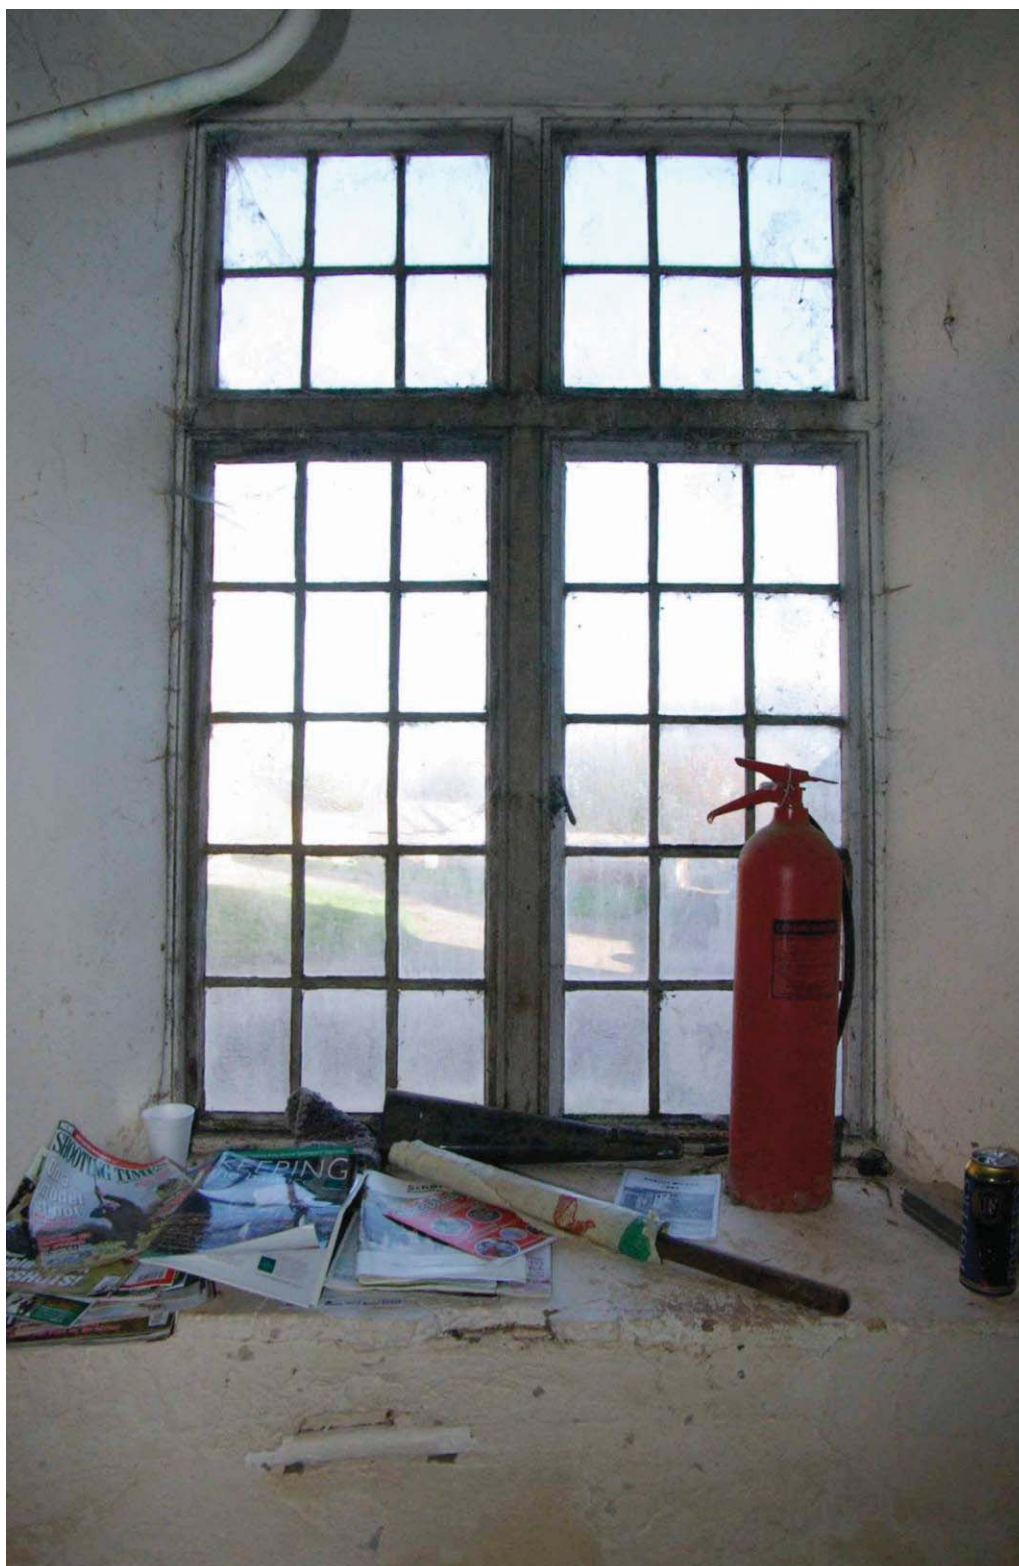
On the north-eastern wall are two windows and the large plank and batten door as described earlier (figs. 16 and 17). The door appears to be original and has two large iron strap hinges. The latch is missing on the inside but the outside handle remains. A later lock, possibly of 19th century date, has been added to the inside of the door. Between the two windows is a large tap 1.1m above floor level. A pipe leads from the floor up to the tap and continues up to a small spherical cistern partially recessed into the wall (fig. 18). A protective metal guard around the tap has a hook for hanging buckets on during filling (fig. 19). Set into the floor below the tap is a semi circular brick base which has been partially truncated by a modern service trench (fig. 20). A second tap set at 1.65m above floor level is located between the door and window (fig. 21). This tap does not have a guard or cistern but does have a semi circular stone base below it on the floor. In the eastern corner are the wooden stairs which are unusually wide for a service building and which may indicate heavy traffic up and down them (fig. 22). There is no evidence in the plasterwork behind the stairs to suggest that there was ever a window in this location and nothing to indicate why the outer stonework appears to be slightly disturbed. The stairs appear to be in their original location as the roof beams attached to it have stop-chamfers in the same style and size as on the main beams.

Figure 16 Ground floor window detail
Looking south-west

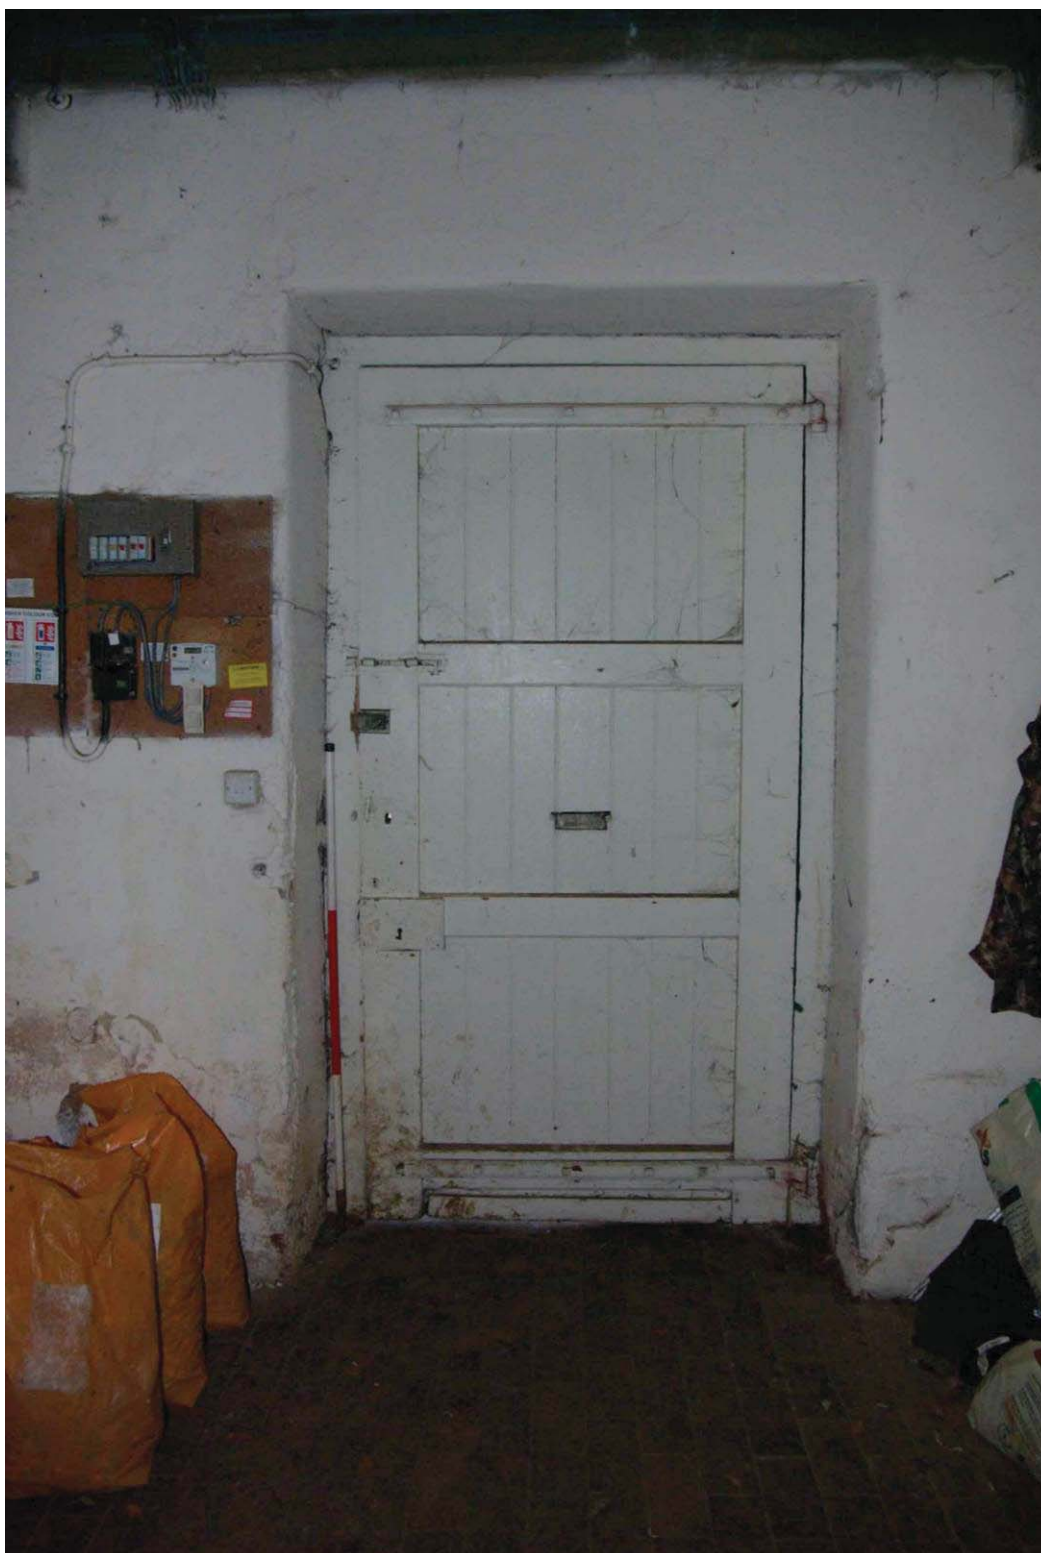
Figure 17 Internal detail of ground floor door
Looking north-east. 1.5m scale

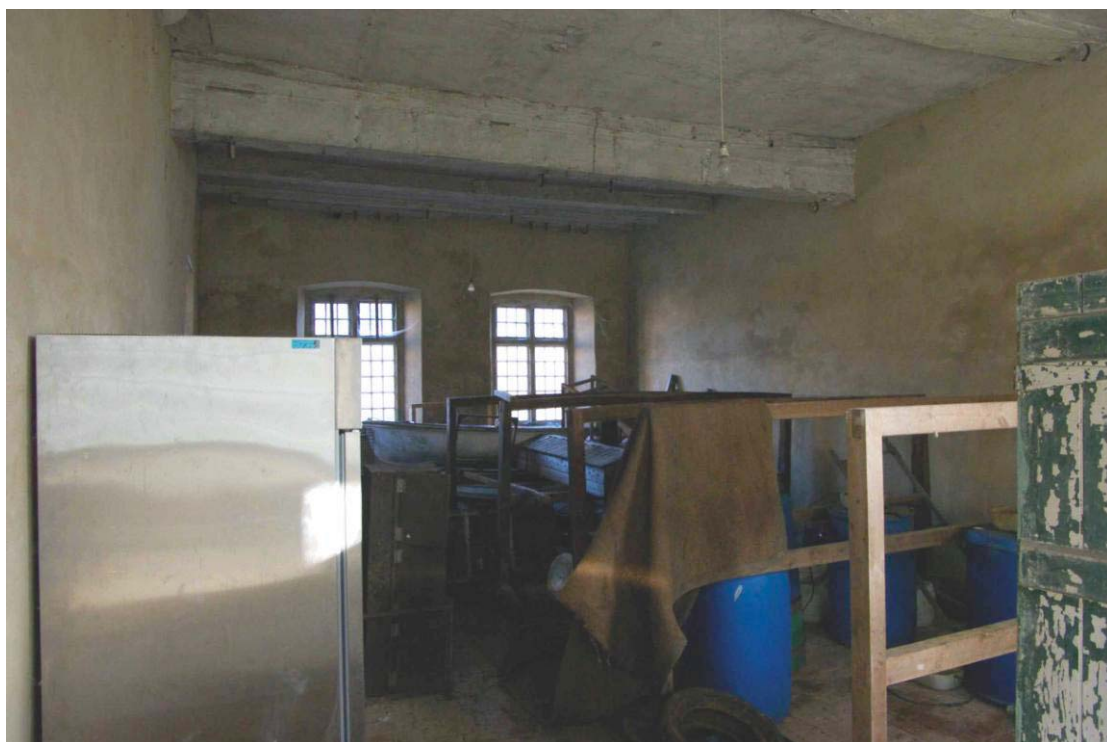
This room is not part of the proposed works and will be blocked off at the adjoining doorway leaving the only access as the outside door in the northern corner. The room consists of a single large room with a number of substantial timber beams running across the ceiling at a higher level than the adjoining room described above. Attached to the beams are a series of pulleys which were presumably used to hang and air the wet laundry (figs. 25 and 26). There is no evidence to support the *Cookhouse* sign seen in the main room.

Figure 25 North-east to south-west wing, ground floor
Looking north-east

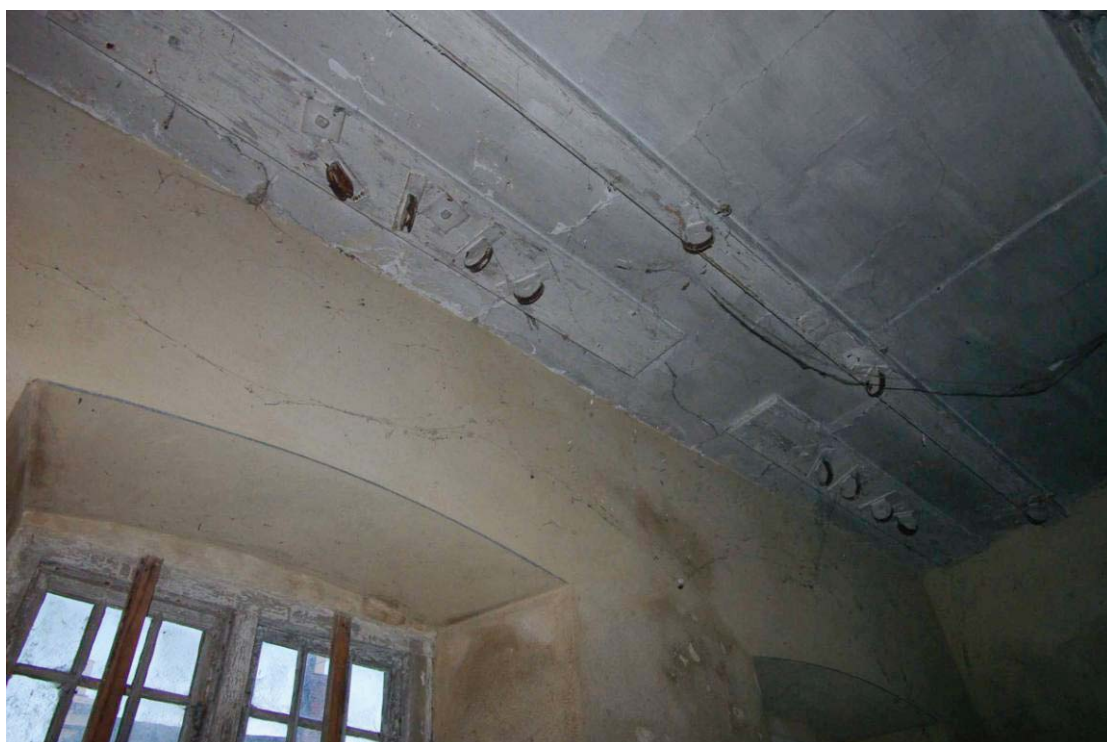
Figure 26 North-east to south-west wing, ground floor. Pulleys in ceiling
Looking east

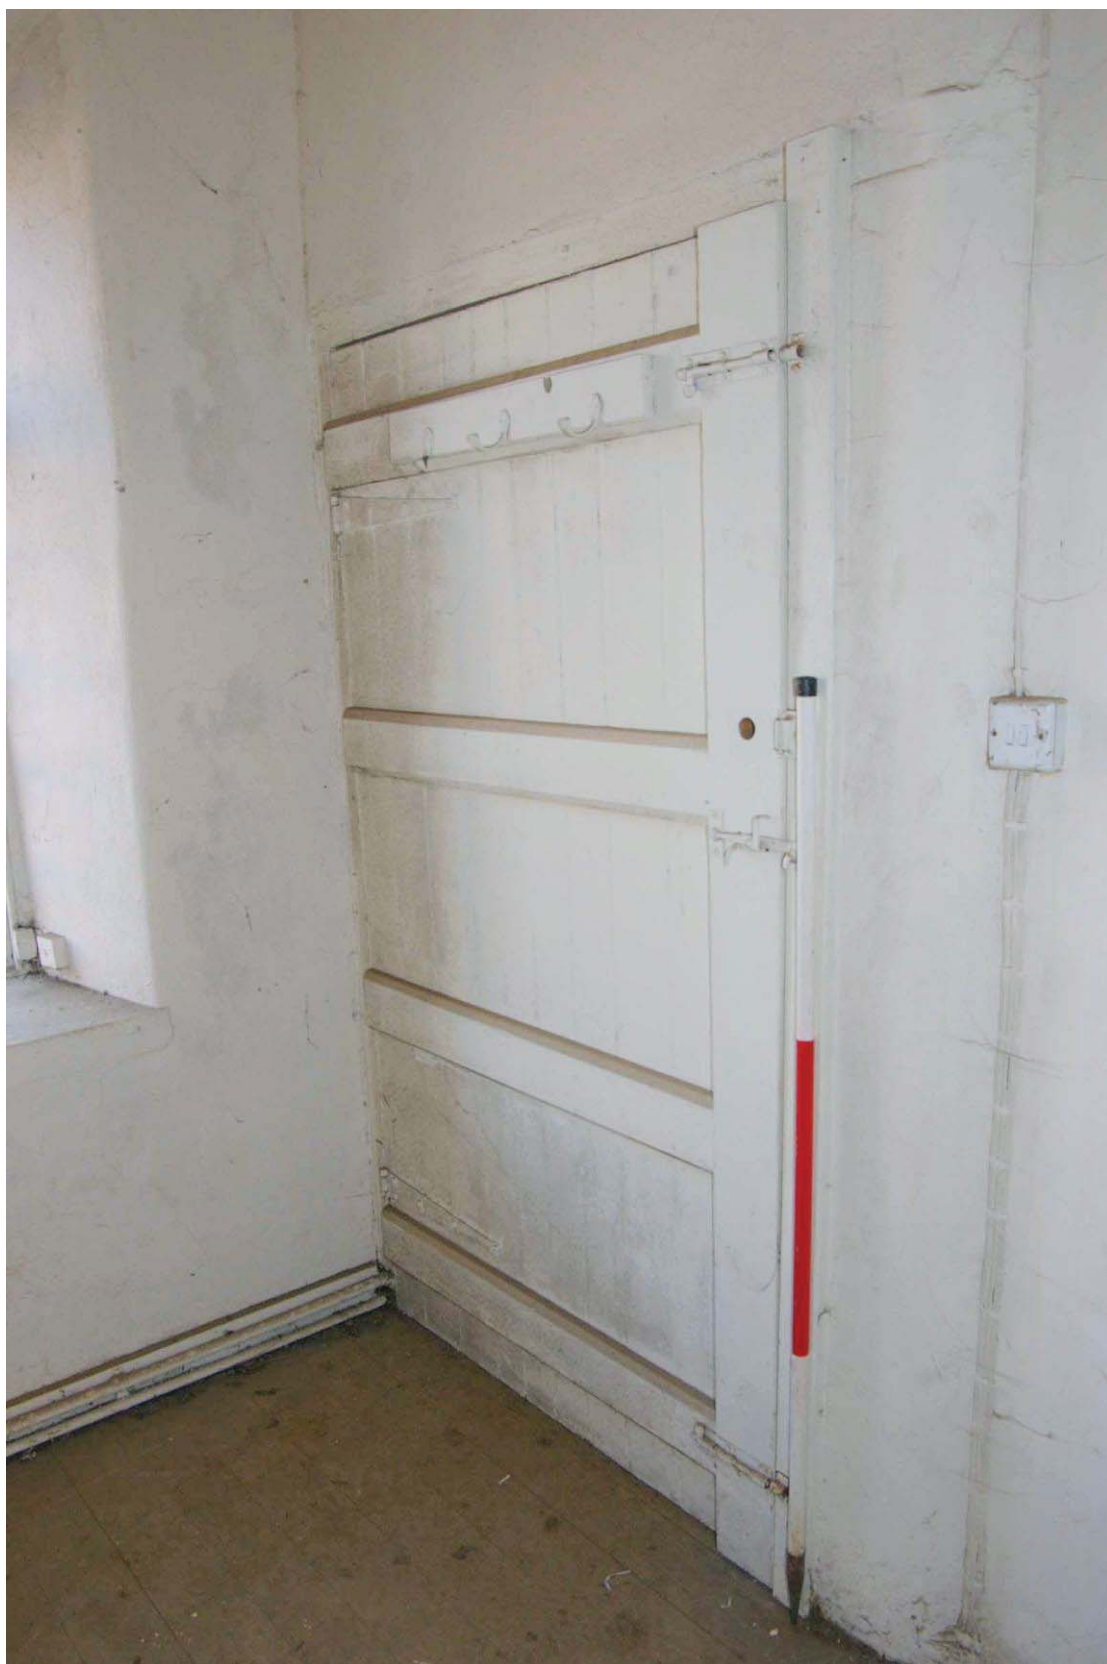
A wide plank and batten door is located at the top of the stairs leading to a small landing (fig. 27). Wooden floorboards are fitted throughout and the ceiling is plastered with the supporting beaded beams partially projecting through. To the west of the landing a number of modern partition walls break the space up into two bedrooms, a bathroom, toilet and small store (fig. 28). The wood and plaster partitions appear to be from the second half of the 20th century and have been located so that both of the northern windows are split down the middle to let light into each of the rooms (fig. 29). The doors to each room are thin plywood panelled doors with Bakelite handles. The toilet and bathroom fittings, with the exception of the cistern, which is an early 20th century design, seem to be of a similar date to the partition walls.

Figure 27 Top of stairs, first floor door detail
Looking east, 1.5m scale
