An Archaeological Watching Brief Carried Out at Park House, Stoke Golding, Leicestershire, NGR SP 398 970.

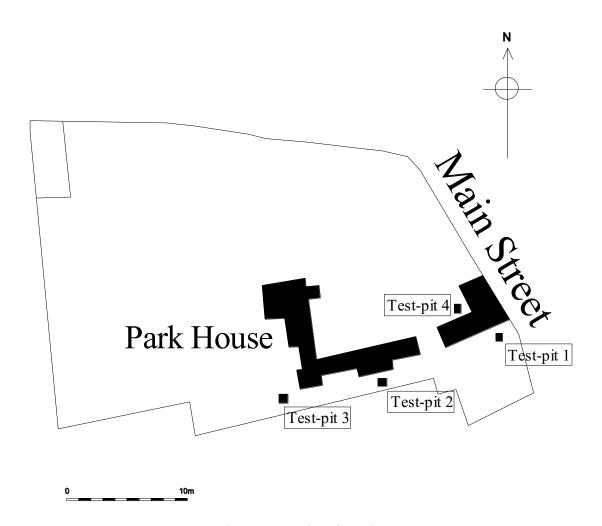
Figure 2 – Location of test pits

The geotechnical test pits were excavated under archaeological supervision to depths ranging between 0.35m in the northernmost test-pit and 1.20m in the others. An examination of the exposed sections indicated that in test-pits 2 and 3 the top 500mm consisted of a dark blackish-brown silty-clay topsoil with fragments of roof tile and post medieval pottery; the roof tile was found at the horizon between the topsoil and the subsoil in pit 2, this pit was situated in an area previously used for garden cultivation, therefore it was unsurprising to find the tiles concentrated in this way.

The remainder of the exposed section consisted of orangey-brown glacial clay (test-pit 2) and orange coarse sand (test-pit 3), both of which continued to an unknown depth.

The eastern most test pit (test pit 1) contained evidence of the ground being raised at some point in the past, a dark brown buried soil (300mm thick) being noted 300mm below current ground level, above this was a 200mm thick layer of re-deposited subsoil (the same mid orangey-brown clay noted elsewhere on the site) and 100mm of topsoil. Test-pit 4 was situated in the south east corner of the yard area. The section here consisted of 50mm of blue-grey aggregate of 10mm diameter, above 100mm of fine grey-yellow gravel forming the modern yard surface. This overlay a layer of large cobble stones (averaging 100mm across) which formed an earlier yard surface. These cobble stones were bedded directly onto a pale yellowish grey-brown clay which continued for unknown depth, this pit only being excavated to a depth of 350mm. The section of the hand dug pits within the barn consisted of earth and gravel floor layers.
