**Historic Building Survey
of Units A and B, Bindleys Yard,
School Lane, Market Harborough,
Leicestershire**

Conservation Area Consent: 08/00854/CON

For: Oastlodge Limited

**Historic Building Survey of Units A and B, Bindleys Yard, School Lane,
Market Harborough, Leicestershire (SP 732 872)**

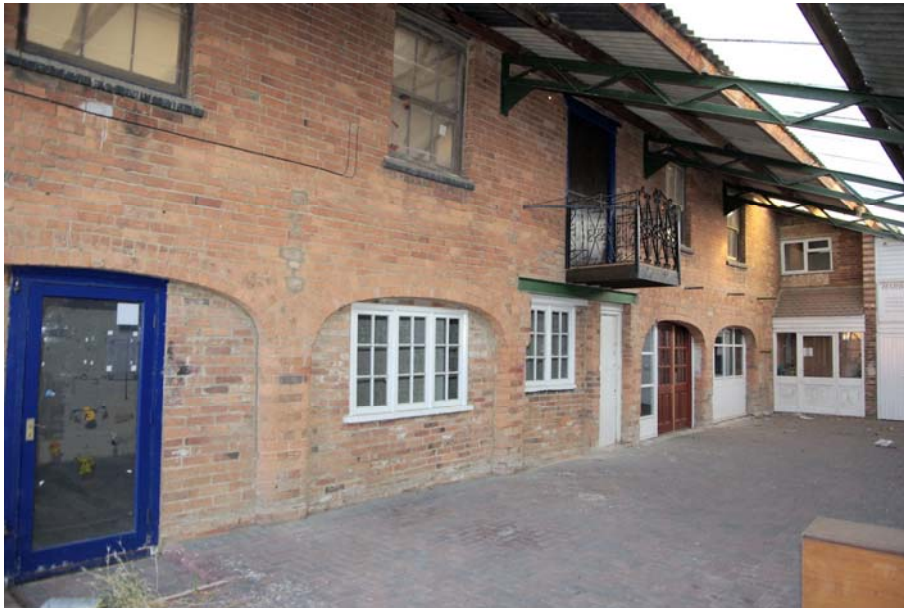
Figure 11 Unit A Front (South) Elevation.

Unit A is the larger of the two units; it is of two storeys and originally functioned as coach house, possibly with a combination of domestic accommodation and storage on the first floor. It is constructed in red brick, laid in Flemish Garden Wall bond. The bricks, measuring $9\frac{1}{4} \times 4\frac{1}{2} \times 2\frac{3}{4}$ inches, are rather soft and some have weathered badly. The ground storey of the principal south elevation (*Figures 8 & 14*) is dominated by five carriage entrances, all originally with depressed arch heads though the central opening has since been modified (see below). There are bull nosed brick piers between the carriage entrances, with chamfered bricks at the top (*Figure 14*). The arches are constructed from two courses of headers. All of the carriage entrances have been blocked in some way, that at the west end has been bricked up and has a modern glazed door, the adjacent arch is also bricked in and has a three light casement window. Interestingly, the bricks used to block the arches are themselves early hand made examples, presumably reused here. The two carriage entrances to the east have recent timber and glazed inserts, one with a double door. The central carriage entrance has been modified, an inserted RSJ replacing the original brick arch. Below this is an inserted door and window. At the west end of the south elevation is an inserted window with a concrete lintel over. At first floor level there are timber sash windows above all but the central carriage entrance. These have chamfered blue brick sills; the later roof over the courtyard obscures any view of the lintels, but there does not appear to be any decoration at eaves level. Above the central carriage entrance there is a door at first floor level, with a projecting modern balcony that is a curious construction of mass-produced wrought iron gates. There is no indication that the doorway is inserted and this appears to be an original opening.
