**A Photographic Survey of Building 2,
254 Braunstone Lane,
Braunstone Town, Leicestershire.**

Planning Application: 07/0768/1/PX

For: Parkers of Leicester Ltd

**University of Leicester
Archaeological Services**

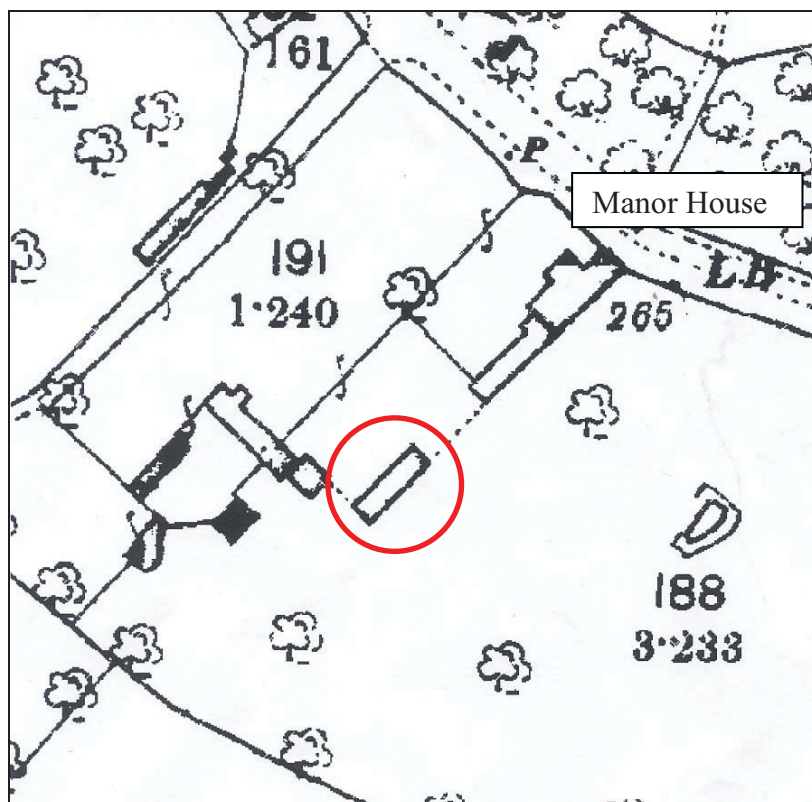
The building is clearly identifiable on the first edition OS map (*Figure 2*) as is a range of since demolished buildings immediately to the north-west, which has the appearance of a farm complex. The Manor House is located to the north-east, fronting Braunstone Lane. There is also what appears to be a fence or boundary between Building 2 and the Manor House, suggesting Building 2 belongs to this other farm complex, not the Manor House. The fact that the buildings doors face the north-west also suggests that the building relates to the former farm complex, not the Manor House. Even with the distortion of the reproduced maps it is possible to see that Building 2 is slightly out of alignment with the projecting rear wing of the Manor House.

Figure 2 First Edition OS map 1854-1901.

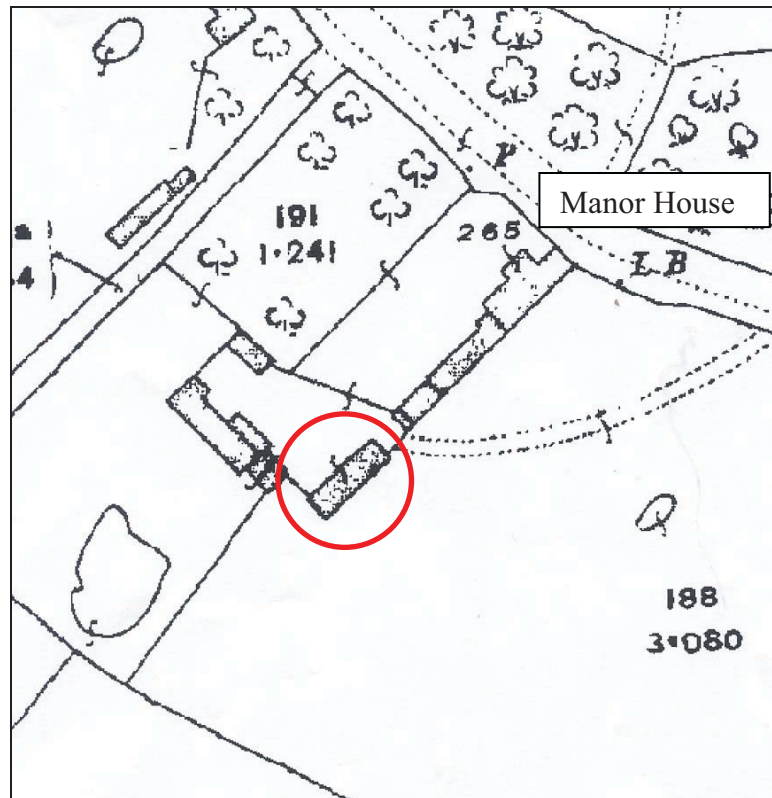
With only occasional alterations and additions, later editions of the map (*Figures 3, 4 & 5*) all apparently show the same arrangement with the boundary between Building 2 and the Manor House remaining constant. The third revision (*Figure 5*) records the building as being wider than in earlier editions and as no evidence of this can be seen on the current building in all likelihood it represents a lean-to of some sort added to the building and since lost. The evaluation trench in this area did uncover a layer of compacted gypsum, possibly the floor of this lean-to (Richards 2008).

Figure 4 Second Revision OS map 1906-1939.

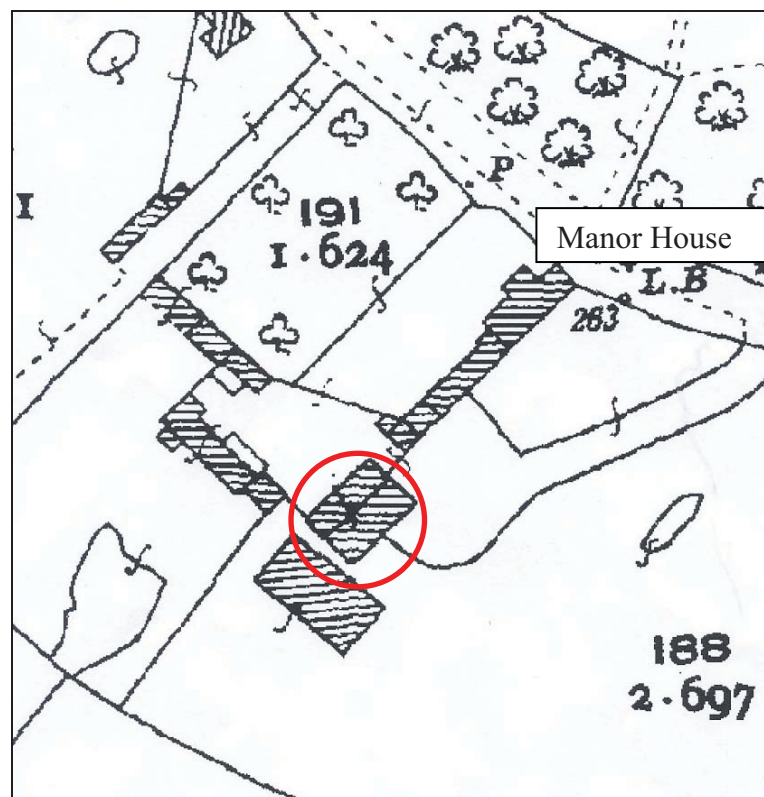
The third revision OS map is also the first to record Building 3, to the south-west. This map evidence confirms that the building dates from the immediate post-war period. Vast numbers of this type of building, using Fletton Bricks and corrugated asbestos cement roofing sheets upon steel trusses were built at this time. The design had been introduced during the war and used extensively by the War Department; as a result such buildings are frequently mis-identified as being military in origin. The bricks used to block the door in the south-western gable of Building 2 are the same Fletton Bricks used in the construction of Building 3. The gap between the two buildings would suggest that the door was in use at the time Building 3 was built, otherwise the building would have been likely to have been built abutting Building 2; however the use of matching bricks would suggest the door was blocked soon afterwards.

Figure 5 Third Revision OS map 1924-1949.

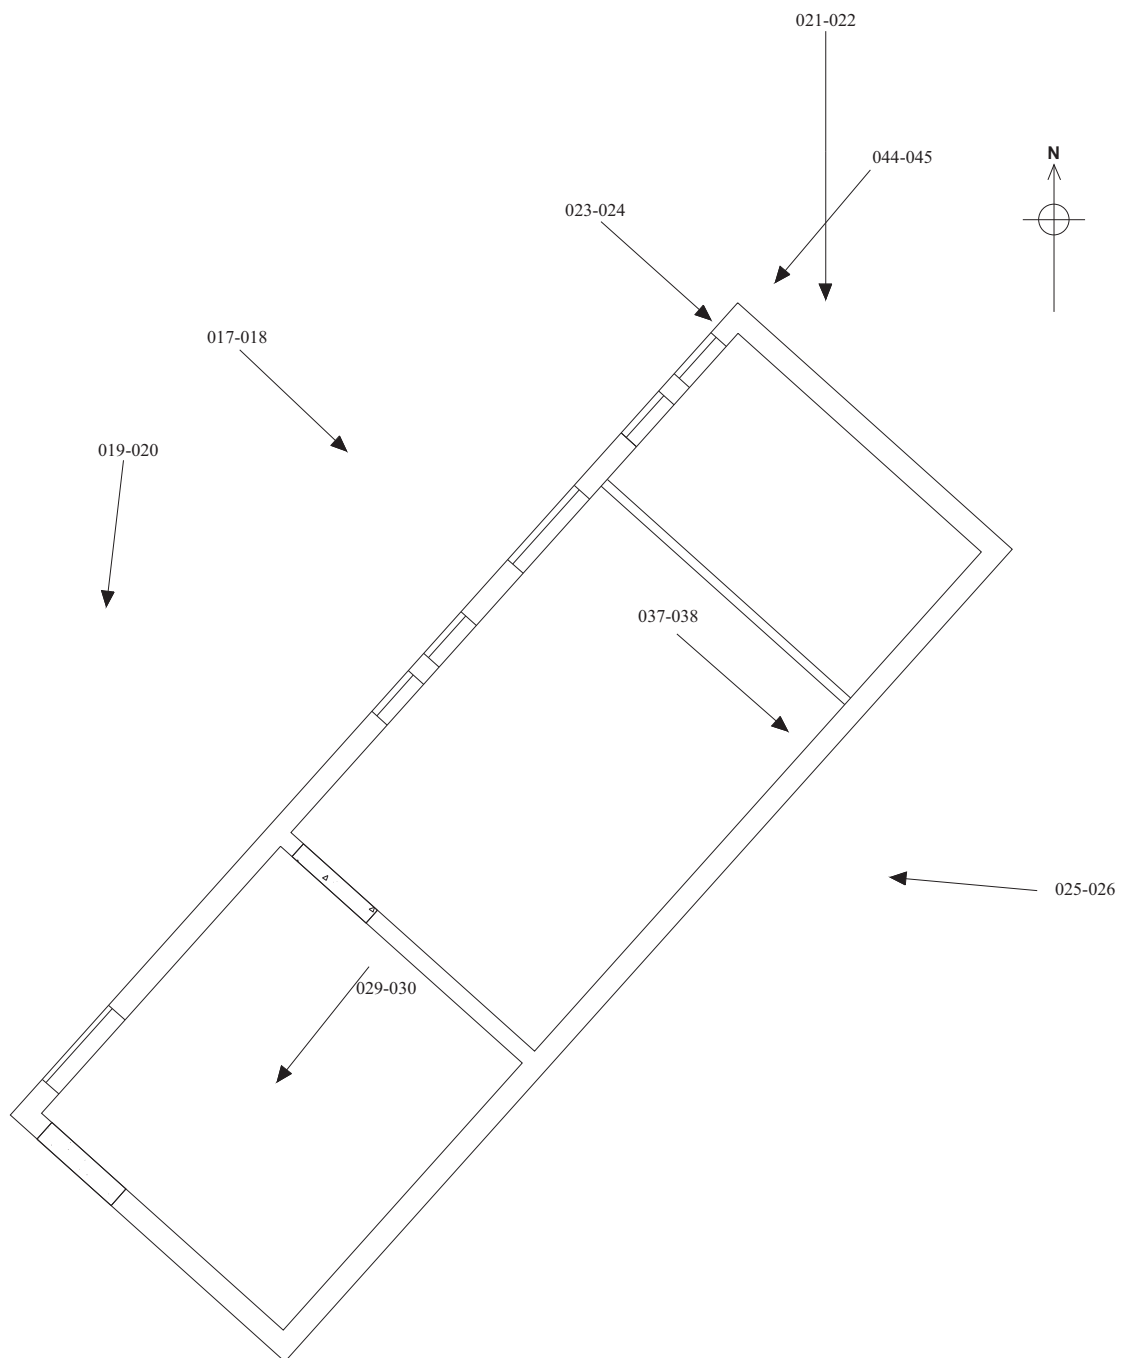
Figure 7 Sketch Plan of Building 2 showing direction of photographs mentioned in the text.

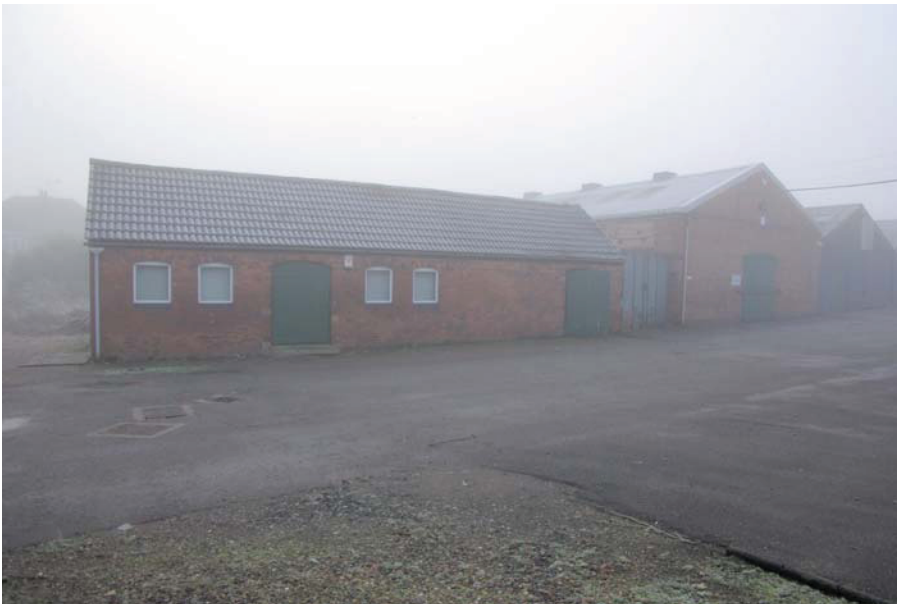
The proposed development area consists of four buildings of interest; one is to be retained and three others are scheduled for demolition. Although only Building 2 is being recorded as part of this photographic survey its relationship with the other buildings was noted (*Figure 9*). Each building has been allocated a number for identification purposes and a letter where internal sub-division is also required.

Figure 9 Building 2 with Buildings 3 & 4 to the right (south-west).
