**A Photographic Survey of the Former
BUSM Factory, Ross Walk,
Leicester
(NGR SK 5909 0643)**

For: Westleigh Homes

ULAS Report Number 2009-096

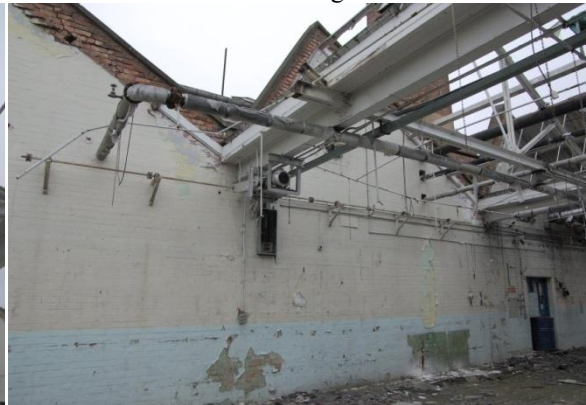
Building 44 has by far the largest footprint of all the buildings within BUSM, but is only single storey and is one of the earliest BUSM buildings, unfortunately it has been largely demolished prior to this photographic survey being carried out (*Figure 17*), and leaving only the external walls and some other limited detail. The building was originally BUSM's I.V.I tack & nail plant and was a single storey red brick building with a north light roof. Along the westernmost wall there are a series of W.Cs with no access from the factory floor. There area also a range of small building along the easternmost wall including a stump of a chimney, suggesting this building originally had its own boiler. Limited remains of a drive shaft can be seen on the eastern wall (*Figure 20*); an electric motor had apparently been retrofitted to power the shaft and was still in position.

Figure 20 Building 44, original driveshaft.

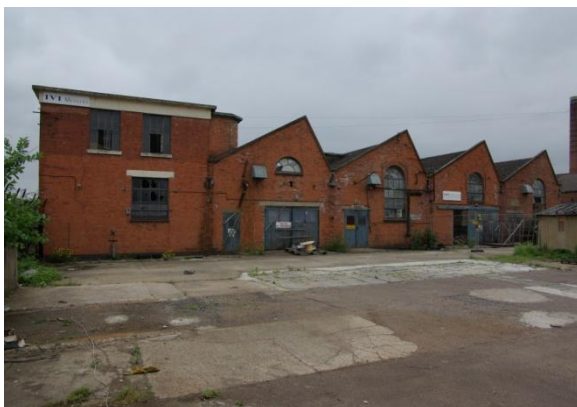
Building 46 is located to the east of building 44 and has an identical bay to that of 44 fronting Hildyard Road (*Figure 21*). To the rear (north) of this there is a factory floor, which although still roofed, is also in a ruinous condition. Generally it is identical in appearance to 44 and was also part of the Tack & Nail plant; abundant warning signs indicate the building originally housed the molten salt bath, a process of heat treating metal components, evidence of which may be seen in the large concrete pad towards the rear of the building. The roof trusses are again identical, although no clear makers stamp could be seen, while the columns are identical in appearance to those seen within building 44, but bear a different foundry stamp, originating from RUSSELL & SONS LEICESTER. There is an unusual line of dormer windows in the in the south-facing roof of the central bay, the exact purpose of this is unclear.

Figure 21 Building 46, Eastern Elevation.

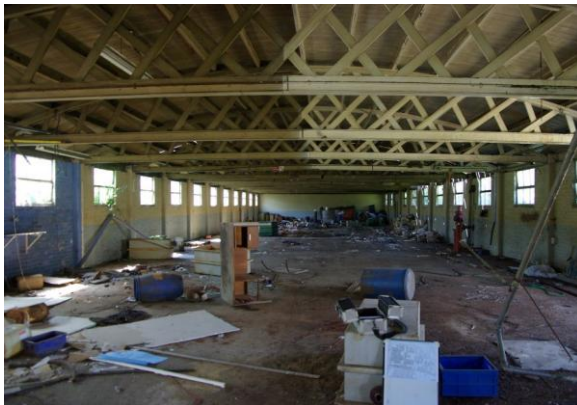
Building 54 is largely open-sided supported on concrete columns, while Building 55, on the other hand has red-brick walls with Crittall-style windows. Discolouration visible on the trusses also suggests that the building had been partitioned lengthways (*Figure 27*). Interestingly one of the northernmost trusses of building has suffered a structural failure causing the roof to collapse (*Figure 29*); whether this was caused by an impact or a design or build flaw is unclear.

Figure 27 Building 55, Internal.

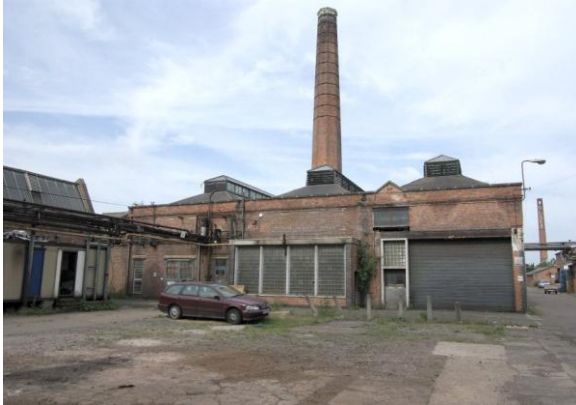
Buildings 68 and 69 are the original boiler house and associated buildings powering the site (*Figures 35 & 36*). Unfortunately excessive asbestos contamination prevented any internal examination; a limited view through the windows indicates that there are several modern boilers still in place. As expected the boiler house is a substantial red-brick building with flat roof with sky lights. There is a large vehicle door towards the northern end of the eastern elevation, while the centre of this elevation has an unusual extension of glass bricks, the exact purpose of which is unclear. There appears to be a parapet and a brick cornice at height, and the corners of the building are finished in bull nosed blue bricks. As with a number of other buildings there are traces of World War II camouflage visible on the building. Coal for firing the boiler was originally bunkered towards the northern edge of the proposed development area and moved by loading shovel to the front of the boiler house where it was loaded into a hopper which transferred the coal into the boiler house via an opening two thirds of the way up the building. On the south-westernmost corner of the boiler house is an octagonal chimney.

Figure 35 Building 68 boiler house.

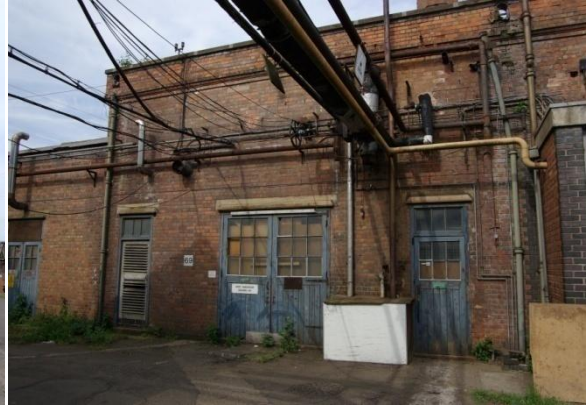
The boiler house has been extended to the south with the construction of Building 69 which is very similar in appearance but has a very unusual finish to the brickwork on the south-east corner. The southern elevation is well sheltered from the elements and as a result the World War II camouflage has survived exceedingly well.

Figure 36 Building 69, eastern elevation.

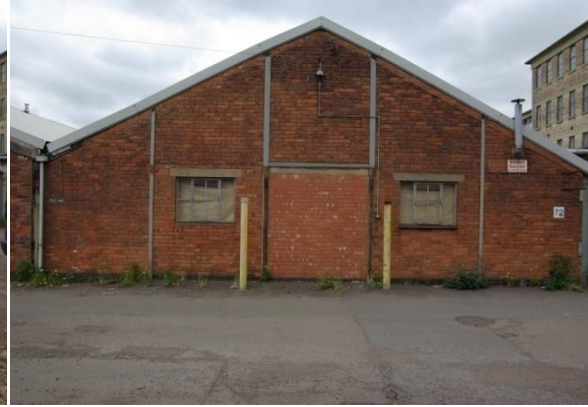
Building 72 abuts the southernmost wall of Building 51. Unlike 51 it is brick-built with a limited steel frame (*Figures 39 & 40*), with a roof of modern box profile polycarbonate. The steel bears the makers stamp LANCASHIRE STEEL CORP^N ENGLAND; the corporation was formed in 1930 by the amalgamation of a number of iron and steel companies, primarily in Manchester, with the principal works at Irlam now in Greater Manchester. The corporation was nationalised by the Labour Government in 1951 only to be de-nationalised by the Conservative Government shortly afterwards. Finally, with the formation of British Steel, the corporation along with all the United Kingdom's steel producers was nationalised in 1967 (Caswell et al 2002).

Figure 40 Building 72, Southern Elevation, Steel Frame.

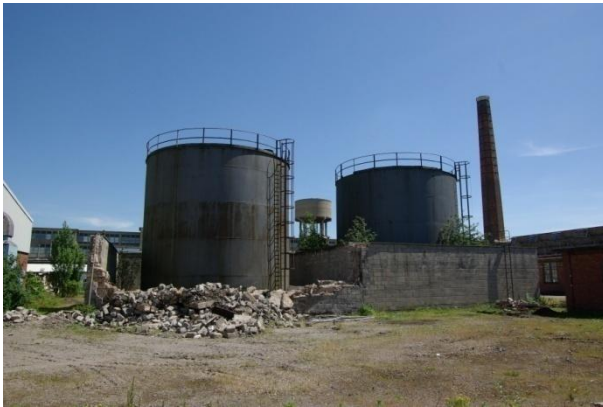
There are a number of other structures within the proposed development area including two large bunded oil tanks adjacent to building 67 (*Figure 51*). The most significant, however, is the concrete water tower, built in 1954 which is over 36metres (120 feet) tall and holds 50,000 litres. The huge tank is supported on impossibly thin looking concrete legs (*Figure 52*) and is a substantial land mark when viewed from the north and west, however due to its proximity to the equally tall Ross Walk frontage buildings it is invisible from the east.

Figure 51 Oil storage tanks.

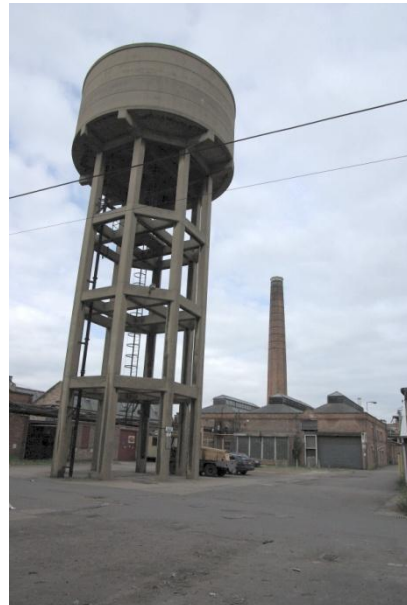
Figure 52 Water Tower, with chimney in Background.
