**An Archaeological Impact Assessment of
47 and 49 Market Street,
Ashby-de-la-Zouch,
Leicestershire (NGR: SK 357 167)**

University of Leicester Archaeological Services

Report 2005-056

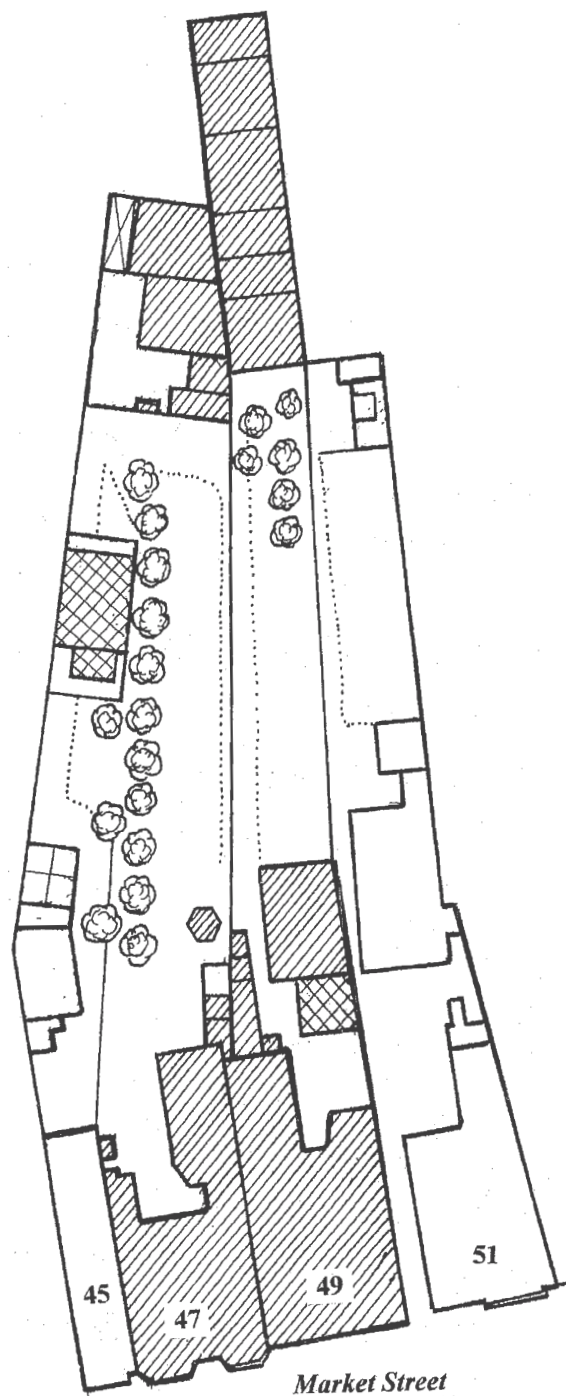
At the rear of the property a single storey, detached, two-bay unit, now used for storage. The 1883 Ordnance Survey map clearly shows this building was originally attached to the rear of No 47, (*see Fig.3*). The differing sizes of bricks in this store indicate it was built originally as a single bay, possibly in the early 19th century and a second bay was added later in the same century. Sample dimensions of bricks (n=15) in the earlier phase of building range between 205<230mm [1 @235mm] x 110<115mm x 55mm [1 @60mm]. The bricks of the later phase (n=15) range between [1 @218] 220<230 [1 @233mm] x [1 @62] 65<70mm x 110<115. The roof of this unit now has a gable close to the house and a half-hipped gable at the north end. Behind this unit there is a substantial area of garden with trees and what would appear to have been an extensive glasshouse. The extreme north end of the plot has been severed from the original burgage plot and has a series of buildings on it whose function is unknown. The plot configuration of No.47 implies that what is 45 Market Street is probably a much earlier subdivision of the original burgage plot

Much of the rear elevation of No 49 is obscured by a series of later single and two storey brick extensions mostly of mid-19th origin but with some early 20th century additions, (*see Fig.3*). These provide access to the ground floor retail units and first floor office space and as workspace to the ground floor premises.

Fig.3 Detail based on 50inch, Ordnance Survey Map, [1883], Sheet XVI.9 showing the layout of the plots of 47 and 49 Market Street, with extensive garden areas to the rear of the properties and the severed north ends of the original plots. Nos 45 and 51 Market Street included (in outline).
