**An Historic Building Analytical Survey (Level 3),
Huskissons Lodge Farm Buildings,
Wansford Road, Kings Cliffe,
Northamptonshire.
NGR: TL 013 978**

ULAS Report No. 2009-137
©2009

For: Mrs D Coleman

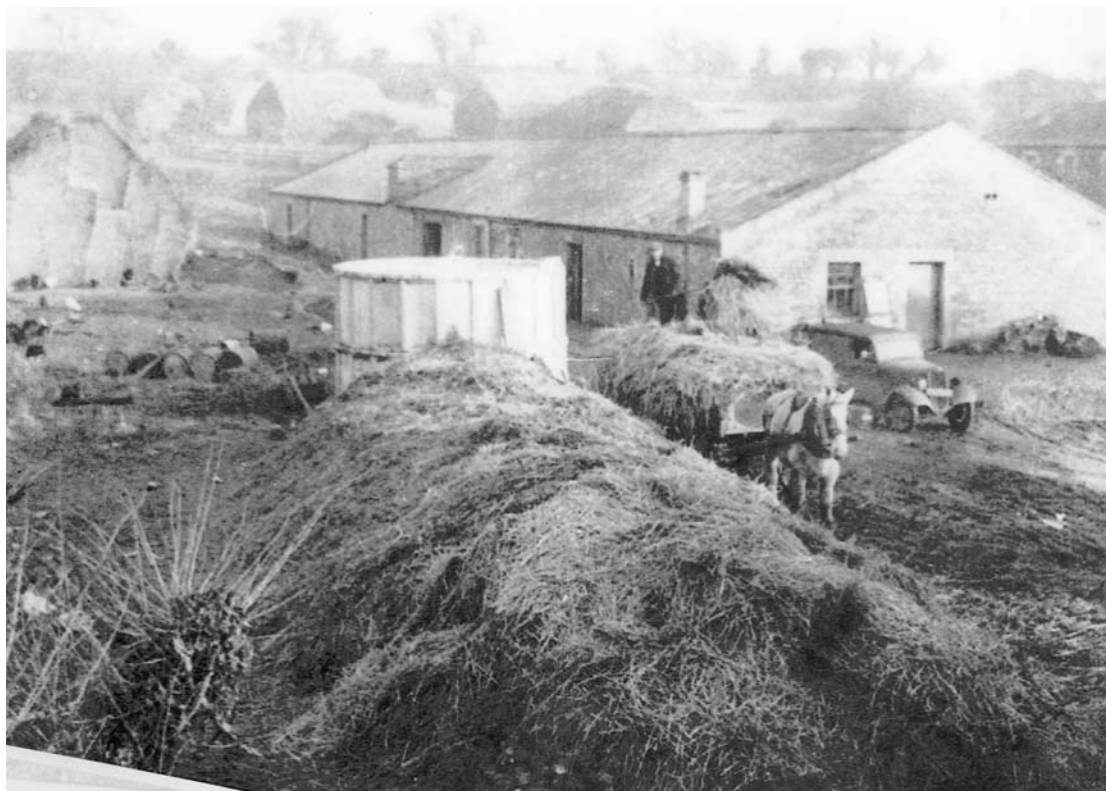
that this building was used as a pig pen. The corrugated-iron barn and silos appear at some time after the 1952 OS revision. A photograph of the buildings taken in the late 1940s does not seem to show this barn either (fig. 5).

There is no trace of a small dormer window above the height of the eaves which is clearly shown in the 1940s photograph (fig. 5). Any structural evidence of this would have been seen in the original roof covering which has been replaced at this point by the corrugated sheet metal.

Figure 5 Huskissons Lodge farm buildings in the late 1940s
Picture supplied by client

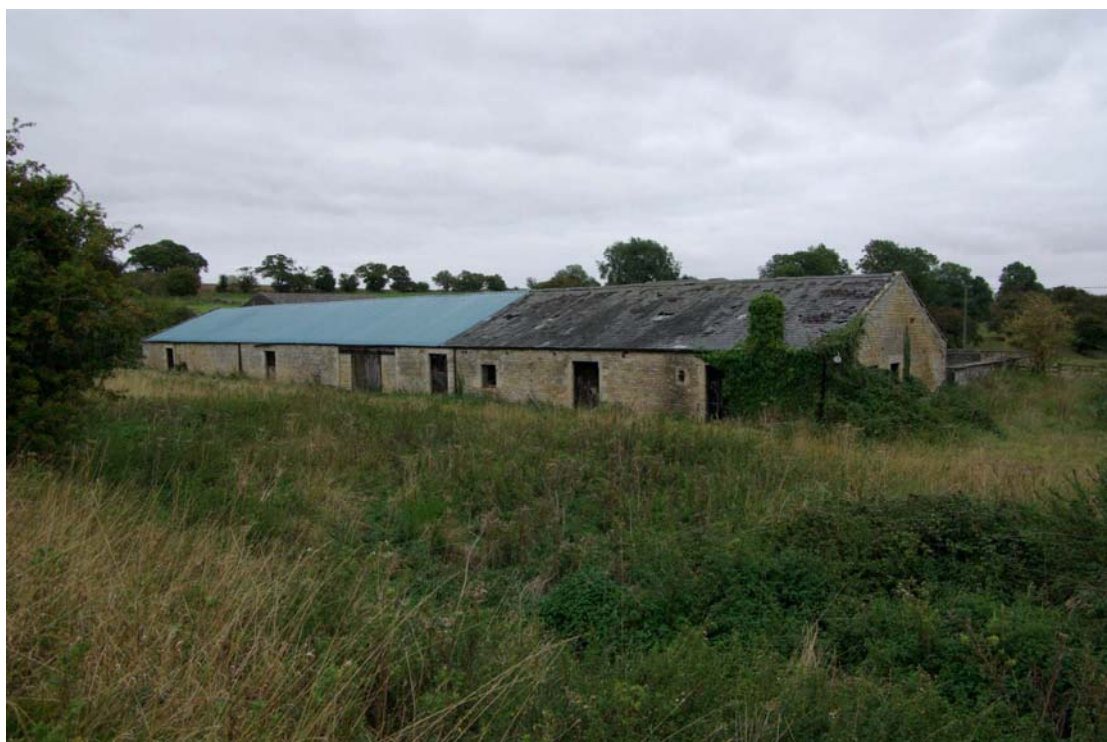
The north elevation is a single storey range extending across the whole width of the complex. Most of the roof covering is of modern corrugated sheet metal although an area at the western end is still covered with the original slate (fig. 14). All the doors and the single window have dressed quoins and lintels with chamfers on the doors which all appear to be as originally built. A row of circular vents of the same size as on the east elevation run along the range at eaves height. The eastern door is a plank and batten door which folds in two in an attempt to give more space to get in and around the doorway when it is open. A recessed double sliding door is located in the centre of the range and is flanked by two stable doors (fig. 15). Most door fittings are missing but a decorative latch plate of the same pattern as seen on the southern elevation survives on one door. Other doors have a simple finger hole to allow the internal wooden latch to be lifted. A small arched opening with a dressed limestone head is located to the east of a ventilated door of a small machine room (room 2) (fig. 16). A brick-built chimney breaks the eaves near to the western corner of the range. Regularly spaced dressed blocks of limestone show where the north to south roof trusses are located inside the buildings.

Figure 14 North elevation
Looking south east

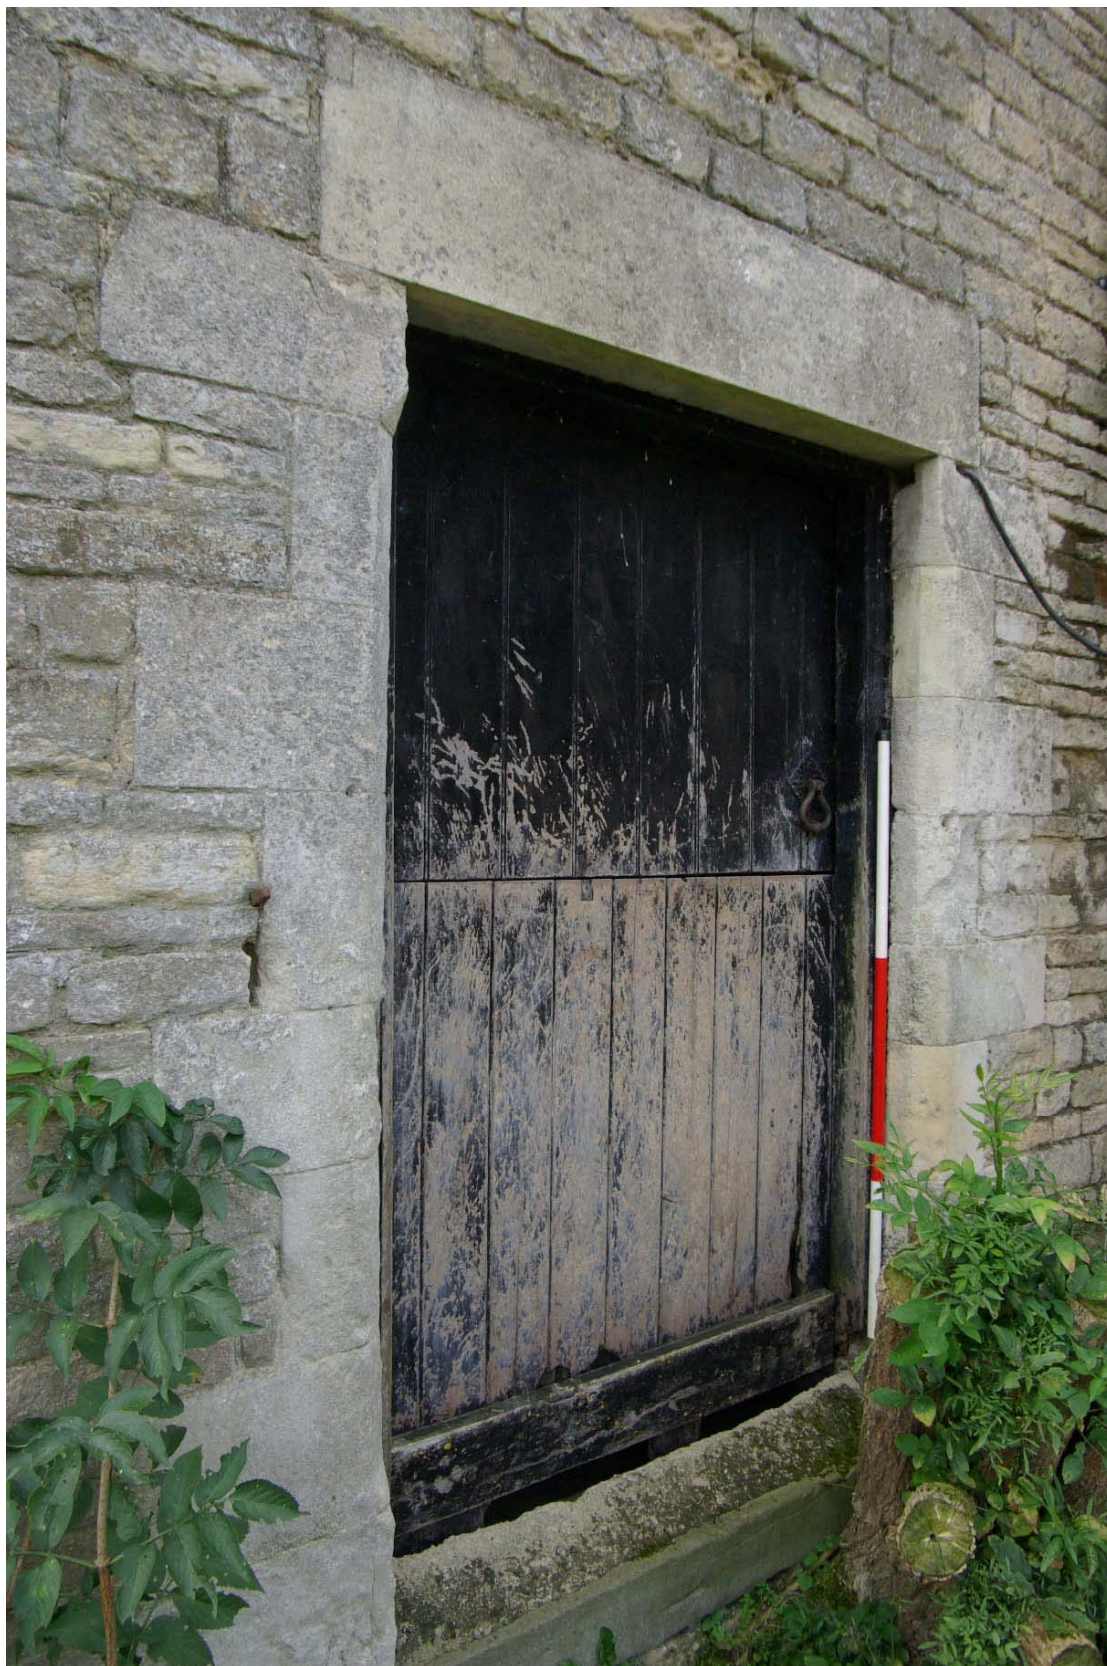
Figure 21 Central building north door detail
Looking south west. 1.5m scale

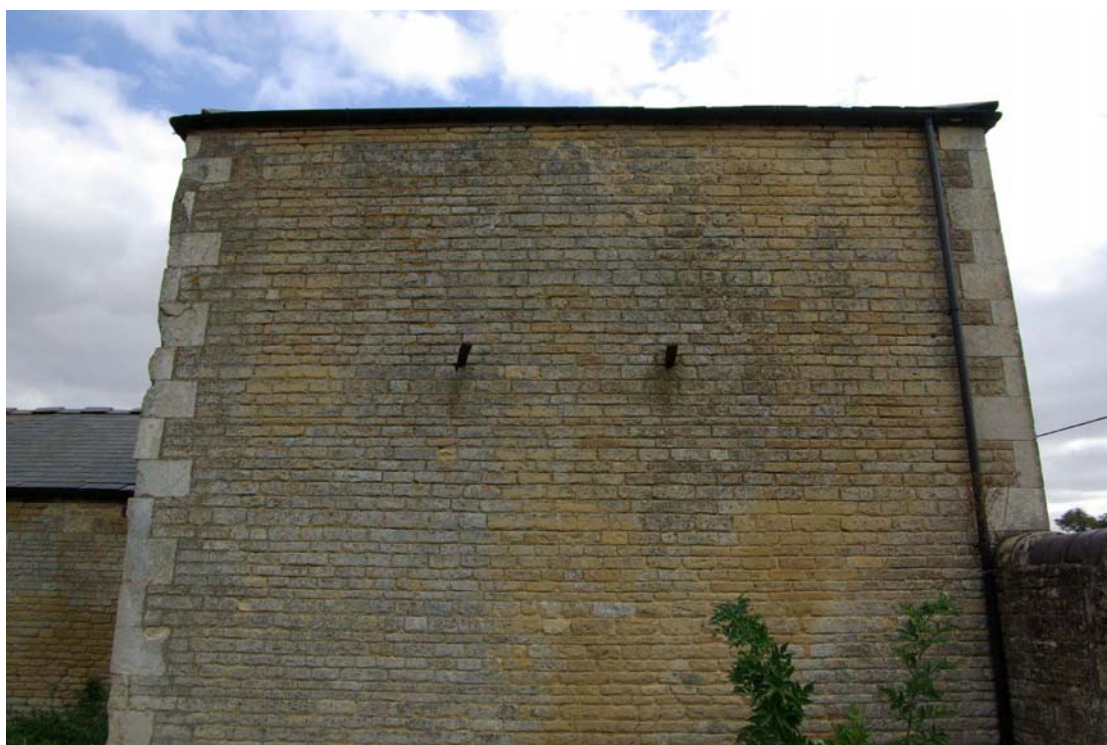
Figure 23 Courtyard 2 central building west elevation and building scar
Looking east

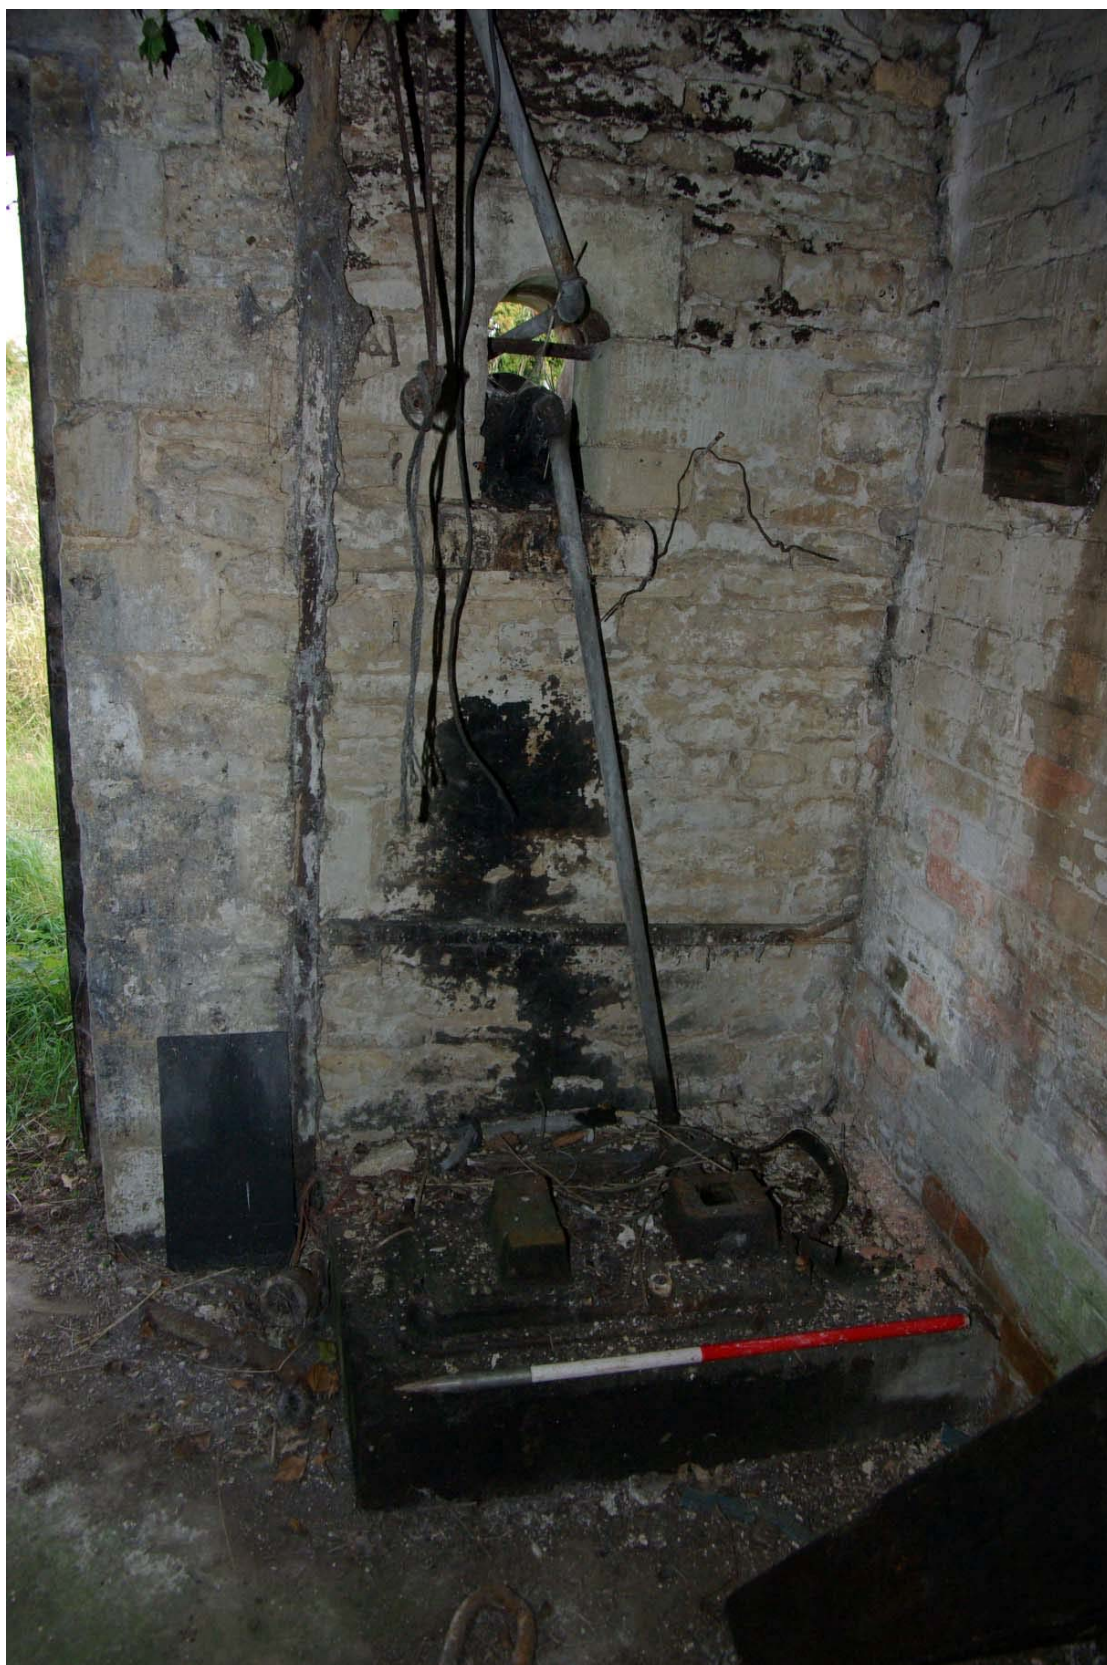
Figure 26 Room 2 machine base
Looking north east. 1m scale

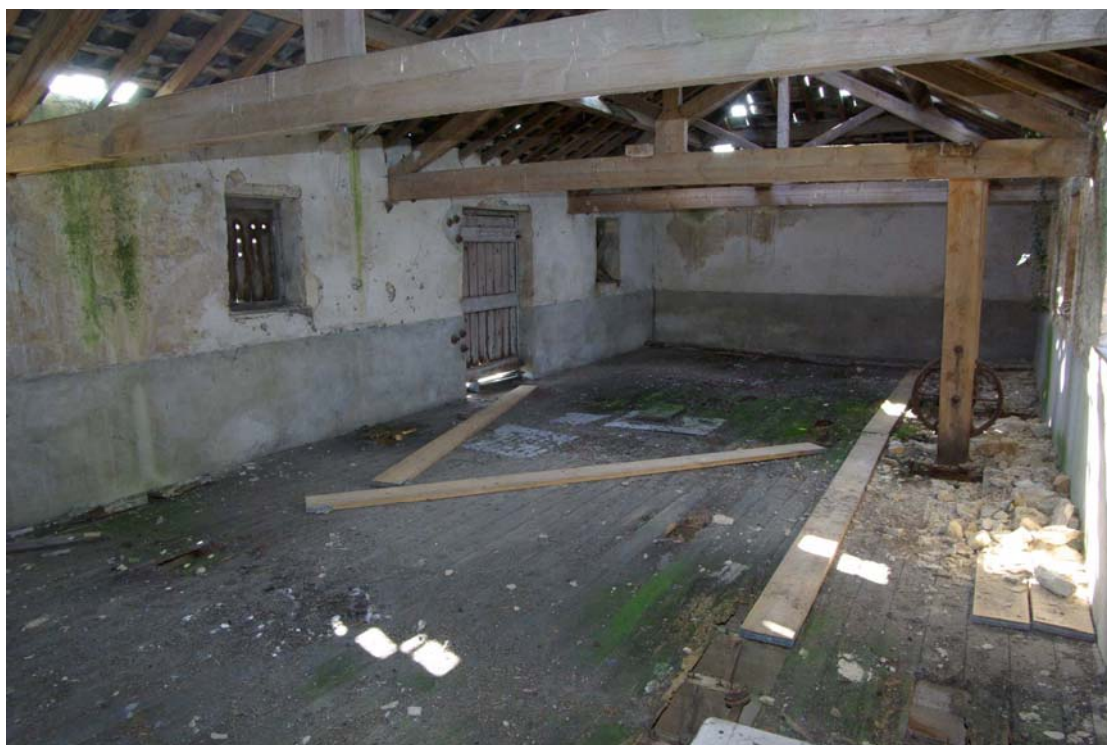
The first floor room floorboards are in a very poor state of repair due to the number of holes in the slate roof. It has an enclosed banister around the top of the stairs which lead up into the room which appears to have been plastered relatively recently up to sill height (fig. 40). To the east of the main loading door can be seen the bolts attached to the loading jib noted on the southern elevation. Opposite this are the remains of a hand-powered winch supported between two large timbers (fig. 41). The roof structure is the same as in room 11 and the cart shed.

Figure 40 Room 13 central building, first floor
Looking south west
