DALKEITH CORN EXCHANGE

Historic Building Recording

for Melville Housing Association

May 2013

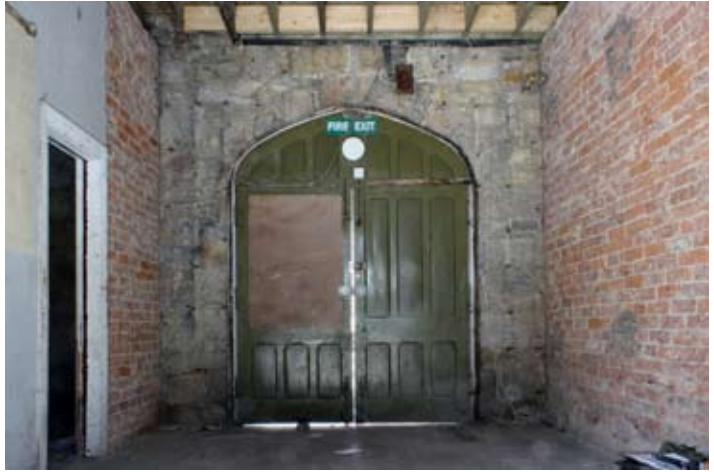
Photo 013

West elevation External stone wall of squared stones built to courses. Nails for carrying lathe and plaster finish evident. Three external doorways mirroring the openings on the east elevation. Main two-leaf central entrance door still in use (Photo 013). Smaller flanking doorways boarded up. Two large rectangular windows, now boarded up (Photo 017). Massive stone lintels.

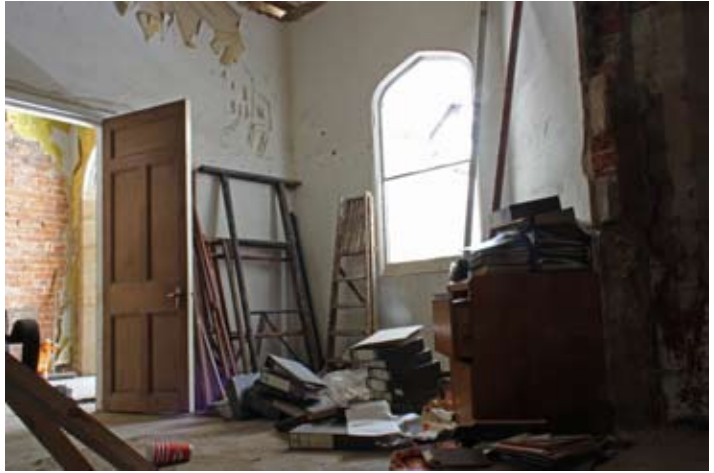
Photo 015

East elevation Plaster mostly intact, partial wooden panelling to dado in rooms. One wide central opening and two narrower to flanking passages, all with tudor arches. Southern archway boarded up. No evidence of door fittings. Two small casement windows, one to each room (Photo 015). Northern window largely boarded with small sliding window inserted. Bevelled ashlar projections which would have formed corners to original room layout. The northern one houses a decorative cast-iron fireplace, although no direct connection to a chimney could be ascertained. Partial stubs of original projecting brick walls.

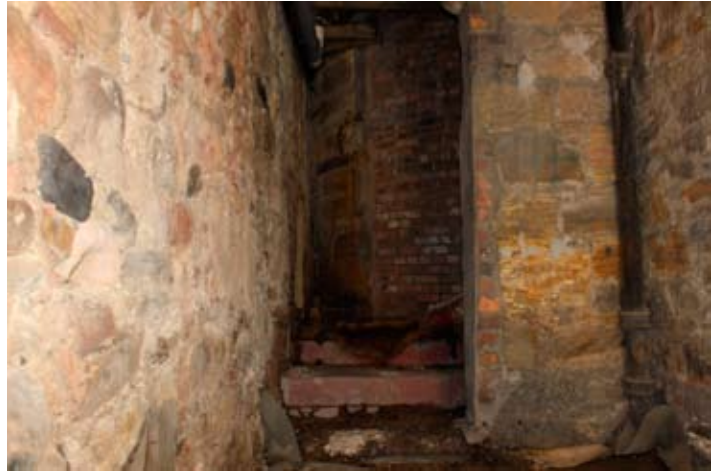
Photo 026

First floor accessed by external projecting stone stair on south elevation of main hall. This has been constructed in place of the westernmost buttress on this side. These stairs would have been open to the close to the east but has been subsequently been blocked (Photo 026). Plaster mostly survives. Curved wooden handrail (Photo 011). Exposed ceiling timbers look recently replaced.

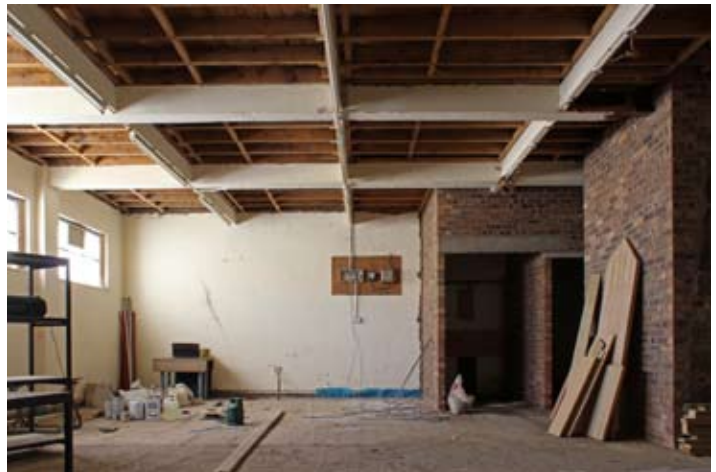
Photo 028

This extension comprises a brick-built structure supporting a flat timber roof that adds six main rooms and a number of smaller alcoves and storage spaces to north of the hall. Large sections of the original plaster have been removed, exposing the roof trusses and much of the brick work (Photo 028). There is no evidence for major alterations or additions to this structure.
