32 – 38 MILLHILL, MUSSELBURGH, EAST LoTHIAN

HISTORIC BUILDING SURVEY

commissioned by Loretto School

January 2017

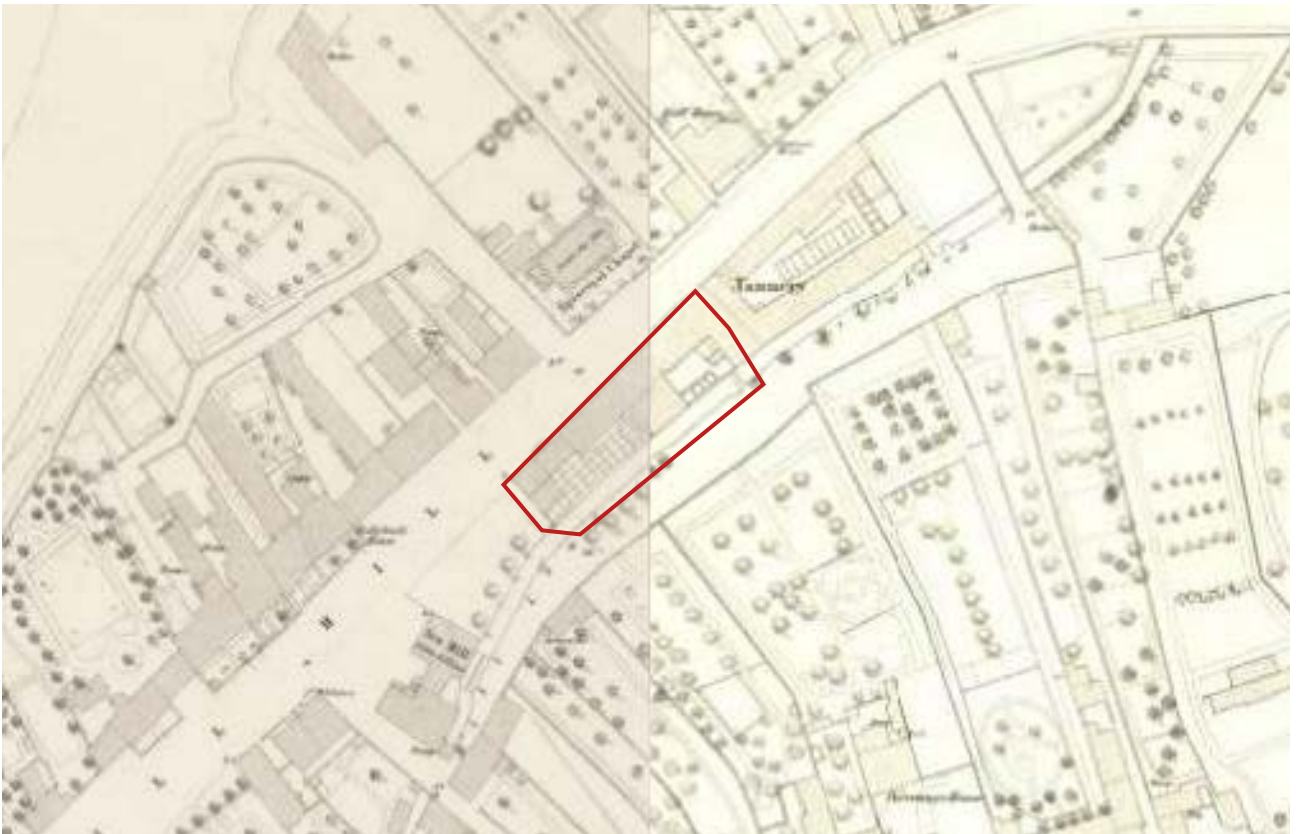
ILLUS 2 Extract from the 1853 OS map

The buildings were first clearly depicted on the 1853 Ordnance Survey (Illus 2) displaying a series of buildings fronting Millhill with a mill lade to the rear of the properties. These buildings are marked as a tannery on this map. The series of small square features depicted
