ABBNEYHILL, EDINBURGH

Historic Building Assessment and Excavation

commissioned by Watkin Jones

October 2014

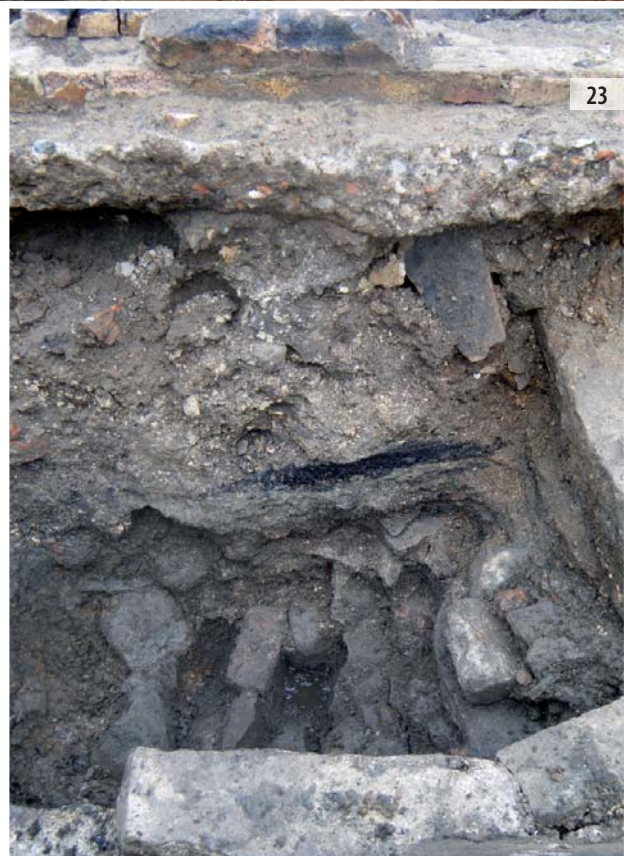
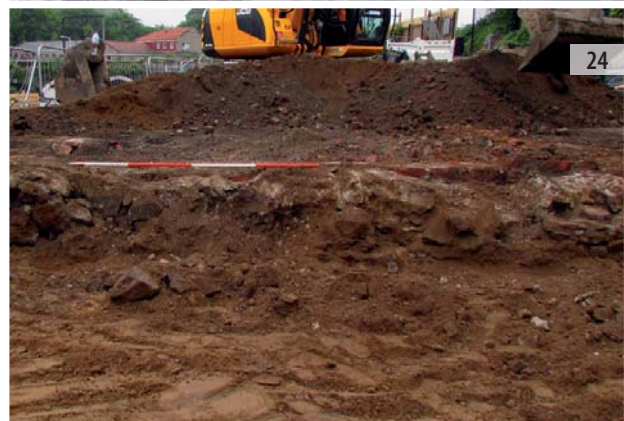
ILLUS 24

View of stone wall [152], facing NE

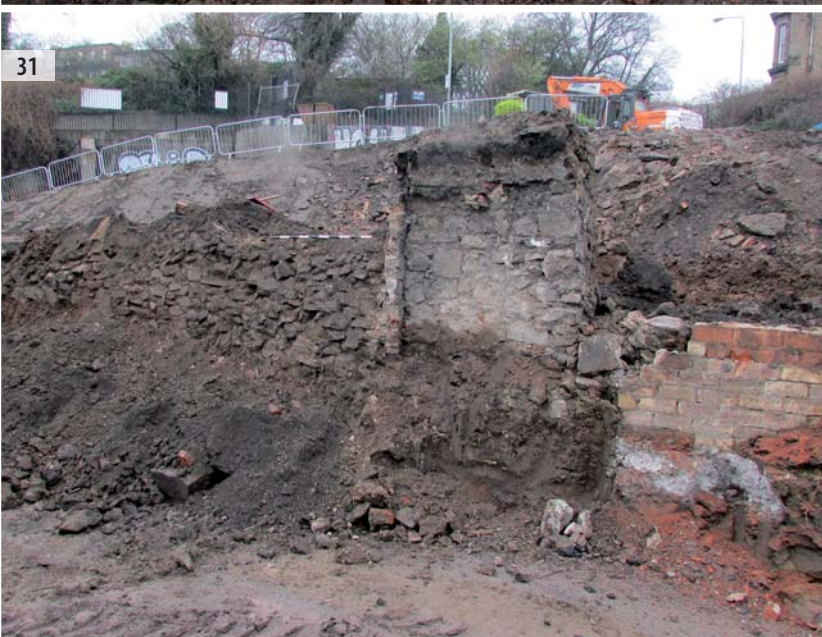
ILLUS 30

View of chimney base [078], facing S

recorded further to the north. The platform [078] was constructed of 11 stepped courses of brick 1.25m high sat on a concrete base forming a large rectangular foundation 3.2x2.8m cut into the geological subsoil (Illus 30). Given the foundations location north of the main brewery building it is possible that the chimney base was associated with the washhouse established in 1922.

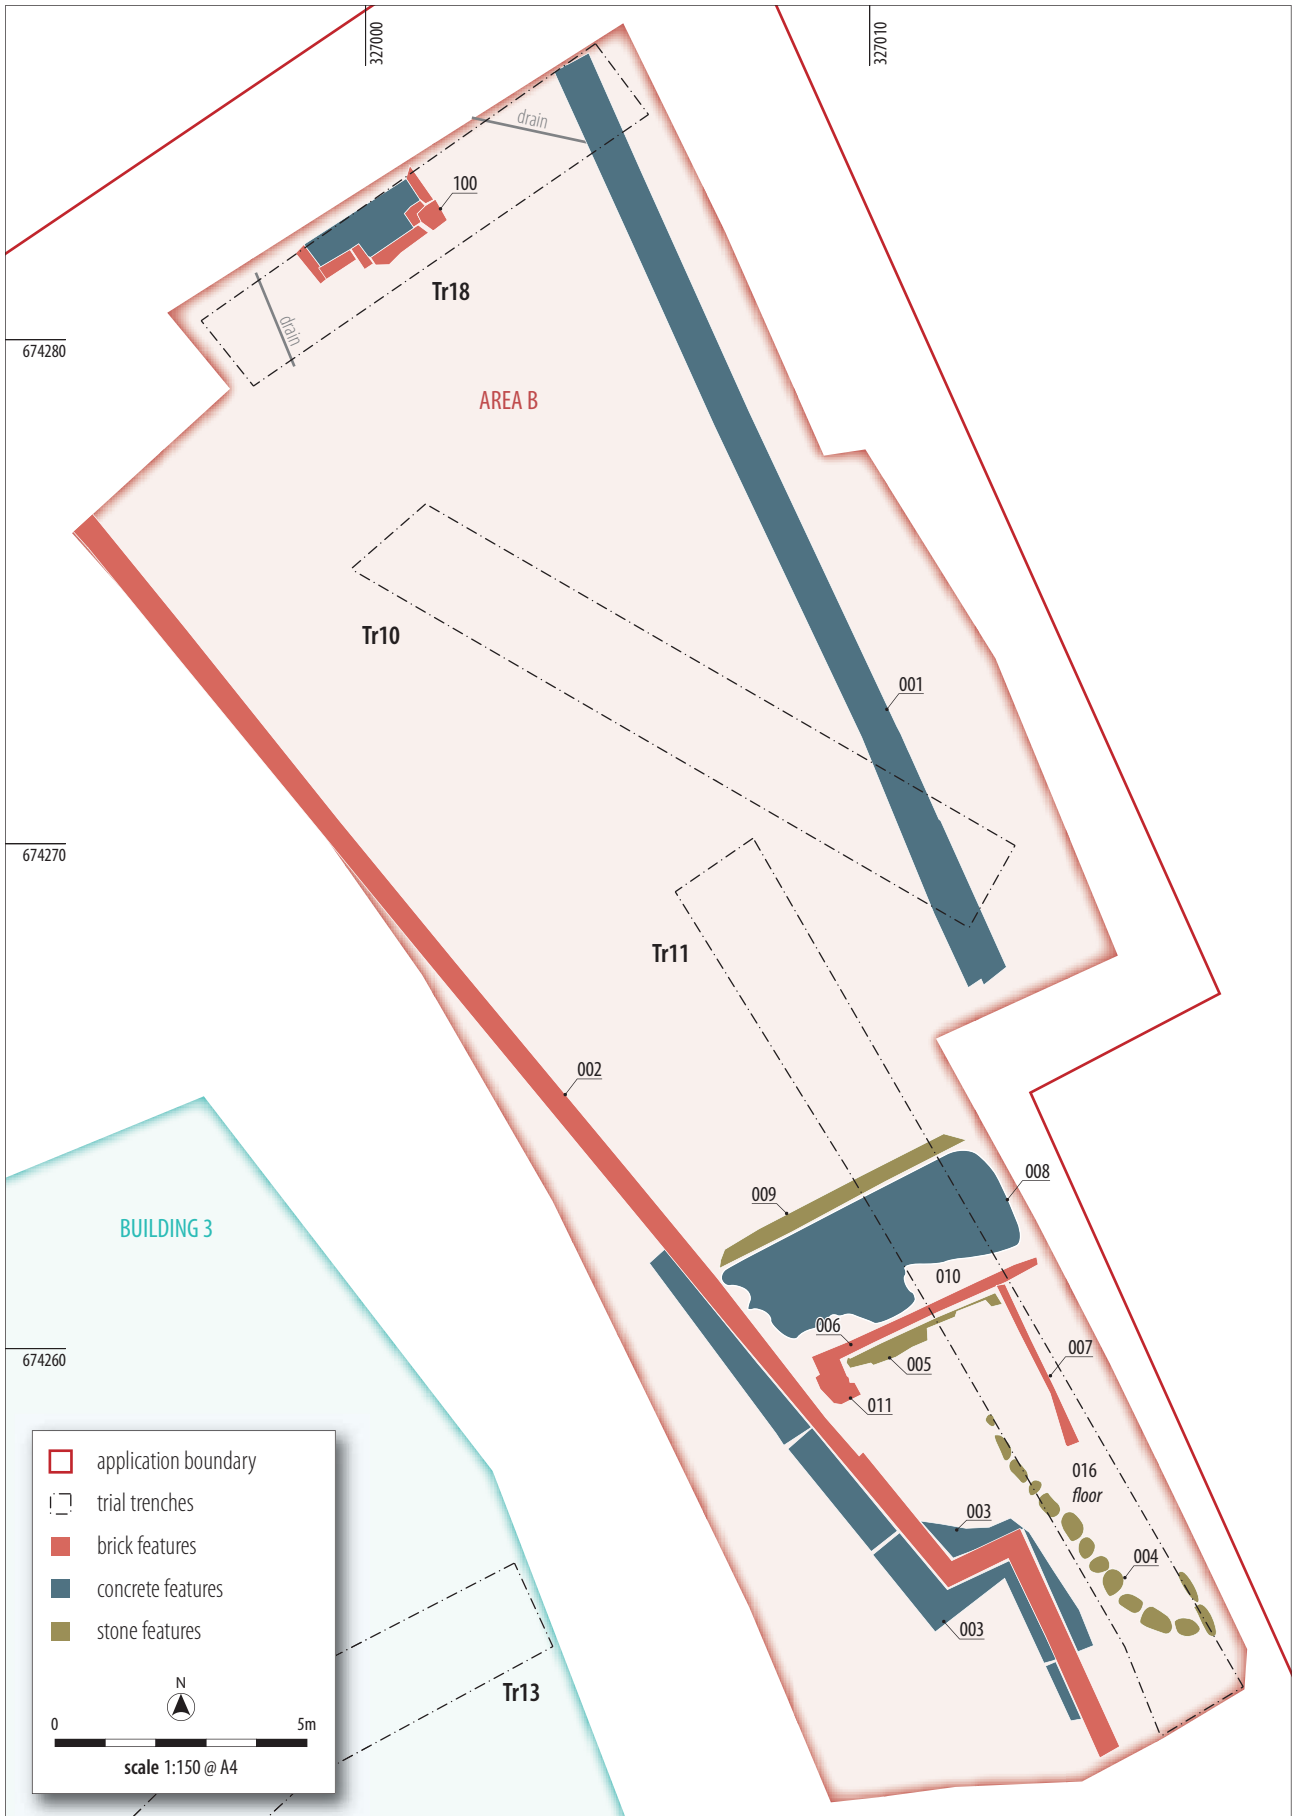
ILLUS 33

Detail plan of Area B

Area B (Illus 33) was located at the eastern end of the site and measured approximately 40x15m. It was targeted over Trenches 10, 11 and 18. Once the tarmac and hardcore were removed a layer of demolition rubble was excavated to a variable depth of 0.4m to the north and 1.3m to the south. To the north of the area a feature [100] was uncovered which consisted of two concrete blocks at the south-west edge of a concrete surface and a wall of roughly hewn sandstone blocks marking the western, eastern and southern edge of the concrete surface with a 0.35m wide gap in the eastern edge (Illus 34). The foundation of the feature consists of large roughly finished sandstone blocks which sat on natural geology. The concrete surface continued to the north, beyond the limit of excavation but the trench was not extended due to the risk of destabilising the northern boundary wall. To the east of [100] was a linear feature consisting of concrete blocks [001] oriented N-S. A cut for the concrete blocks was noted and the backfill between the cut and the blocks consisted of broken brick rubble and sand with wooden plank formers still present in the cut indicating the blocks were of poured concrete construction. The blocks were stepped up matching the contours of the slope, and their orientation matched the current south-eastern boundary wall of the site.

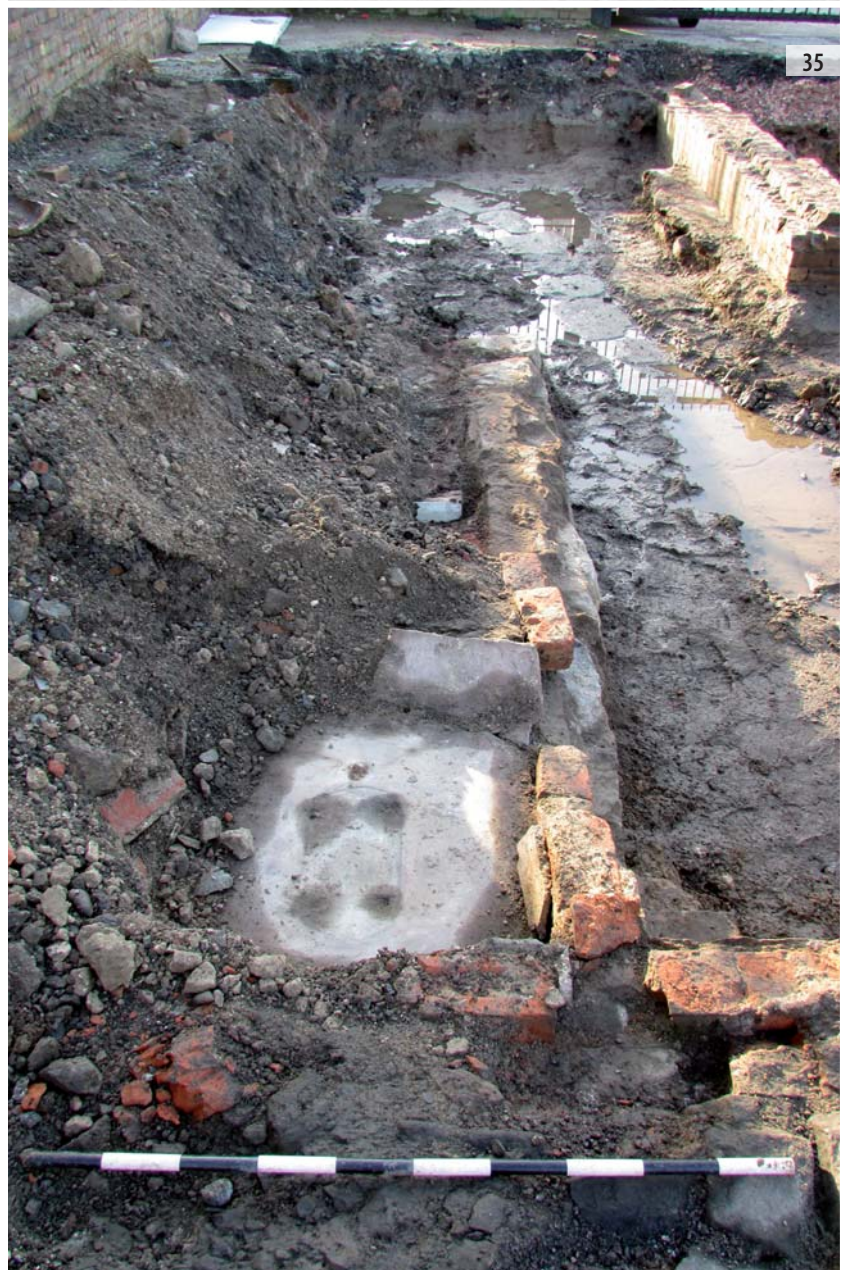
ILLUS 35

General view of Area B showing wall [007] with wall [002] in the background, facing S

On the west side of Area B a brick wall was recorded [002] standing up to six courses high (Illus 35), three stretchers wide and containing bricks stamped UFP. The wall was orientated N-S but had an abrupt turn to the west for 2m close to the southern end. The wall was sat on a foundation consisting of a concrete and rubble mix which had neat edges to the west and rough edges on its eastern side, and was stepped as the ground level rose to the north. This wall truncated a number of features to the east.

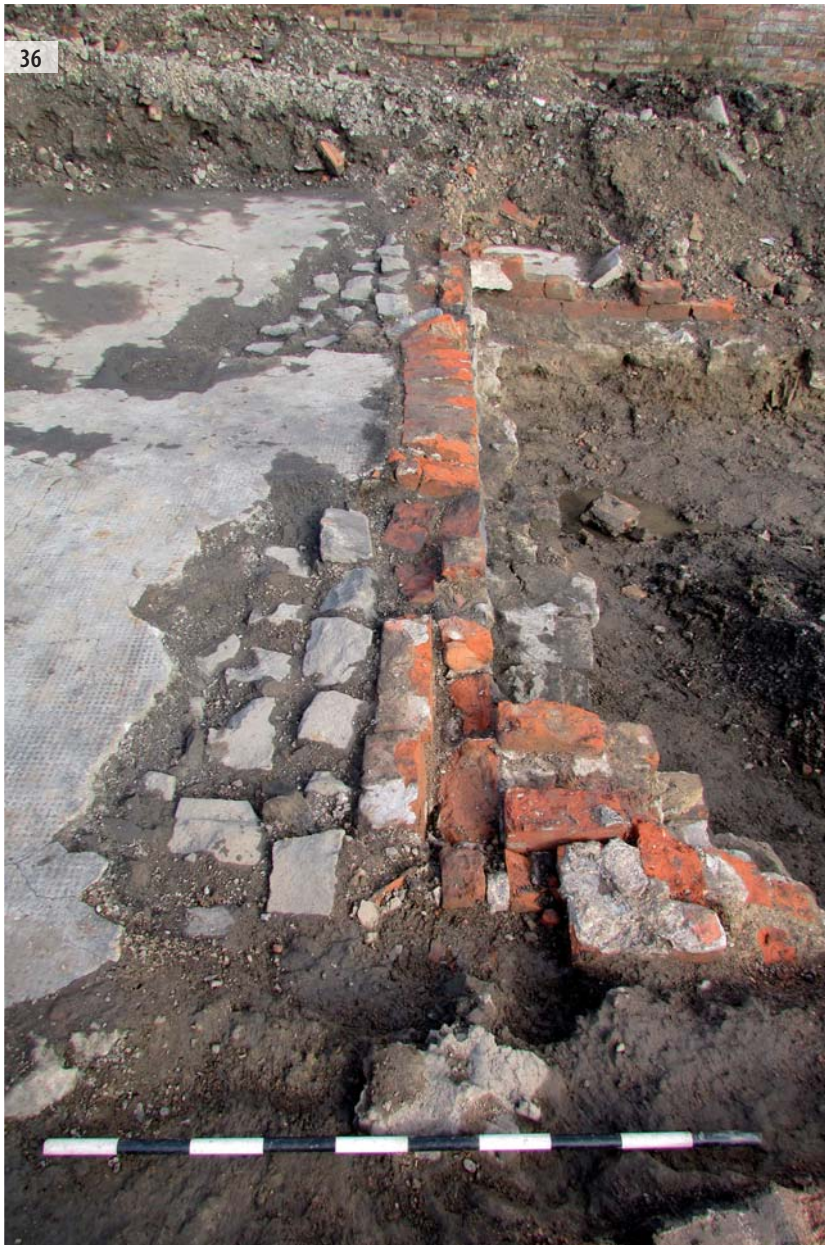
ILLUS 36	20
Detail of wall [009] and floor [010], facing E

The features in the southern part of Area B are interpreted as the foundations of a tenement building shown on the 1853 OS map and subsequent maps. Wall [006] formed the back wall of the tenement and surfaces [008] and [010] the external floor/backyard. Surfaces [007] and [016] were the internal floors and wall [005] was an internal dividing wall. The slabs [004] were probably part of the subsurface remains that predate the tenement and possibly represent the base slabs of a stone-lined culvert. All parts of the tenement were heavily truncated by the demolition process and by the subsequent construction of the boundary wall [002]. According to local knowledge this wall represented the former eastern boundary of Chatham's Garage, which was itself demolished when the garage extended its car park into land acquired from the neighbouring primary school.
