CARBERRY MAINS, EAST LOTHIAN

Historic Building Recording

commissioned by Elayne Blackwood

January 2015

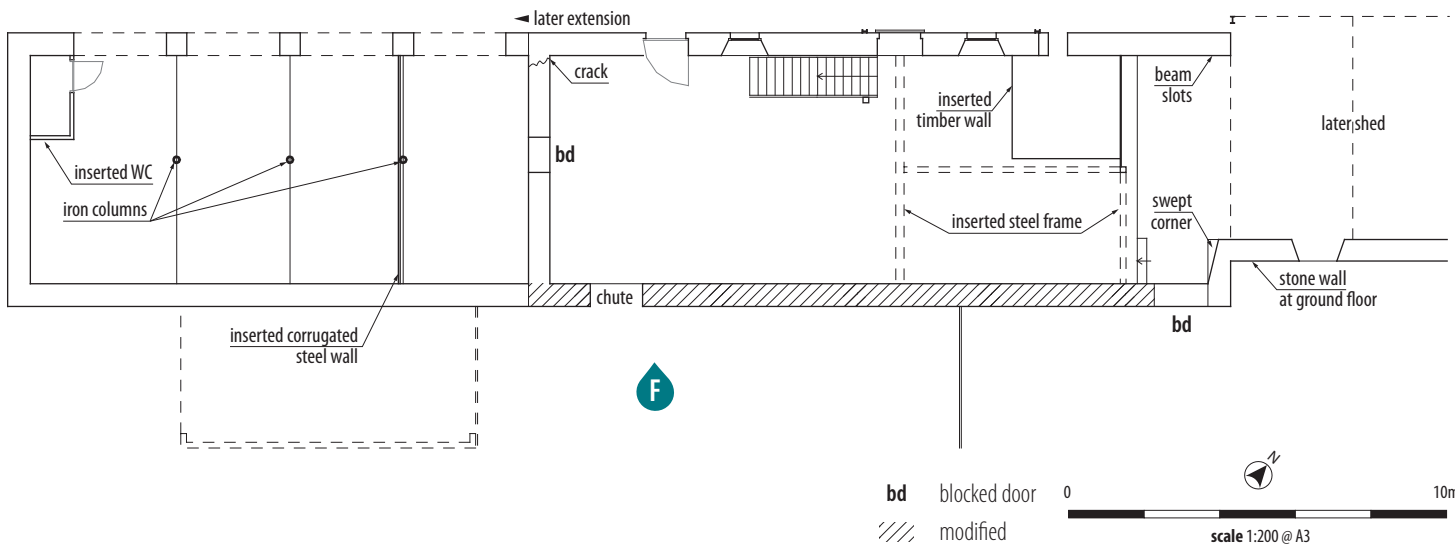
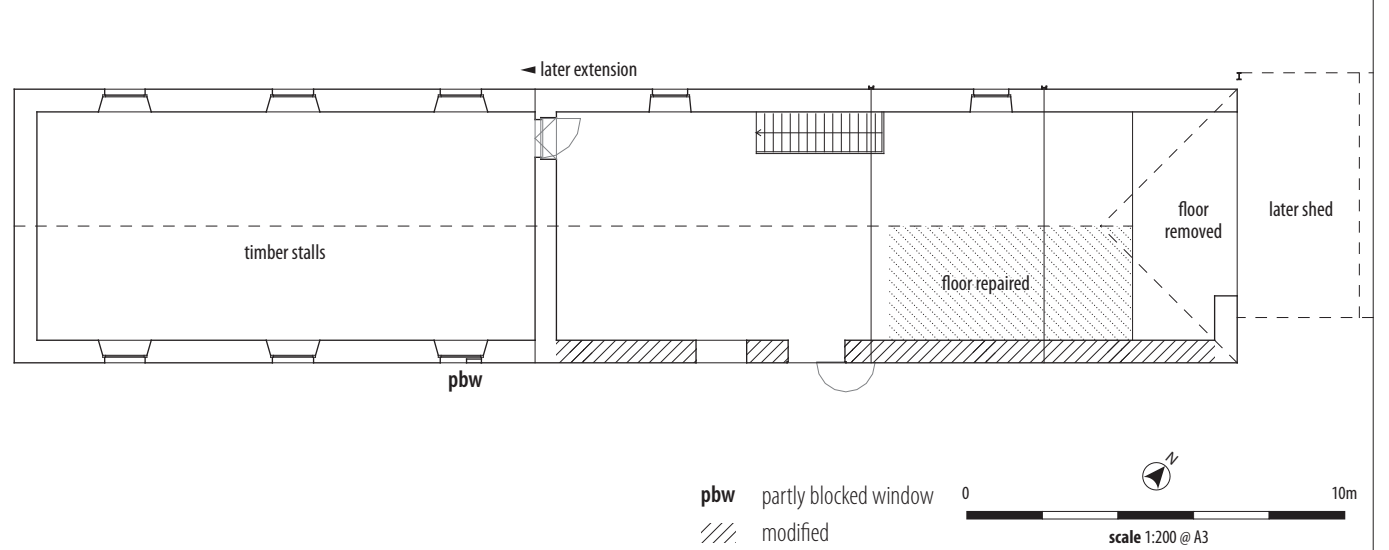
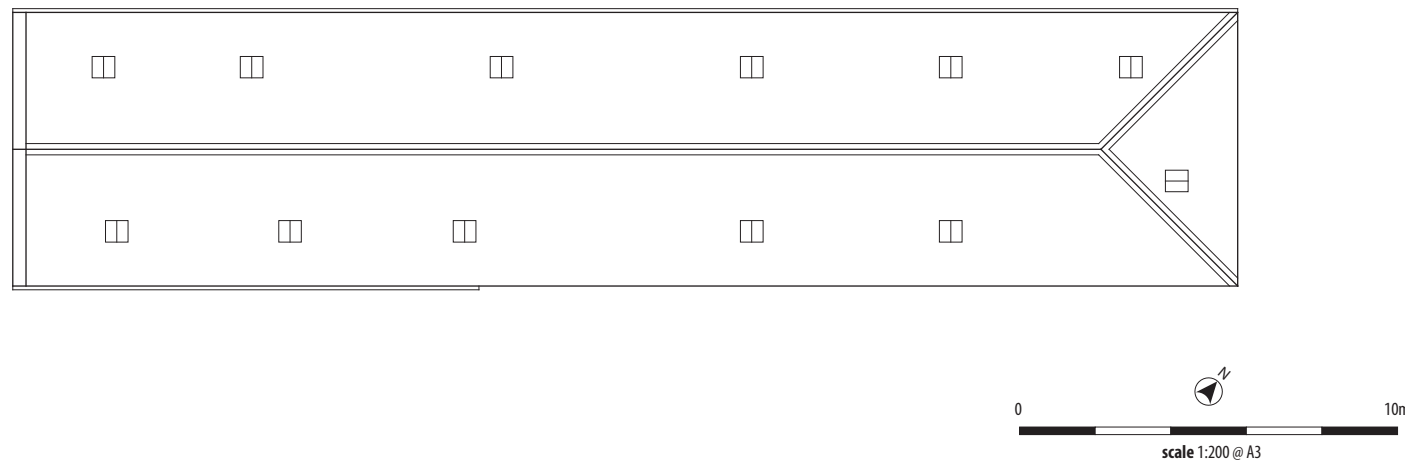
The building was principally constructed of uncoursed squared stone, much of which had been roughly tooled. Door and window surrounds and quoins were ashlar with neater horizontal tooling. The earliest visible bonding was a yellowish lime mortar, though this had been repointed with more modern grey mortar in places. The stone was badly weathered to the windward (south-westerly) side (Photo 046). The pitched slate roof was in good condition, and was hipped to the north-east, with twelve skylights providing illumination for the first floor.

The north-western elevation (Illus 5e, Photos 046–7) formed the main frontage to the farmyard. The north east end had been truncated at ground level, suggesting a single-storey building had once extended further in this direction. At first floor level, intact quoins were still present. Nearly all the openings on this elevation appeared original,

in floor level. This may have been blocked with the construction of the south-western extension. A large crack was visible in the masonry in northern corner.

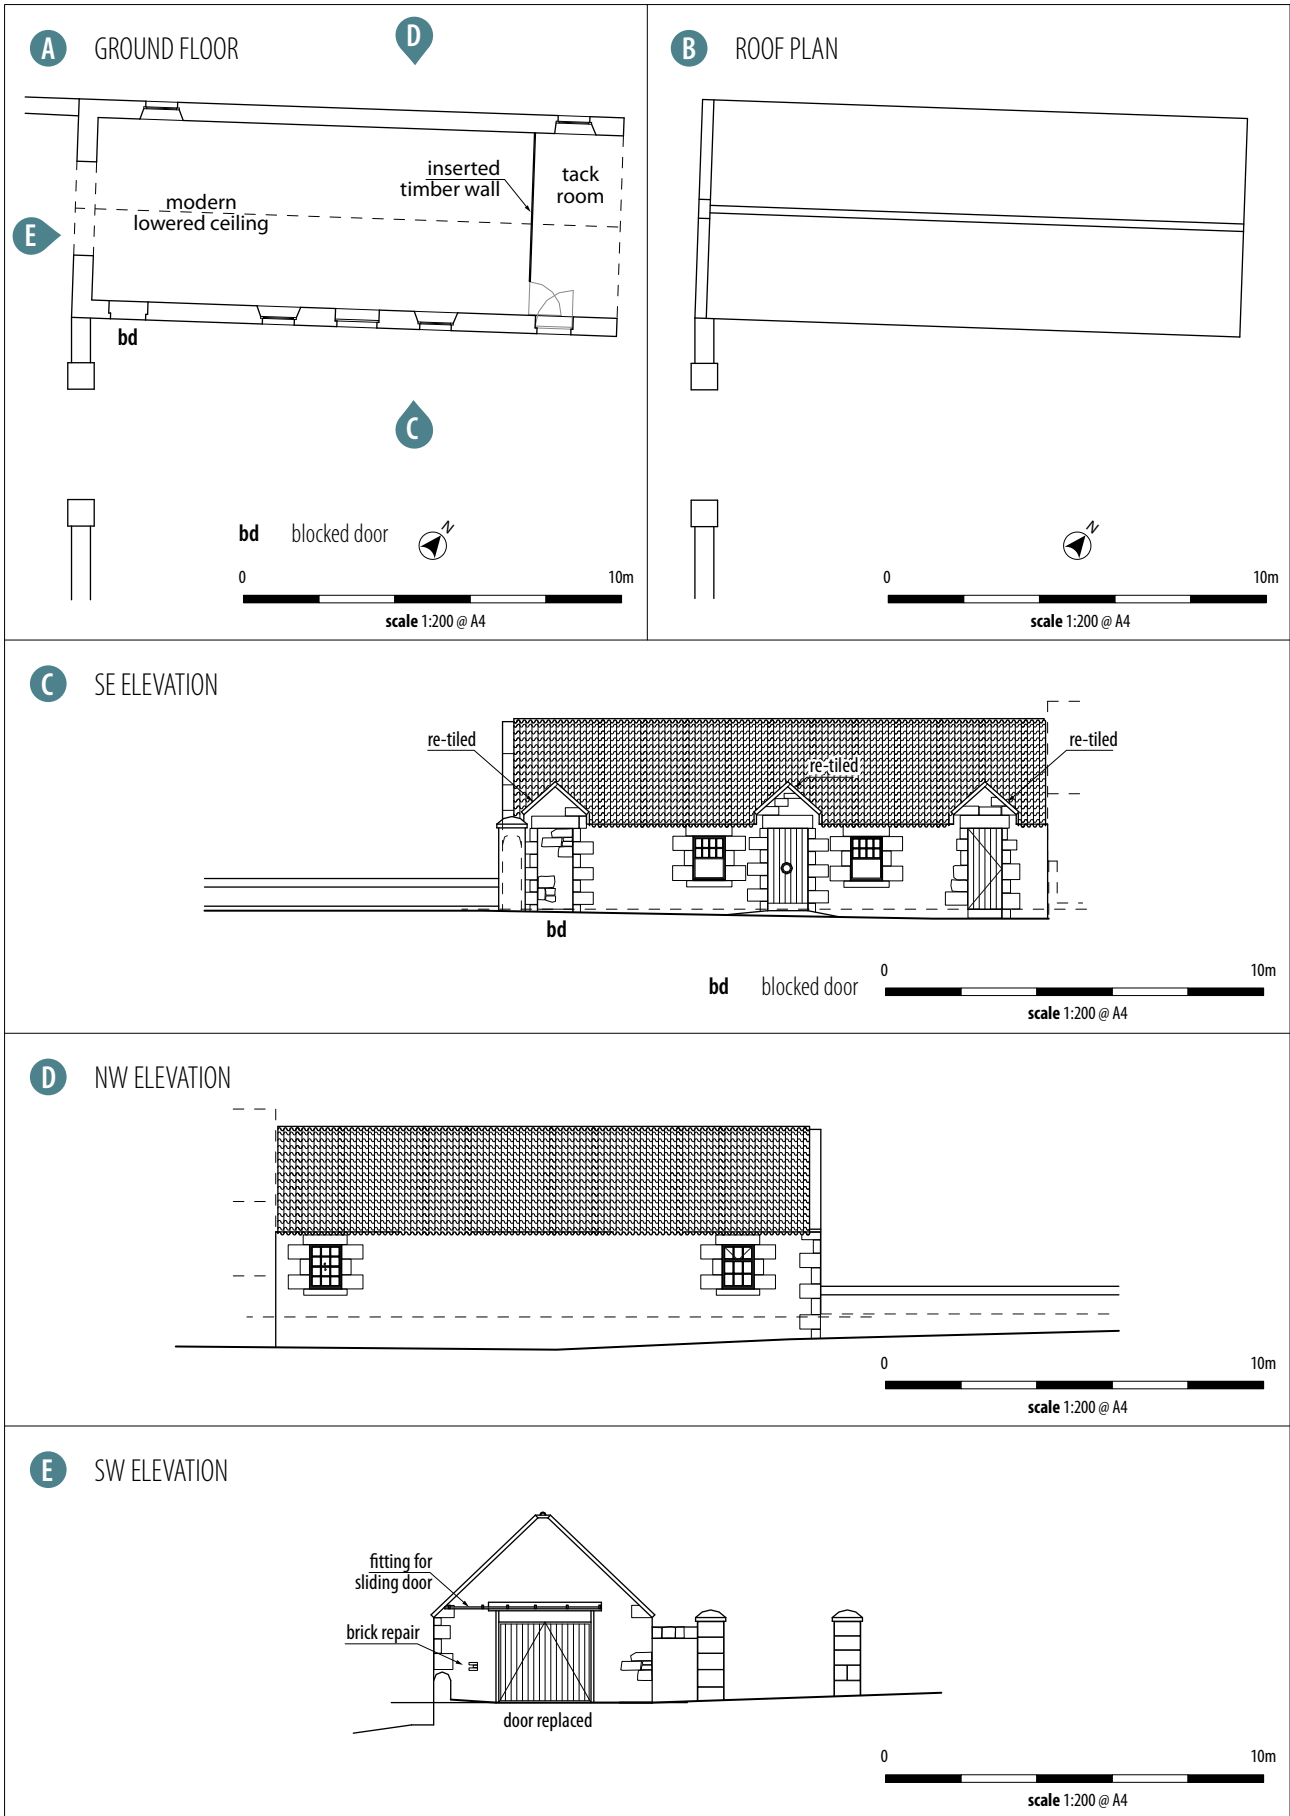
ILLUS 9

The roof differs in style, being of pan-tile and featuring (recently repaired) gabled pediments over the doors on the south-eastern elevation. The building had previously extended further to the north-east, or been joined to another building – the gable end has been demolished and a modern breeze-block and steel shed have been built against where it would have been (Photo 043). The main access was through the south-western elevation (Illus 9e, Photo 030), where the sliding rail of the original door was still visible. This had been carefully replaced with a modern up-and-over garage door in a timber frame. The south-east elevation (Illus 9c, Photo 032) comprised three doorways (one of which had been neatly blocked) with gabled pediments and two small sash windows, forming a modest but attractive façade. The north-western elevation (Illus 9d, Photo 034) was plain, with a small sash window at either end.

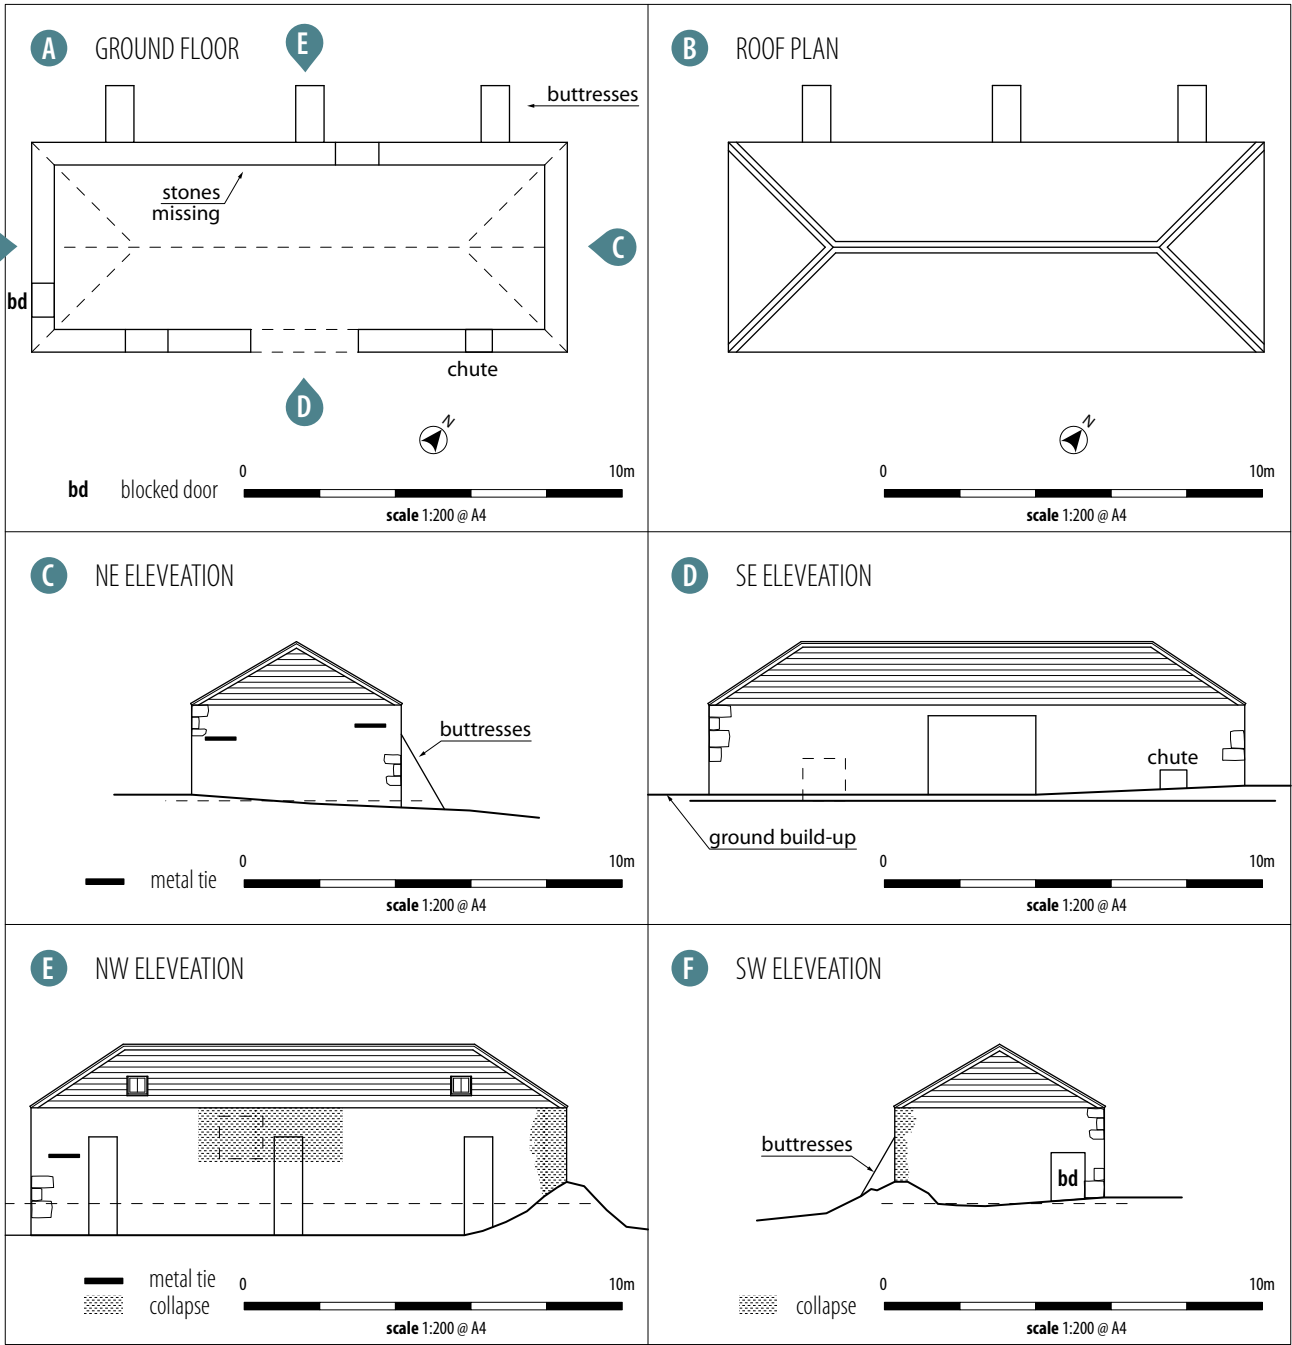
ILLUS 11

The external masonry was of random angular square faced stone which was probably originally rendered, although very little of this survives. The existing coarse grey mortar is likely to represent to more recent re-pointing. The stone was very weathered to west and south-west (Photo 082), similar to the steading buildings at Carberry Mains. Metal ties had been inserted at various places to hold stone together. The western corner and part of the north-western elevation had collapsed entirely. The slate roof was hipped at both ends and had collapsed in places. Damaged areas were covered up with corrugated steel sheeting.

The main access was through the large door on the south-east elevation (Illus 11d, Photo 078). The door must have been replaced at some time, with a new sliding mechanism and concrete and steel lintels resting on the original jambs. A small square window and a chute were also recorded on this elevation. The south-west elevation (Illus 11f, Photo 079) featured a small blocked door – the western corner had collapsed. The north-west elevation (Illus 11e, Photo 080) was supported by three canted stone buttresses (Photo 081), which did not appear to have been keyed into the main stonework – this may suggest they were a later addition although no map evidence

was found that shows the barn without them. A high-level opening had collapsed and was covered in corrugated steel sheeting. Two small rooflights were also present. The north-east elevation (Illus 11c, Photo 077) was plain other than for several metal ties.

The interior comprised a single space (Photo 085). The roof structure was relatively light weight and generally in good condition. The floor was of concrete and may have been re-poured at some time. The internal masonry comprised similar random angular blocks as outside but had been more comprehensively pointed with grey mortar. There was no evidence for whitewash or other internal render.
