## STOTT PARK BOBBIN MILL

*Historic Building Recording of lade prior to repair  
for English Heritage*

*July 2016*

HA Job no.: SPBM16/01

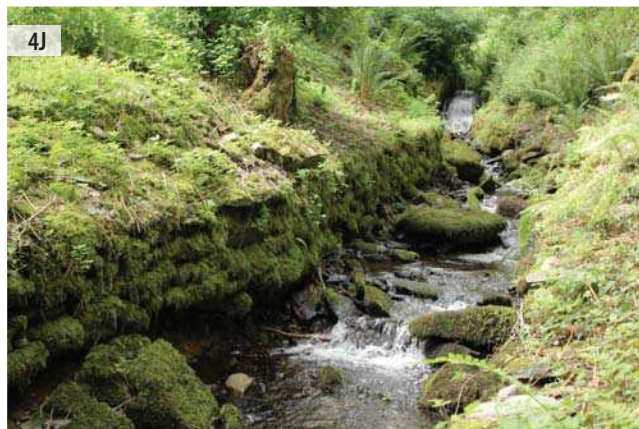
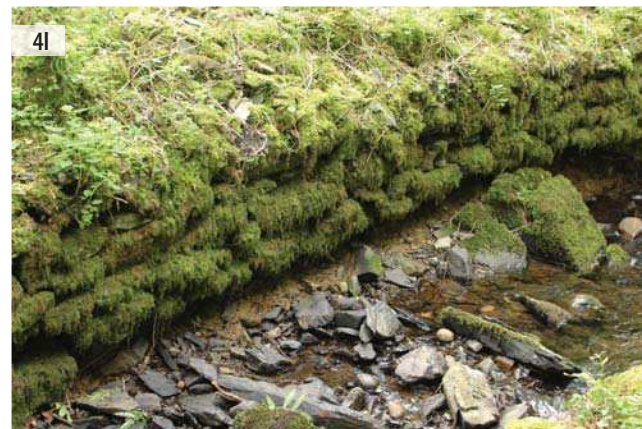
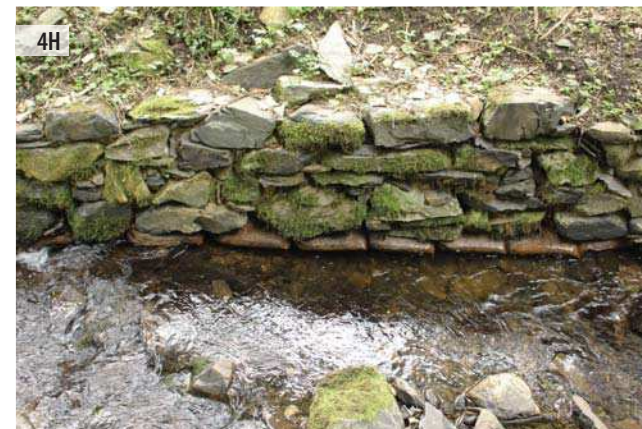
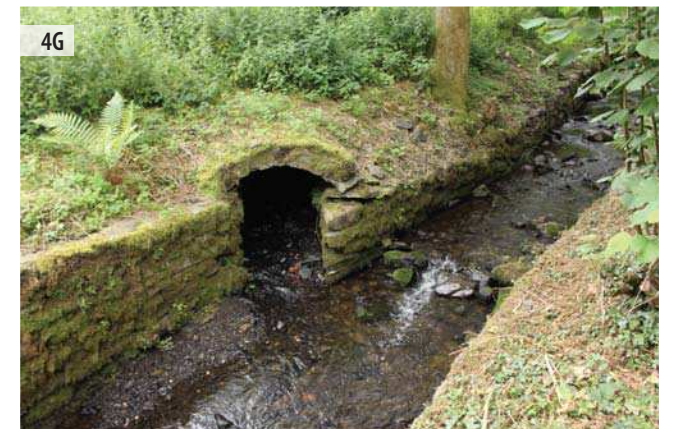
At several locations along the length of the lade significant undercutting and loss of the lower stones of these walls is apparent (Illus. 4E, 4I, 4J). This is particularly significant at the section of the lade located immediately to the east of the weir. This increase in damage here is probably due to the increase water flow in this area. Rubble from the damaged areas of the lade has also made its way

further east along the channel, pushed along by the fast flowing water (Illus. 4E, 4F). This rubble has potentially caused further damage on its way. An area to the east of this appears to have previously undergone consolidation works (Illus. 4H).

The weir has undergone serious damage. The length of the weir (from west to east) has been truncated due to the damage, and the walls themselves have been severely eroded due to excessive water flow (Illus. 4C, 4D). A large quantity of rubble can be seen in the lade, most heavily concentrated downstream from the weir, suggesting it is at least partially comprised of damaged segments of weir structure.

ILLUS 4 Site plan  
 ILLUS 4A E facing view of sluice gate  
 ILLUS 4B E facing view of newly exposed lade branch  
 ILLUS 4C NW facing view of damage to northern side of weir  
 ILLUS 4D SW facing view of damage to southern side of weir  
 ILLUS 4E W facing view of rubble downstream from weir  
 ILLUS 4F NW facing view of rubble in lade  
 ILLUS 4G SW facing view of outflow lade from mill  
 ILLUS 4H S facing view of previous consolidation works  
 ILLUS 4I SW facing view of significant undercutting of lade walls  
 ILLUS 4I SW view of undercutting of lade walls and related rubble
