ROINEACH MHOR, GLEN CLOVA, ANGUS

Historic Building Recording

For KDM Architects on behalf of Mr Hugh Niven

September 2016

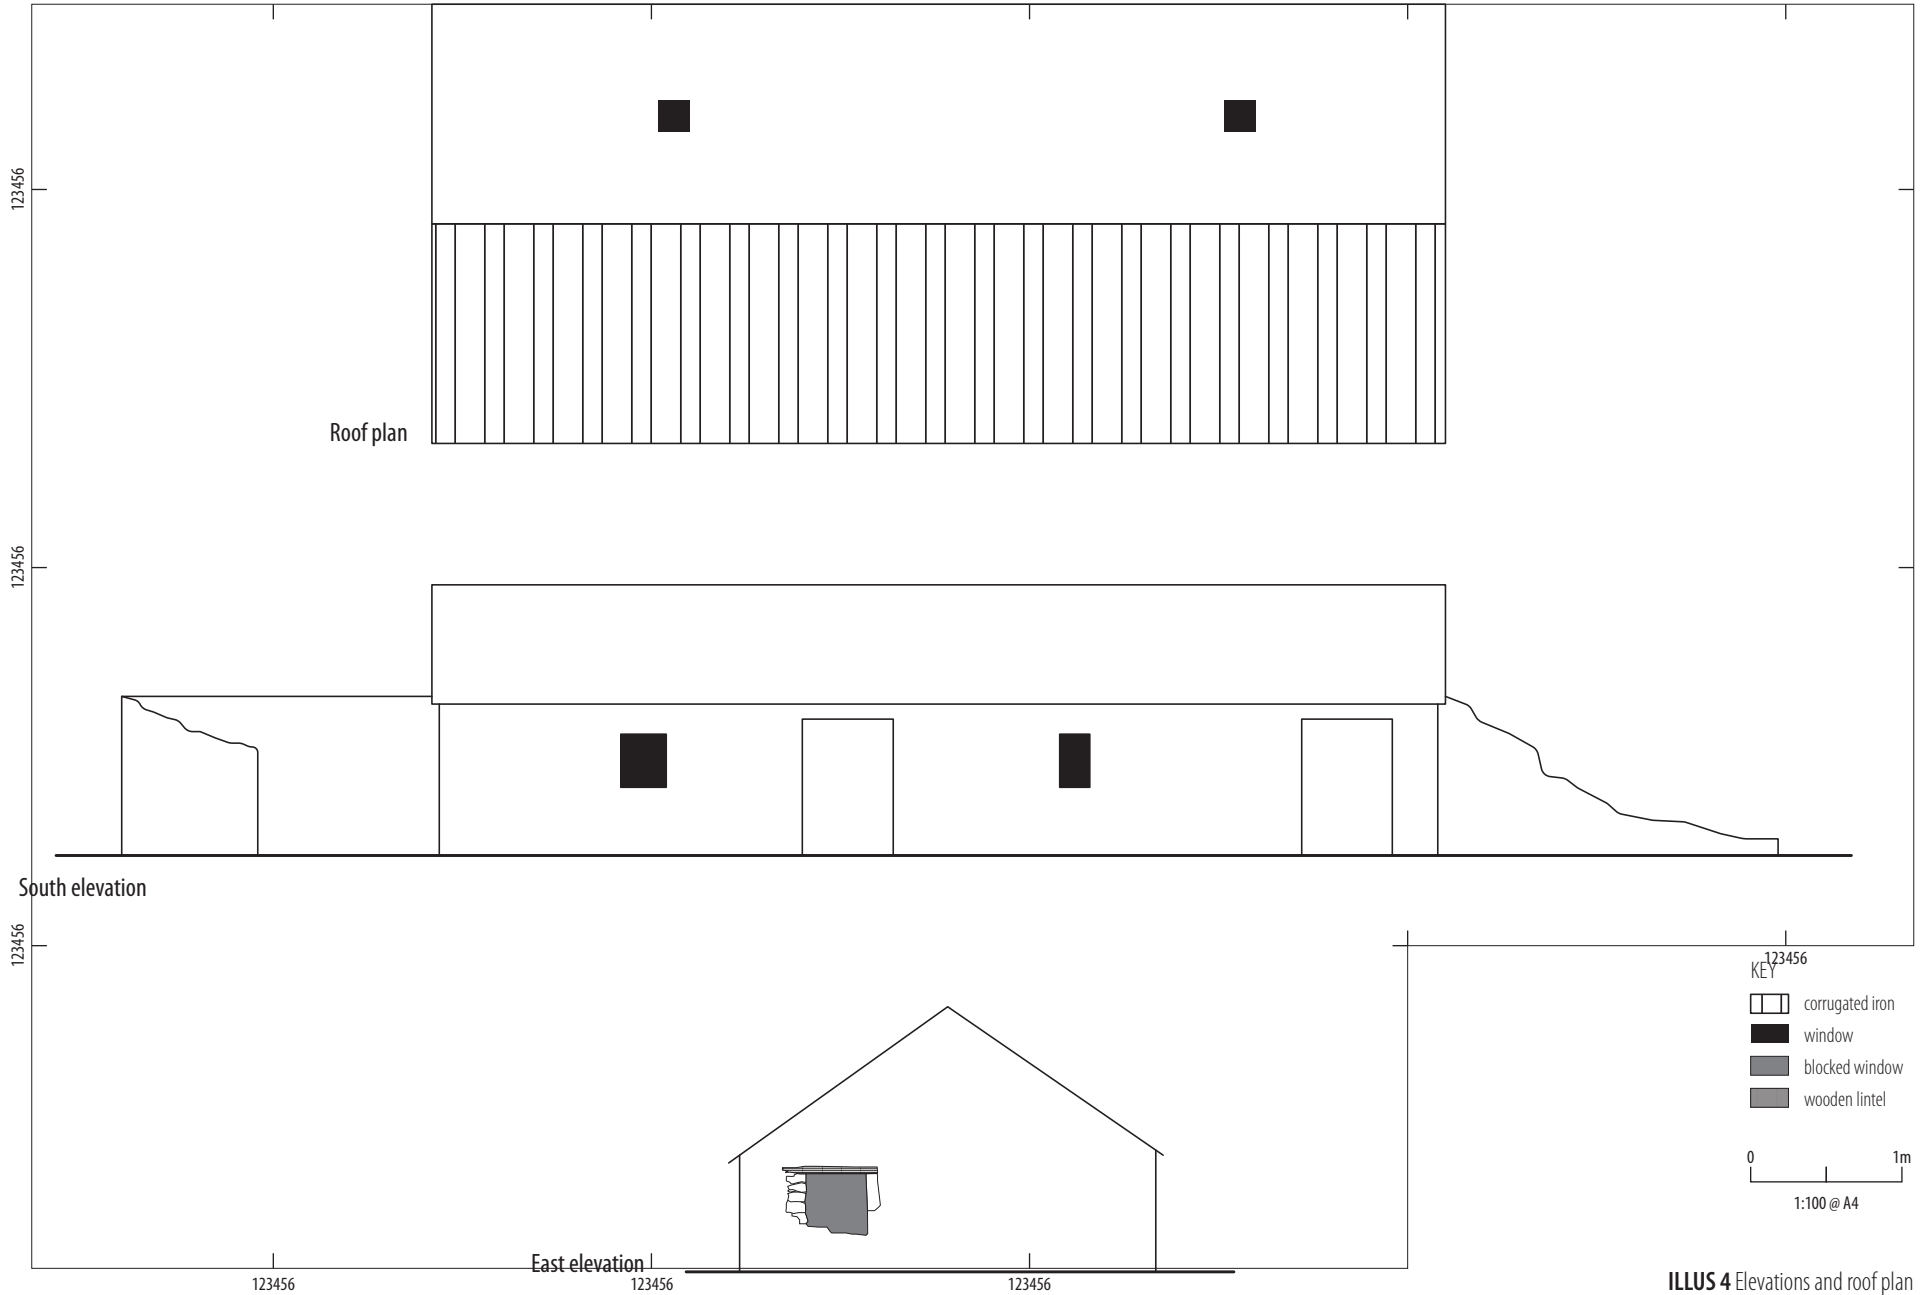
ILLUS 4 Elevations and roof plan

The roof exhibited evidence of repair, as shown by the different materials on the north and south-facing aspects. The north side was roofed with slates, which appeared to be original. Two unglazed openings were present on the northern side measuring c0.4m by 0.4m, located mid-way up the roof, approximately 3m from the west and 2.5m from the east. The underside of the tiles was clad

with stone. The east and west elevations showed the north side of the roof was repaired with cement infill, possibly a patch repair in the eaves. The south-facing roof was clad with corrugated iron panelling, trimmed with lead flashing. On the east and west elevations, wooden planks used as flashing were visible and followed the pitch of the roof. Rounded ridge tiles were present along the apex.

The repair to roof material may have represented the fourth phase, with the replacement of slate tiles for corrugated iron panels on the south facing roof pitch. Although no evidence for roof collapse was evident, it is likely that damage to the roof on this side had necessitated replacement and repair.
