Project Code: HLU07
Date: 11th July 2007
Client: The National Trust for Scotland

Lund House, Unst, Shetland Islands

Historic building recording

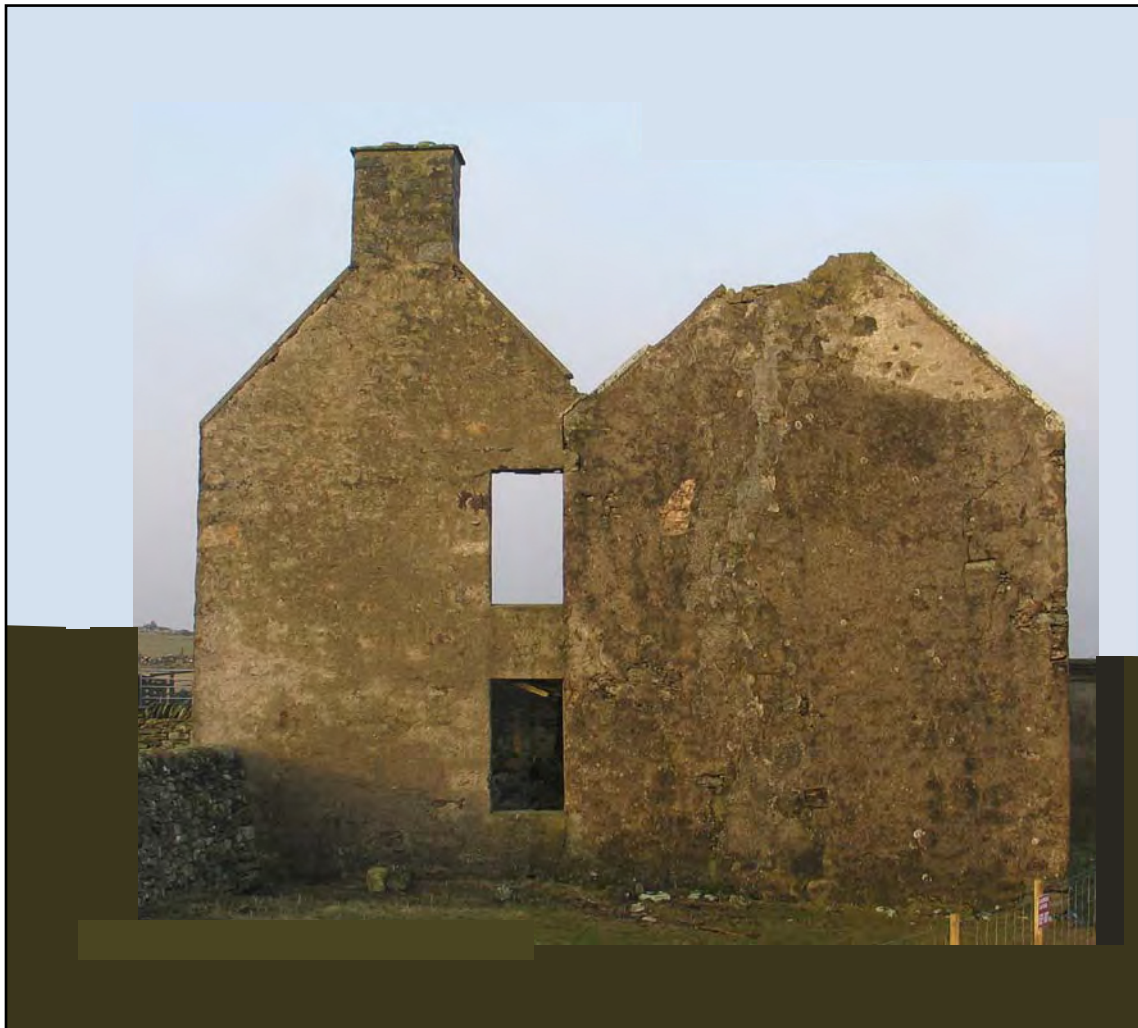
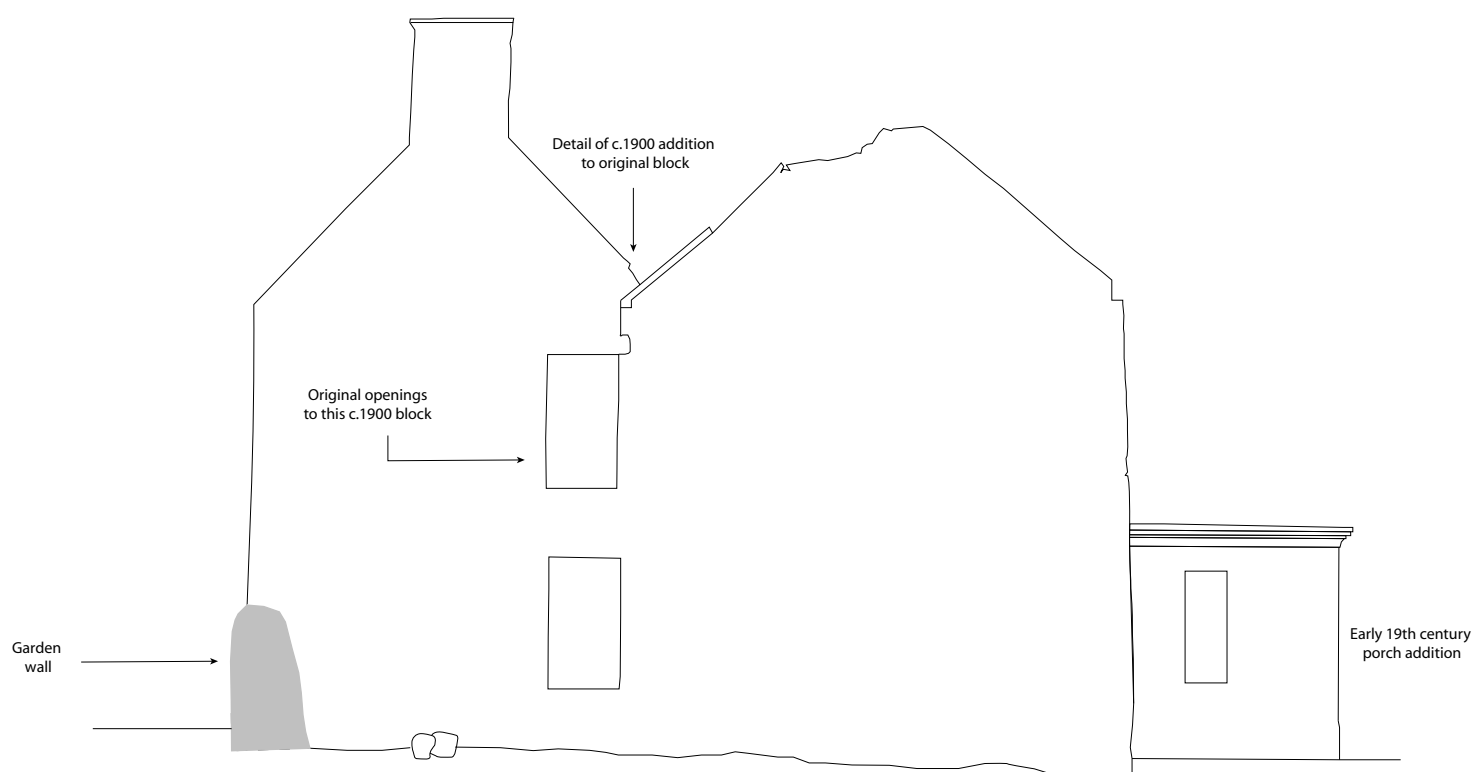
HLU07: east elevation, and photo montage

The NE gable survives almost to its full height and is harled with later cement patching (Plate 12). Only the later S gable has two openings which are probably original to this part of the building. The south block clearly abuts the north with the gable 'clasping' the original north coping. The north gable chimney has collapsed into the interior and most of the coping is missing. The south gable has a large gable stack with a plain cap and plain coping. Both of the large window openings use the central wall of the building as their north jamb. The lower window retains cement fillets which suggest it had an 8-pane sash and case window.

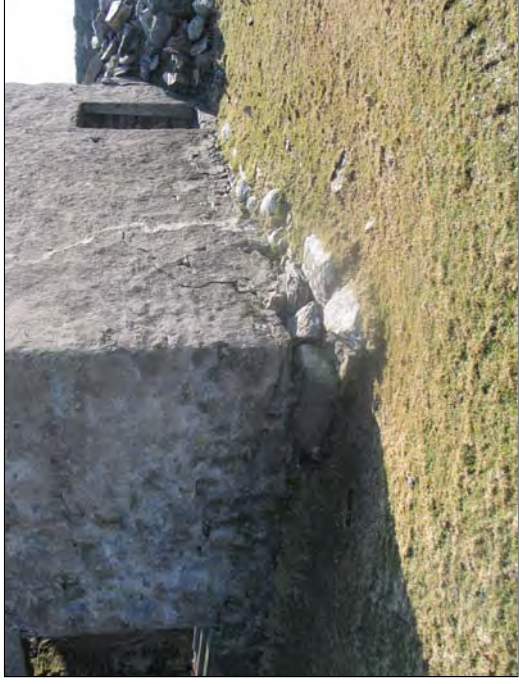
Plate 8 - boulder foundation at W corner

The SW elevation is comprised of two gables; the north gable of the main earlier block is gabled and harled, with two openings (Plate 7). Attached to the SE, the later gable of Phase 2 has largely collapsed and most of the rubble is still *in situ*. The rubble boulder foundation is visible at the base of the north gable (Plate 8). The north gable has two openings, an upper window and a lower doorway. The window may have been inserted, though the harl obscured the detail – the frame has been removed. The lower doorway opening has been partly filled and re-used as a window. The bolt hole remains from its use as a doorway and it has very heavy stone lintels inside and out, with a re-used intermediate timber lintel. Both openings have had the timber elements removed.

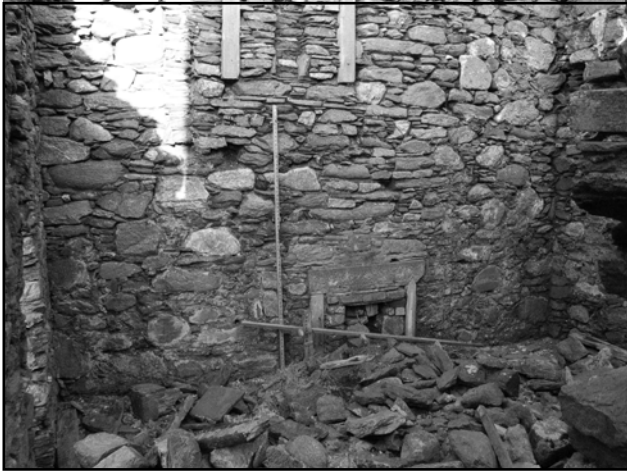
Plate 13 - Interior, NW Block, NE room

The main early range had three joisted internal floors and a thick partition wall separating each floor into a smaller NE room and a larger SW room (later subdivided). On the ground floor, the NE room is rubble filled but some late lathe and plaster remains (Plate 13). The rooms above retain some plaster on the hard which shows a subdivision on the first floor (Plate 14). The east gable houses a fireplace for each floor; the upper two have been altered when the floors were raised. The first floor fireplace has also been moved to the centre from the left (Plate 15). The windows in the NW wall have been altered obscuring their original form and the doorway to the south was probably inserted around 1900 when the 3rd Phase was built. The upper doorway to the SE incorporates the splayed jamb of an original window opening (Plate 16).

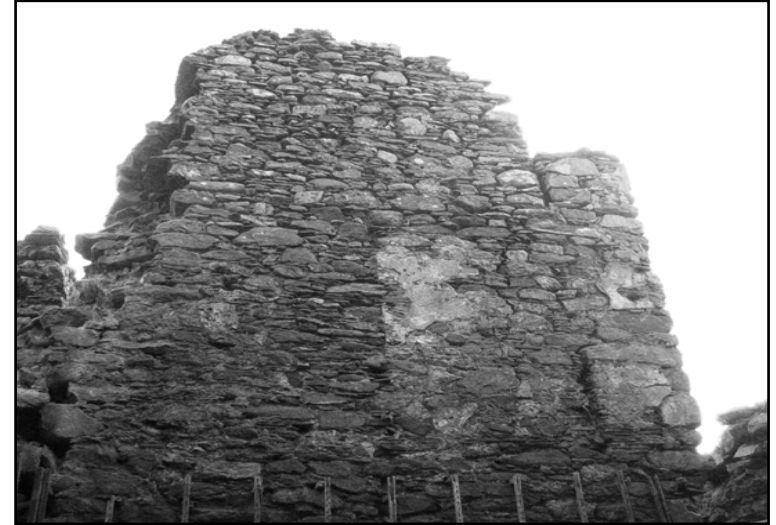
Plate 14 - Interior, NW block, mid-gable from NE

The NE room and SW rooms are separated by a very thick partition wall, now partially collapsing. The partition is not full width, leaving a full height opening at the NW – this is probably a later alteration since there is a joint in the wall where it has been rebuilt/buttressed at the NW (shown in Plate 14). This wall is also coming away from the central wall, slightly obscuring their relationship. The window in the NW wall opposite the partition has probably been inserted later in order to regulate the main façade, as it is in an awkward and unusual position in relation to the interior layout.

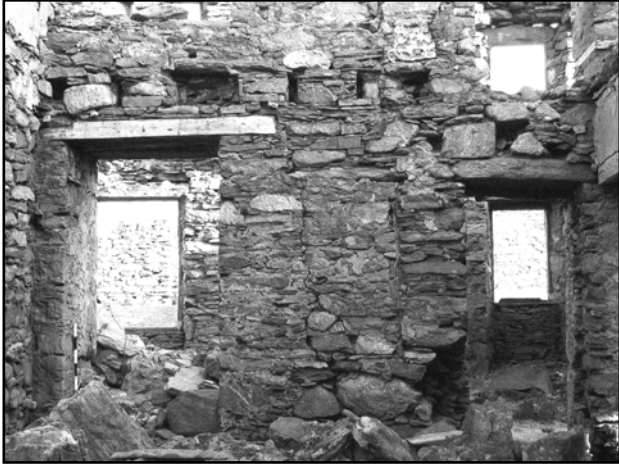
Plate 17 - Interior, NW block, mid-room, view to SE

The SW part of the main block is sub-divided by a single storey partition into two rooms. This partition is definitely later, though there may have been two rooms originally. The current ground-floor mid-room operated as a hallway in the later Phase of the house with two doorways to the SE blocks (Plate 17). The NE doorway here is inserted and has a high timber lintel, related
