## BEAL FARM, NORTHUMBERLAND

*Level 2 Historic Building Record  
for Edwin Thompson (Berwick upon Tweed)*

*March 2023*

HA Job no.: P23-050  
NGR: 406626, 642750  
Parish: Kyloe  
Council: Northumberland County Council

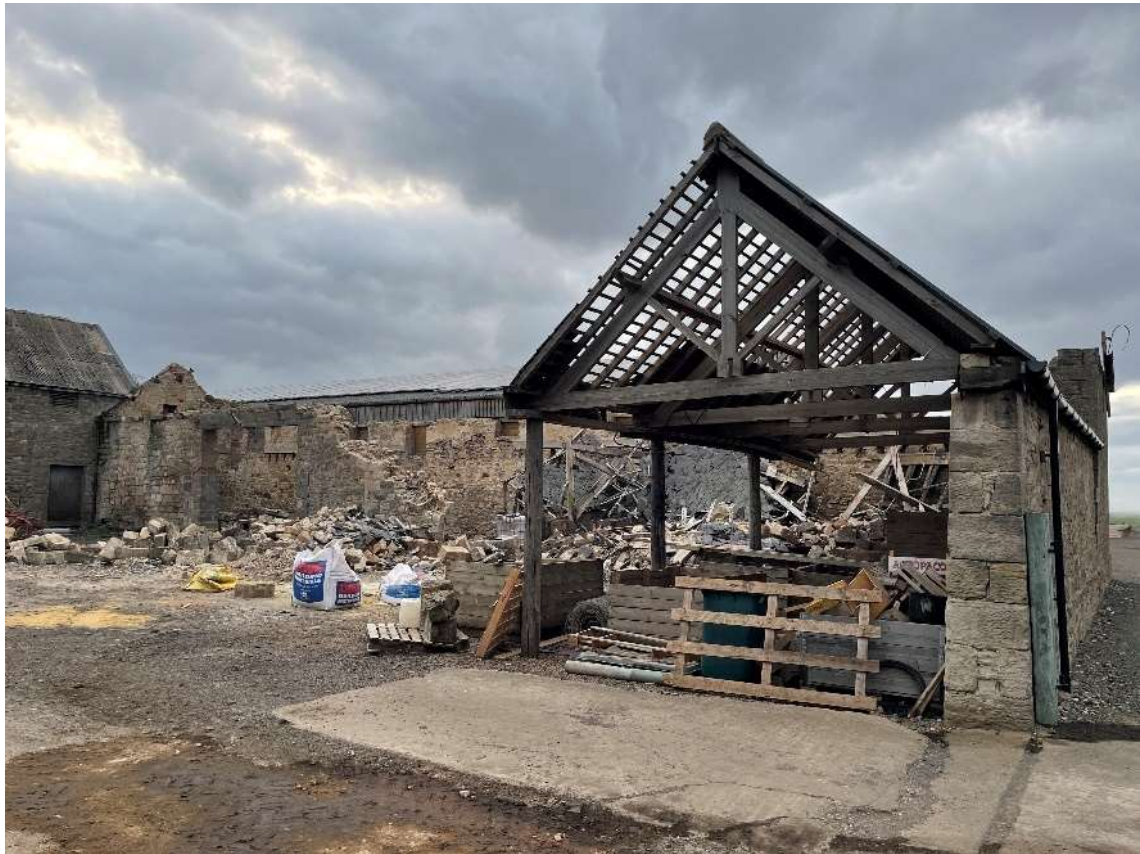
Figure 12. View of Building 2 facing north

- 6.1.8. Building 2 provided the only remaining evidence of the east range of the farmstead. The OS mapping indicates that this building had been added to the farm at a slightly later date, abutting the eastern end of Building 1's southern elevation. It comprised a single storey barn with a dressed stone east wall and an open timber post-supported roof to the west side (Fig 12). The pitched roof had been re-covered (same materials as Buildings 4 and 5) and supported by four king post trusses, the tie beams resting on the solid masonry of the eastern wall and supported by timber uprights at the western end.

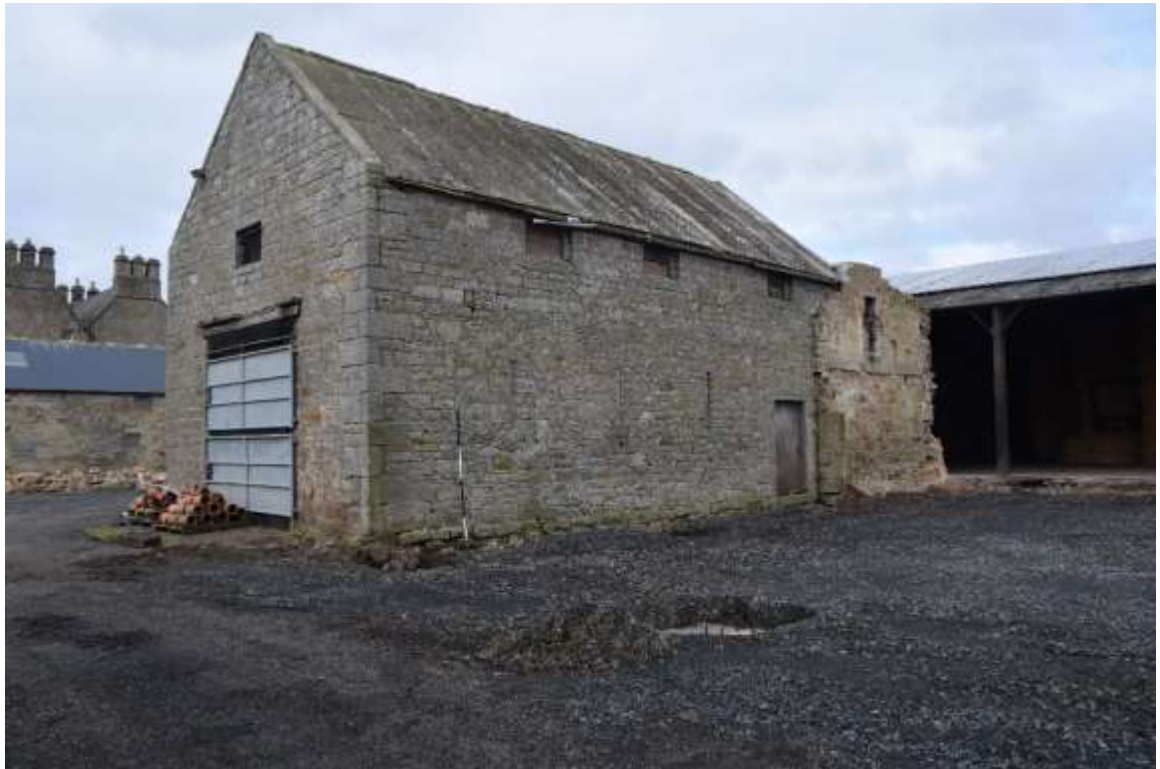
Figure 13. View of the south and east elevations of Building 3

- 6.1.9. The site visit made a photographic record of the present farmyard to provide context to the demolished buildings. Surviving buildings include a large barn (Building 3) extending into the northern half of the courtyard. This was a tall gabled structure that abuts the north range. The south facing gable includes a later inserted door, entrances to each side and windows vents high up on the side elevations (Fig 13). The east elevation also includes several tall narrow ventilation slots. The roof covering is asbestos/corrugated cement sheeting. The north range (Building 4) to the west of the barn had been modified, although repeated the design of Building 1 with segmented arched cart doors along its south elevation and louvered window vents across the upper floor. These would likely have housed carts and farm machinery, with granaries or hay loft above.

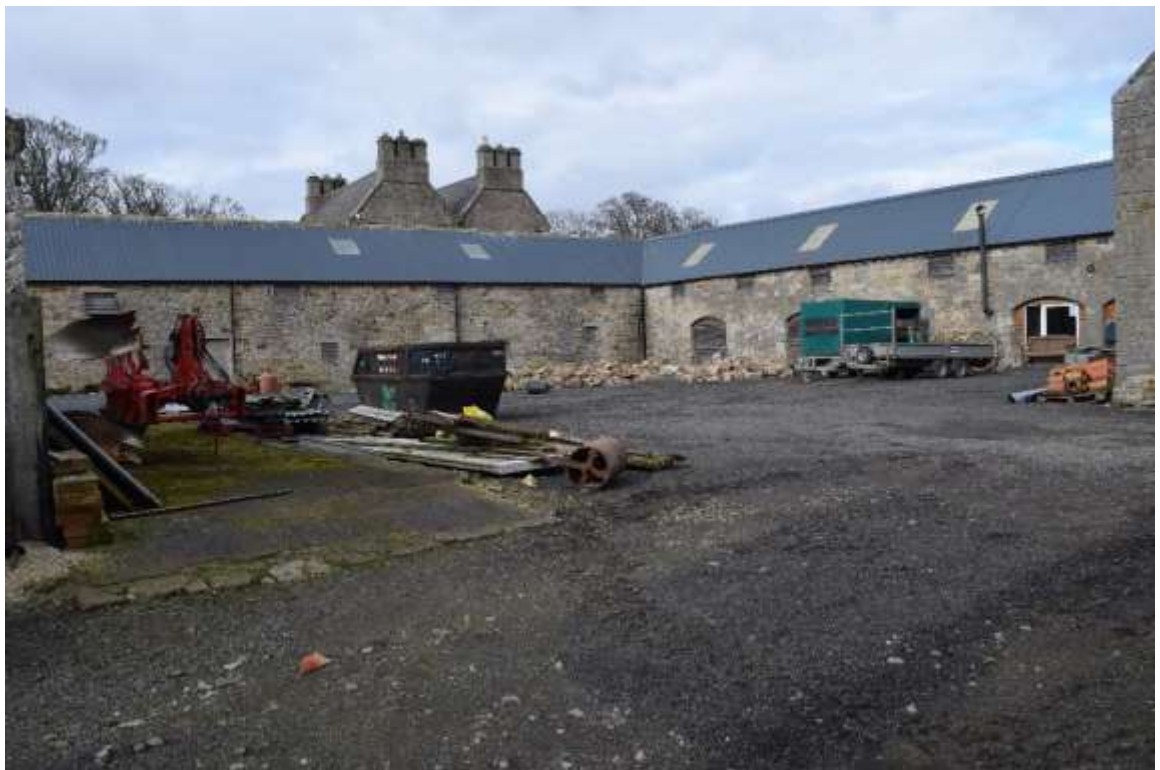
Figure 14. View of Buildings 4 and 5 facing north-west

- 6.1.10. The west range (Building 5) also survived although included several modifications and alterations (Fig 14). The majority of the west range includes an upper floor with the southern end dropping to a single ground floor level. The east facing elevation includes several stone-blocked doors and two breeze-blocked doors indicating several phases of change. The elevation also includes several windows set at different levels providing evidence that the range had several uses. At the centre of the elevation a series of beam slots provided evidence that a covered barn must have abutted this wall. Both Buildings 4 and 5 had been re-roofed.

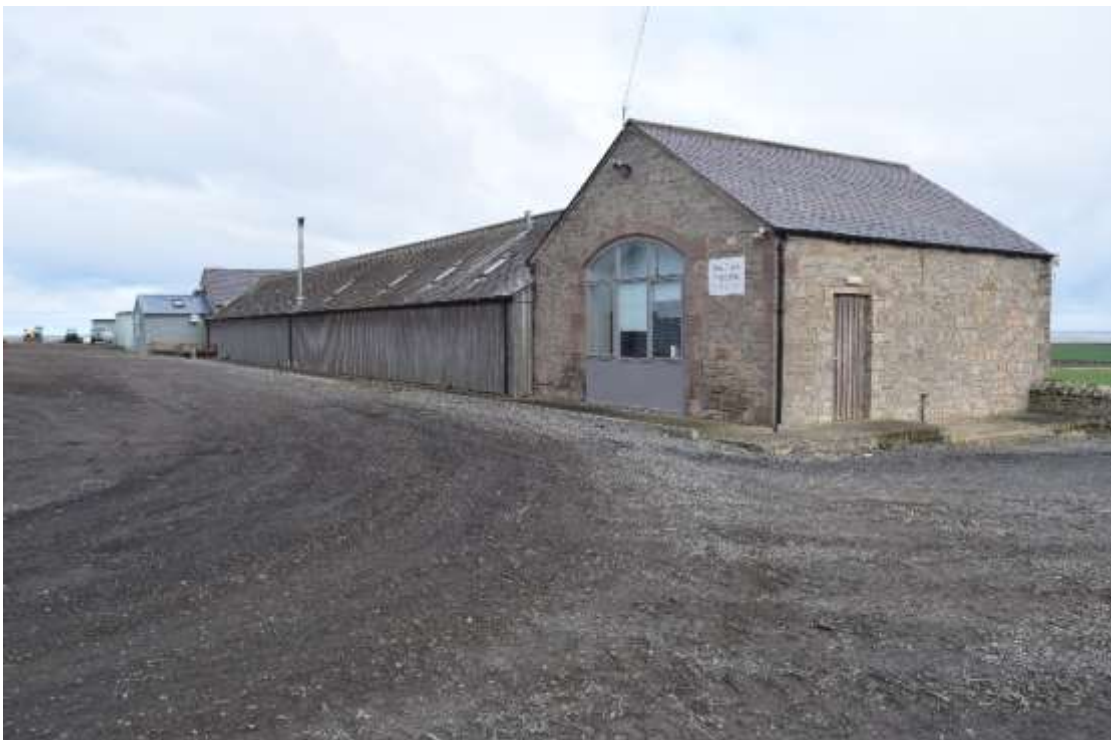
Figure 16. View of Buildings 8 showing the west and south walls, facing north-east

- 6.1.12. The south range (Building 7) is a single storey stone constructed building with a tall arched central entrance. The entrance is housed in a gabled two floor block with arched cart doors leading though a short pend. Both the internal north elevation and the external south elevation include an upper loading door. There are no openings on the south facing external elevation of the south range.
- 6.1.13. The stable block (building 8) to the east of the farmstead has been modified throughout although some of its original features are still visible such as the segmented arched cart door on the west facing gable at the south end of the building and a standard door on the south wall (Fig 16).

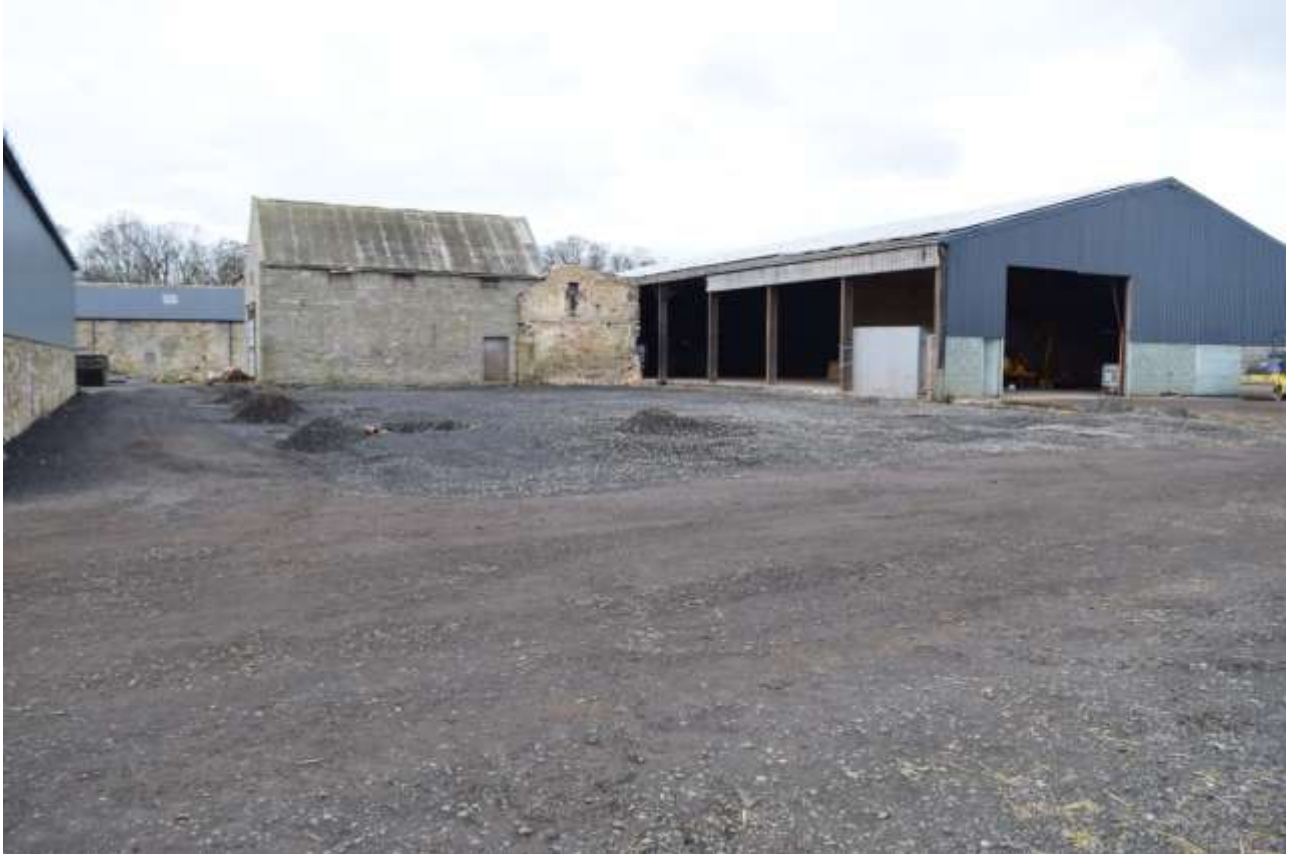
<i>Client:</i> Edwin Thompson	<i>Photo No.</i> P23-050-06	<i>Date:</i> 06-03-23	<i>Direction Taken:</i> W
----------------------------------	--------------------------------	--------------------------	------------------------------

*View of the location of removed Buildings 1 and 2 showing the remaining gable of Building 1 adjoining the barn (Building 3)*

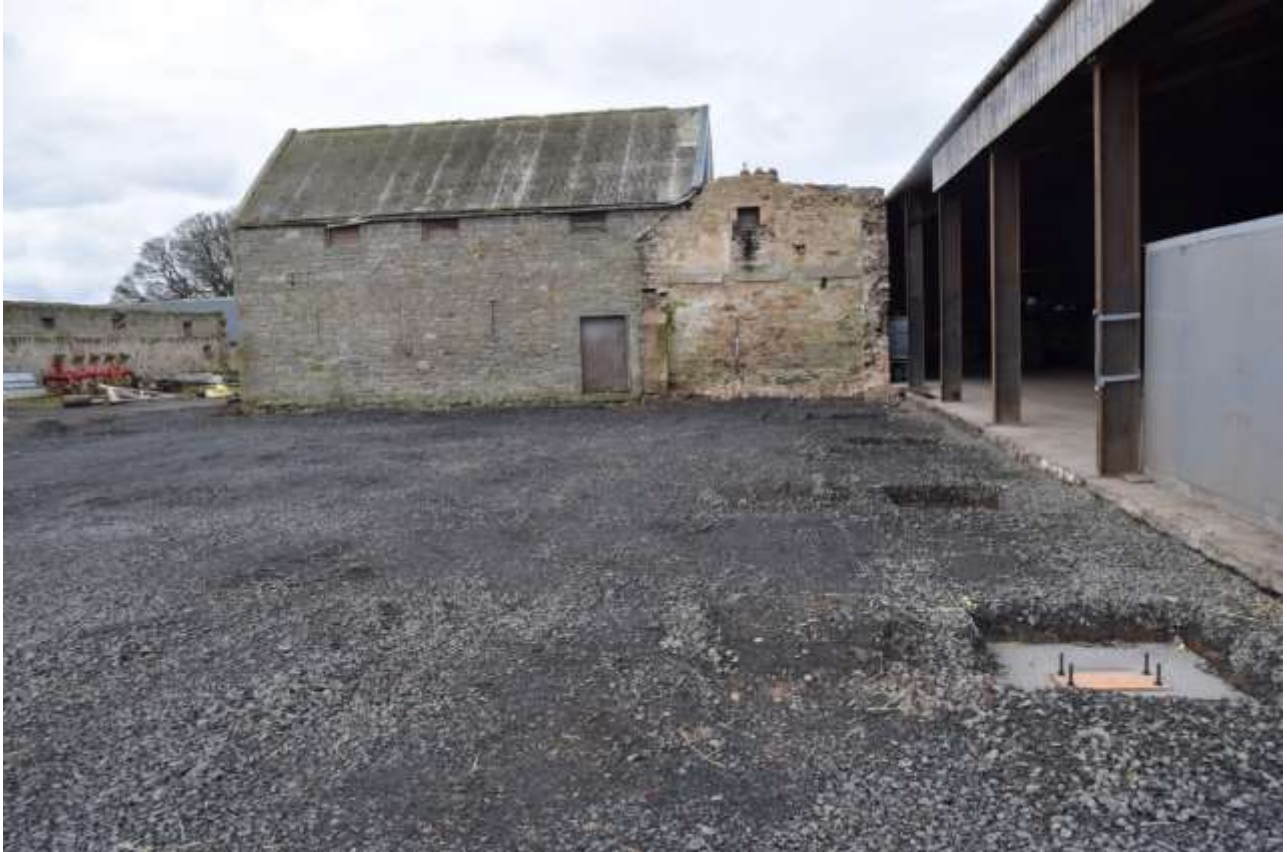
<b>Client:</b> Edwin Thompson	<b>Photo No.</b> P23-050-08	<b>Date:</b> 06-03-23	<b>Direction Taken:</b> W
----------------------------------	--------------------------------	--------------------------	------------------------------

*Detail of the remaining east facing gable of Building 1*

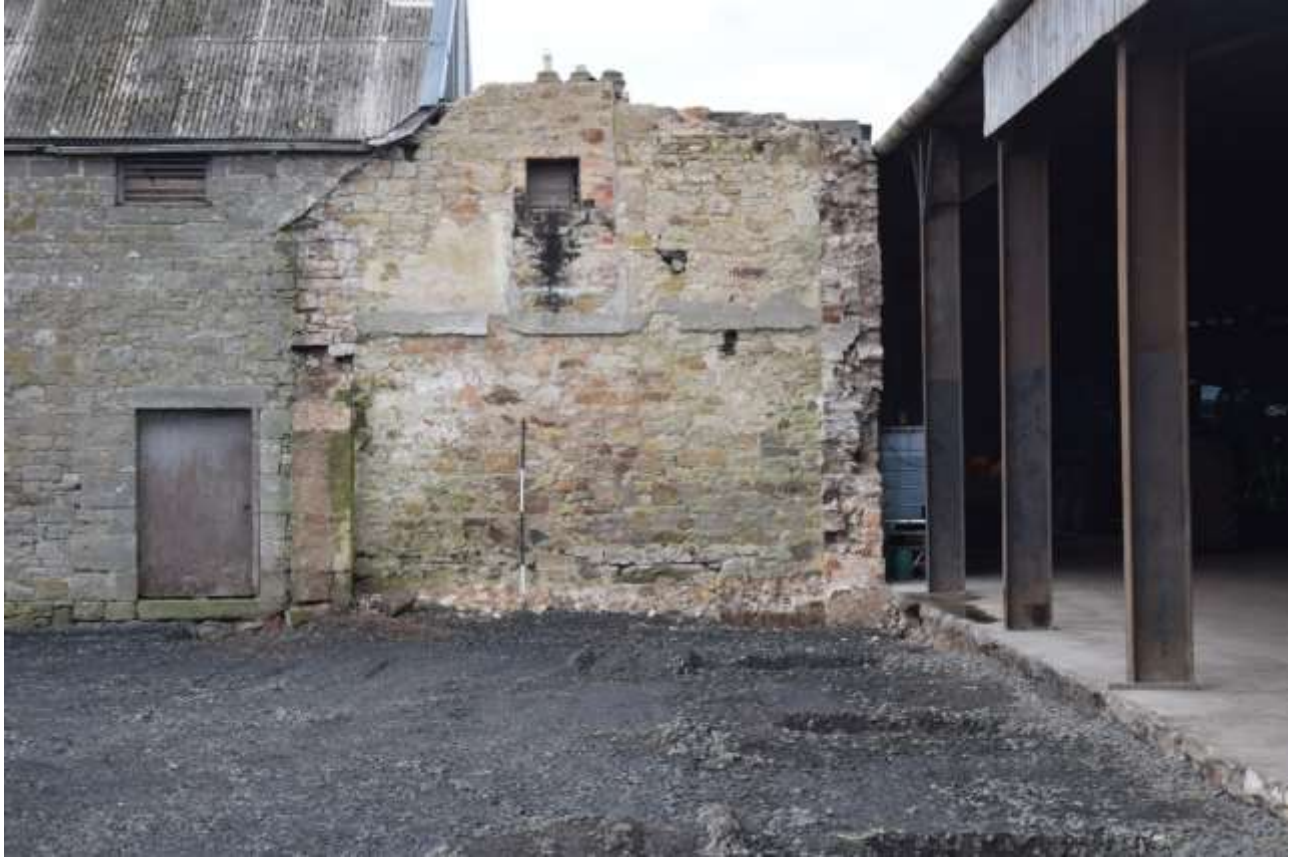
<b>Client:</b> Edwin Thompson	<b>Photo No.</b> P23-050-09	<b>Date:</b> 06-03-23	<b>Direction Taken:</b> W
----------------------------------	--------------------------------	--------------------------	------------------------------

*Detail of the remaining gable of Building 1*

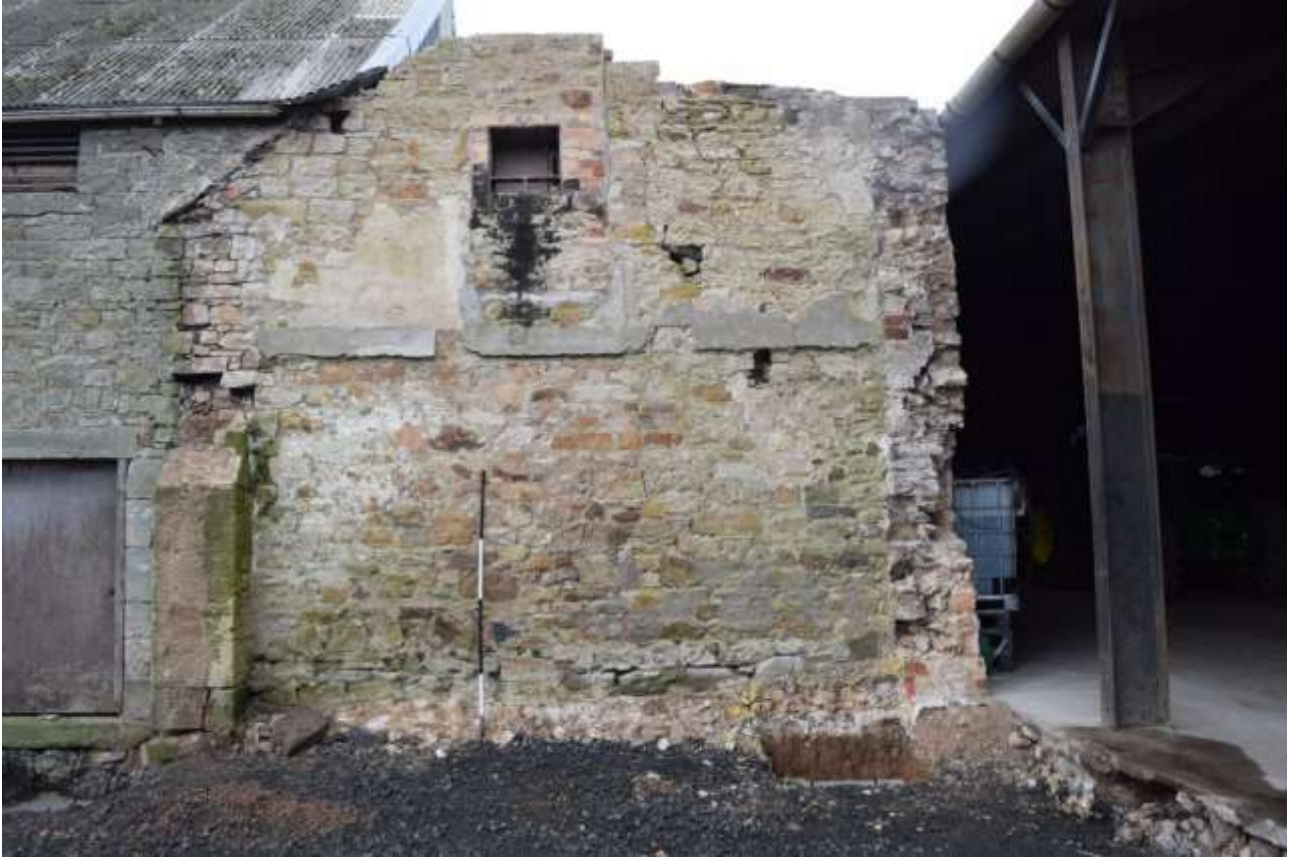
<b>Client:</b> Edwin Thompson	<b>Photo No.</b> P23-050-010	<b>Date:</b> 06-03-23	<b>Direction Taken:</b> E
----------------------------------	---------------------------------	--------------------------	------------------------------

*Detail of the remaining gable of Building 1 within Building 3*

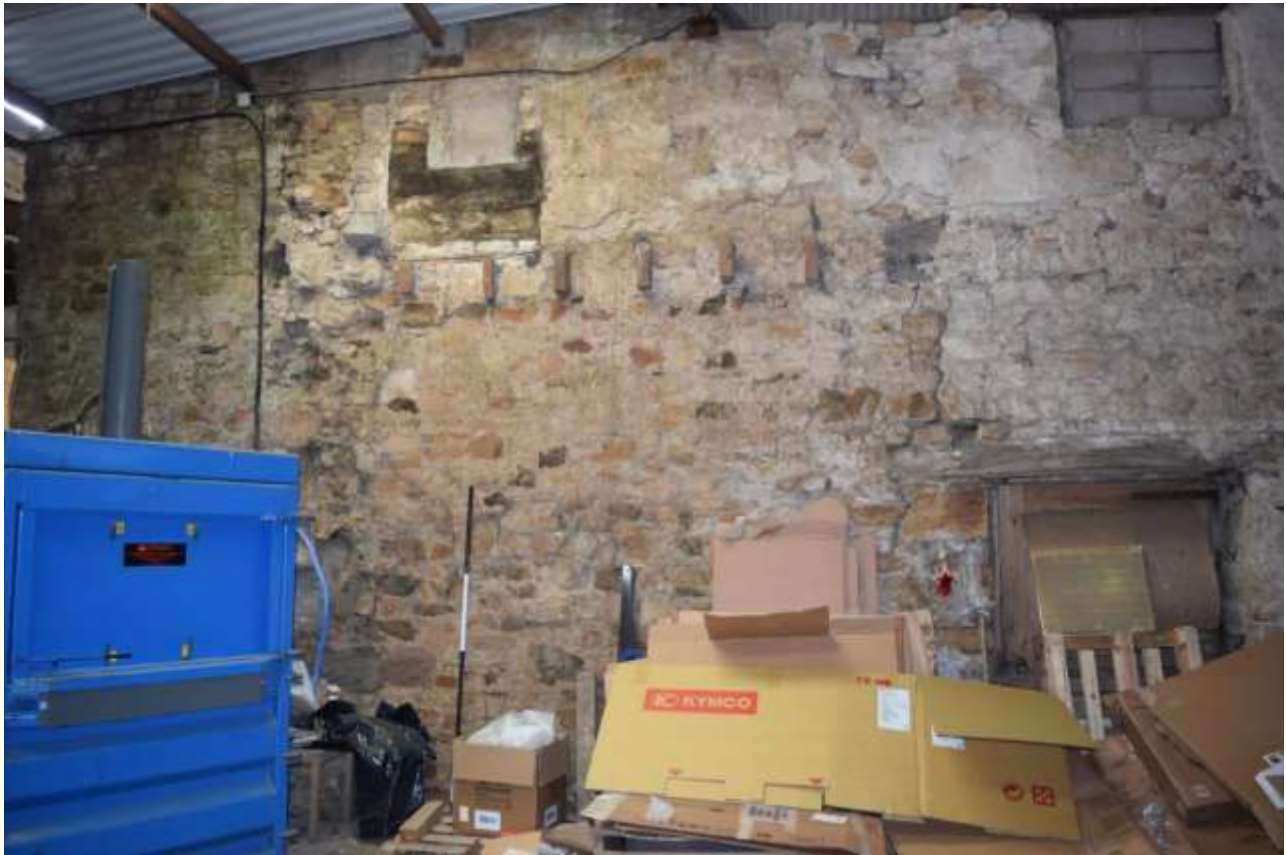
<b>Client:</b> Edwin Thompson	<b>Photo No.</b> P23-050-011	<b>Date:</b> 06-03-23	<b>Direction Taken:</b> E
----------------------------------	---------------------------------	--------------------------	------------------------------

*Detail of the remaining gable of Building 1 within Building 3*

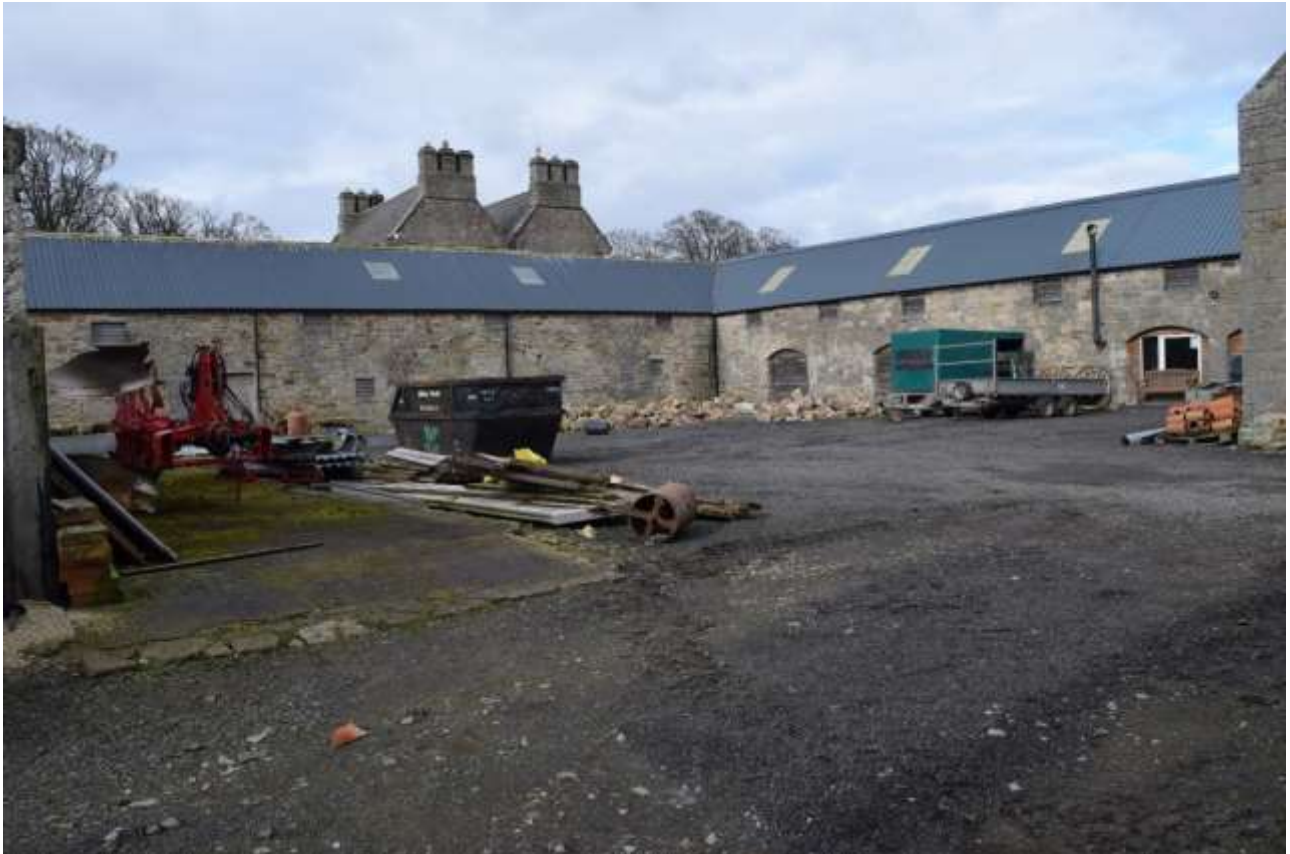
<b>Client:</b> Edwin Thompson	<b>Photo No.</b> P23-050-018	<b>Date:</b> 06-03-23	<b>Direction Taken:</b> S
----------------------------------	---------------------------------	--------------------------	------------------------------

*Internal north facing elevation of the remains of Building 6*

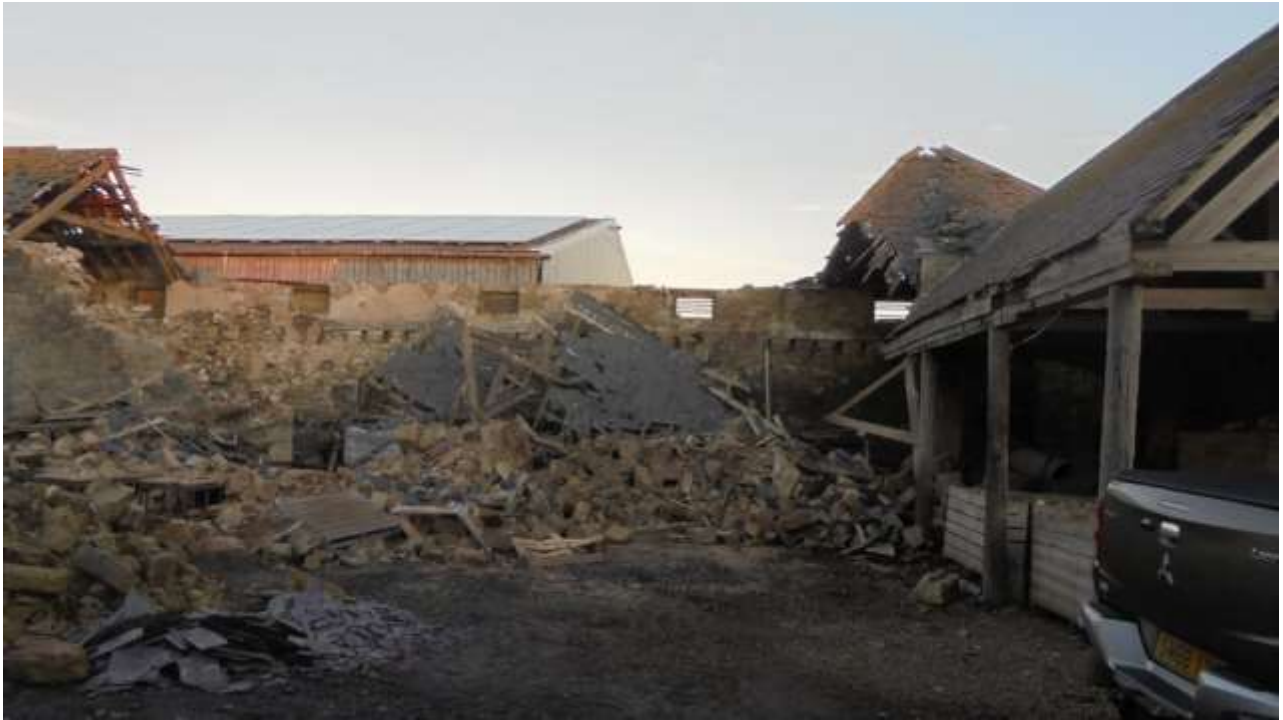
<i>Client:</i> Edwin Thompson	<i>Photo No.</i> P23-050-038- client	<i>Date:</i> 06-03-23	<i>Direction Taken:</i> N
----------------------------------	--	--------------------------	------------------------------

*Detail of damage to south elevation of Building 1*

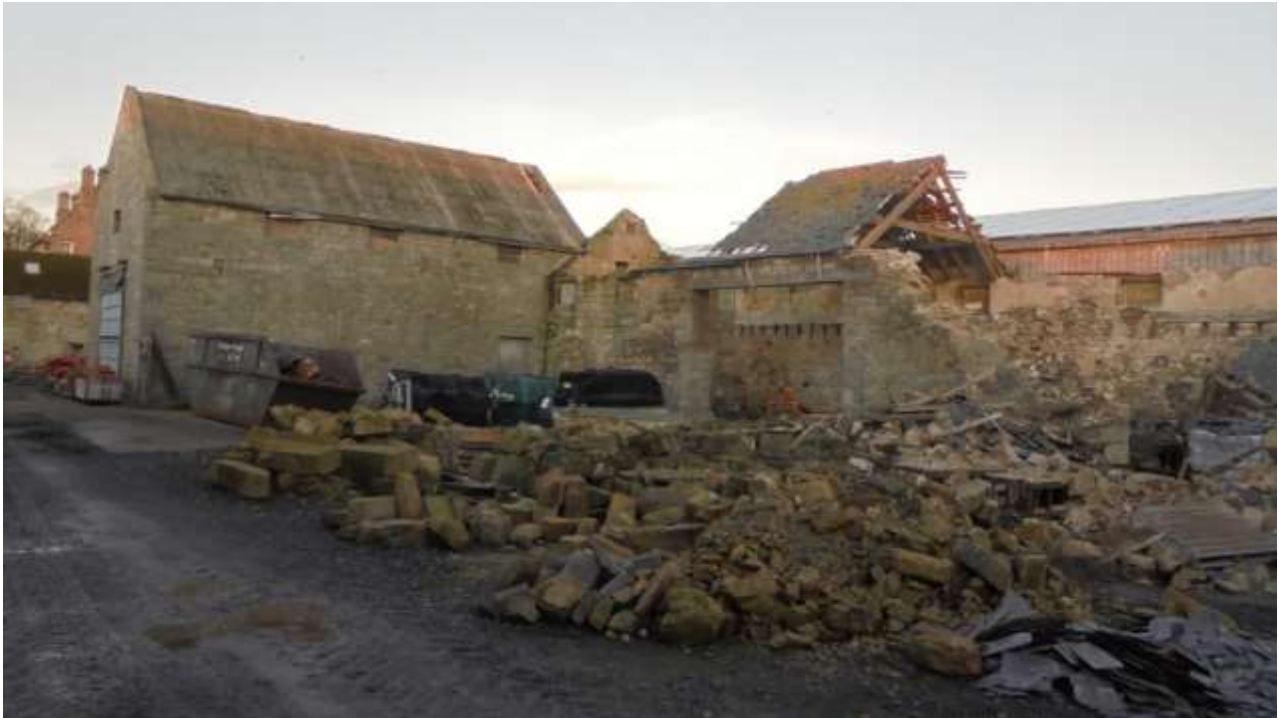
<b>Client:</b> Edwin Thompson	<b>Photo No.</b> P23-050-039- client	<b>Date:</b> 06-03-23	<b>Direction Taken:</b> NW
----------------------------------	--	--------------------------	-------------------------------

Remains of south elevation of Building 1

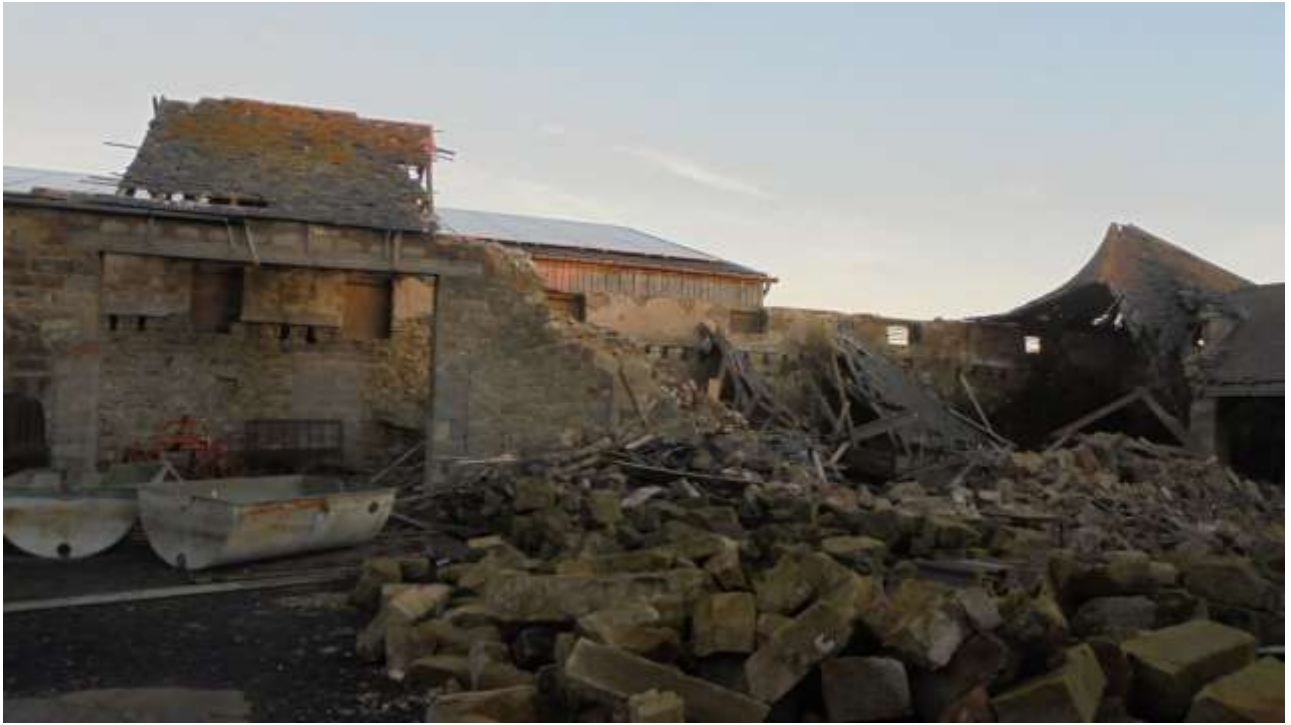
<b>Client:</b> Edwin Thompson	<b>Photo No.</b> P23-050-040- client	<b>Date:</b> 06-03-23	<b>Direction Taken:</b> N
----------------------------------	--	--------------------------	------------------------------

Remains of south elevation of Building 1

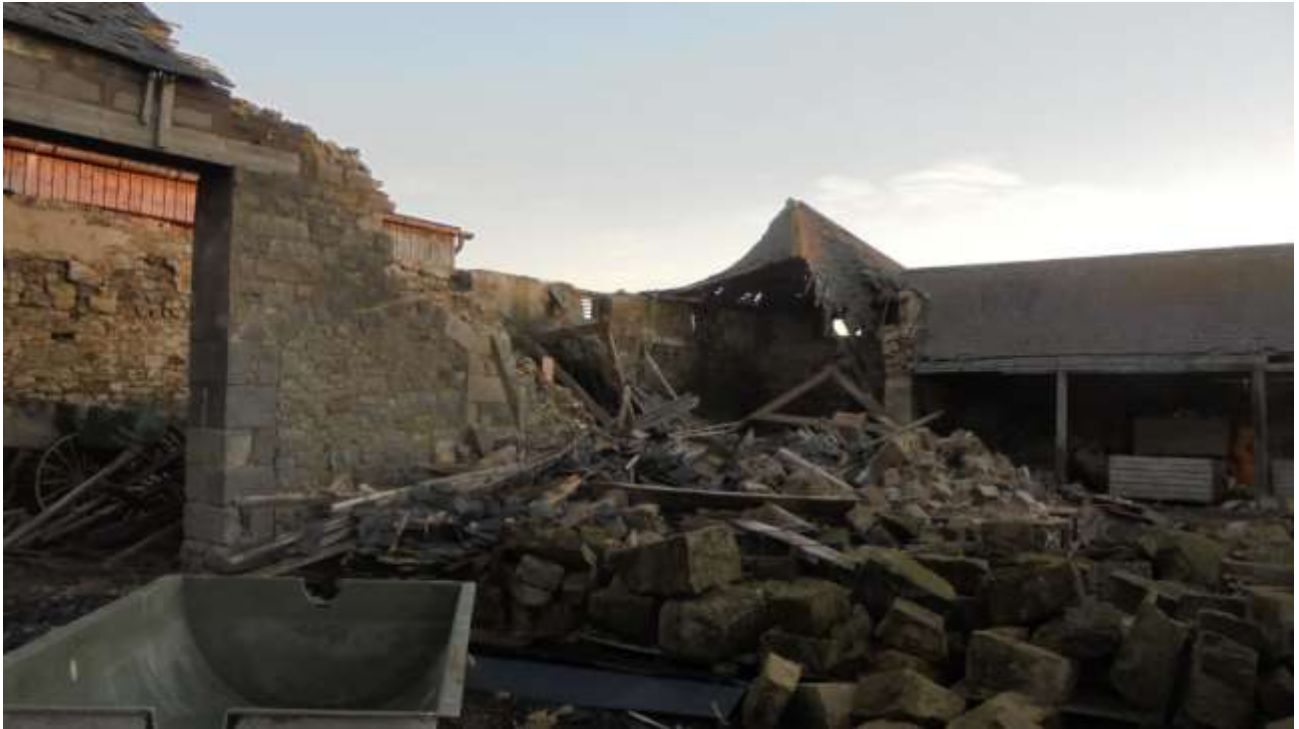
<i>Client:</i> Edwin Thompson	<i>Photo No.</i> P23-050-042- client	<i>Date:</i> 06-03-23	<i>Direction Taken:</i> NE
----------------------------------	--	--------------------------	-------------------------------

*Detail of damage to south elevation of Building 1*

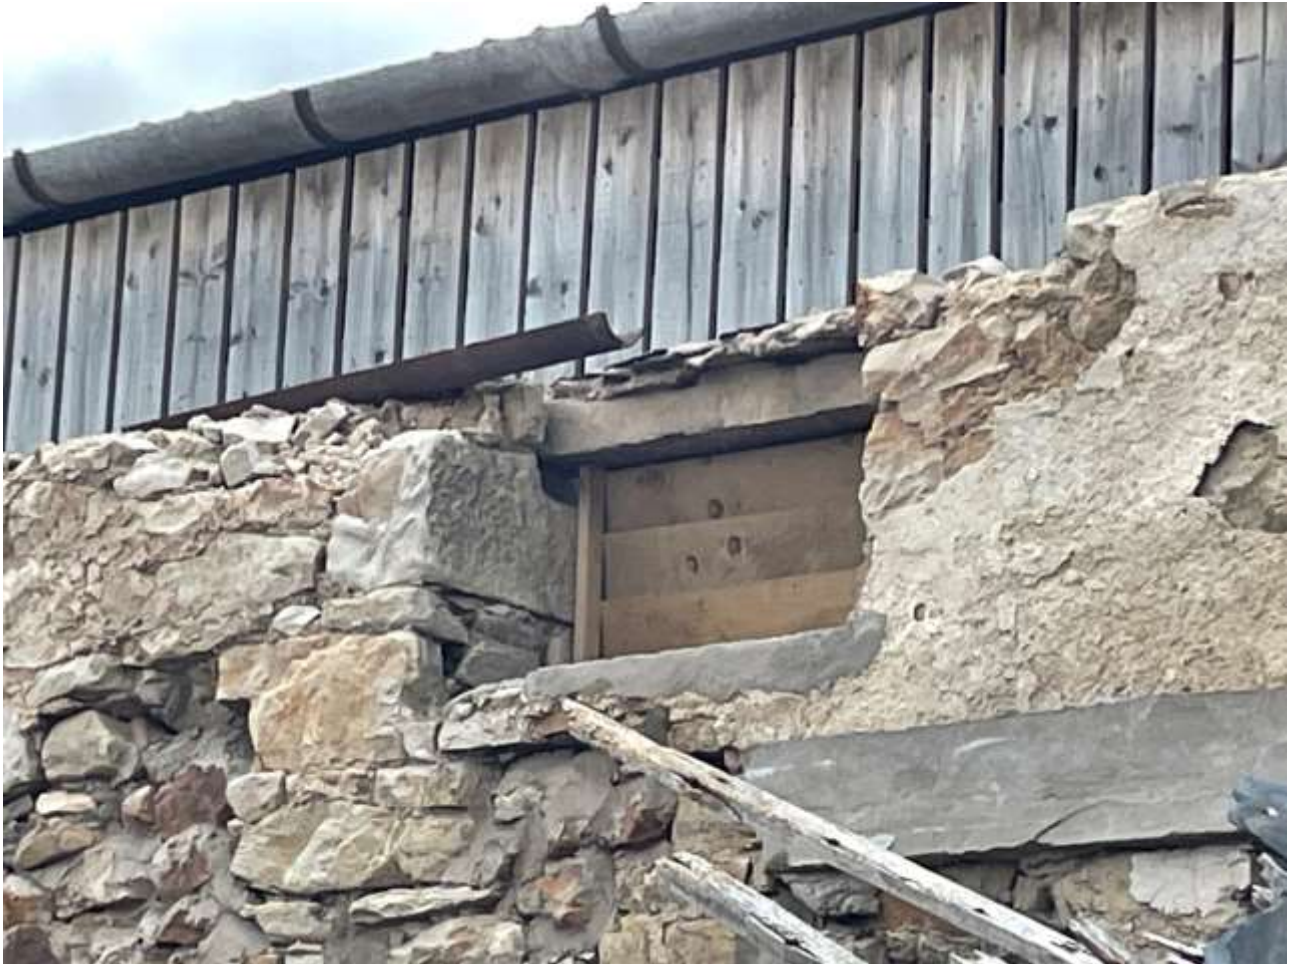
<i>Client:</i> Edwin Thompson	<i>Photo No.</i> P23-050-048- client	<i>Date:</i> 06-03-23	<i>Direction Taken:</i> NW
----------------------------------	--	--------------------------	-------------------------------

*Detail of remains of a window on the north elevation of Building 1*
