Project Code: GUYZ09
Planning application reference number: A/2006/0232
Date of report: August 2009
Client: The Northumberland Estates

GUYZANCE MILL, GUYZANCE, ALNWICK,
NORTHUMBERLAND GRAIN MILL
Results of Historic Building Recording
and Watching Brief

Results of Historic Building Recording and Watching Brief

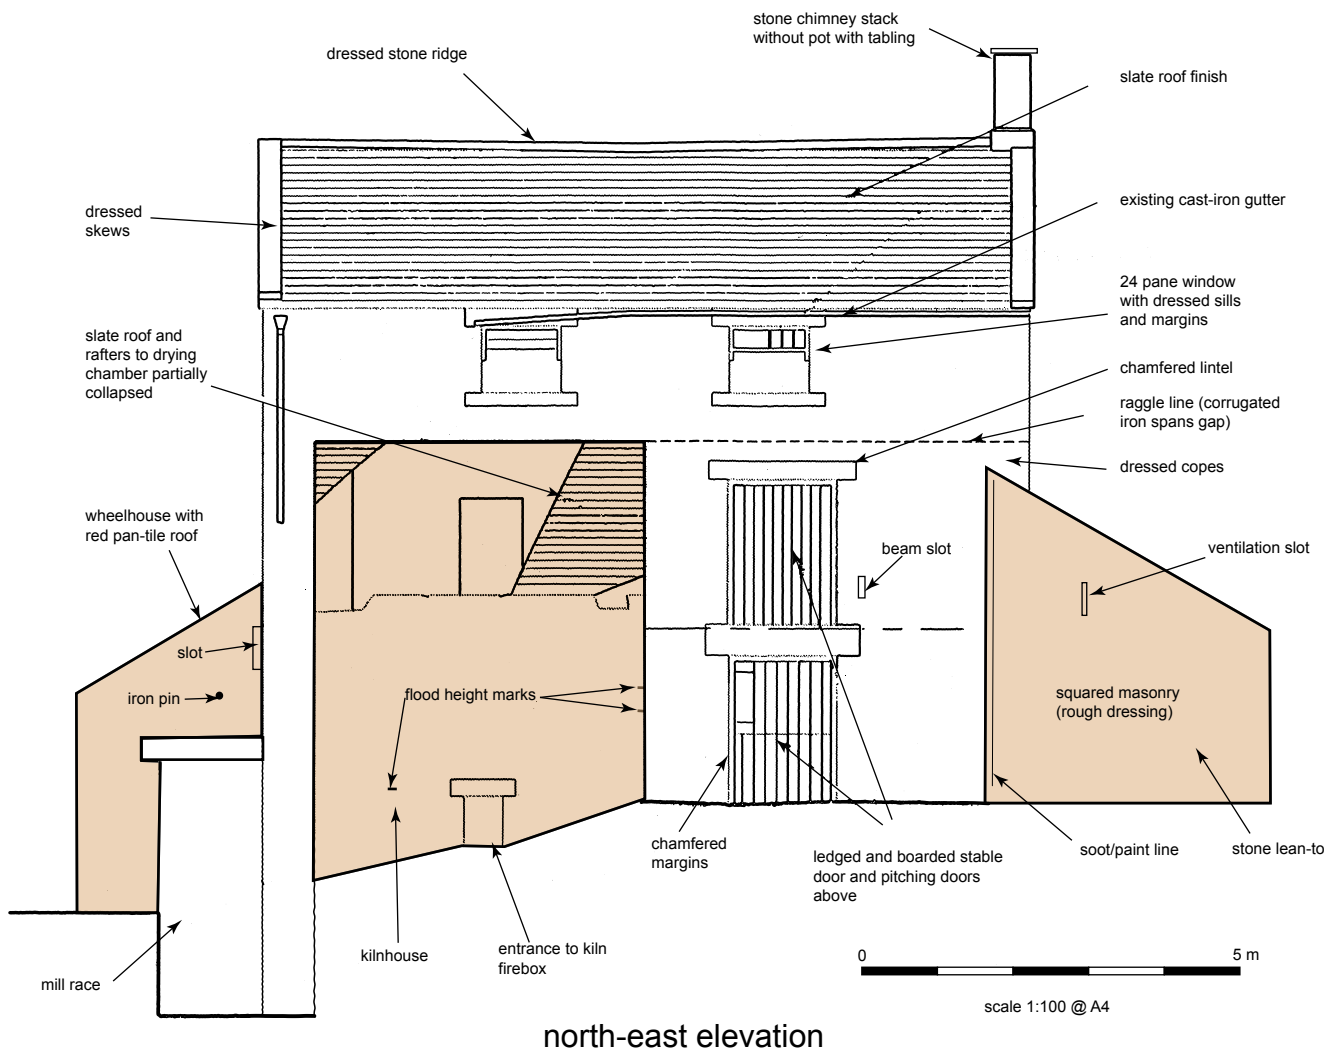
Illus 6

North-east elevation (Illus 5 & 6)

The north-east façade has a stable door at ground floor level located below a boarded double pitching door at 1st floor, both doors are within chamfered surrounds. Two windows are located at 2nd floor level, each with slightly projecting sills. The windows have no surviving carpentry.

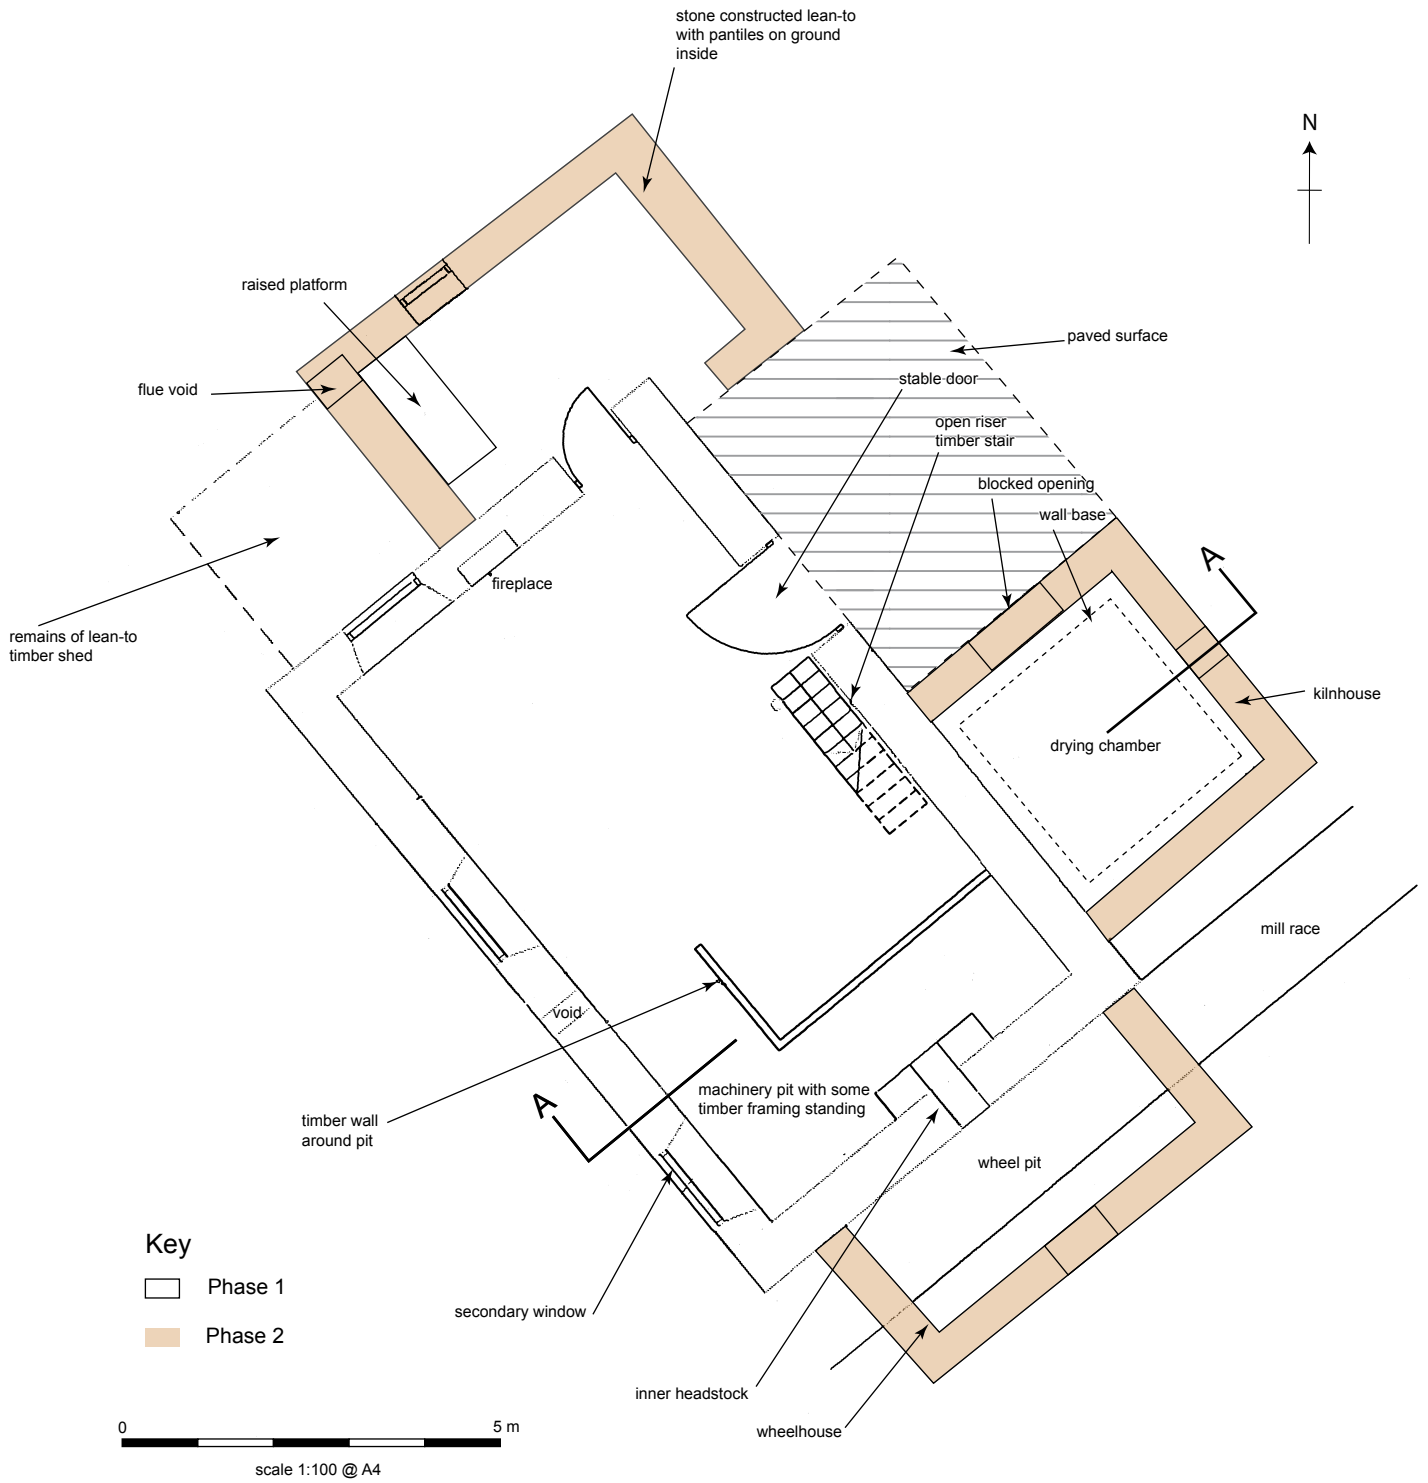
Illus 8
Ground floor plan

The ground floor is accessed from the door in the north-west elevation. A small domestic fireplace is located in the north-west wall with dressed stone mantel. The floor is formed from compacted earth and is covered in flood detritus.

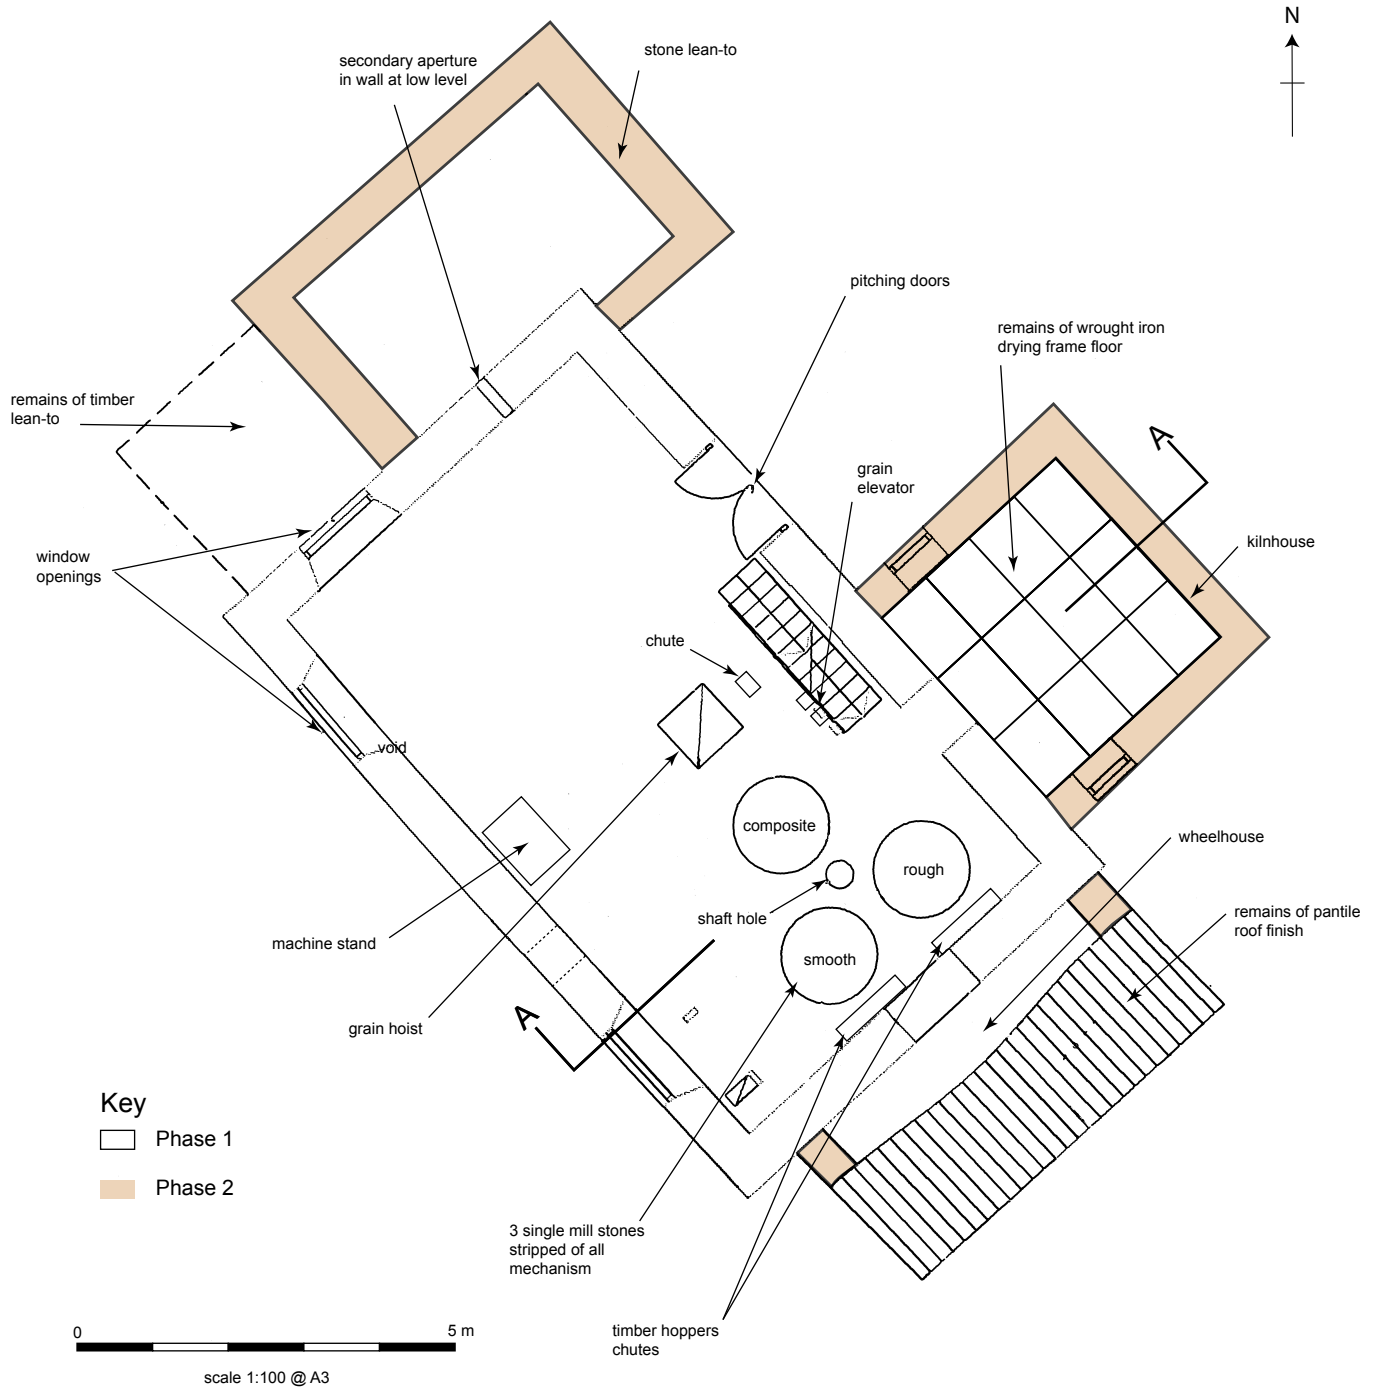
Illus 10
First floor plan

Further evidence of movement of grain and corn can be seen in a number of square apertures and chutes in the floor and ceiling. The largest square aperture is a sack hoist running from ground to 2nd floor. Evidence of rope wear on the wooden frame of the aperture and a surviving iron pulley wheel situated on the frame indicate a block and tackle system was in place to move sacks between floors.

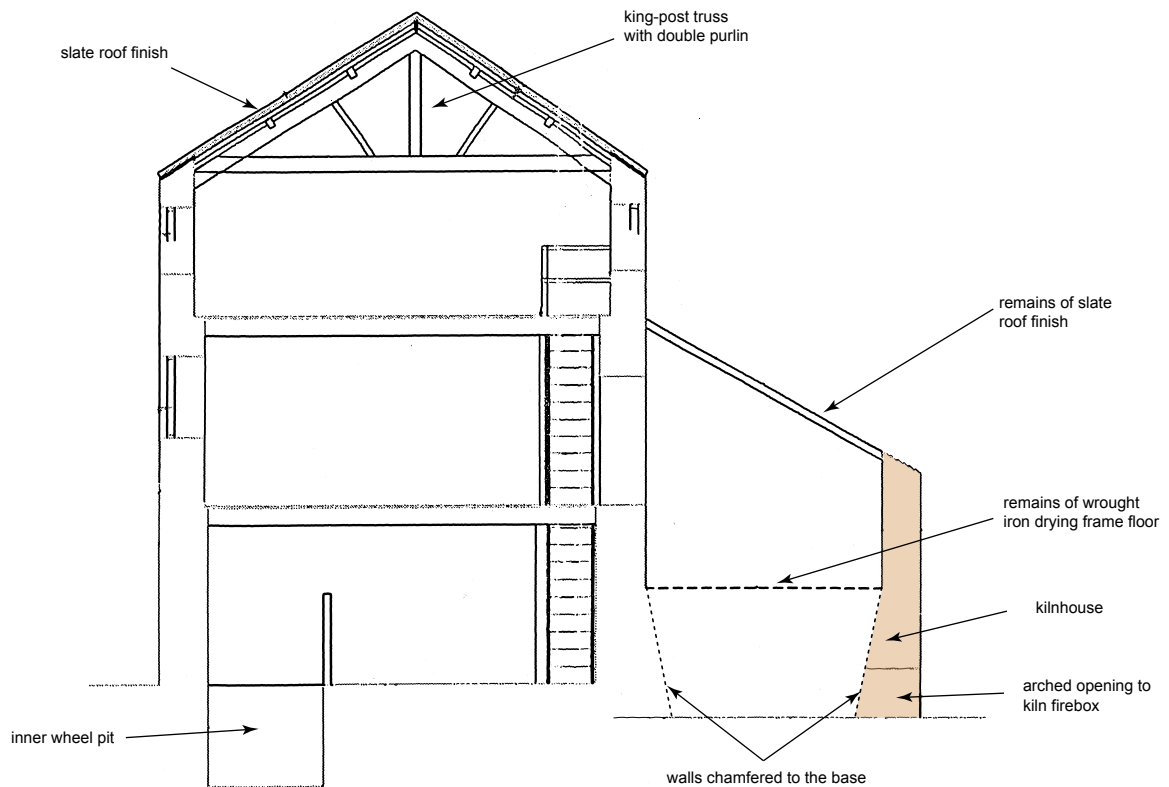
section A - A

the remains of a wrought iron grid framed drying floor fixed onto the internal walls. The internal walls of the kiln taper inward immediately below the drying floor to the ground. This would have helped direct the heat and smoke from the firebox on the ground floor to the grain drying on the floor above.
