LAMB'S HOUSE LEITH, EDINBURGH

Historic Building Recording and Monitoring of Ground Works

for Groves-Raines Architects

August 2012

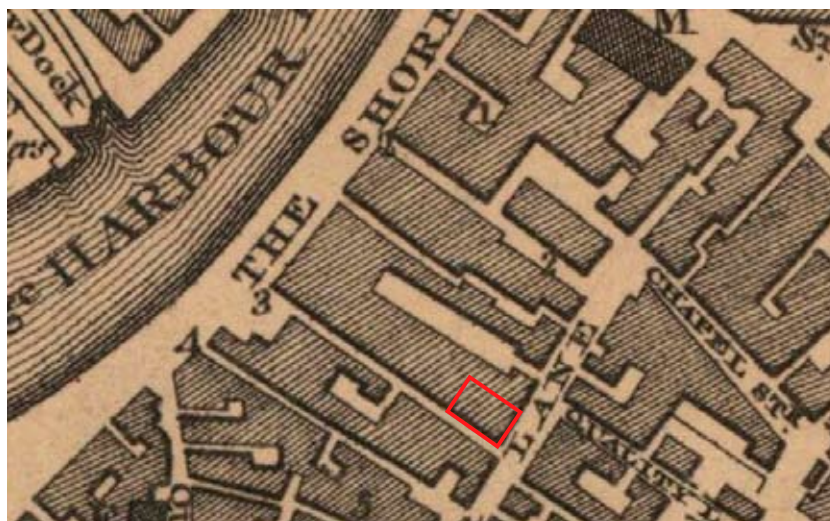
Illus 2

Ainslie's map of 1804

shows that Lamb's House faced onto Water's Close, which originally extended all the way through from the Shore to Water Street (or Water Lane). Two rows of buildings, with a narrow close between, are first shown on John Ainslie's map of 1804 (Illus 2) and again in less detail on Lancefield's map of 1851. A clearer view of the layout can be seen on the 1st edition Ordnance Survey 1852 (Illus 3). This depicts the narrow pend of Waters Close leading to the shore. Also by this date, the building facing Lamb's House at the end of Water's Close had been demolished, and its footprint is shown as a walled yard. Further redevelopment took place over the course of the 20th century, and the only building that remains today of the buildings that formerly stood between Water's Close and Burgess Close is that at no. 57–58 Shore / 10 Burgess Street.

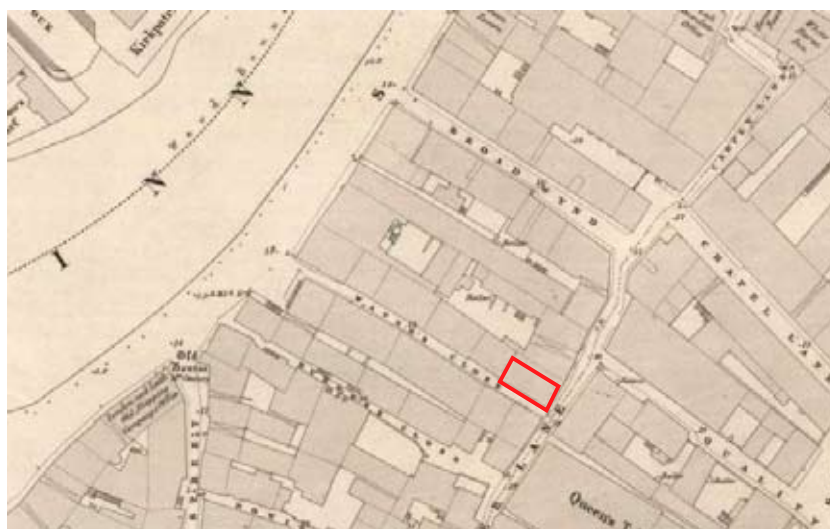
Illus 3

1st edition Ordnance Survey 1852

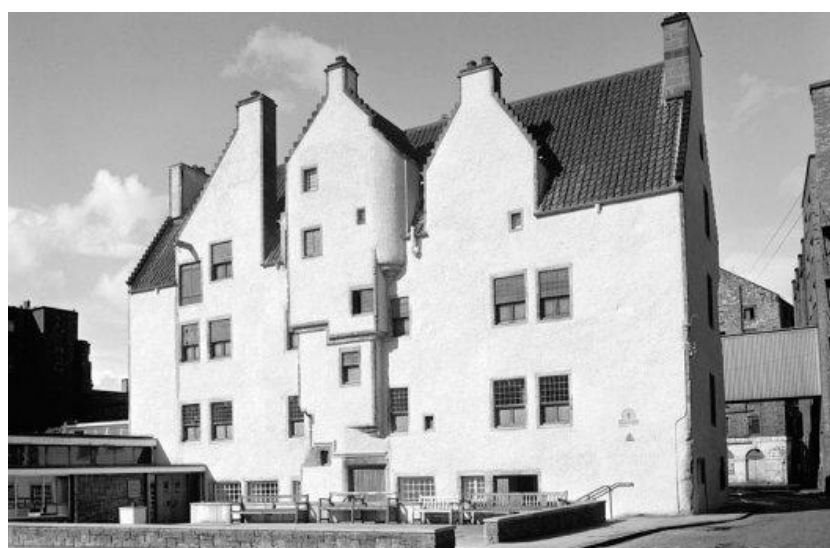
Illus 4

View of the principle elevation of Lamb's House

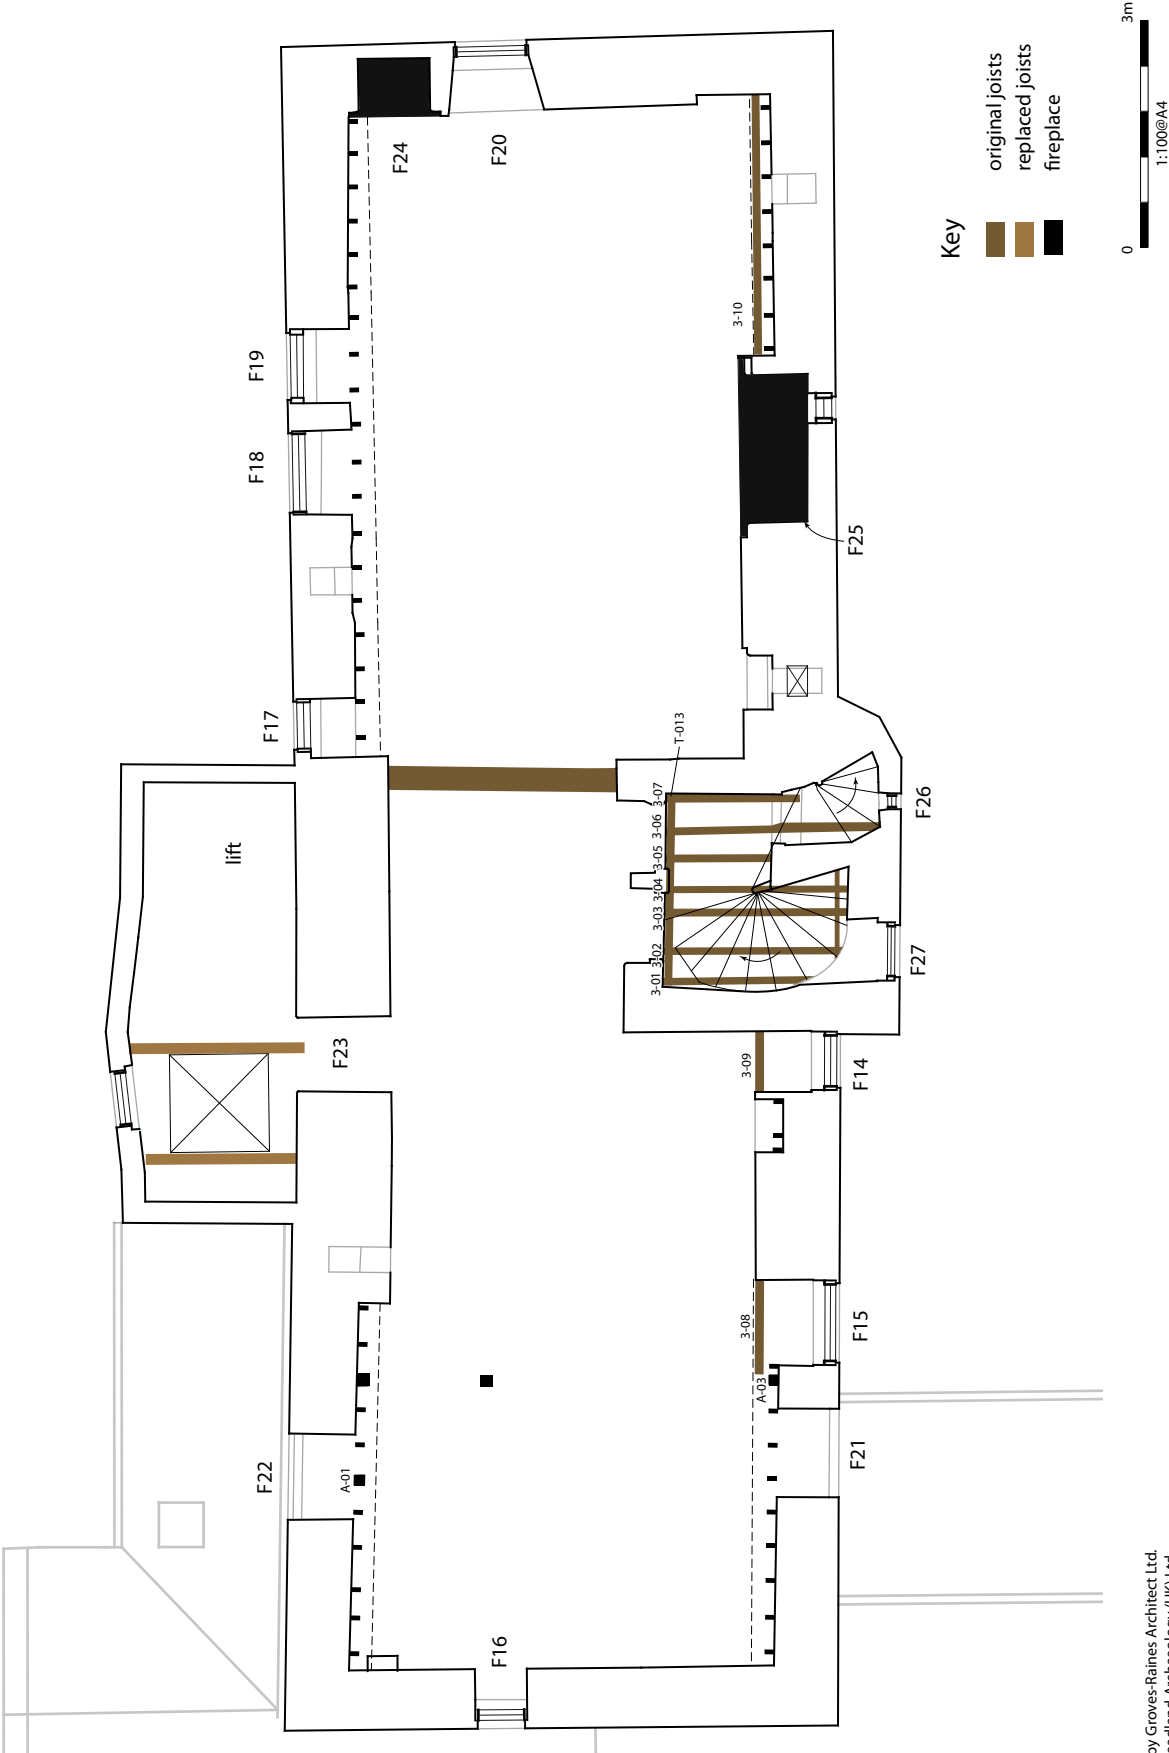
Illus 13
Third floor plan

The entrance to the third floor (Illus 13) was reached by the top of the main stairwell but also included a smaller stone turnpike stairwell to the SE that led to the a garret room and the attic space above. The treads of the smaller turnpike stair were much less worn than those of the main stairwell, indicating that the third floor was probably less regularly used. It is possible that this floor was originally accessed by ladders or wooden steps although no evidence for this was recorded. The ceiling of the main stairwell included a number of original timber beams (Illus 14), timbers 3-01 to 3-07.

compared with voussoirs on the lower floors, appear much newer and are probably the result of the repairs undertaken in the 1930s. On each side of the staircase a large fireplace (F53–F54) was located, each with heavy dressed margins with rounded and corbelled lintels. Fireplace F54 (Illus 9) however, had much more evidence of use, such as sooting and chipping and it is potentially much older than F53 which could, as with the voussoirs in the adjacent windows, be a 20th century replacement for an earlier feature. A further small fireplace (F61) was located on the SE wall comprising a hearth with a simple rounded dressed stone surround.

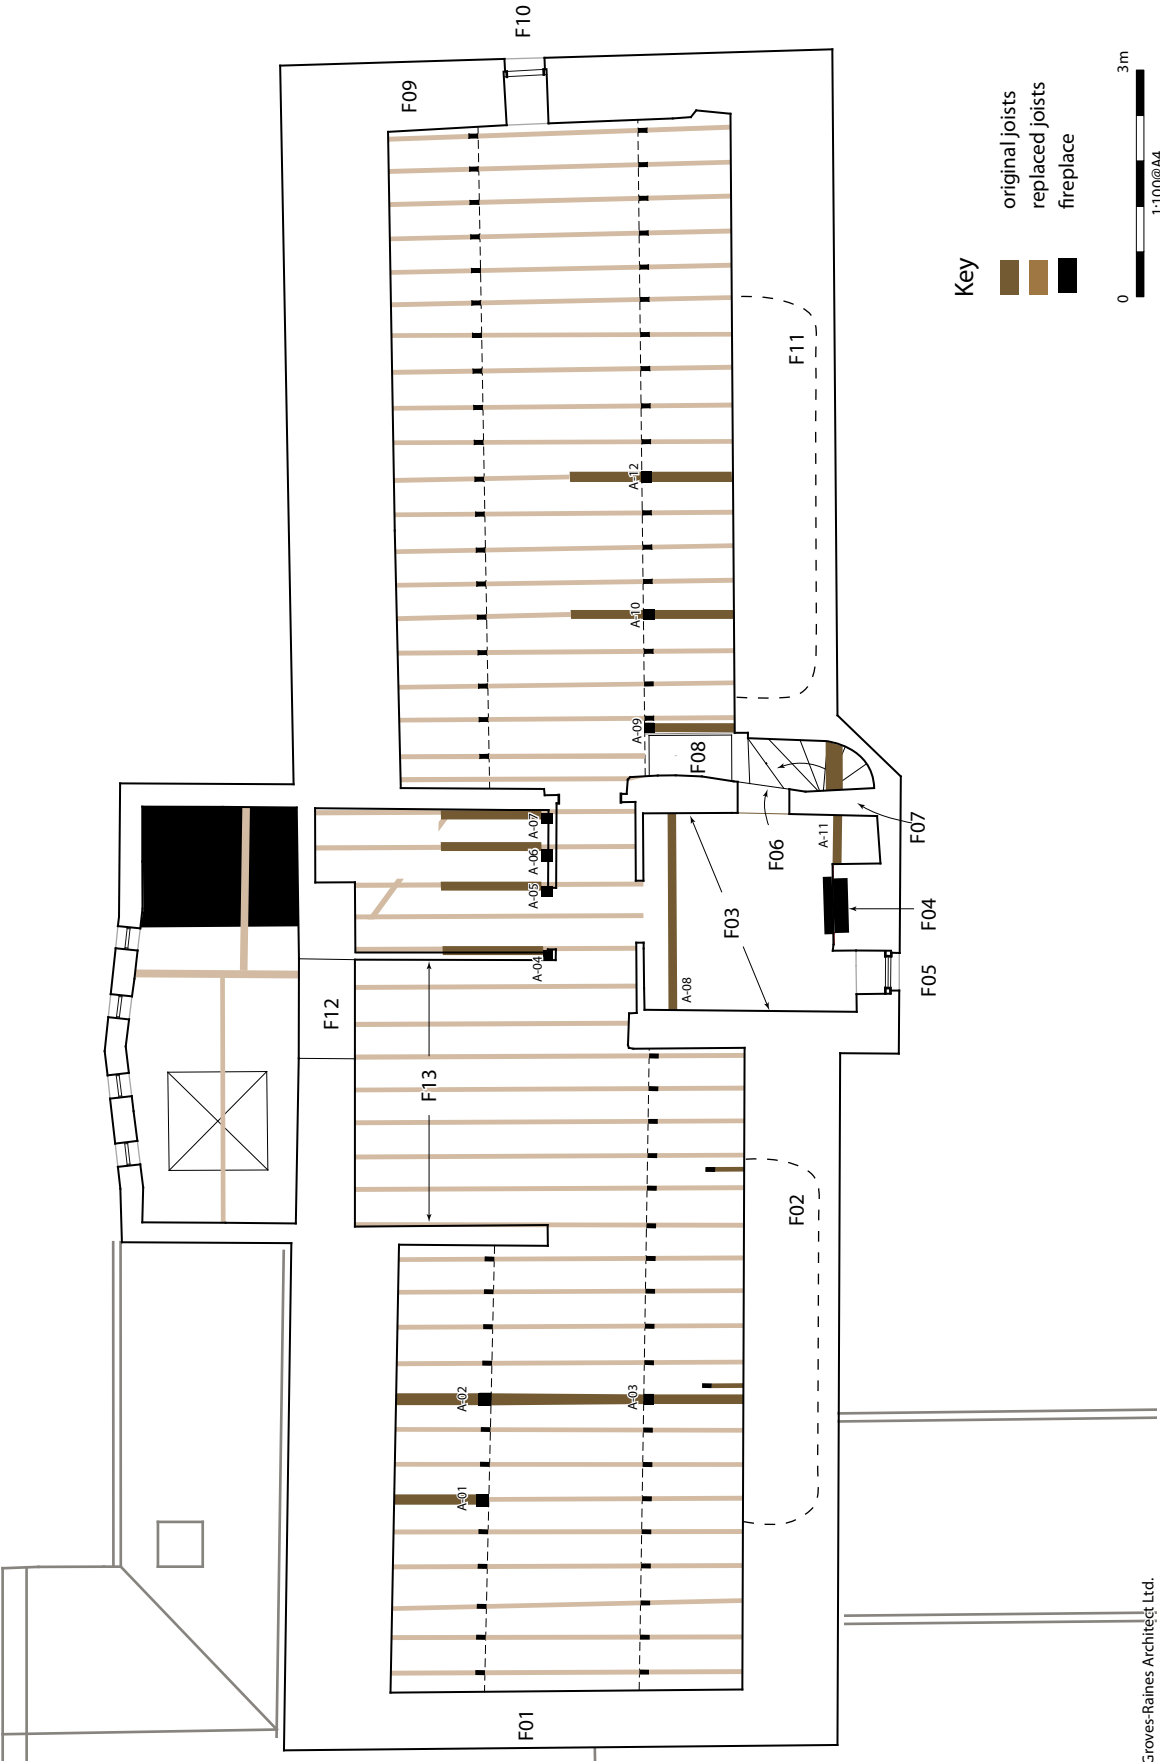
Illus 16
Attic plan

due to ongoing restoration making the interpretation of this area difficult. The remaining walls show evidence that they were rebuilt above 1.8m from the current floor level, probably as part of the roof repairs in the 1930s. A re-used oak beam (A-08) spanned the two ante-room walls to support the roof rafters. The beam had roughly chamfered edges and numerous small checks (cut-outs).

The majority of the rafters had been replaced but a number of older and possibly re-used roof timbers were recorded in the attic space. Of these timber rafters A-01 to A-03 included half lap splice joints two of which were top over bottom joints the third having a side by side joint (Illus 18). All three rafters had one or more mortice and tenon joints at various points along the timbers. This may indicate that they are re-used timbers. Rafter A-03 also had a carpenter's mark 'XXIII' (Illus 19).

A large re-used horizontal timber beam (A-08), apparently oak (Crone pers. com.) was located above the entrance (F06) 1.9m above the floor level. Timbers A-04 to A-06 also had half lap splice joints clamped with large iron bolts. A single rafter (A-12) on the south side of the roof included a mortice and tenon joint on the underside with a dowel hole on the west

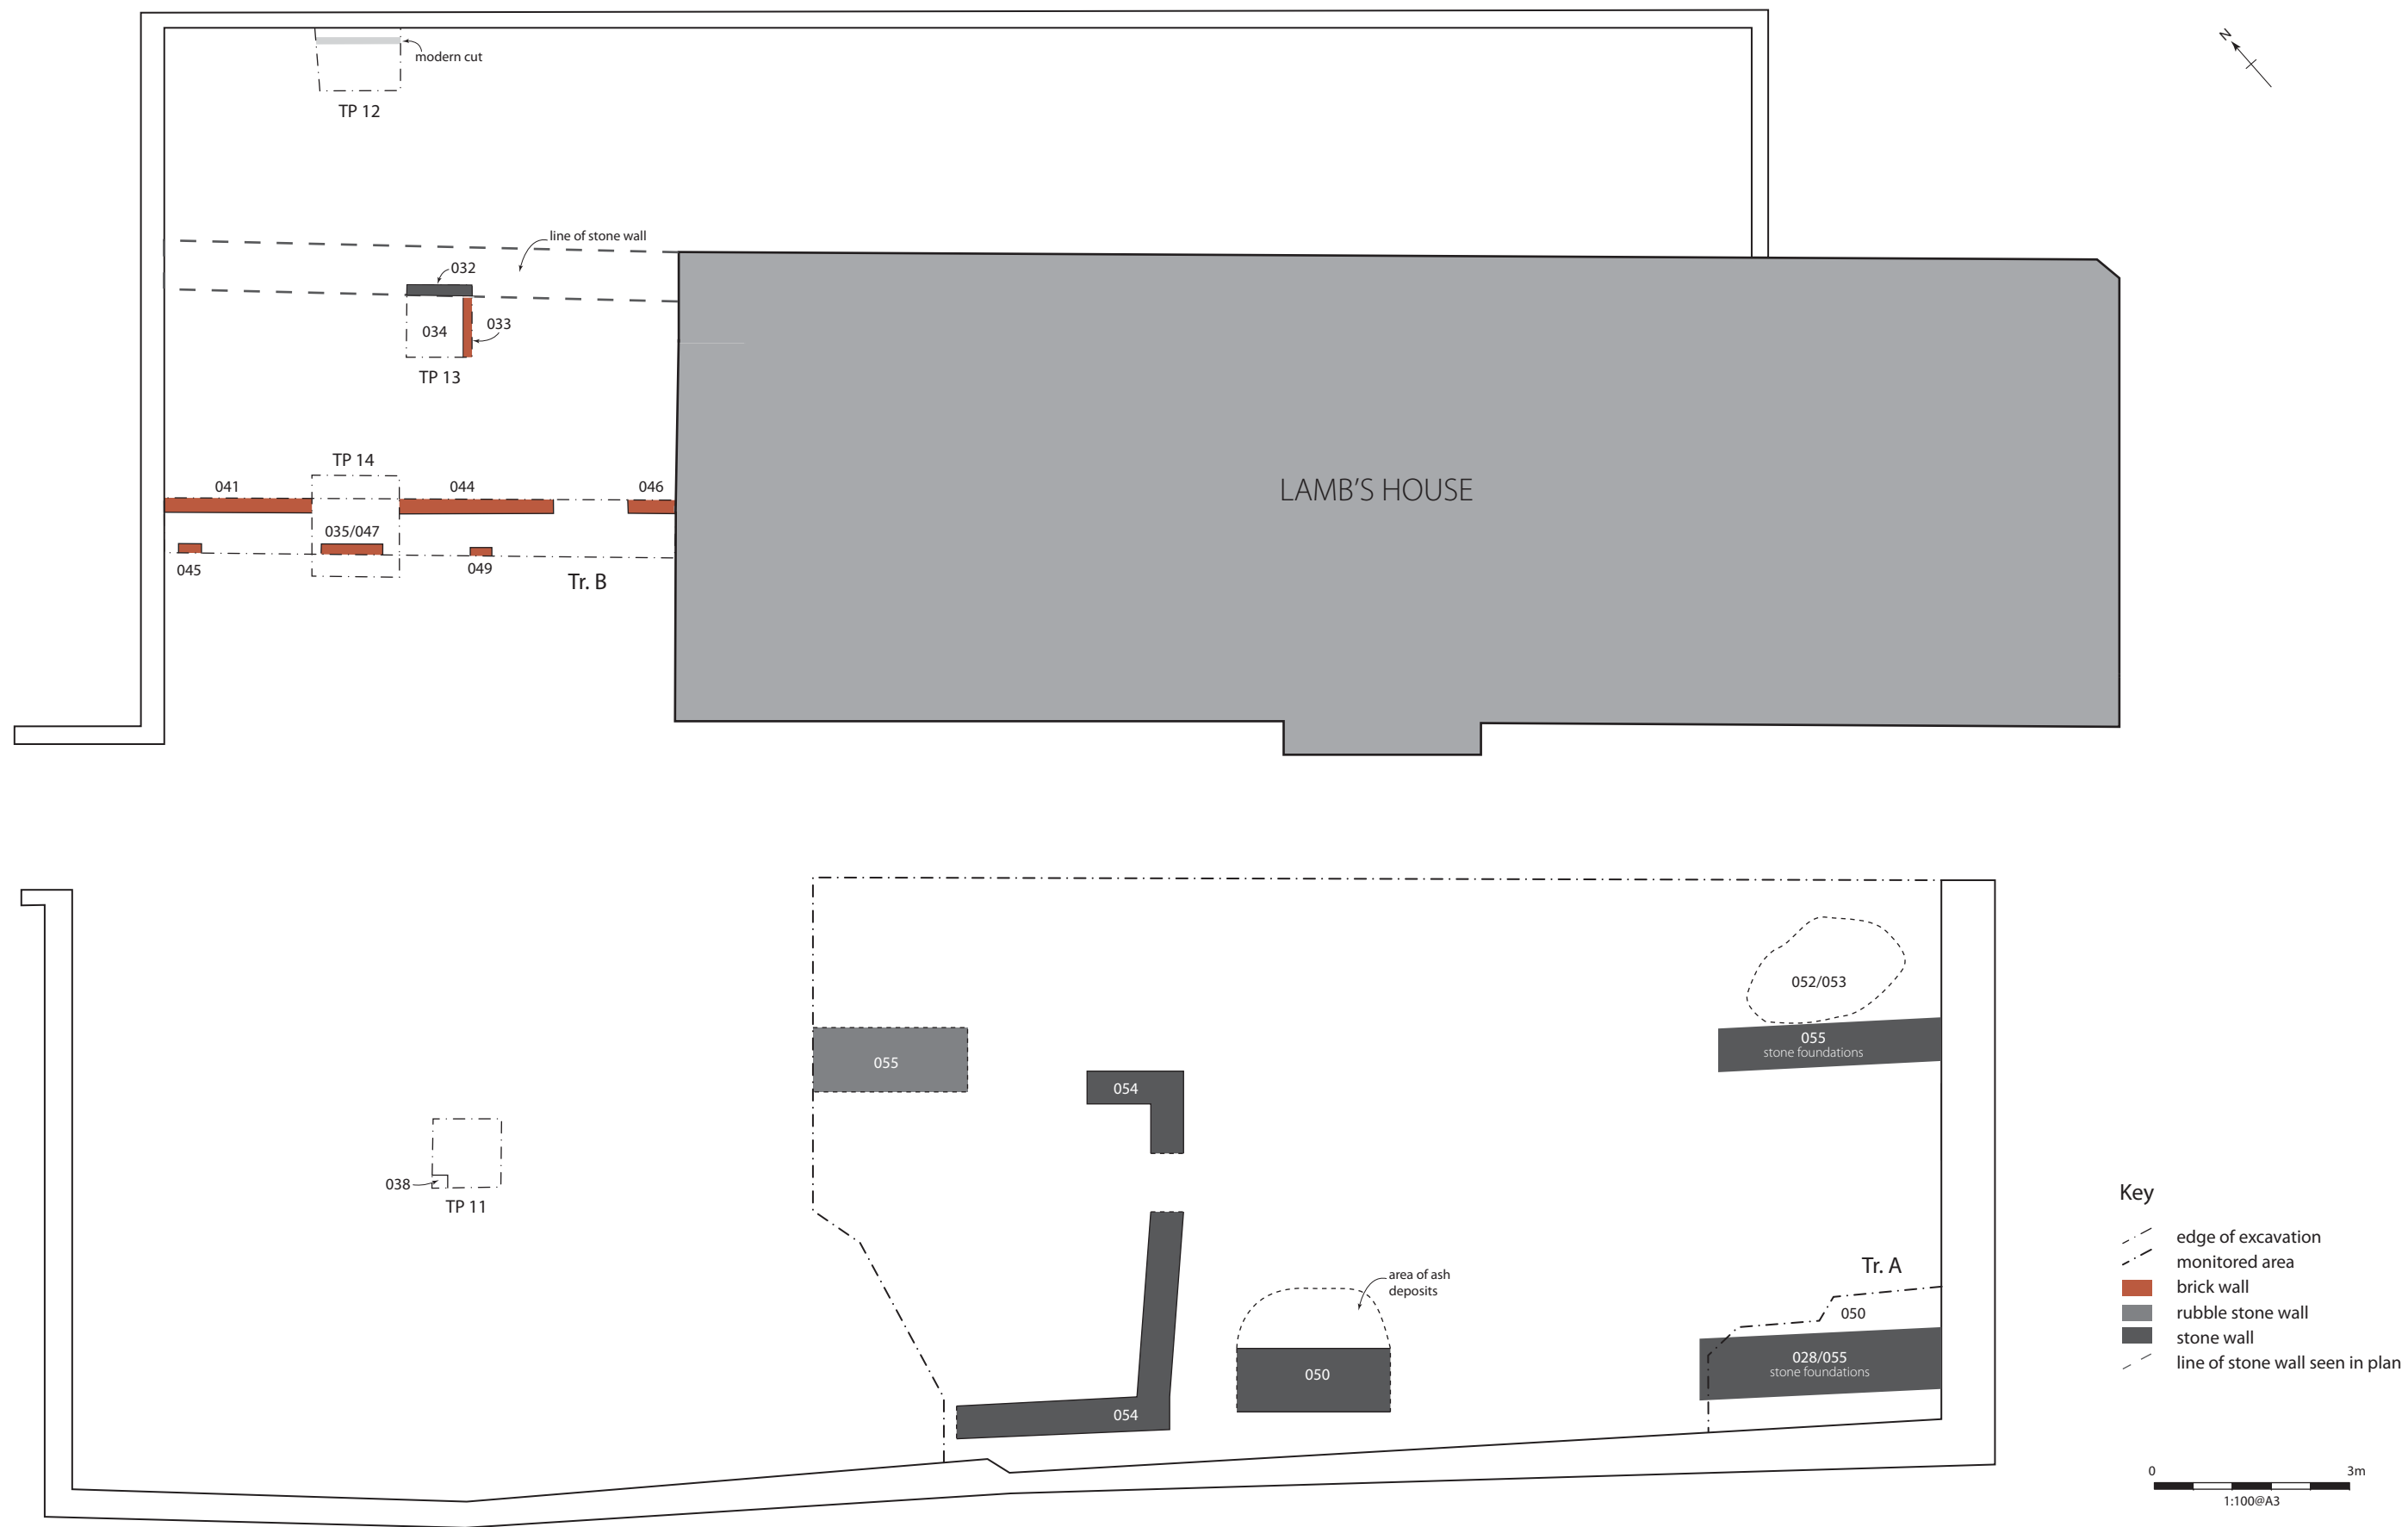
Illus 20
Location and features recorded in trenches and test pits

During the ground works associated with the excavation of Trench B the surface of the area to the NW of Lamb's House was reduced slightly. This revealed the top of a stone wall foundation running between the NW corner of Lamb's House and the NW site boundary wall. This is thought to represent the remains of a building contemporary with Lamb's House. Part of this wall was also recorded within Test Pit 13 as feature [032].

Disturbed remains were recovered of what are thought to be the footings a further wall [055] running parallel to both Lamb's House to the N and wall [050] to the S. In plan, this was formed of two areas of loose rubble bonded with lime mortar sitting on the alluvial sand. This wall was removed during the ground reduction works but was recorded in the NW facing section (Illus 25) of the development area. This wall along with wall [050] probably represent the remains of the building first clearly depicted on the 1852 Ordnance Survey map but potentially having much earlier origins. This mapped building may even have originally been contemporary with Lamb's House as we know this faced onto a narrow lane leading down to the shore. Immediately N of wall [055] a small spread of dark brown sand [052] with frequent oyster shell and animal bone, possibly represents the remains
