ST MARY'S CHURCH, ALFRICK, WORCESTERSHIRE

Watching brief and Historic Building Survey

for S T Walker & Duckham on behalf of Alfrick PCC

3 March 2011

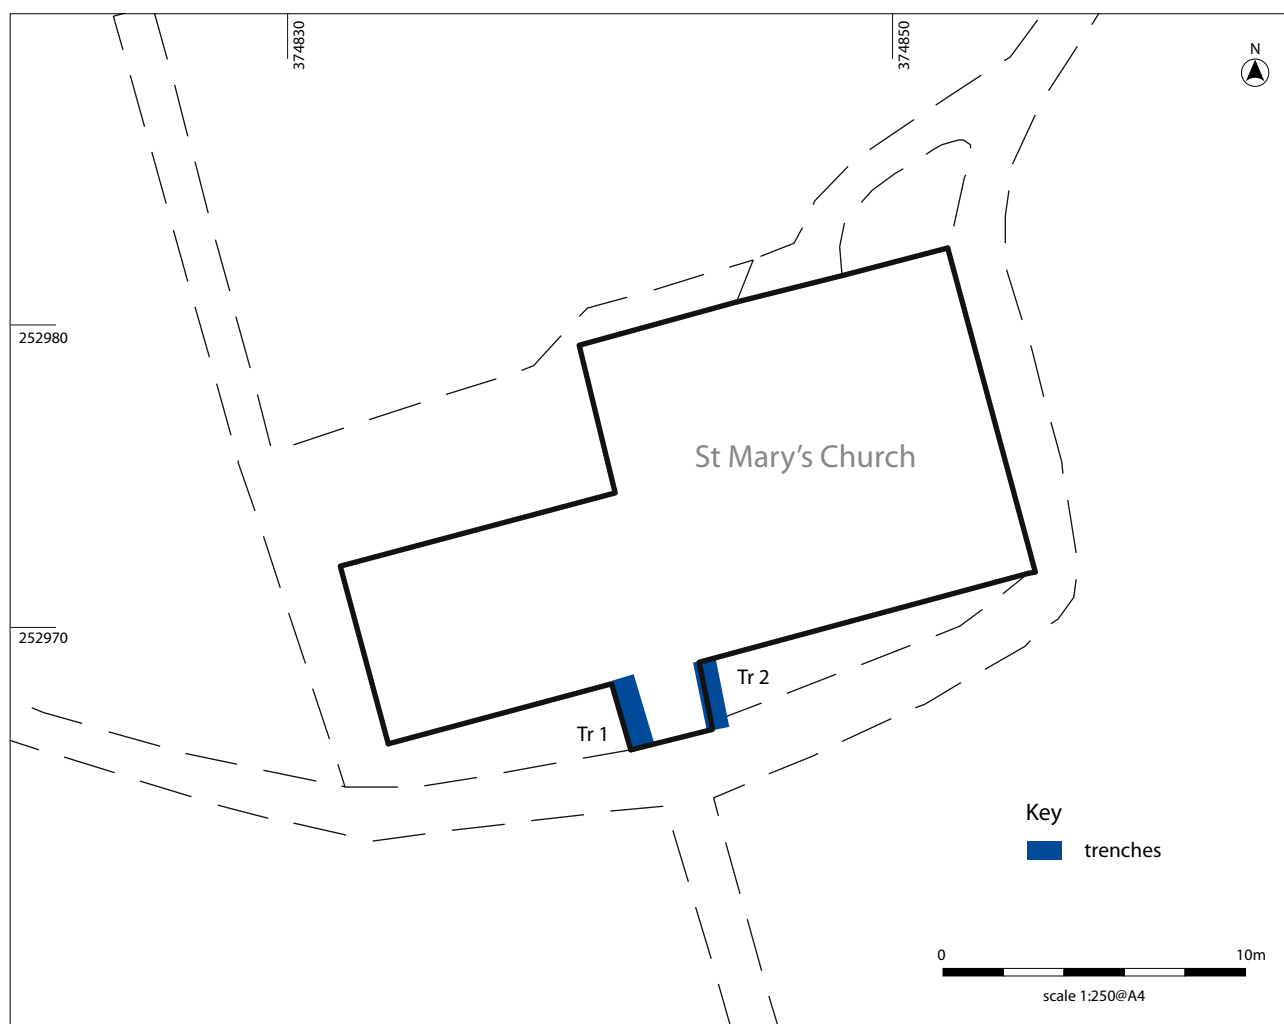
Illus 6
Location of trenches 1 and 2

The proposed works involved supporting the oak frame on jacks while the stone plinth was removed, new foundations dug and a new plinth constructed. Two trenches were excavated in total. These trenches were located under the porch walls at the south facing entrance to the church and were excavated by hand under direct archaeological supervision.
