HIDCOTE MANOR GARDEN, GLOUCESTERSHIRE

Archaeological Trial Trenching

for The National Trust

August 2012

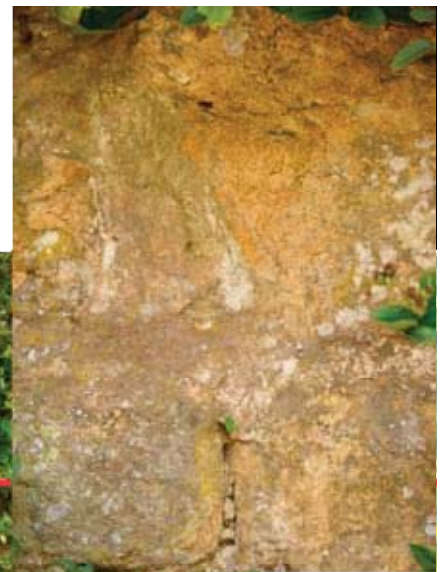
Illus 5

The relative antiquity of the small length of car park wall to the east of the courtyard is brought into question through the inclusion a concrete lintel within the doorway. This maybe a modern repair but further evidence that that the wall is of more recent date is that the wall is not keyed into the adjoining restored barn, but rather butted up to the building, suggesting a later construction date. Furthermore, the overall dimensions of the wall conform oddly to metric measurements.
