# NEWARK FARM, HEMPSTED, GLOUCESTERSHIRE

Historic Building Recording

commissioned by CgMs Consulting on behalf of Newland Homes Limited

13/01203/FUL

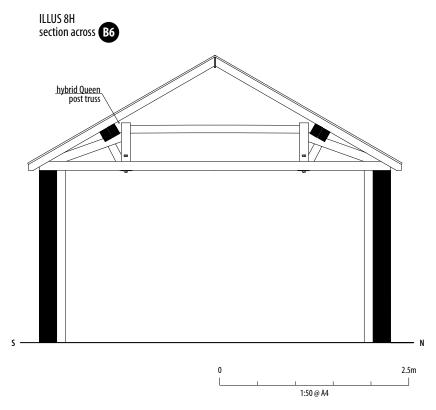
## Illus 8h

The truss is constructed from a strutting beam or tie beam spanning the width of the building with two short Queen post strut beams braced by a straining beam. The two Queen posts are attached to the tie beam through the use of a captive nut and bolt within the tie beam. Two small angled braces run from the strutting beam and attached to the principal rafter upon which the purlins are cut, the purlins then support the common rafters and the common rafters meet at the pitch of the roof in a running ridge board, leaving the roof open between the trusses (**Illus 26**). The construction of the roof trusses is an unusual design and possibly reflects a local vernacular adaptation unique to the building at Newark Farm. In particular its

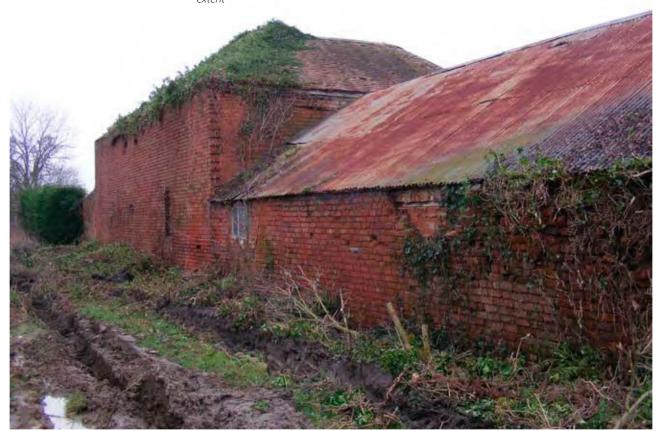
**Illus 19**NNW view of Building 2a showing original extent

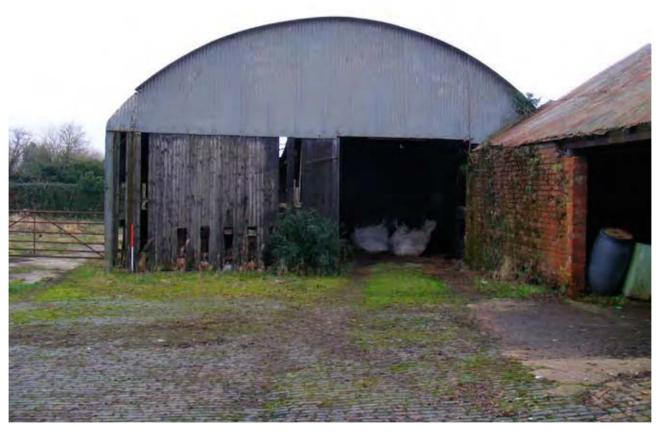
Building 4 is known as the Dutch barn and represents a later addition to the farm, the building consists of a iron framed structure of four bays capped with a curved trussed roof formed from drawn iron rods and bolted angle iron, the in-filled panels of corrugated iron sheet are supported by wooden horizontal timbers (**Illus 21**).

**Illus 21** *E view of western elevation of Building 4*
