CHURCHEND MILL, STROUD, GLOUCESTERSHIRE

Historic Building Recording

commissioned by The Environment Agency

July 2014

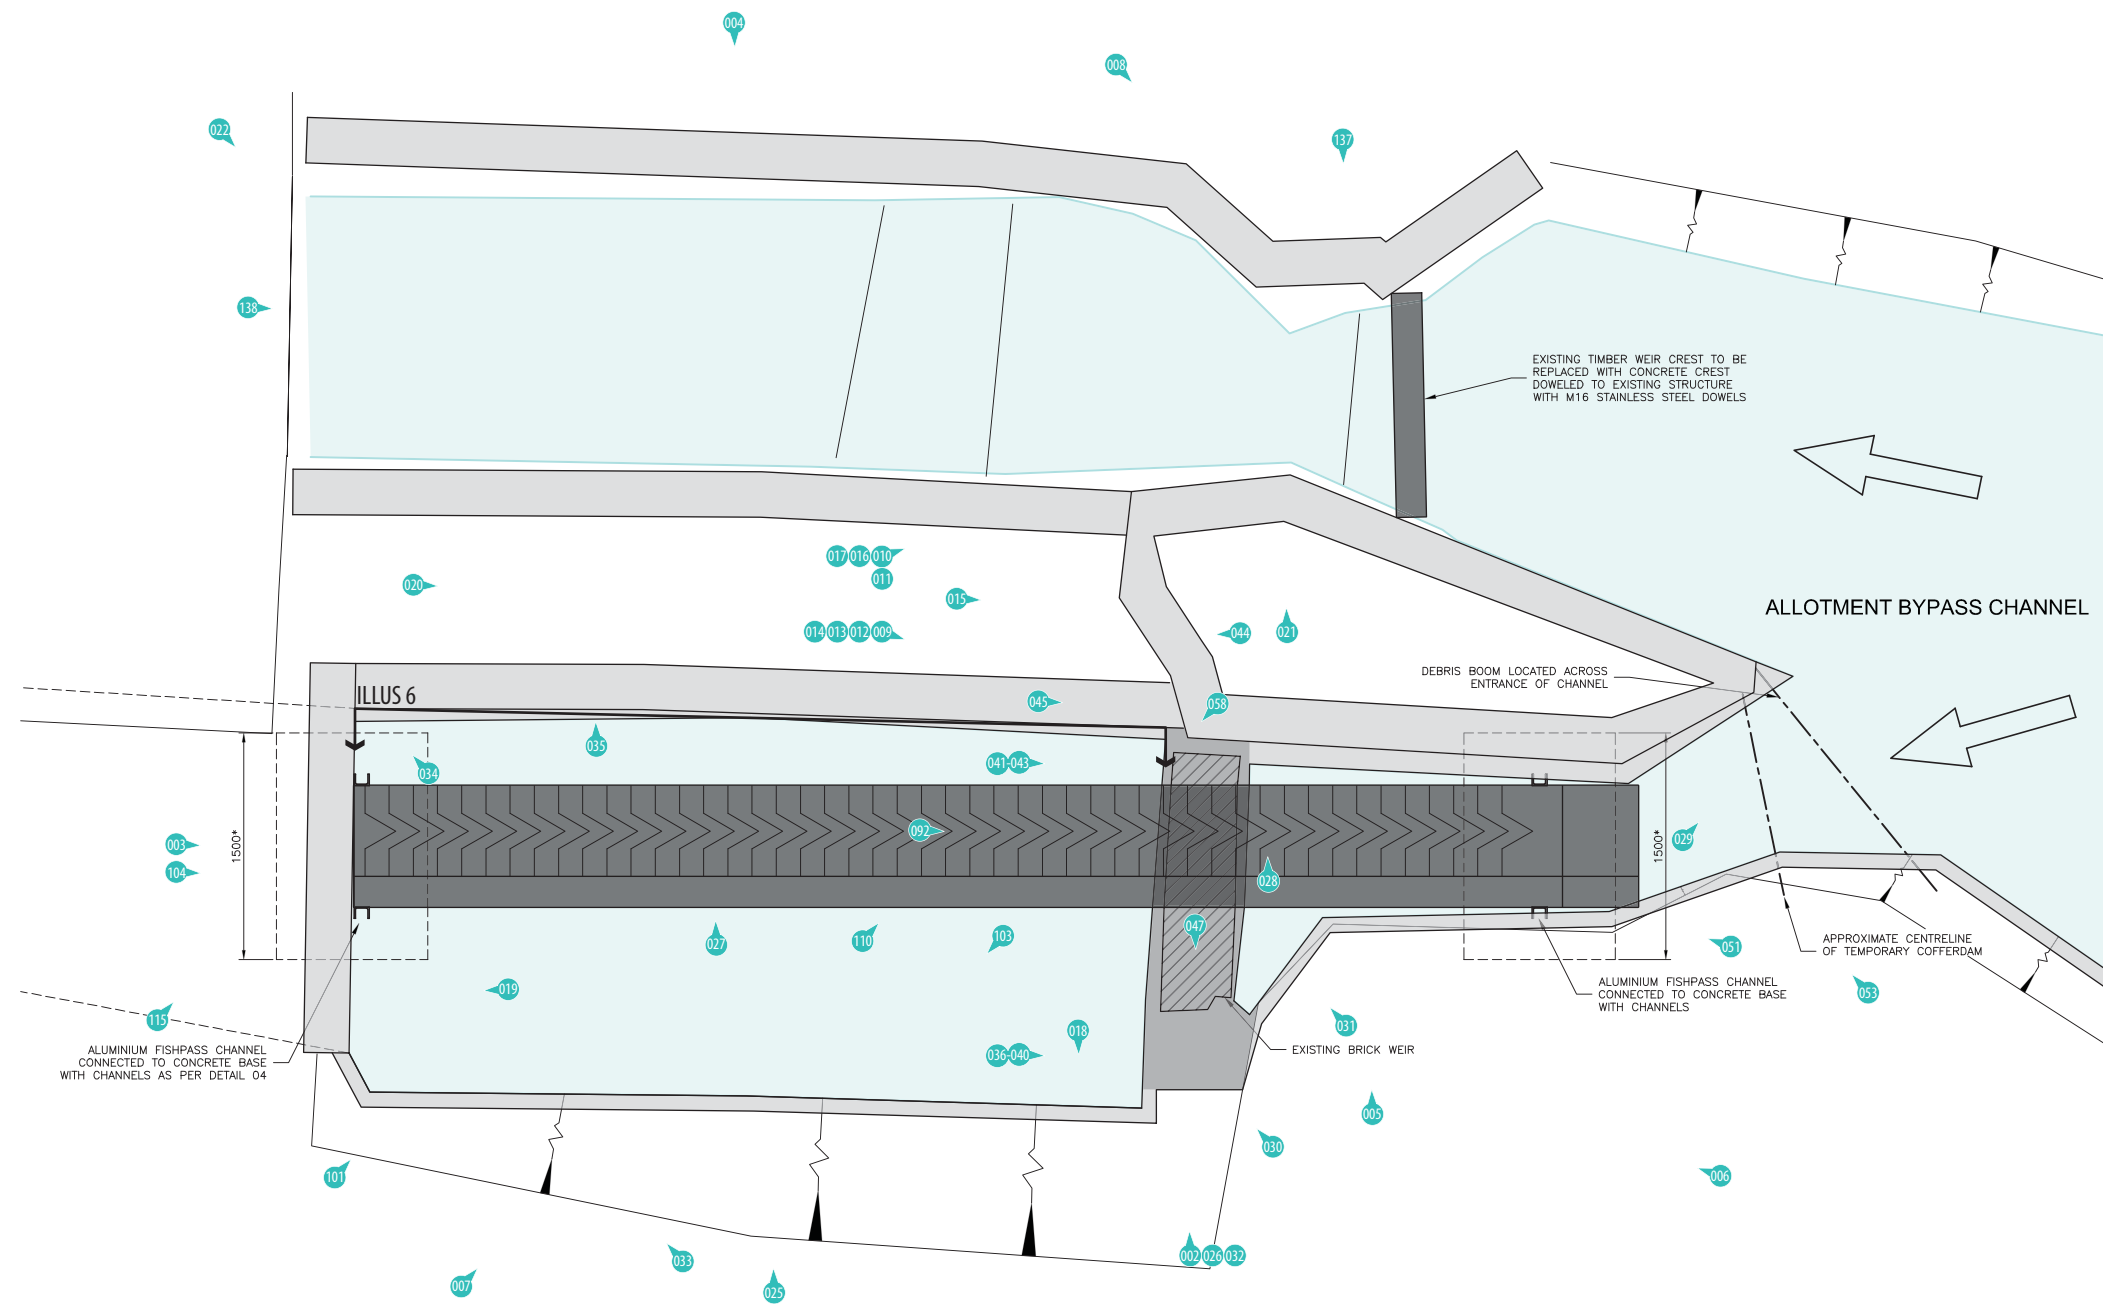
ILLUS 2
Area 1 – Allotment Weir: Plan of structure and photo locations

No upstanding masonry relating to the former mill complex exists above the current ground level at the allotment site (**Illus 4**). The double channel weir arrangement survives within the river channel itself which may explain the preservation of this feature.

The feature consists of two adjacent channels which formerly used an arrangement of sluice gates to control the volume and velocity

of water entering the southern channel which formerly contained a water wheel. Both channels are faced with square ashlar blocks. The internal structure of the Allotment Weir was not observed.

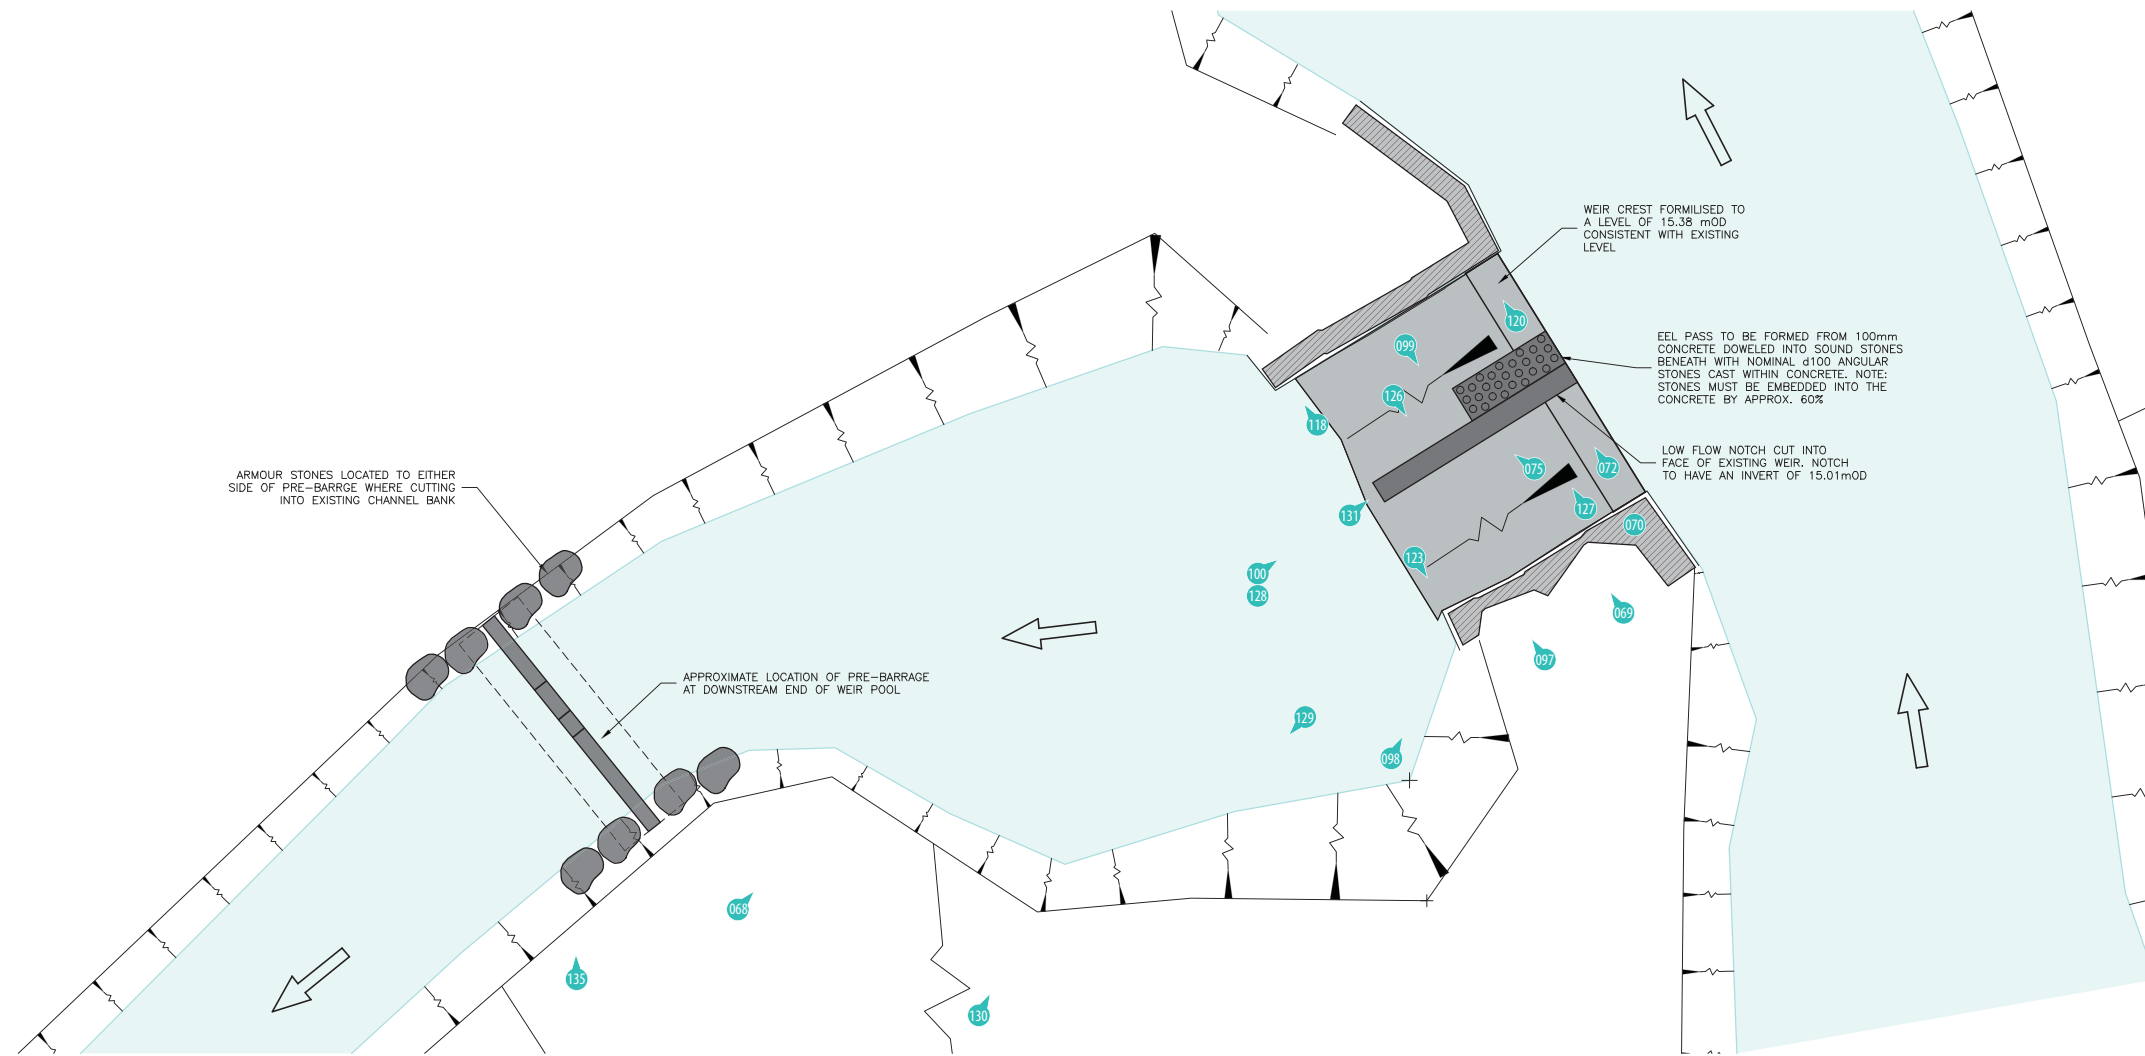
Within the structure of the bypass weir evidence of repair in the form of concrete patching and some iron strapping was observed. Although no indication of dating of the repairs was possible, it may be assumed that the repairs are relatively modern and were carried out to maintain the integrity of the weir and the run off.

The construction of the low flow notch in the bypass weir has allowed the core work and the construction methods involved in the original construction of the bypass weir to be examined. The core of the weir is formed of bonded red brick with a stone facing, it seems unusual that the weir would be formed of brick and faced in stone and the method may reflect a cost saving in the construction of the weir when compared to a weir completely built from stone, however it may be a deliberate design feature; the close bonded brick core being easier to water proof than a loose stone rubble core. The capping stones have the benefit of being more resilient to water erosion than the brick and are more aesthetically pleasing.
