GLEBE FARM, MAGNA PARK, LUTTERWORTH SOUTH

HISTORIC BUILDING RECORDING

PLANNING REF. 15/00865

October 2019

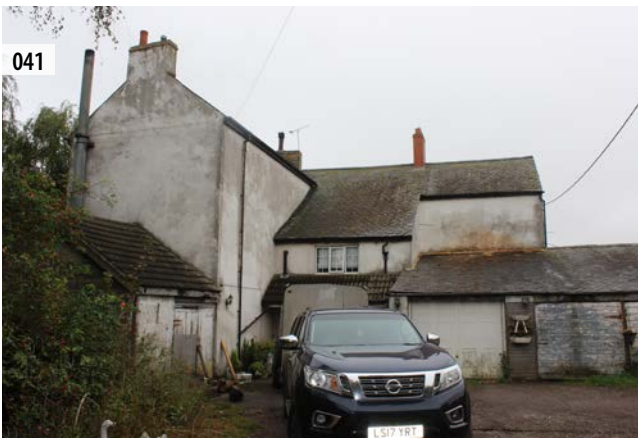
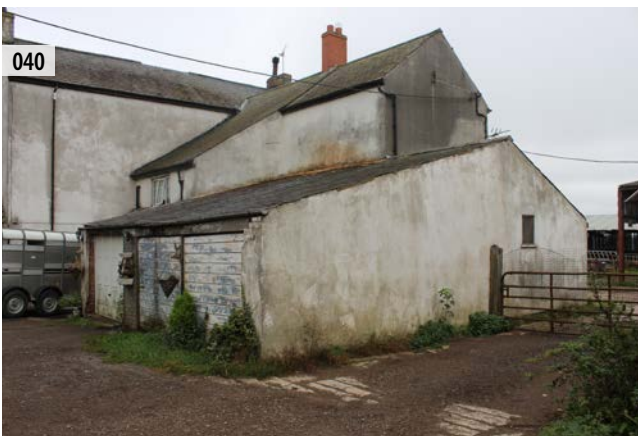
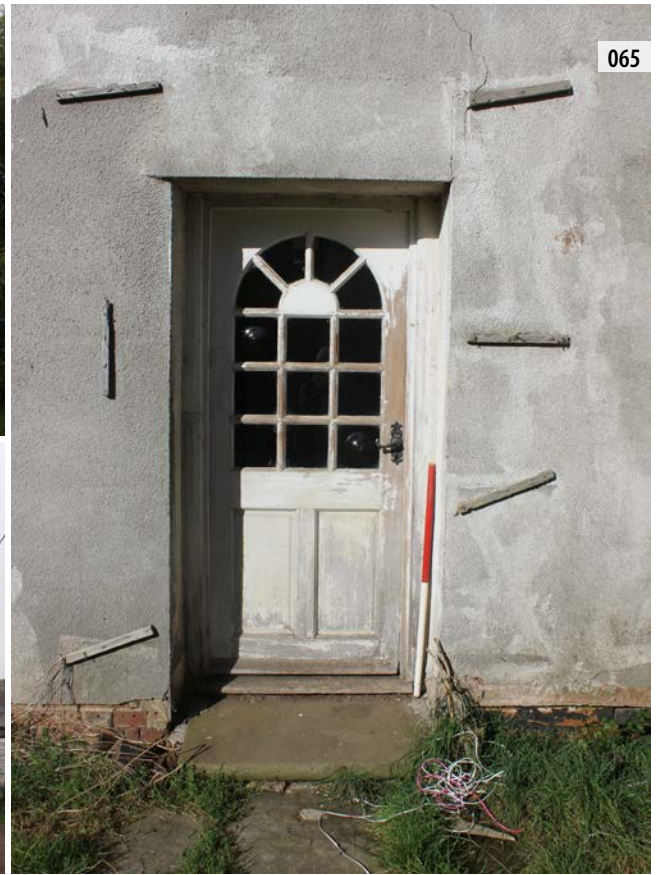
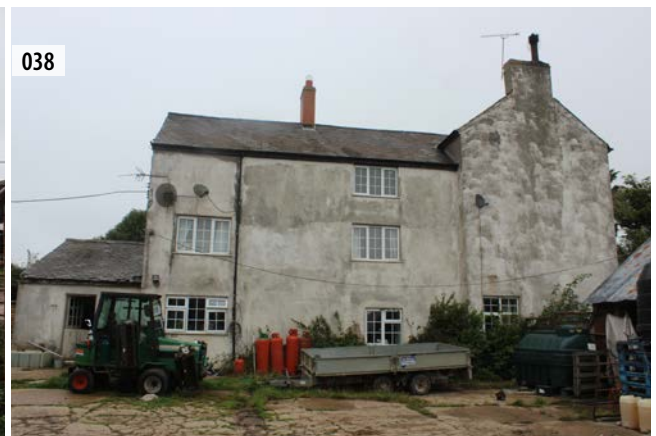
FARMHOUSE EXTERNAL PHOTOGRAPHY SP11-HBR 042 SP11-HBR 065 SP11-HBR 041 SP11-HBR 040 SP11-HBR 038

All elevations of the building were cement rendered and painted a light grey colour. Damage to the render on the east elevation confirmed the render lay over red-brick but no visual inspection of the brick and bonding was possible.

The principal elevation is the east elevation (Photo 042). The front of the building is cement rendered over red brick, visible in damaged areas of the render and painted a light grey colour. A single doorway is located at ground-floor level central to the façade, with eight, multi-light UPVC double glazed windows, two at ground floor level and three on the 1st and 2nd floors. Each window has south and north side casements. The door is of timber construction, with an upper glass, multi-light gothic style central arch. A series of small timber strips are affixed to the frontage surrounding the door indicating the possible presence of a former porch or decorative structure such as trellis fixings (Photo 065). Plastic guttering runs along the eaves over back painted timber fascia boards.

The gable end of the north-south block lies at the east end of the elevation, with the three storey east-west block central and a single storey extension on the west end (Photo 038). A single, multi-light UPVC double glazed casement window is located at ground floor level on the gable end of the north-south block. Two variably sized, multi-light, casement, UPVC double-glazed windows are located at ground floor level centrally. Two further at first floor level and a single at second floor level on the eastern side of the east-west block. The west extension has a central timber Dutch Door, the upper panel comprising multiple lights within a timber frame.

The entire facade is cement rendered and painted light grey. Black plastic guttering is located at the eaves over black painted timber fascia boards. An iron down-pipe is located towards the west end with a modern electric security light at ground floor level and satellite dish and television aerial at 2nd floor level.

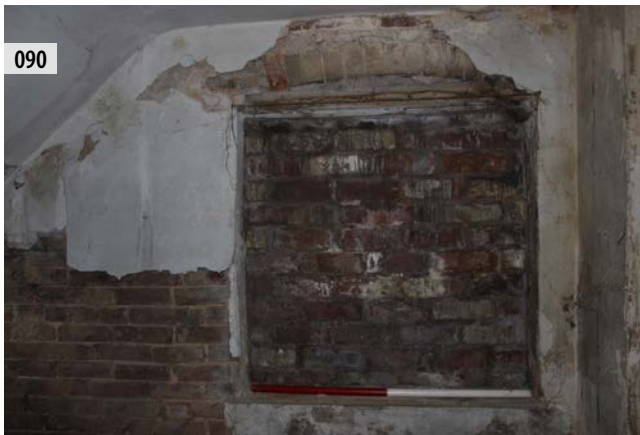
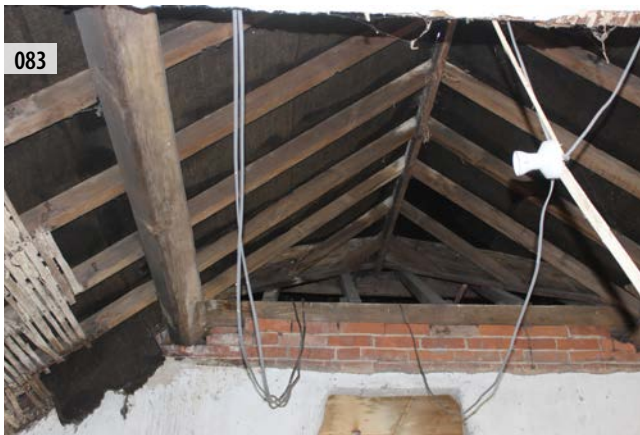
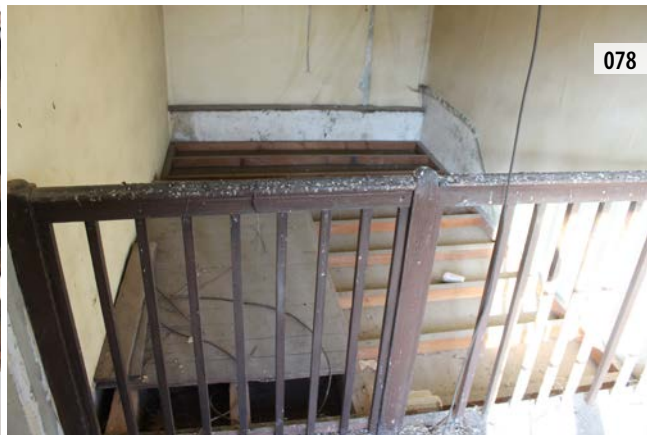
FARMHOUSE 2ND FLOOR SPLL-HBR 090 SPLL-HBR 089 SPLL-HBR 083 SPLL-HBR 078

An open doorway leads to room FH14, also broadly square in plan, with white painted brick walls rising to lath and plaster eaves and ceiling (Photo 089). The lath and plaster was in poor condition having collapsed in several areas exposing the timber roof construction, which appeared to be built on to and over the north-south block

of the building (Photo 083). Areas of exposed brickwork indicated a Flemish Garden Wall bond in red brick. A multilight UPVC window was located in the south wall, with a brick constructed chimney breast on the west wall. Two steps in the east wall lead up to Room FH15 through an open doorway.

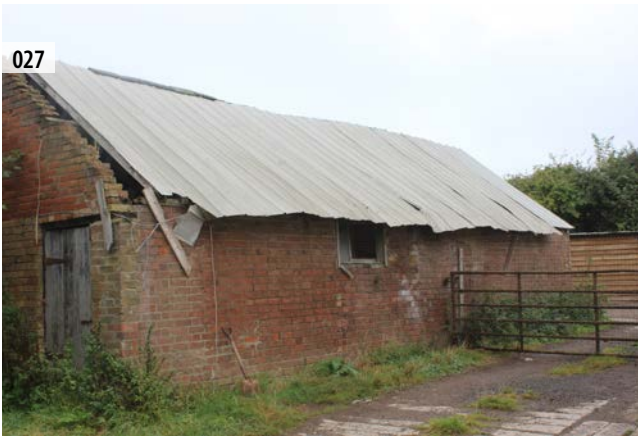
BUILDING 1 EXTERNAL SPLL-HBR 025 SPLL-HBR 029 SPLL-HBR 027 SPLL-HBR 028

The north elevation formed the principal elevation and was a partially open gable end (Photo 029). The upper half of the elevation was of 16 courses of red-bricks in a Flemish Garden Wall bond. A timber lintel lay over a square opening located centrally above an east-west timber beam. A vertical timber support and lintel was located centrally below the beam. Two brick pilasters lay at each end of the elevation, the eastern pilaster having bull-nose bricks on its corners. A pitched roof, with metal sheet cladding affixed to purlins was evidenced, with a gap apparently caused by damage to the brickwork directly below the apex of the roof.

The south facing elevation represented a gable end and was constructed in yellow and red bricks (Photo 028). Yellow bricks, in Flemish Garden Wall bond formed the lower half of the wall, extending up to eaves level below a pitched roof. Red brick, in a random bond, extended from the eaves to the roof apex. A timber, out-swinging door was located at the east end of the elevation, with a timber lintel.

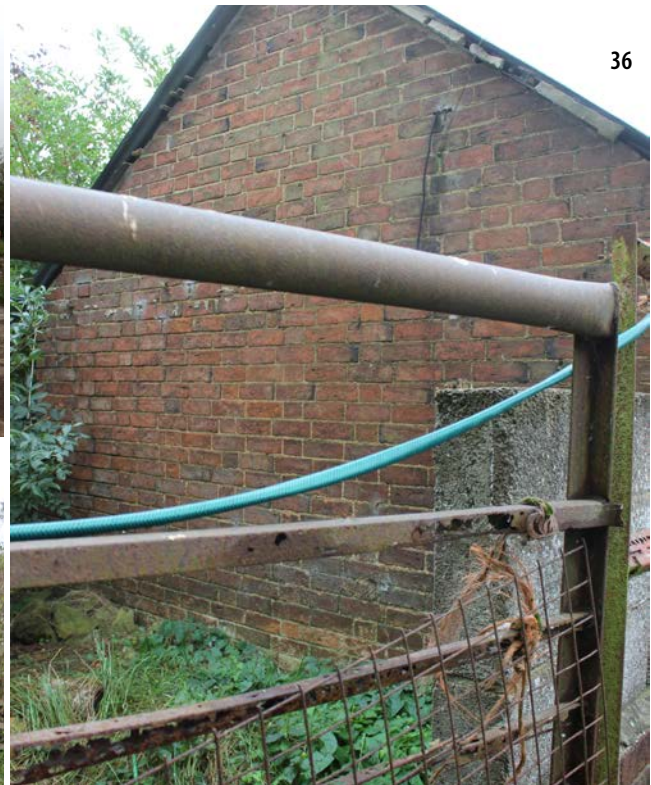
BUILDING 2 EXTERNAL SP LL-HBR 026 SP LL-HBR 030 SP LL-HBR 027 SP LL-HBR 036

The west facing elevation formed the principal elevation of the building (Photo 026) and was constructed in red brick in a Flemish Garden Wall bond. The façade had been broken through in three areas, north, south and centrally, with damaged brickwork visible and a window frame overhanging in the central void. Partial timber architraving of former doorways was visible in both the north and central voids. Five timber window frames were located in the southern half of the elevation, immediately below the roof eaves. No fascias were present with corrugated metal sheeting forming the roof covering.

The south facing elevation was partially obscured by vegetation growth. The elevation was open with damaged brickwork and later timber supports visible on the east and west walls indicating probable demolition of the walls at this point (Photo 030).

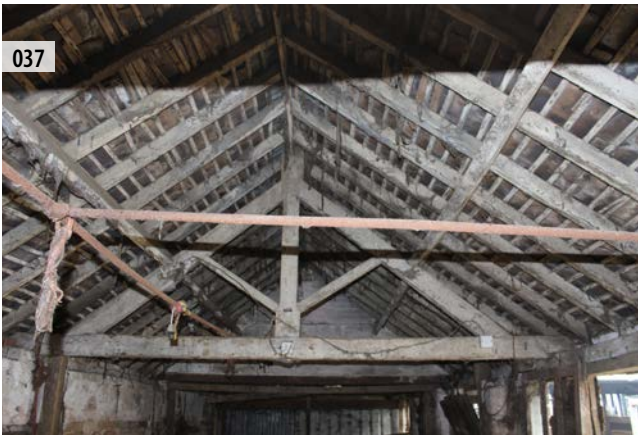
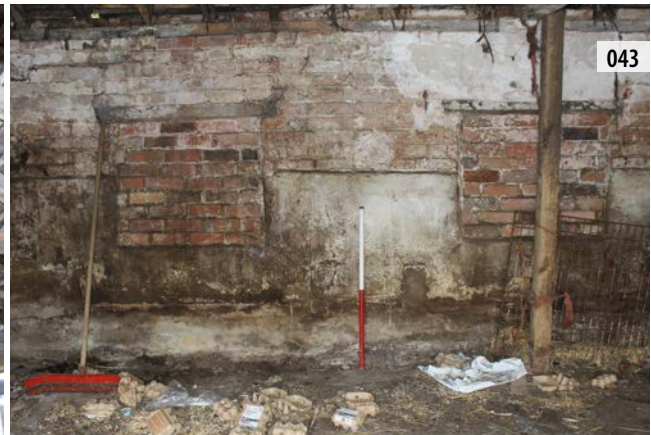
BUILDING 2 INTERNAL SPLL-HBR 037 SPLL-HBR 043

The interior of building 2 was subdivided into three main cells. The northern cell, 2.1, a small rectangular space measuring 3.5 x 2.5m was sub-divided through the construction of a breeze block southern wall. The wall abutted the east interior with a narrow gap to the western wall. The walls comprised whitewashed plaster over brickwork with a plasterboard ceiling, also whitewashed. A window opening was located at eaves level in the east wall and was block from the outside with plyboard. The floor was a cement render.

The southern cell, room 2.3, was sub-divided from the rest of the building by corrugated metal sheeting fixed to a rough timber frame and the timbers forming the roof frame. The walls were partially plaster at ground level over brickwork and whitewashed. A single brick blocking was present on the east wall with a single timber framed window opening on the west wall and two brick columns or pilasters on the west wall. A layer of mud and slurry covered the floor area. A further corrugated sheet frame formed the southern end of the cell, beyond which the building was damaged or demolished and in a state of disrepair.
