BEORMA QUARTER, DIGBETH, BIRMINGHAM

HISTORIC BUILDING RECORDING REPORT

commissioned by Armac

October 2019

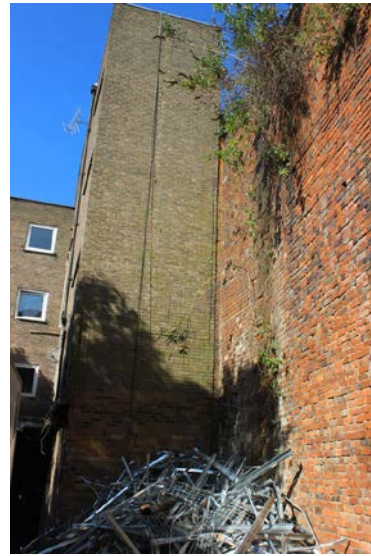
BQDB17-HBR-004.JPG

Effectively forming a rear to the building. Red brick construction, 22.9 x 8 x 11.5cm, with two bonds evident. Northern end constructed in English Garden Wall bond, with the southern end in English Bond. A probable rebuild, at the point where the differentiation in bond was evident, was suggested by a double skin of bricks, cement mortared with rough pointing, overlying English bond brickwork. Variable pointing to the south also indicated a separate phase of build, with the scar of a former downpipe indicating the probable extent of a former build. Very rough or absent pointing was observed below the scar of a former flat roof along the northern half of the elevation, the area suggesting the extent of a former abutting building. Iron fittings, indicating the presence of a former ladder fire escape were observed toward the base of the south of the elevation, with the stairwell of the modern flats built over and appearing to be keyed into the southern extent (Photo 004).

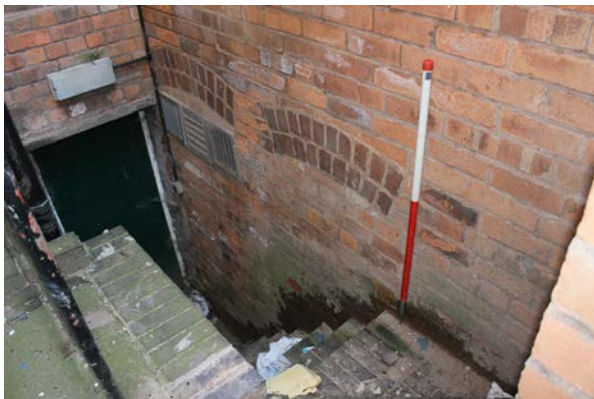
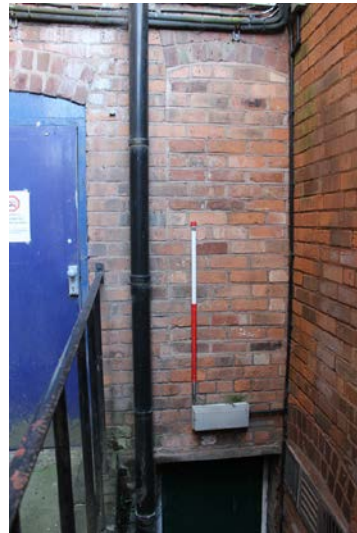
BQDB17-HBR-346.JPG

constructed at ground floor level, with a penthouse office constructed in stretcher bond red brick on a former flat roof. An iron stairway leads from ground to roof level with doorways at each floor and an opening in a parapet wall at roof level. A timber sash window was noted on the second floor, with an oriel bay window at first floor level. A narrow alley leads down the eastern side of the ground floor extension, where a brick staircase provides access down to the present basement fire escape door. Three blockings were observed in this area, two in the below ground brickwork, potentially former lights or hatches, and one former doorway at ground floor level (Photos 346/347).

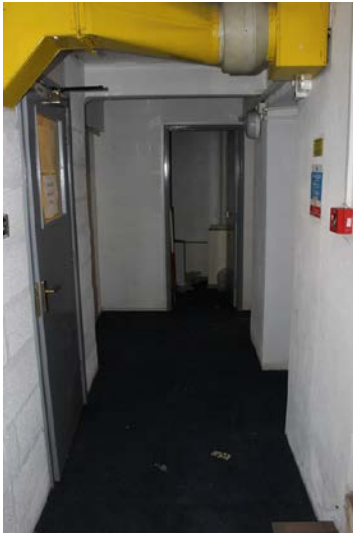
BQDB17-HBR-311.JPG

The cellar has been extensively remodelled and subdivided into two main spaces with an ancillary corridor (Photo 311), off which lie male/female toilets and a kitchenette. Access is via a staircase from the central ground floor area. The front room (Room 1) (Photos 305) is broadly rectangular with painted breeze block internal walls and a stud-partition wall with fixed lights and doorway to the rear room. A small utility room is situated in the south-west corner and is constructed of a combination of brick and breeze block. No evidence of the original cellar frontage was observed or accessible. The rear room is broadly square in shape, with painted breeze block walls and a stepped platform leading to access to the rear corridor.
