**FARM BUILDINGS AT COLVILLE HALL  
CHELMSFORD ROAD  
WHITE RODING  
ESSEX**

**HISTORIC BUILDING RECORD**

January 2013

**FAU Project No.:** 2632

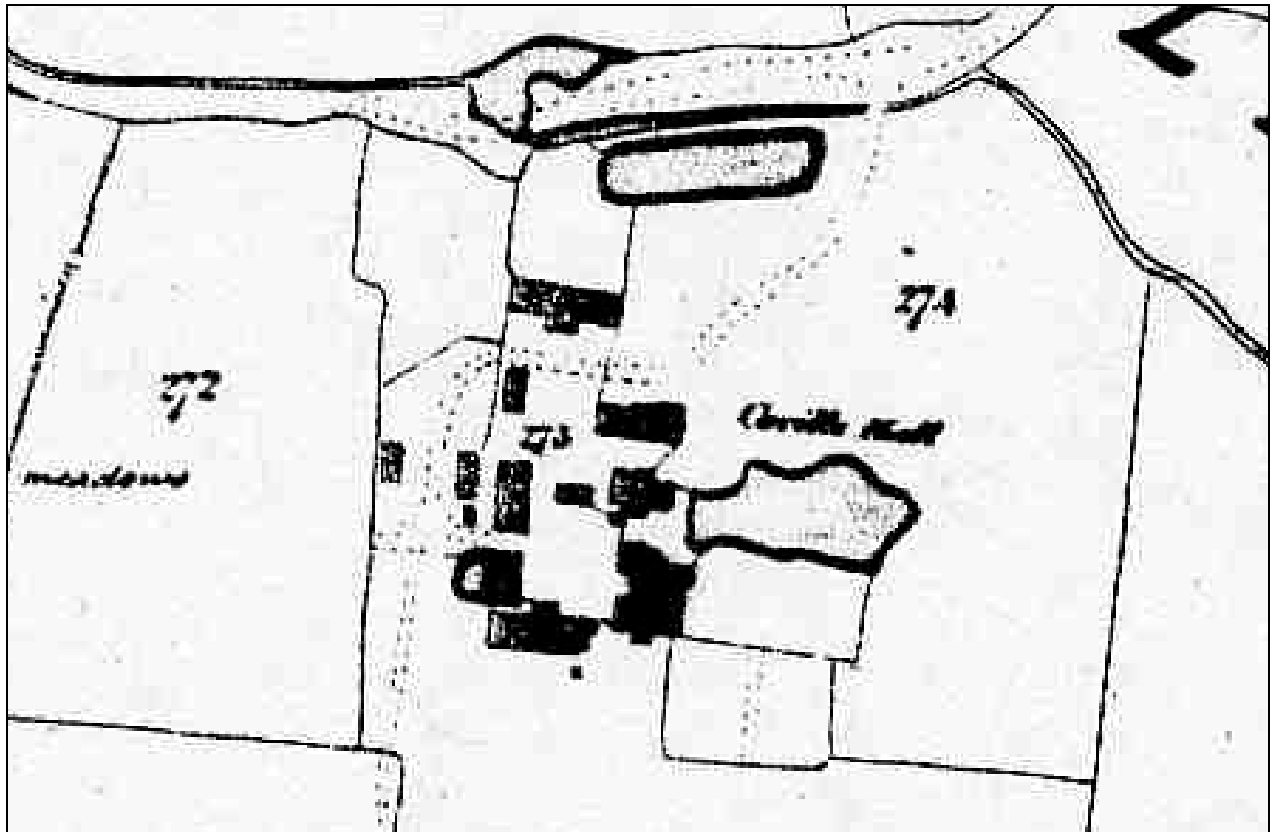
Fig. 2 White Roding tithe map, 1840 (D/CT 299B)

White Roding tithe map (1840) depicts the hall and farm very much as it appears today, with the farm buildings broadly set around two yards and the hall to the south-east. The main exception is that it shows cart lodge 2 in its original three-bay form (fig. 2). The accompanying tithe award mentions a largely arable farm with a holding of at least 220 acres and occupied by Robert Judd (D/CT 299A).

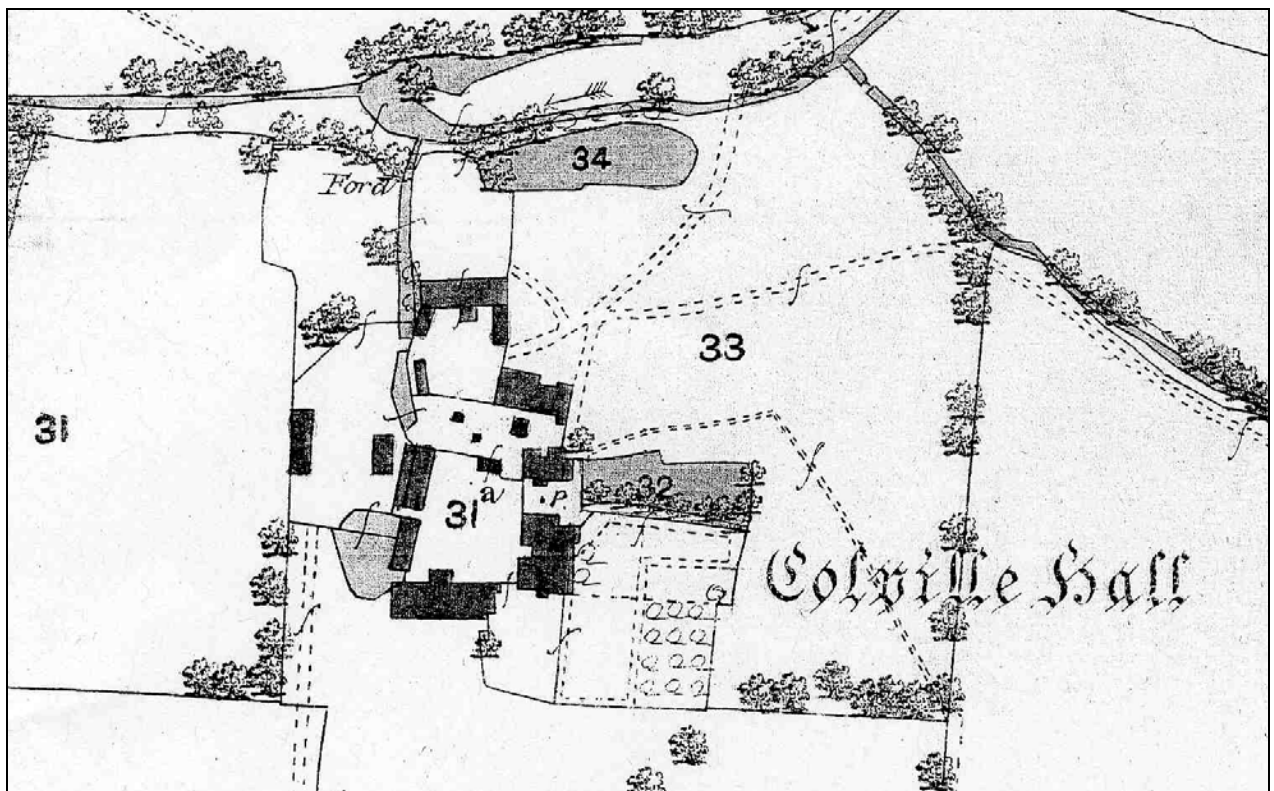
Fig. 3 First edition OS map, 1874 (sheet 42/2)

Sometime in the mid to late 19th century, between 1840 and 1874, the hipped southern bay and north extension were added to the cart lodge, which are first depicted on the first edition Ordnance Survey map of 1874 (fig. 3). The map provides a good representation of the site,

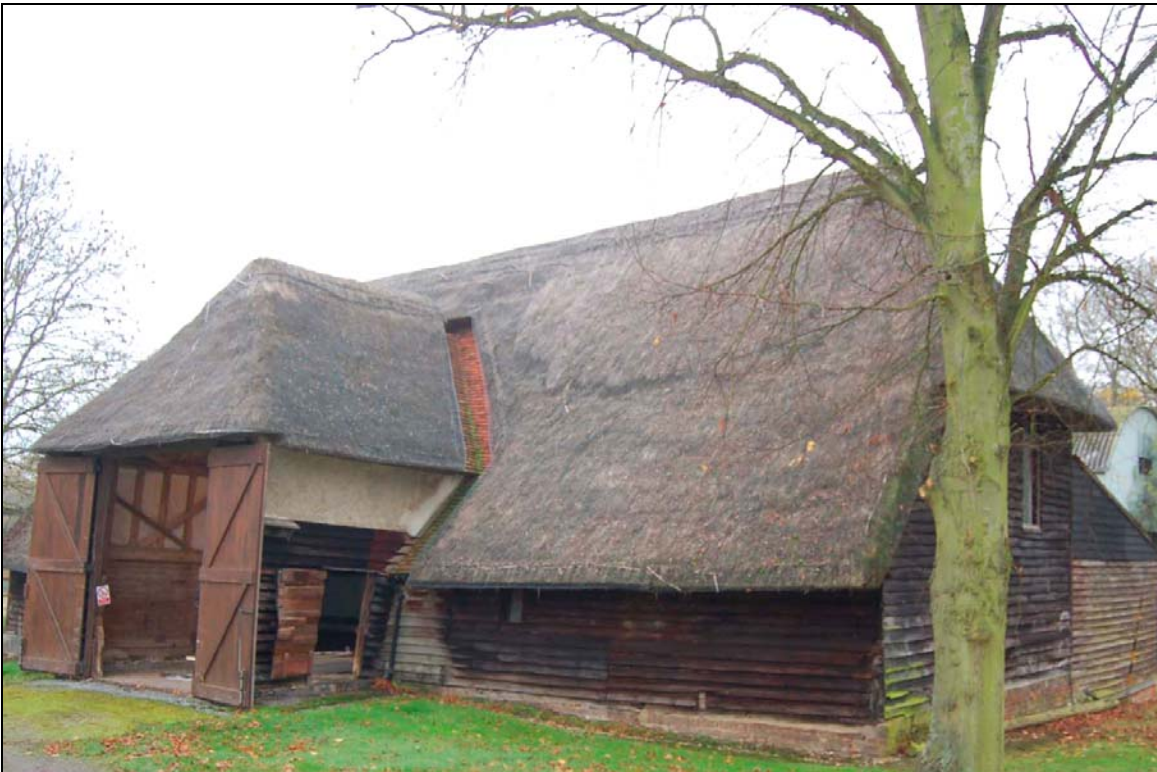
Plate 2 Barn viewed to north-west

The east elevation is fully-boarded and has an inserted leaded window below the eaves, likely to have been added in the 1996 refurbishment (plates 2 & 3).

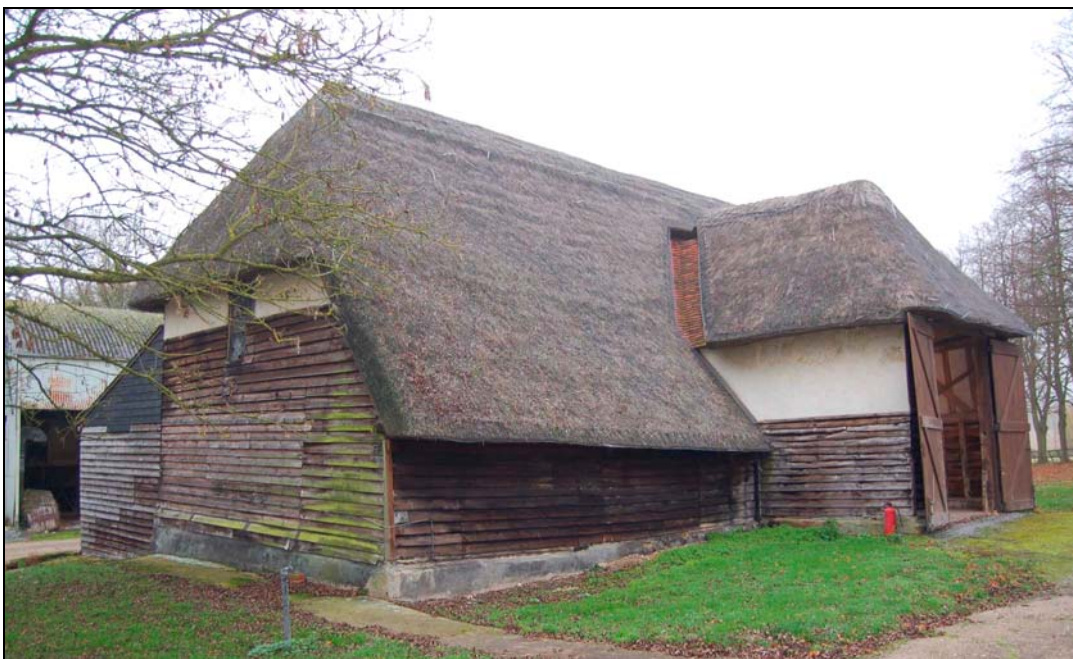
Plate 6 Barn viewed to north-east

The west elevation is fully-boarded with a small cement render panel above it, mimicking former lime render, an inserted leaded window below the eaves and a rendered brick plinth (plate 6).
