BAMBURGH RESEARCH PROJECT

FENWICK STEAD, BELFORD NORTHUMBERLAND

HISTORIC BUILDING RECORDING REPORT

BRP 14/06b

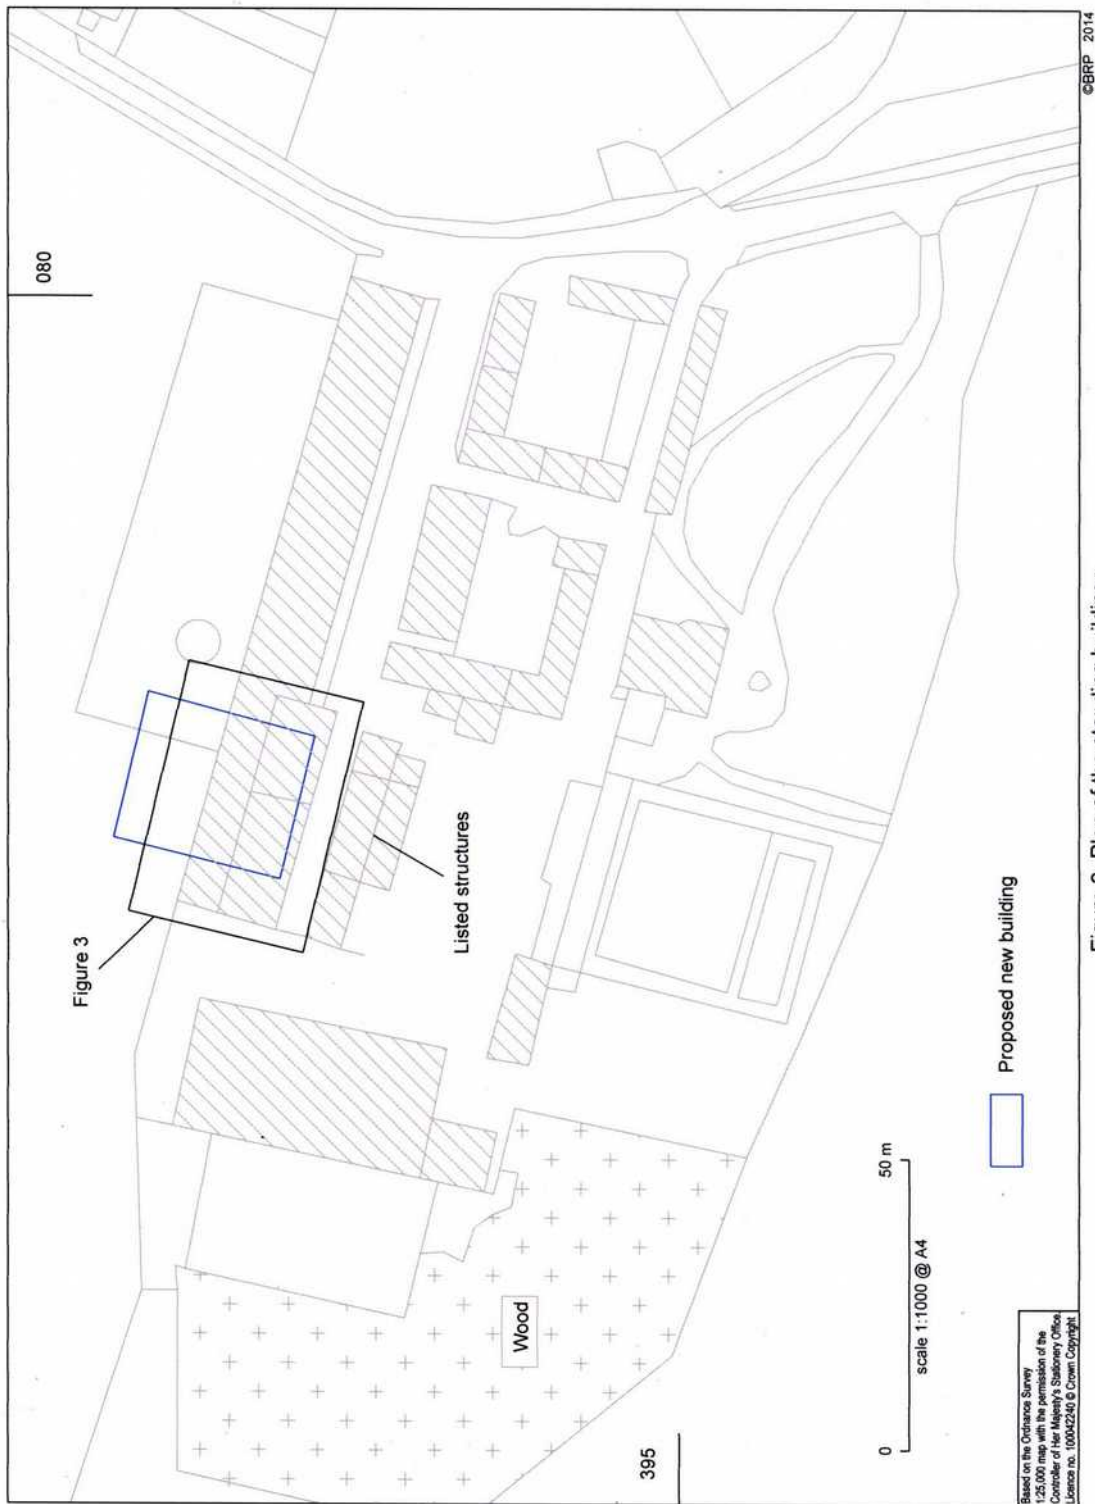
Figure 2 Plan of the standing buildings

4.0.1 The standing building assessment was undertaken by Constance Durgeat and Claire Leever on the 18th July 2014. The buildings formed a basically rectangular range of structures that include three courtyard areas and two buildings. The rooms and courtyard areas were recorded in detail and have been delineated by letter codes from A to E on Figure 3 in order to allow for easy reference within the text. The building range subject to detailed survey comprised single storey structures, built primarily of stone but with some brick additions and repairs. The roof survived on only one of the buildings (Room A), and comprised a simple pitched slate roof. The structures are currently in a state of general collapse and much rubble has accumulated within them.
