An Archaeological Building Recording at Bay Tree Farmhouse, Rodsley, Derbyshire

ARS Ltd Report 2010/11
February 2010
Oasis I.D. archaeol5 – 72283

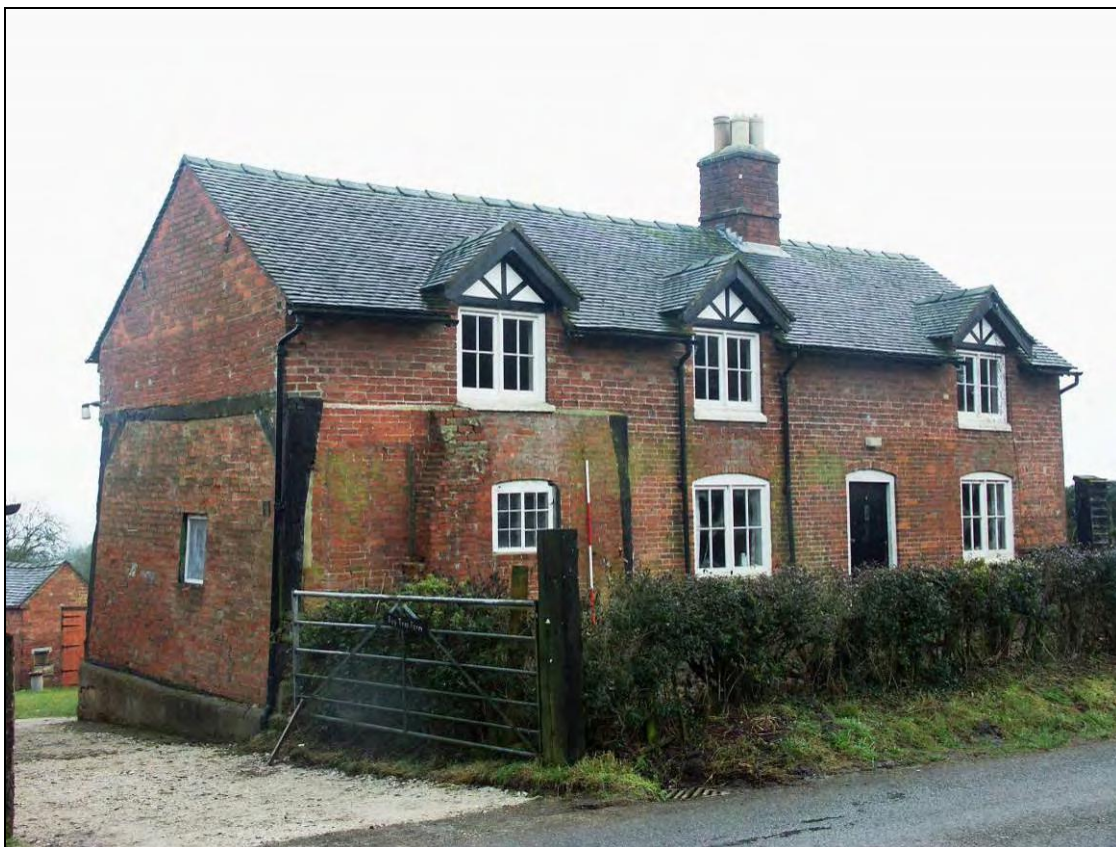
Figure 3: West elevation (scale 2m)

- 4.5 This is the main elevation along Rodsley Lane which consists of three bays with one window on each, a doorway on the ground floor and three plain bargeboard dormer windows below the eaves line on the floor above with timber-framed gables and projecting verges (Fig. 3). The northern bay corresponds to an earlier timber-framed

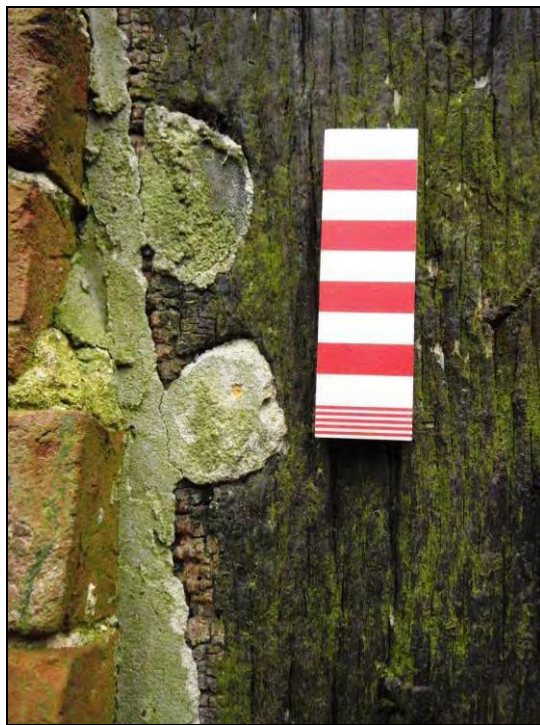
Figure 5: Detail of removed pegs (scale 100mm)

structure (Fig. 4). This bay has two *in-situ* timber posts with flared jowls. The posts are in good state of preservation although the southern post has moderate wet rot damage at the bottom and the top has been slightly truncated. The posts have matching peg holes for the attachment of former braces and a central rail which would have been integral to the timber-framed structure (Fig. 5). This confirms that the current brick infill is a later addition which replaced the original frame. The construction of the brick infill or nogging is very irregular although it seems to be mainly built with orange hand-made bricks (9" x 4" x 2½") bonded with flush, white, medium-coarse lime mortar (up to 10mm thick) and laid mostly to Flemish Garden bond. The base of the northern end of the building has been re-built with concrete which is supporting the timber post. This post has been slightly disfigured with the insertion of three slots carved within it which are supporting the present garden fence (Fig. 6).

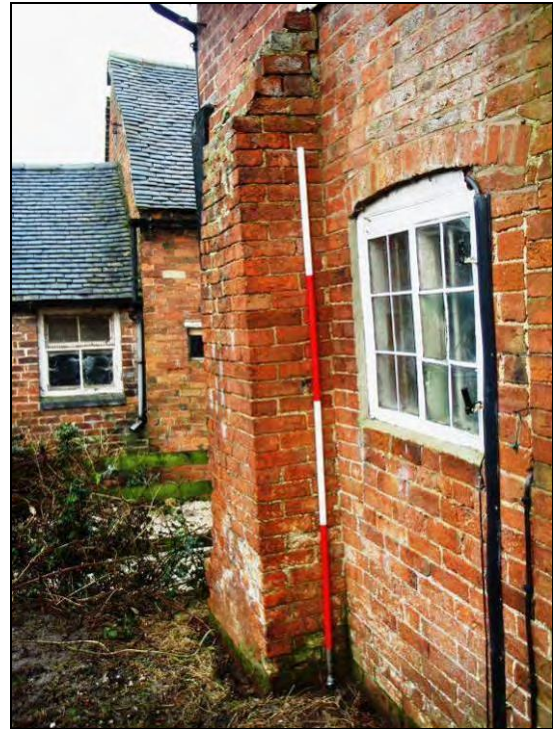
Figure 8: Detail of the chimney and inserted window (scale 2m)

- 4.7 There is a small timber casement window with twelve lights which is inserted within a former blocked-up window opening with segmental arched head (Fig. 8). The blocked-up window opening is similar to the existing ones in the central and southern end of the elevation which may suggest that the nogged brick wall, within the timber-framed structure, is contemporary with the main southern extension.

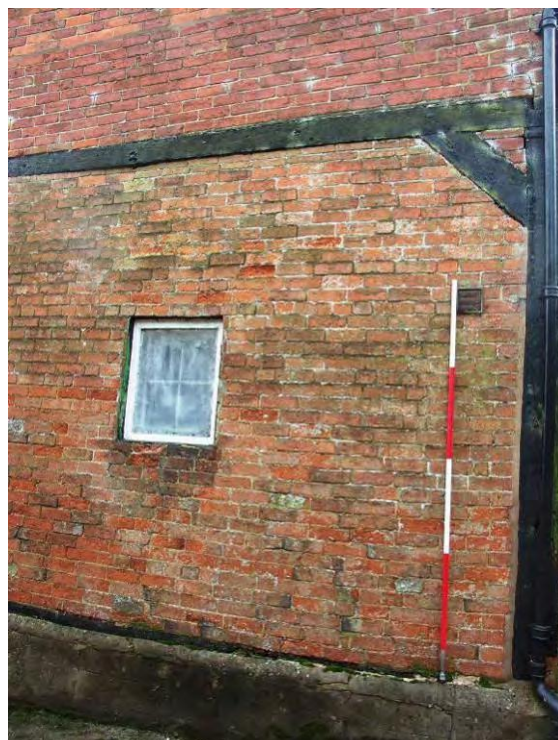
Figure 22: Detail of timber post, brace and wall plate

- 4.16 The north elevation is also fairly plain however; it has further *in situ* elements of the original timber-framed house. These consist of the principal posts tenoned in a wall sill, which is highly rotten, and supporting a wall plate reinforced with two straight up braces and two small iron braces (Figs 21 – 23). Both posts have empty peg's holes for a former rail. The wall plate and braces also have peg holes for studs which had been removed and replaced by the current nogged brickwork which is consistent with the side walls of the northern bay. There is a small fixed window within the nogged brick wall.

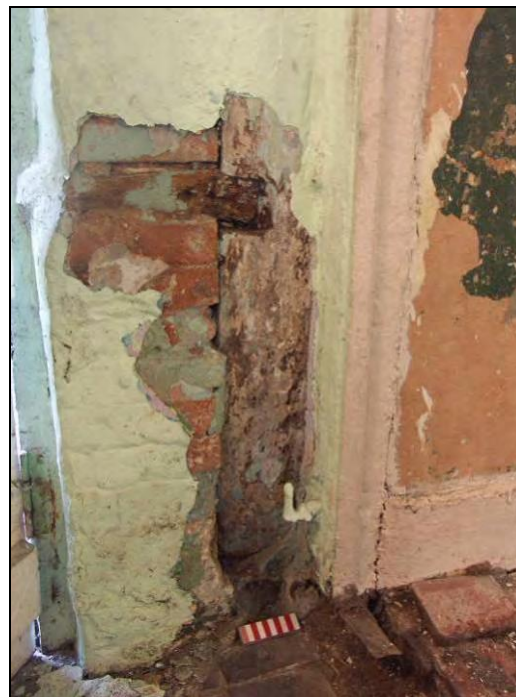
Figure 28: Inclined S-E post in room G-2

- 4.22 The southern wall has surviving elements of the original timber-framed house consisting of the wall rail and studs which are covered with paint (Fig. 26). The sill is missing and has been replaced with bricks. There is a doorway which leads to room G-3 on the southern wall and another doorway in the partition to room G-2.
- 4.23 Removed peg holes filled with cement can be seen on top of the south-east principal post (Fig. 27). The peg holes might have been the joint of a brace which had been removed. The post is in good condition however it is inclined due to earlier structural movements (Fig. 28).

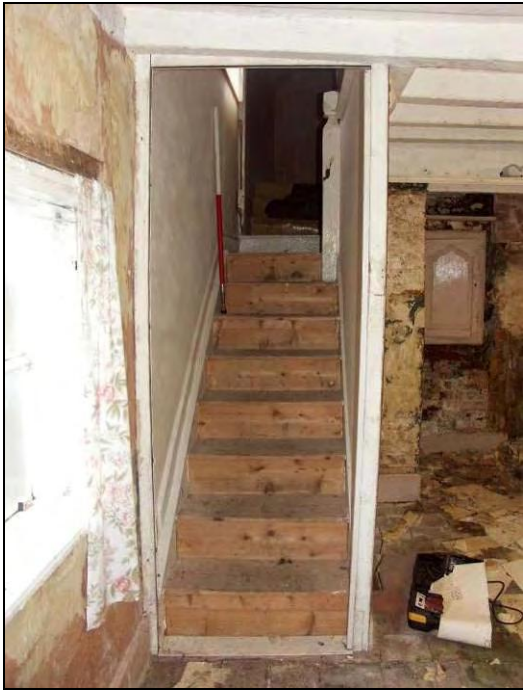
Figure 41: Staircase to the upper floor (scale 1m)

- 4.31 The staircase is a later repair built with soft-wood treads and raisers with a plywood panel on the side (Fig. 41).
- 4.32 The floor level has been raised c. 150mm and is made of red quarry tiles laid with cement over a make-up layer of sand (c. 100-200mm thick). This might have been carried out at a later stage in order to gain greater insulation as the brick walls lack damp proof courses or membrane. Indeed, the original tiles in rooms G-1 and G-2 are laid with mortar but the raised tiles are laid with cement over sand and thus suggest a later date. Moreover, the raised floor has cement skirting throughout the room which is not contemporary with the main construction of the house.

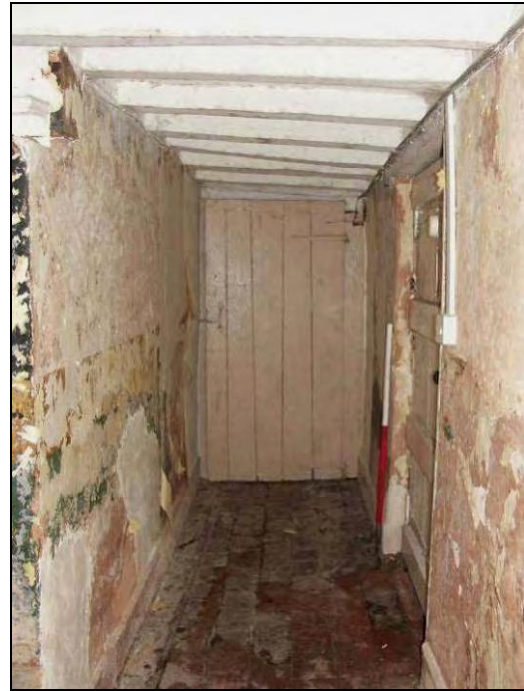
Figure 42: Western passageway (scale 1m)

- 4.33 There are two internal doorways to rooms G-1 and G-4. The former is positioned within the north wall and have no door and the latter is situated at the end of the passageway which has a ledged timber door with iron strap hinges (Fig. 42). The basal section of this door has been sawn off reducing its original size which might have been undertaken in order to accommodate the altered level of the current floor. The passageway is built with bricks but has a timber post and mid rail (1.15 metres high). It is possible that the passageway might have extended north towards room G-2, creating a lobby with a doorway for this room as a kitchen division; and leading to room G-2 through the blocked-up doorway.

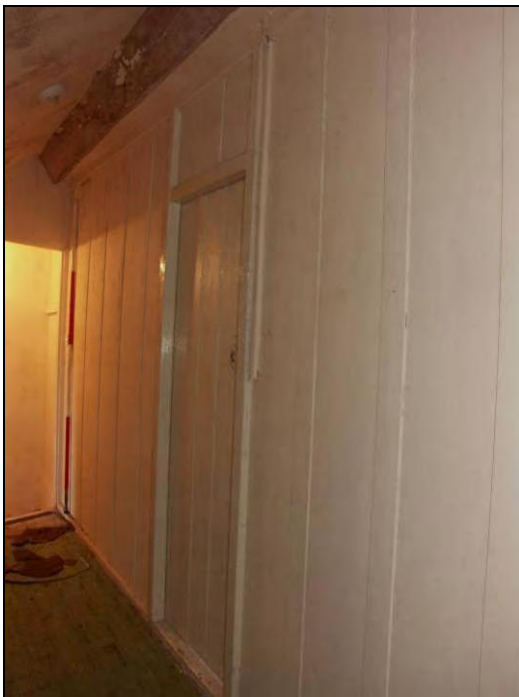
- 4.38 The passageway measures 4.60 metres in length (north/south), 1.40 metres in width (east/west) and its maximum height is 2.40 metres. It has soft-wood panelling on the western side which consists of flush rails and panels (Fig. 50). There is another panel along the staircase which is made of plywood and fixed with silicone. There are two doorways in the passageway. One situated in the panelling for room F-2 and another at the northern end which enables access to room F-1 (Fig. 51). The ceiling is made of lath-and-plaster and the floor consists of lime ash cemented screed which appears to be a later replacement of timber boards.

Figure 50: Panelling along the passageway (scale 2m)

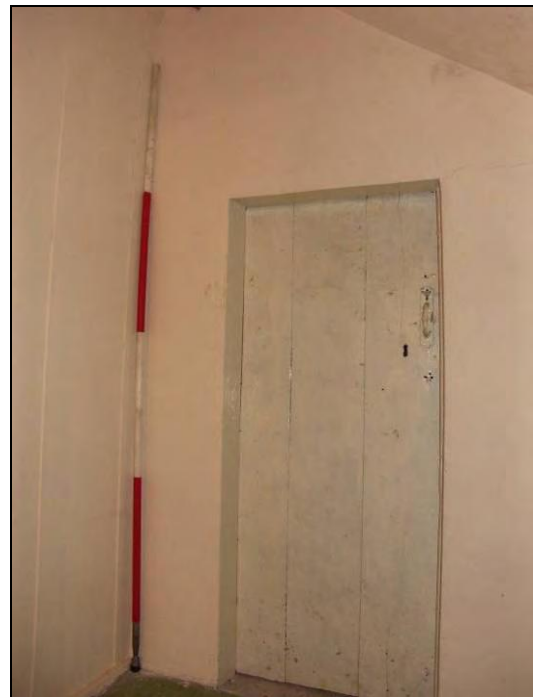
Figure 51: Doorway to room F-1 (scale 2m)

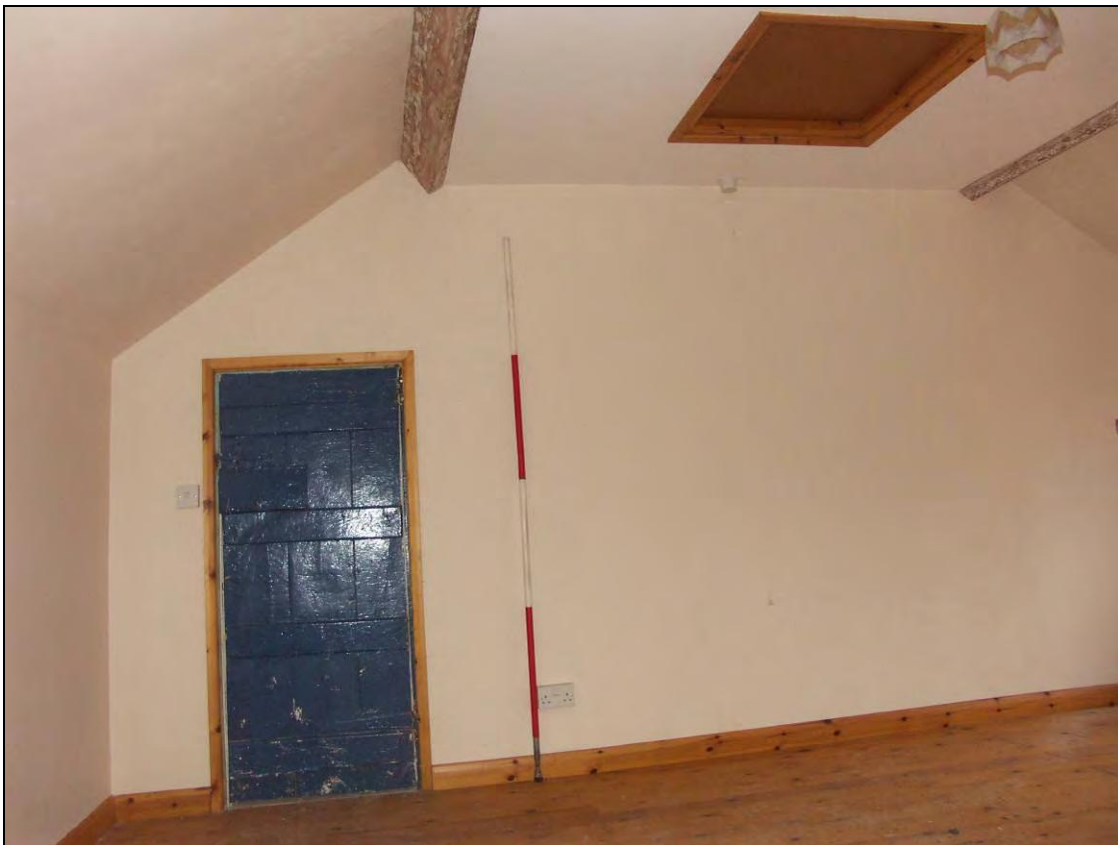
- 4.39 Room F-1 is located in the northern end of the Farmhouse and is a bedroom. It measures 5.20 metres in length (east/west), 4.10 metres in width (north/south) and is 2.36 metres in height. This room is accessed from the passageway through a ledged timber door with iron strap hinges on the south wall (Fig. 52). The entire room has been recently renovated with plaster boards and tongue-and-groove wooden floor (Fig. 53). The ceiling has exposed rafters and angled sides. There is a hatch which allowed inspection of the roof structure which consists of common rafters joint with a ridge board and supported by two tiers of side purlins joint with a collar (Fig. 54). The entire roof structure, including the battens supported by the common rafters, appears to be a later re-build.

Figure 52: Room F-1 with ceiling hatch, looking south (scale 2m)

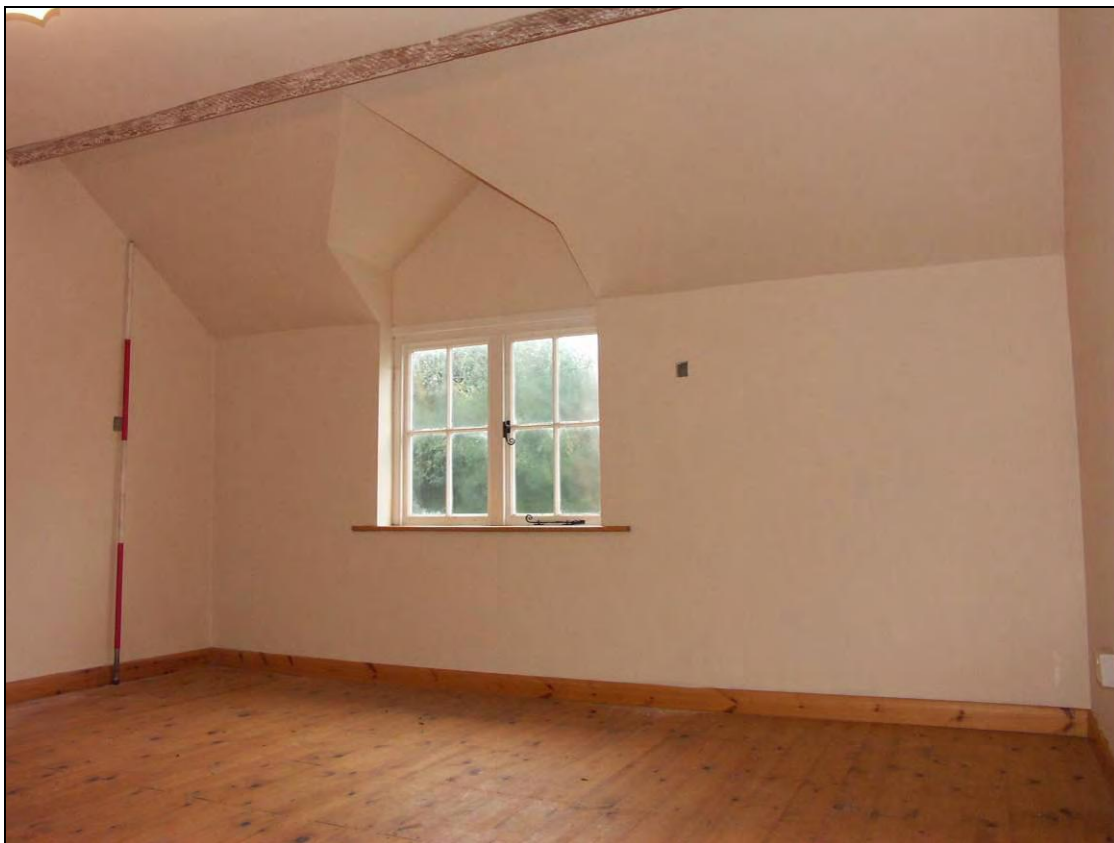
Figure 53: General view of room F-1 with new plaster board walls and floor boards (scale 2m)

- 5.22 The present roof appears to be a replacement of the original structure which might have taken place around the same time. More recent alterations are the current windows which are clearly modern replacement and the addition of plaster boards and floor boards in room F-1.

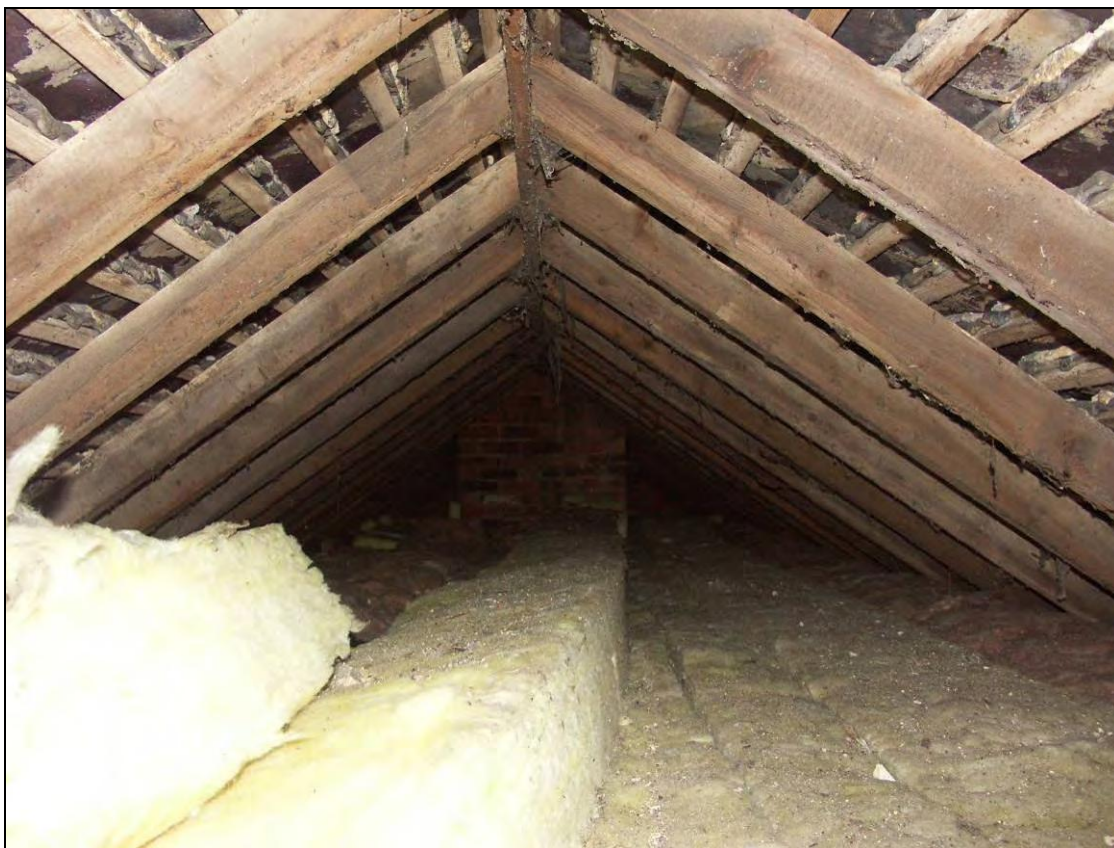
- 4.40 The northern end of the side purlins have been recently repaired with bolted steel plates under the timber. The room is lit by a timber casement window with rat-tail stay and fastener situated under the dormer.

Figure 54: Inside the roof structure, looking south

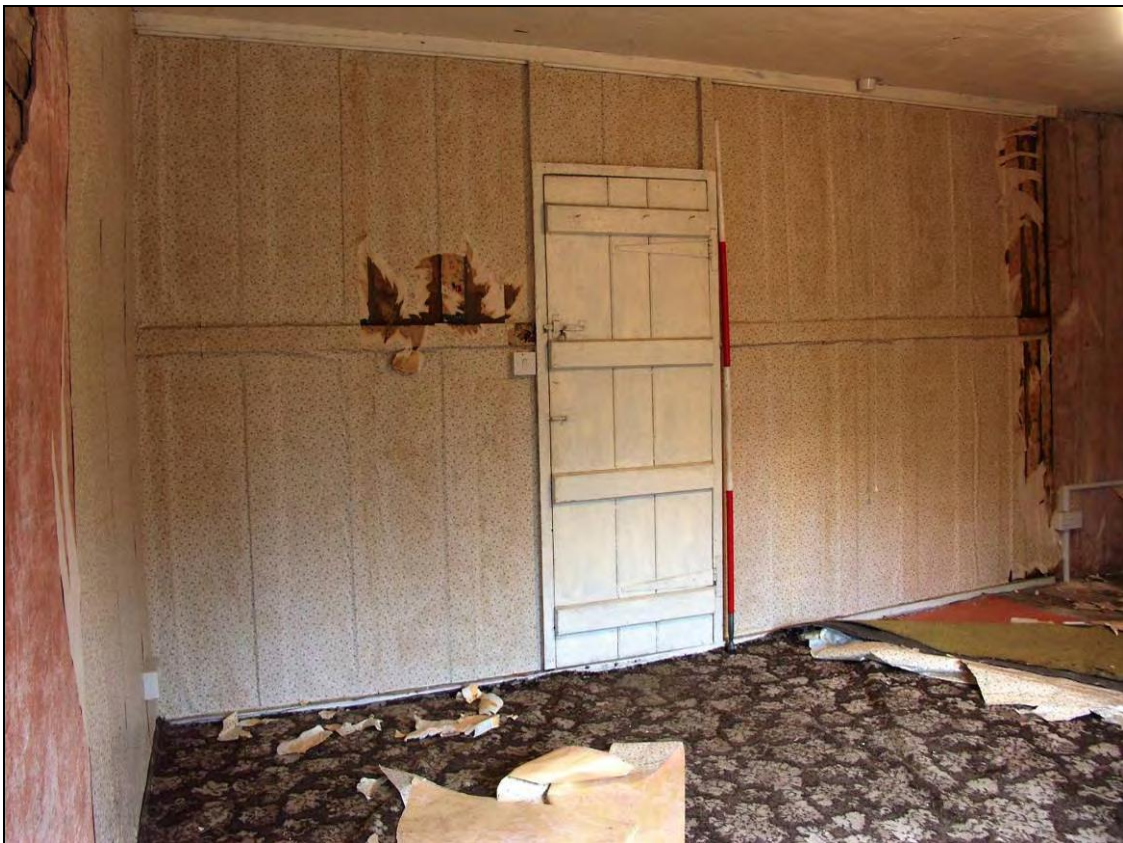
- 4.41 Room F-2 is located in the centre of the Farmhouse and is another bedroom. It measures 4.60 metres in length (north/south), 3.65 metres in width (east/west) and is 2.40 metres in height. This room is accessed from the passageway through a ledged timber door with iron strap hinges on the eastern wall panelling (Fig. 55). The panelling is covered with wall paper and this side has a muntin reinforcing the vertical rails.

Figure 55: Wood panelling with doorway to the passageway, looking east (scale 2m)

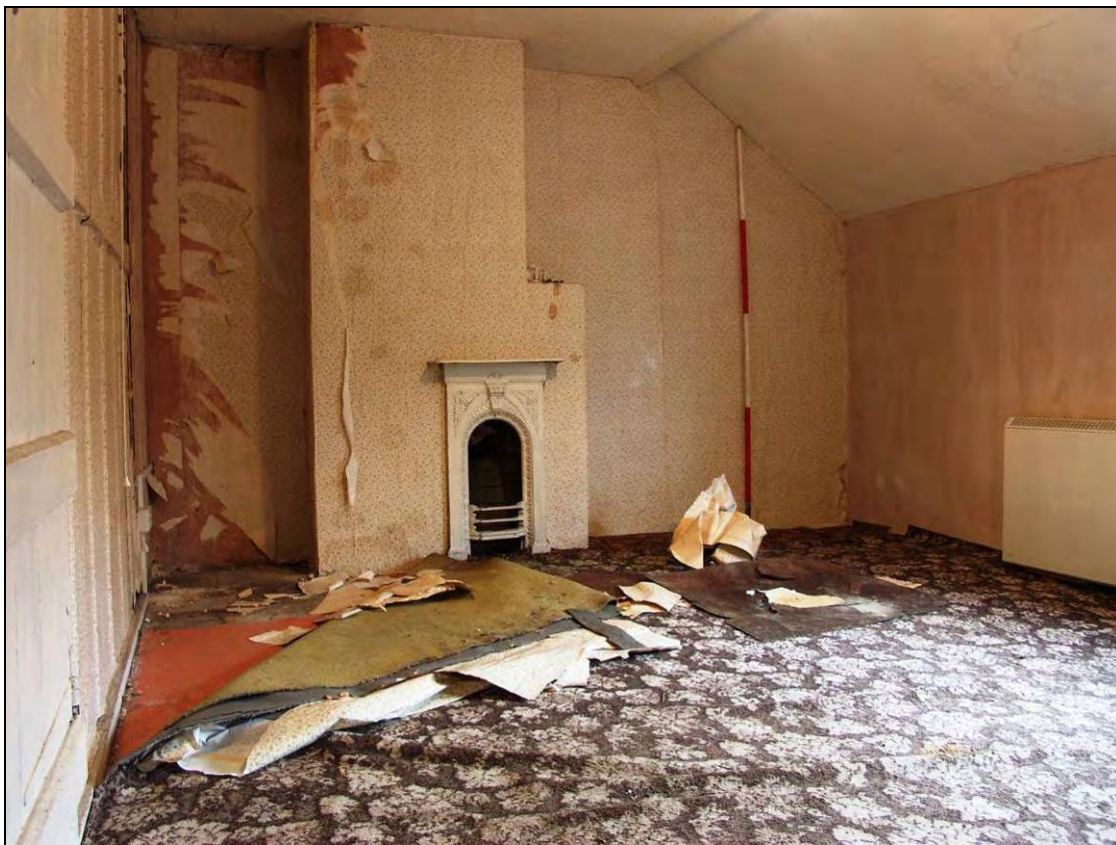
- 4.42 This room has a central fire place incorporated within the brick chimney breast on the south wall (Fig. 56). The brick wall is covered with plaster and wall paper. The ceiling is made of lath-and-plaster with angled sides and the floor consists of lime ash cemented screed which appears to be a later replacement of timber boards.

Figure 56: Room F-2 with central cast-iron fire grate, looking south (scale 2m)

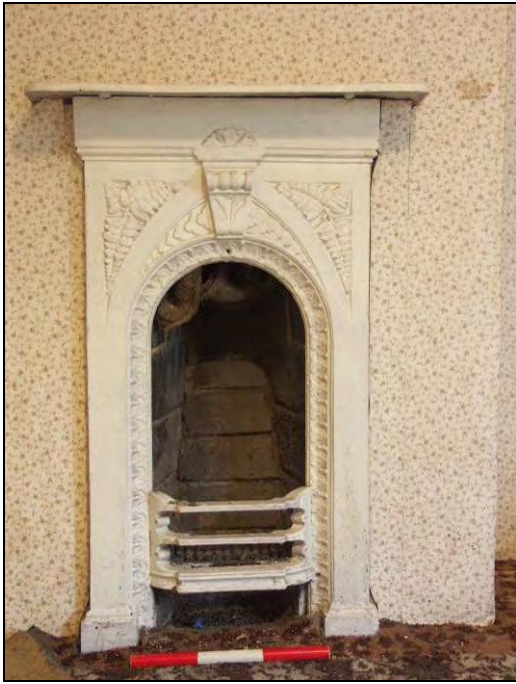
Figure 58: Detail of cast-iron fire grate (scale 300mm)

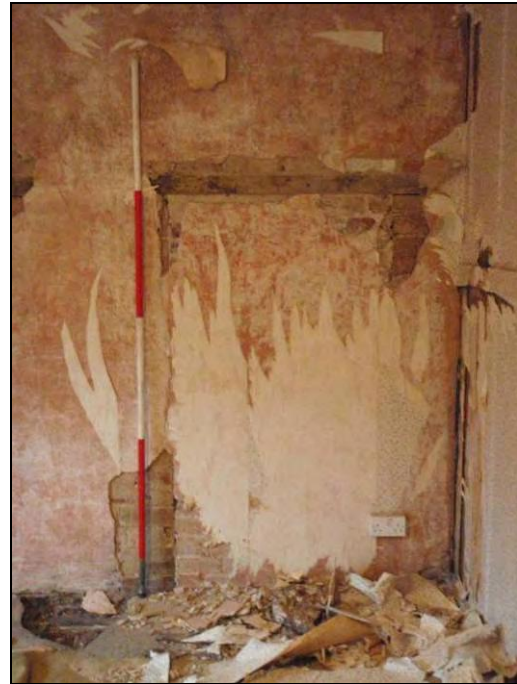
- 4.43 The room is lit by a timber casement window with rat-tail stay and fastener situated under the dormer (Fig. 57). The fire place has a cast-iron fire grate with fire bricks (Fig. 58). The wall plaster is crumbling in several areas of the northern wall which revealed a former doorway which is now blocked with bricks (Fig. 59). This doorway would have connected this room with the adjacent room F-1 prior to the insertion of the wall panelling creating the current passageway.

Figure 59: Former doorway on the northern wall

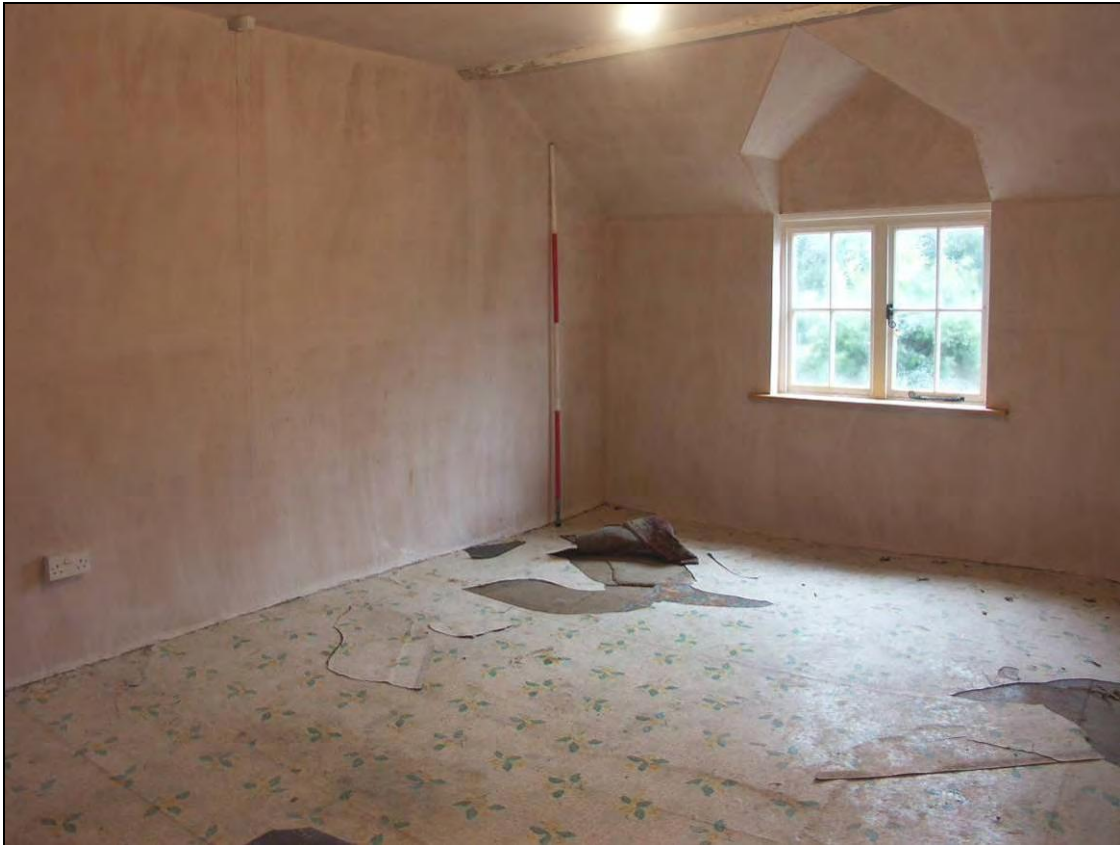
- 4.44 Room F-3 is located in the southern end of the Farmhouse and is also a bedroom. It measures 5.20 metres in length (east/west), 3.70 metres in width (north/south) and is 2.45 metres in height. It has similar structural arrangements and fabrics as the adjacent room F-2 although the walls have been recently rendered with plaster (Fig. 60). The screed floor is in poor condition with several fissures (Fig. 61). The room is lit by a timber casement window with rat-tail stay and fastener situated under the dormer. It has an equivalent central cast-iron fire grate which is part of a back-to-back fire place (Figs 62 and 63).

Figure 60: General view of room F-3, looking south-west (scale 2m)

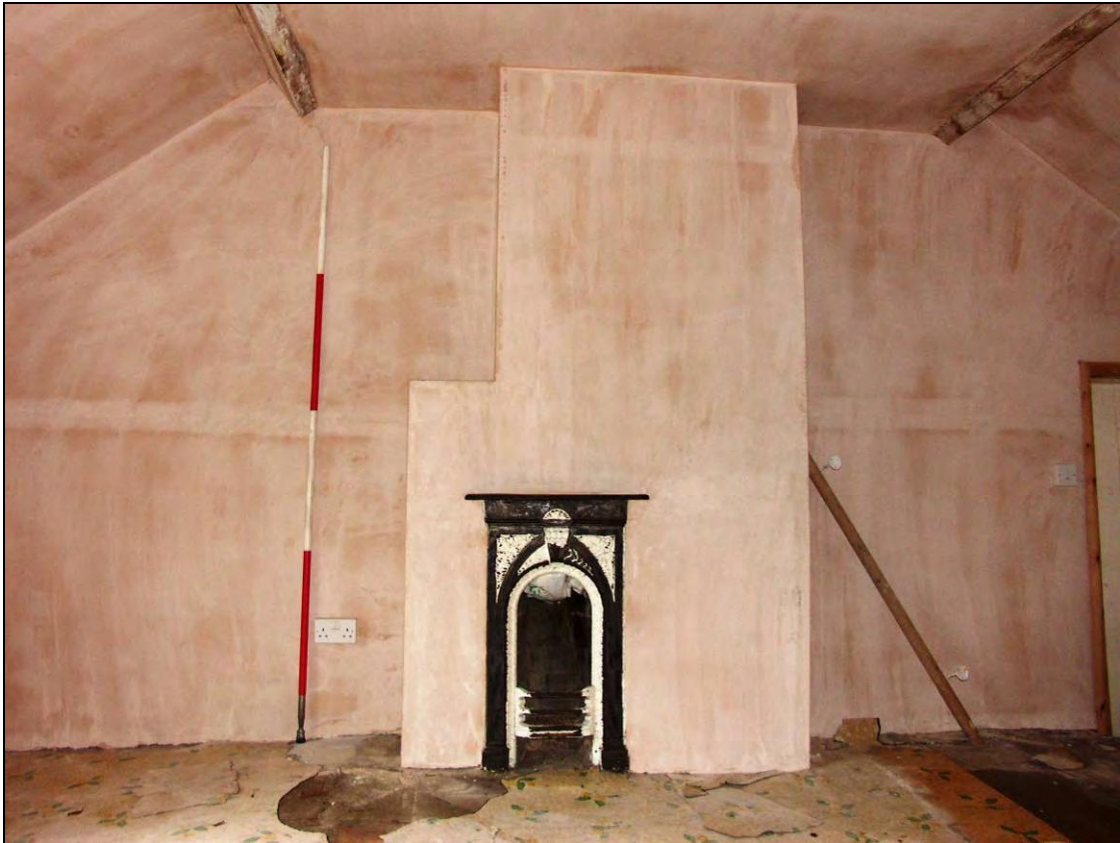
Figure 62: Central cast-iron fire place, looking north (scale 2m)

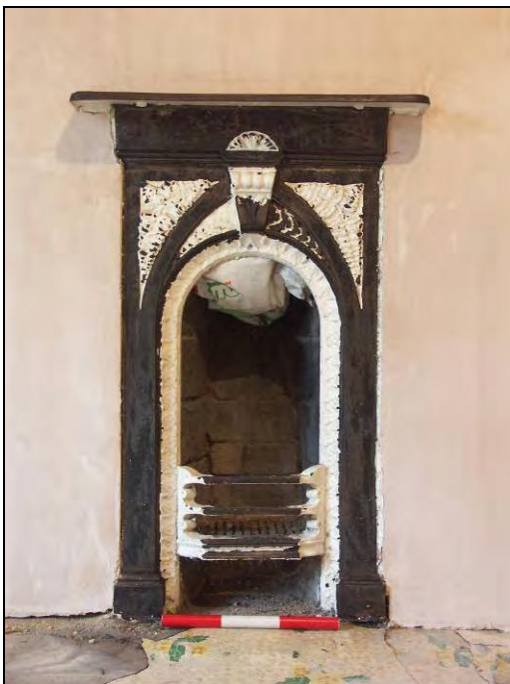
Figure 63: Detail of cast-iron fire grate (scale 300mm)

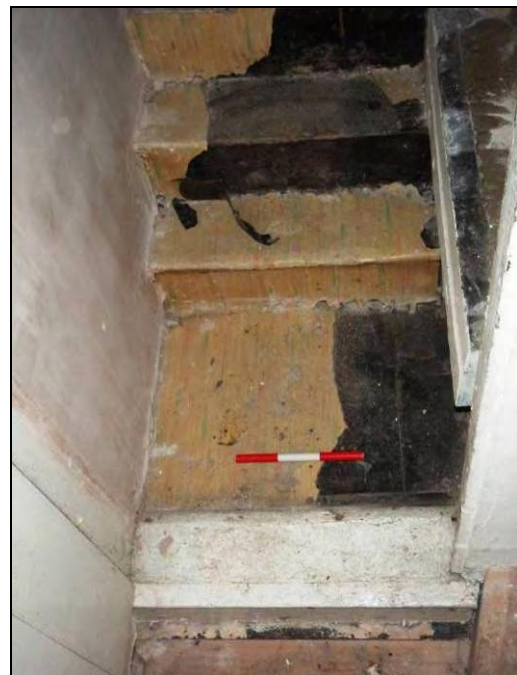
- 4.45 This room is accessed from the staircase through a ledged timber door with iron strap hinges on the north wall. The staircase has a landing and two steps inside the room which appear to be original (Fig. 64). The landing would have accommodated the movement of a door which would have opened inwards. Thus, the primary access to the adjacent room F-2 might have been from a doorway adjacent to the chimney breast in the same alignment as the blocked-up doorway between rooms F-1 and F-2. However, the wall plaster may be obscuring the putative doorway behind it and thus it cannot be established.

Figure 64: Detail of landing (scale 300mm)
