Stretton Mill Farm, Stretton
Archaeological Building Recording

Stretton Mill

ARS Ltd Report No. 2013/54
July 2013

Archaeological Building Recording

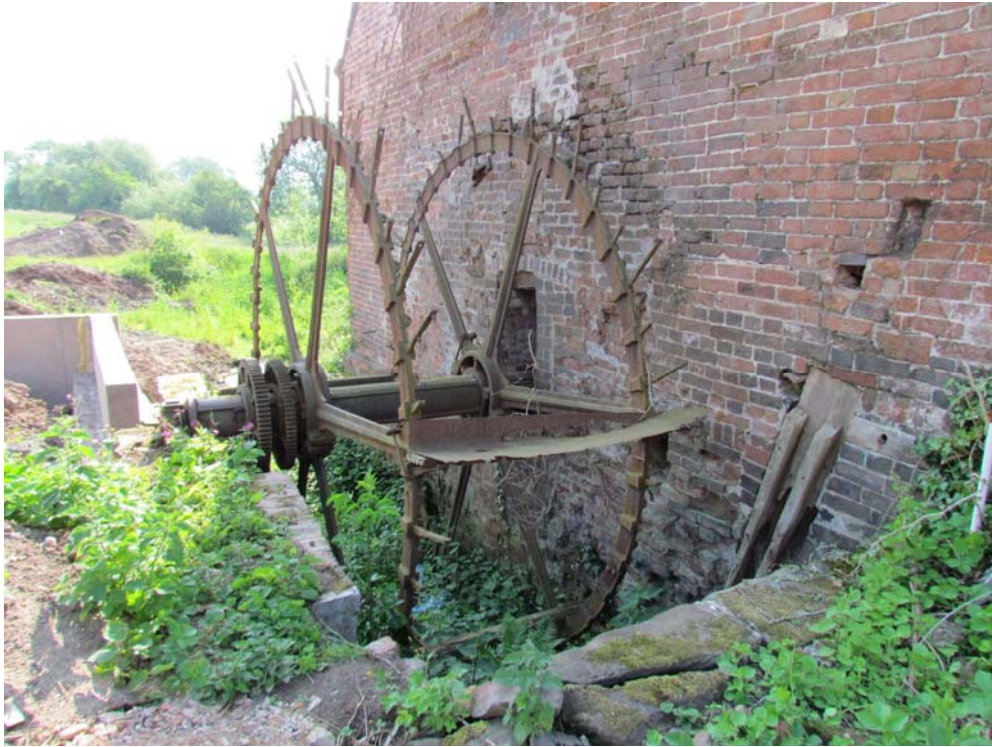
Figure 16: Detail of Waterwheel and Pit (Scale = 2m).

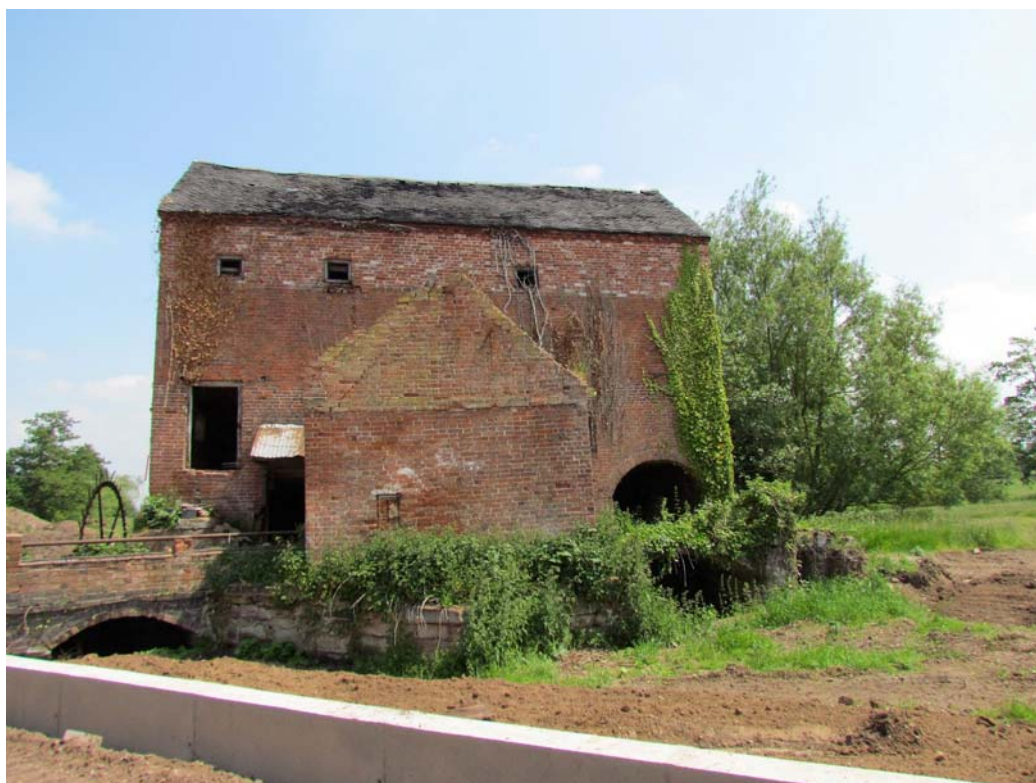
The exterior northwest elevation consists of four-storeys and five bays. The stone plinth is clearly visible and is the red and black brick, single-arched bridge over the northern race with steps on the north side. The change in brick colour may indicate that it has been re-built at a later date with a metal hand-rail. To the left of the entrance door in its brick surround are the remains of brick steps with stone caps. Slightly above the door is a doorway with a timber surround which appears to have been inserted, judging by the brick fragments. The gable of the office building is plain except for a small metal-farmed casement window. To the south are two square windows in brick surrounds, one at ground level and the other above. At the end is a double archway for the southern wheelpit. On the third floor is a small square window with a timber surround and, another three similar windows at loft level. Two changes in the brickwork are evident on this elevation also and there are dentilled eaves.

Figure 17: West Elevation, Looking East.

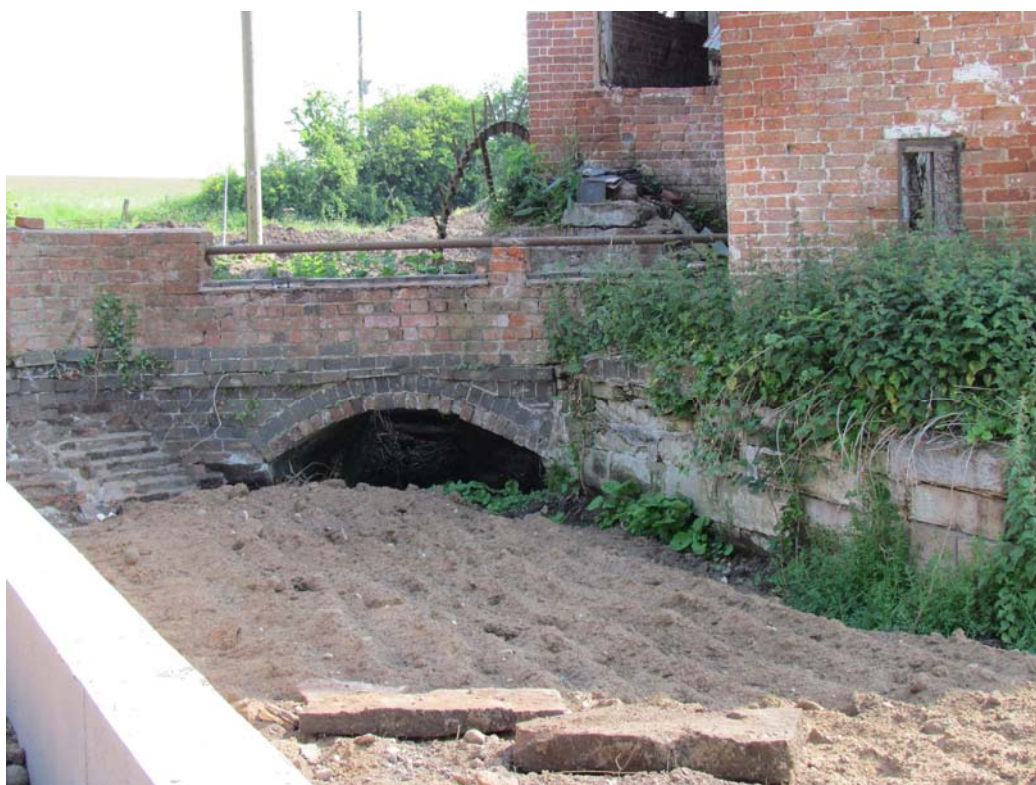
Figure 18: Detail of Bridge Over Northern Mill Race.

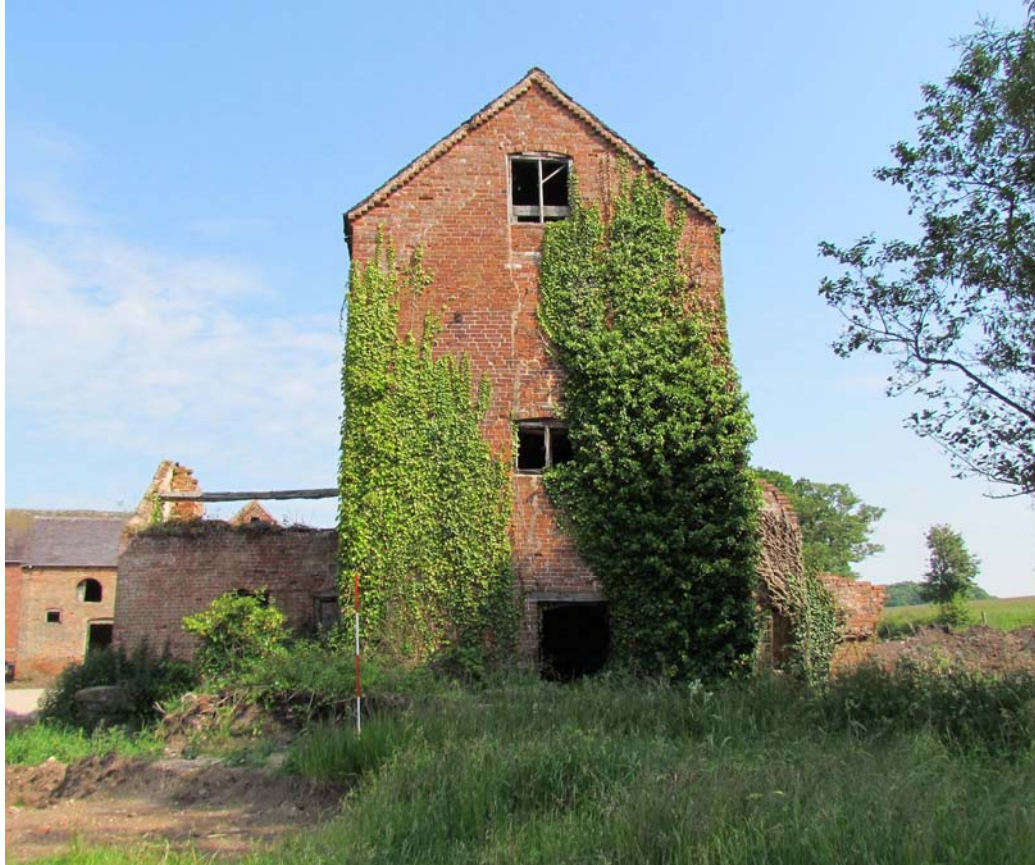
This elevation of the mill is four storeys high and one bay wide, with that of the office building being one bay. The southern mill race brick wall, with its stone cap, partially obscures the lower part of a large square opening with a timber lintel. The office building on this side has a door with a timber surround and a square window without a surround.

Figure 19: South Elevation, Looking North (Scale=2m).

Further up is a timber-framed mullioned window with a segmental arched brick head. Similar changes in the brickwork are visible above this height, although somewhat obscured by ivy growth. There is a similar window in the gable and lines in the mortar may indicate previous alterations in the position of other windows as the height of the mill was altered. The eaves are stepped under the gable.

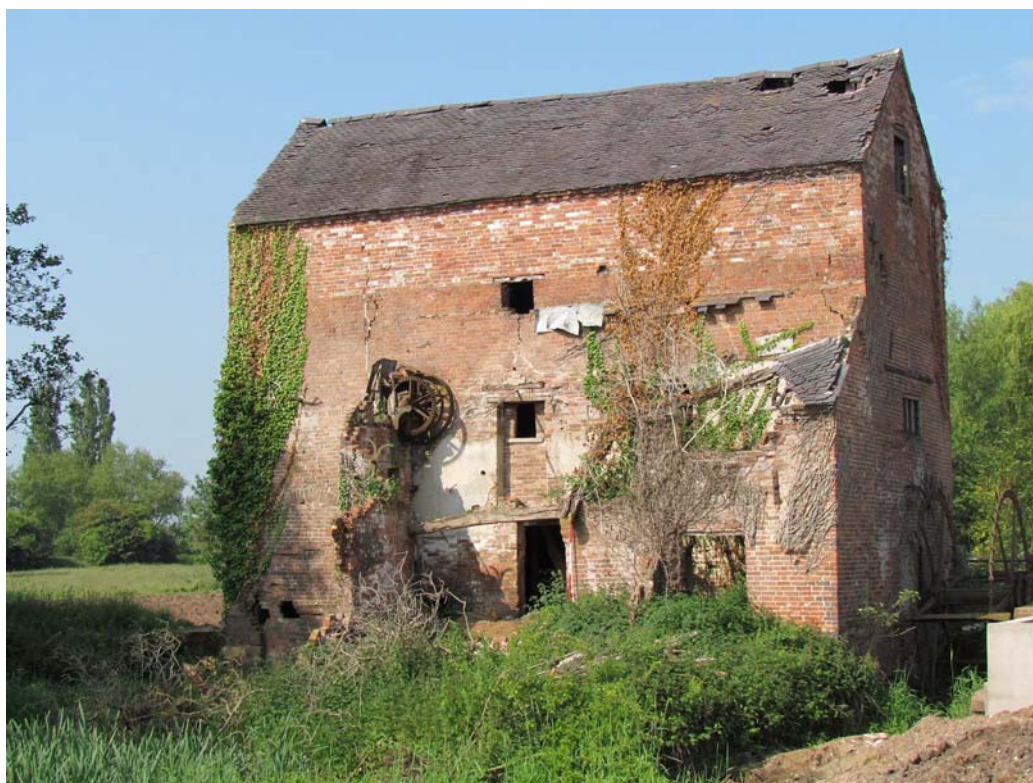
This elevation comprises the four storeys of the mill and the eastern lean-to extension. At the lowest level, is another double archway over the southern wheelpit, the upper arch being infilled here. The remains of the eastern extension can be seen on this elevation, although the roof and much of the walls have collapsed. A pile of surviving tiles is inscribed with the trade name 'Rosemary'. At the top of the left wall, iron gearing protrudes from the mill wall. In the centre of the mill wall is a doorway with a brick surround and there is a square opening with a timber lintel in the extension. Above the door is another doorway with a timber lintel which has been part-infilled to form a window with a concrete sill. A timber lintel above the doorway indicates previous alterations in the doorway. There are also the remains of plaster on the wall. Above the infilled doorway is another small square window with a timber lintel. Due to the existence of the eastern extension, only one change in brickwork is visible on this elevation. The eaves are dentilled here also.

Figure 21: East Elevation, Looking West (Scale=2m).

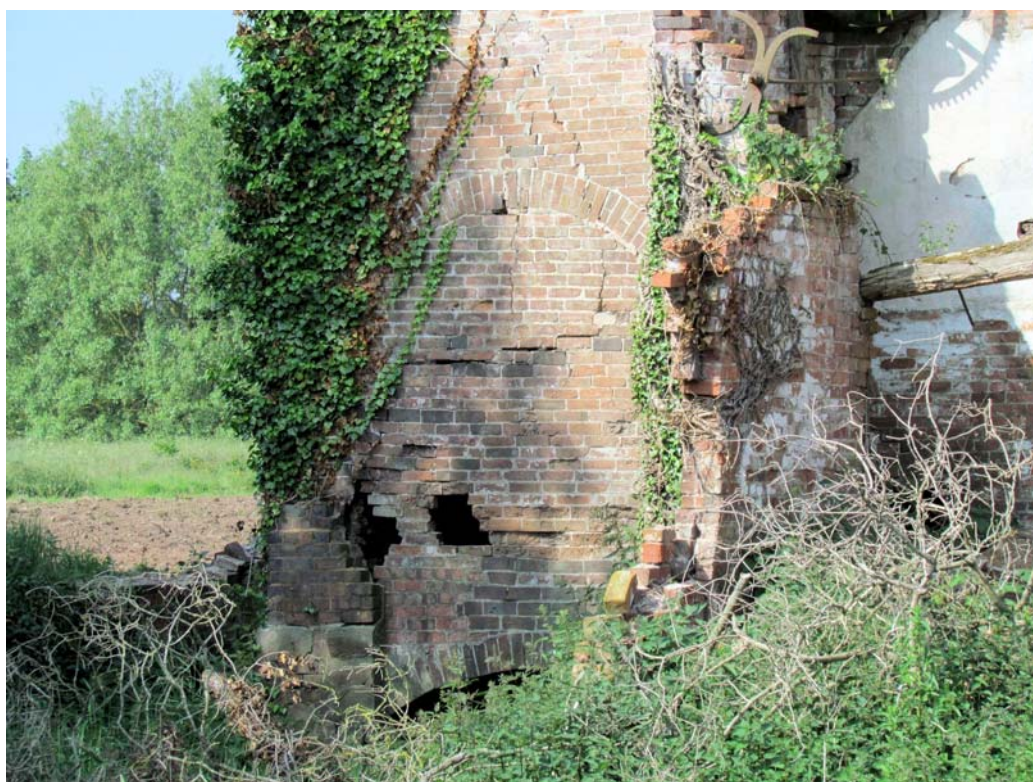
Figure 22: Detail of Double Archway Over Wheelpit.

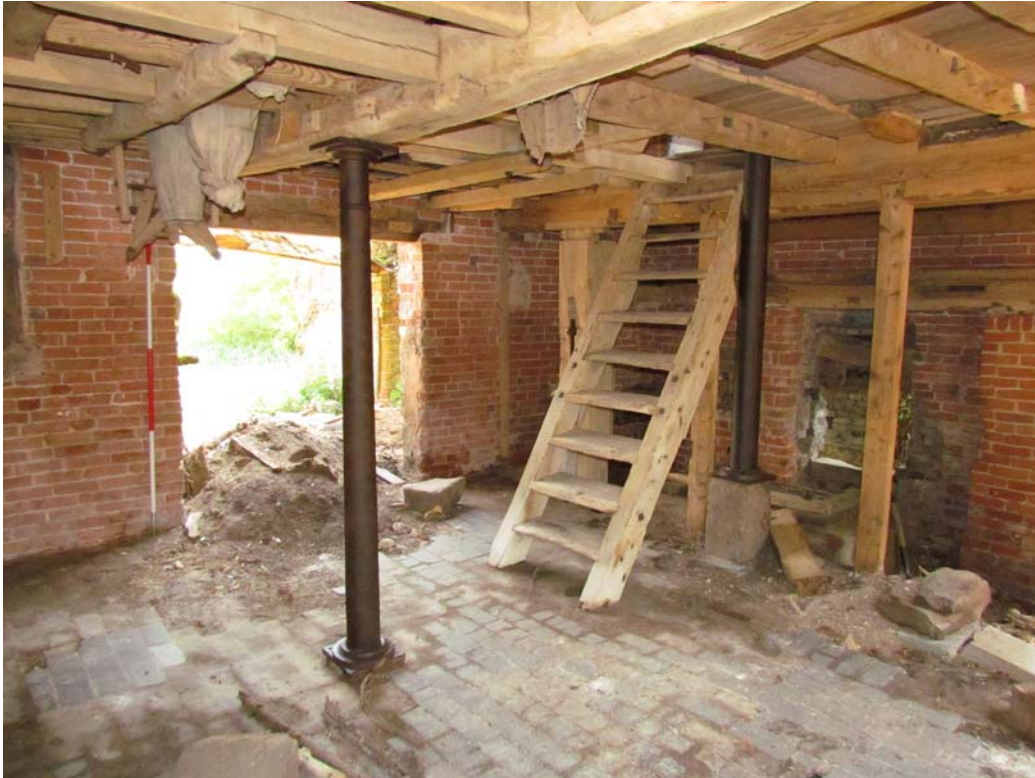
The ground floor of the mill comprises the meal floor, of which the principal spaces will be described. The door surround retains iron hinges. The meal room has unfinished brick walls and a brick floor. The timber ceiling is supported on massive hand-finished chamfered timber beams, with simple run-out stops, tied into the wall. Meal chutes hang from gaps in the ceiling, which appears to have been altered many times with additional joists. Three round iron columns on square bases appear to have been added later to provide additional support and two on square stone bases protrude through the ceiling. A set of simple timber steps provides access to the first floor.

Figure 23: Meal Floor, Looking East (Scale=2m).

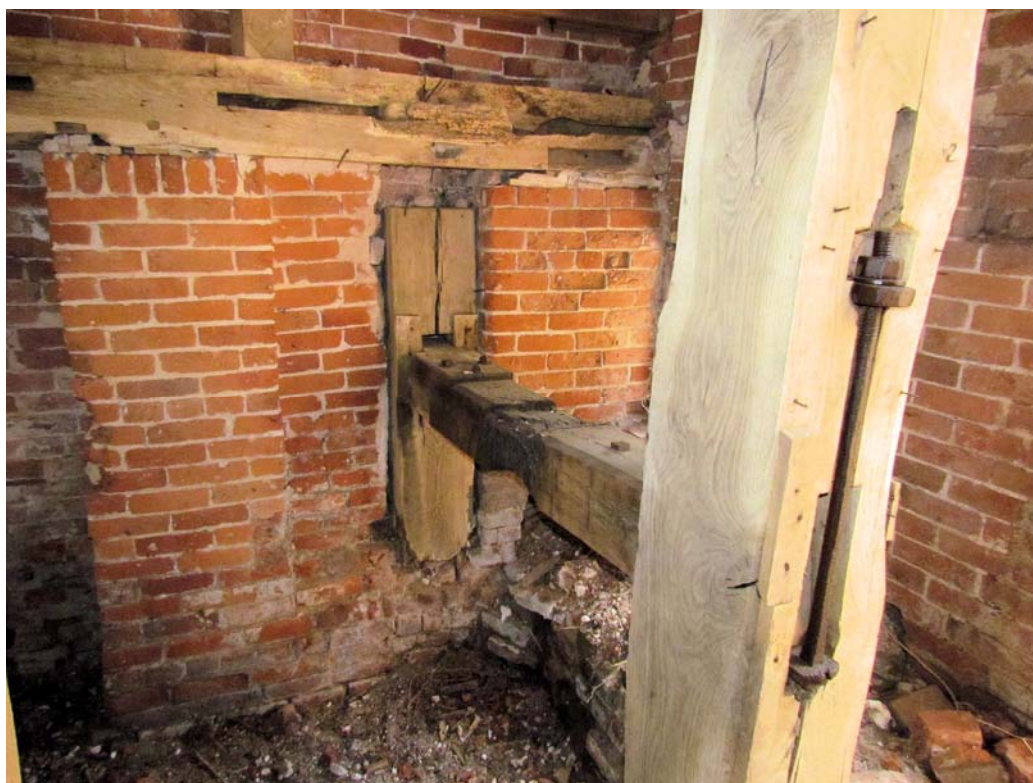
Large square posts with iron rods form the remains of the hurst for the now missing southern mill stones and a large square stone seating for the wheel survives. A large timber beam built into the south wall appears to have been re-used.

Figure 24: Detail of Hurst Structure for South Wheel Gearing and Structural Beam, Looking South.

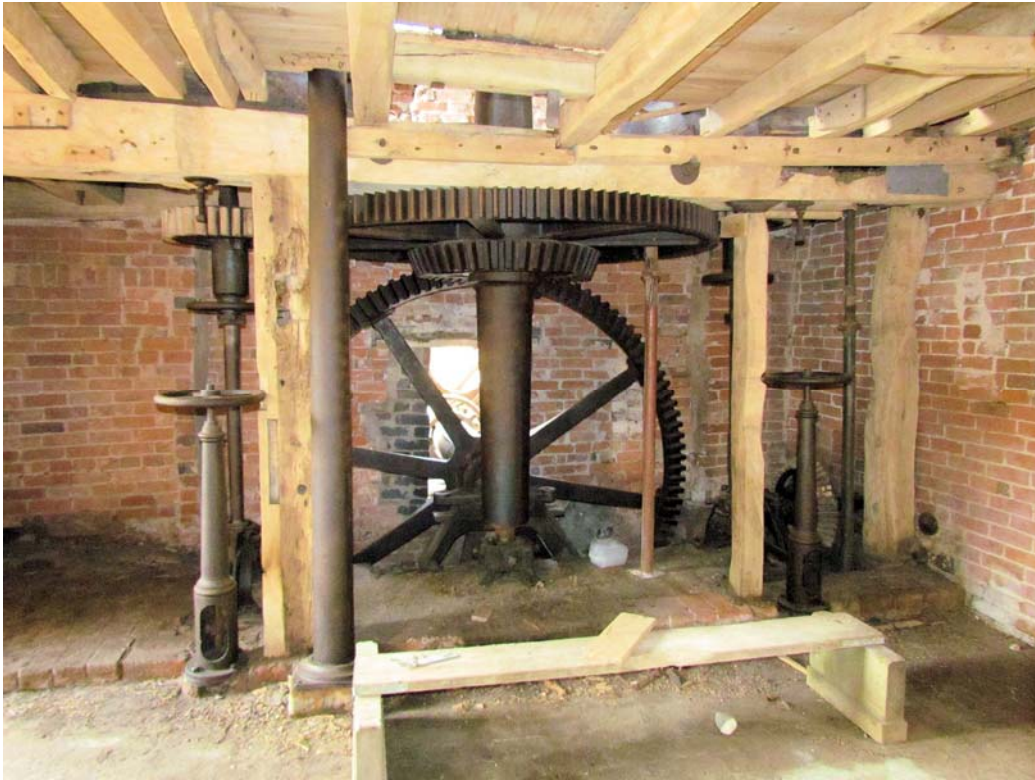
At the north end is the gearing for the north wheel, supported on a timber structure. The gearing retains a pitwheel, wallower and spurwheel, together with stone nuts and spindles connecting through the floor above to the stones. There are also two hand operating valves. A number of iron tools including a large spanner were found on the floor and recorded.

Figure 27: Detail of North Wheel Gearing, Looking North-west.

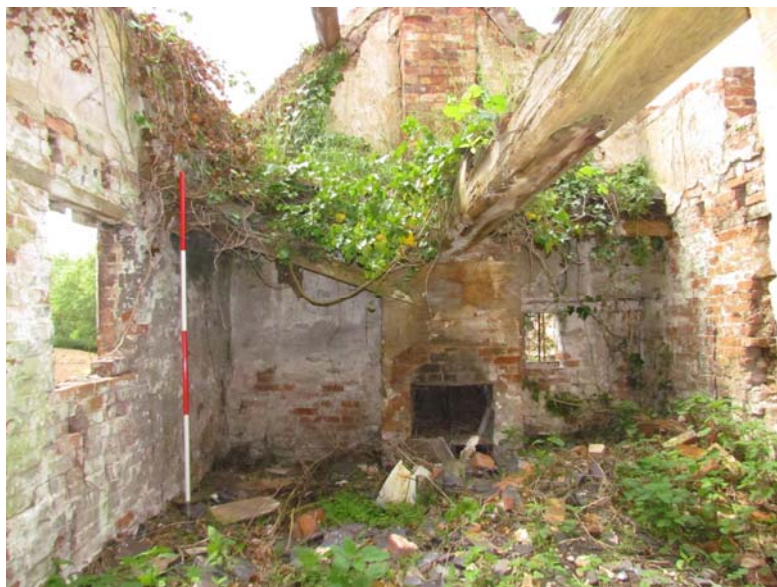
The small office building is one bay and very plain. There is evidence of white-washed walls but no floor remains. A single longitudinal beam, a few surviving joists and holes in the walls are evidence of a former upper floor although this, together with the roof, has gone. A chimney at the west end contains a small fireplace with an iron hearth. A millstone was found leaning against the east wall which the King Appraisal identified as a French Burr stone, used for grinding flour. This may have been one of those formerly positioned at the south end of the stone floor.

Figure 28: Office Building, Looking South-West (Scale=2m).

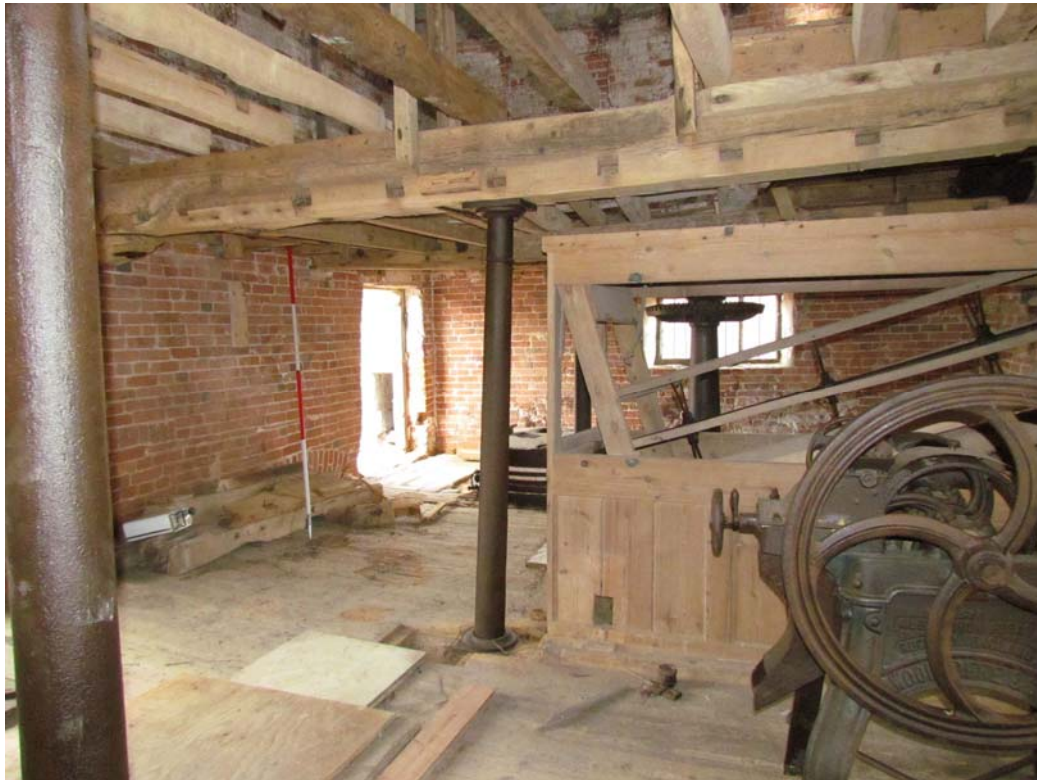
The stone floor is accessed from below by the timber steps and is similar in appearance to the meal floor. The floor is timber boarded, with additional modern plywood. Although the bin floor is supported on large timber beams, additional iron columns have been inserted here also. The vertical shaft from the gearing continues nearly to the ceiling, with a crown wheel at the top to drive pulleys and belt drives. A bolster, for separating white flour from meal, is situated in the centre of the floor, with a freestanding cutting machine. On the floor is a pile of timbers, probably from the floor above which has collapsed.

Figure 29: View Across Stone Floor, Looking West (Scale=2m).

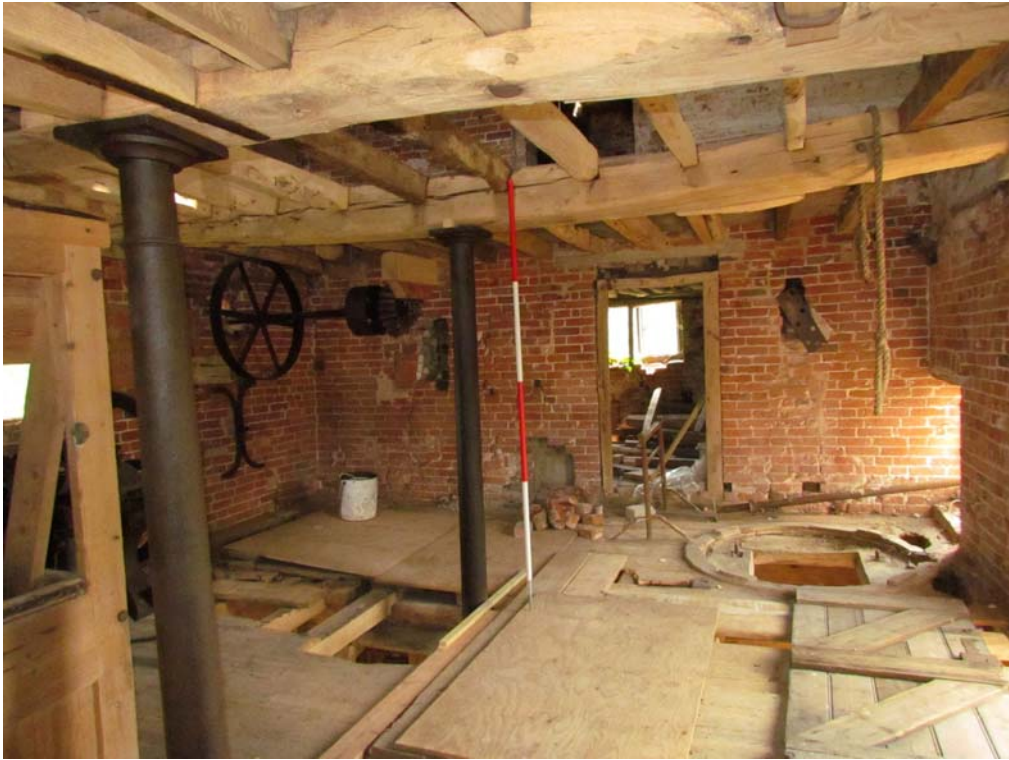
Iron gearing at the south end of the room projects through the wall. There is also evidence at this end of the positions of two other millstones driven by the former south wheel. At the south end, a doorway in a timber surround gives access to the end room which has the remains of white-washing and heavy iron hooks in the ceiling. A pile of timbers is stored here.

Figure 30: View Across Stone Floor, Looking South-east (Scale=2m).

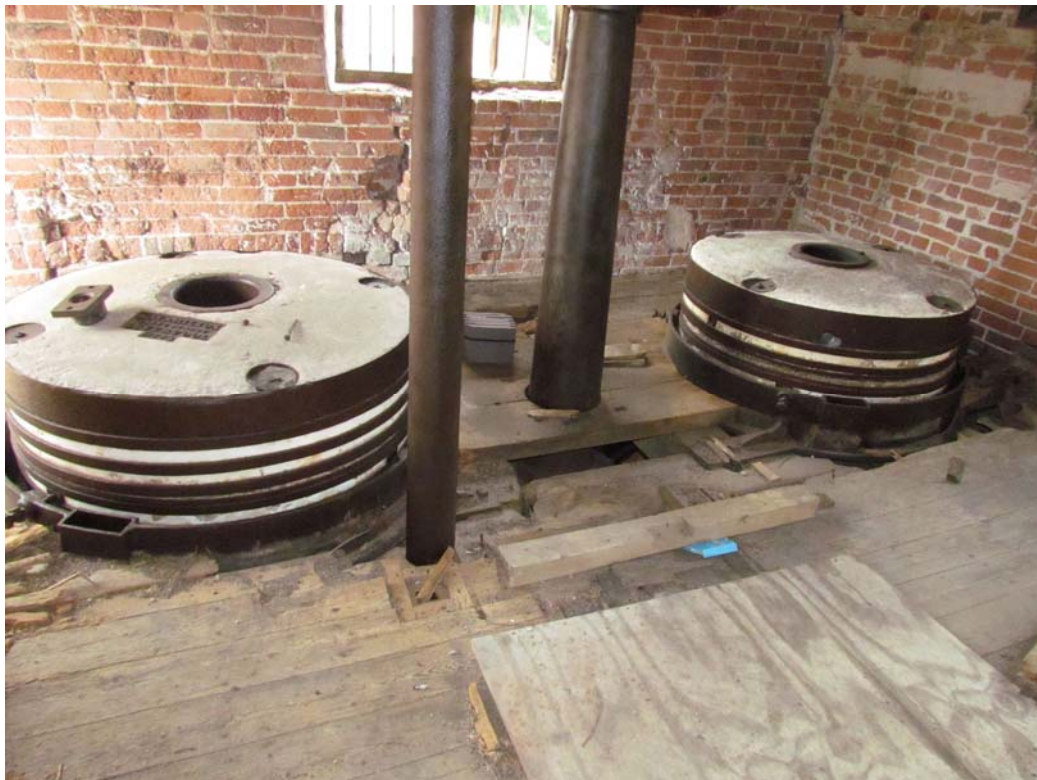
At the north end are two millstones in metal casings, marked 'Kay & Hilton, Fleet Street, Liverpool 1854'. The King Appraisal identified these as coarse Derbyshire grit stones probably used to grind animal feedstuffs.

Figure 31: Detail of Stones, Looking North-east.

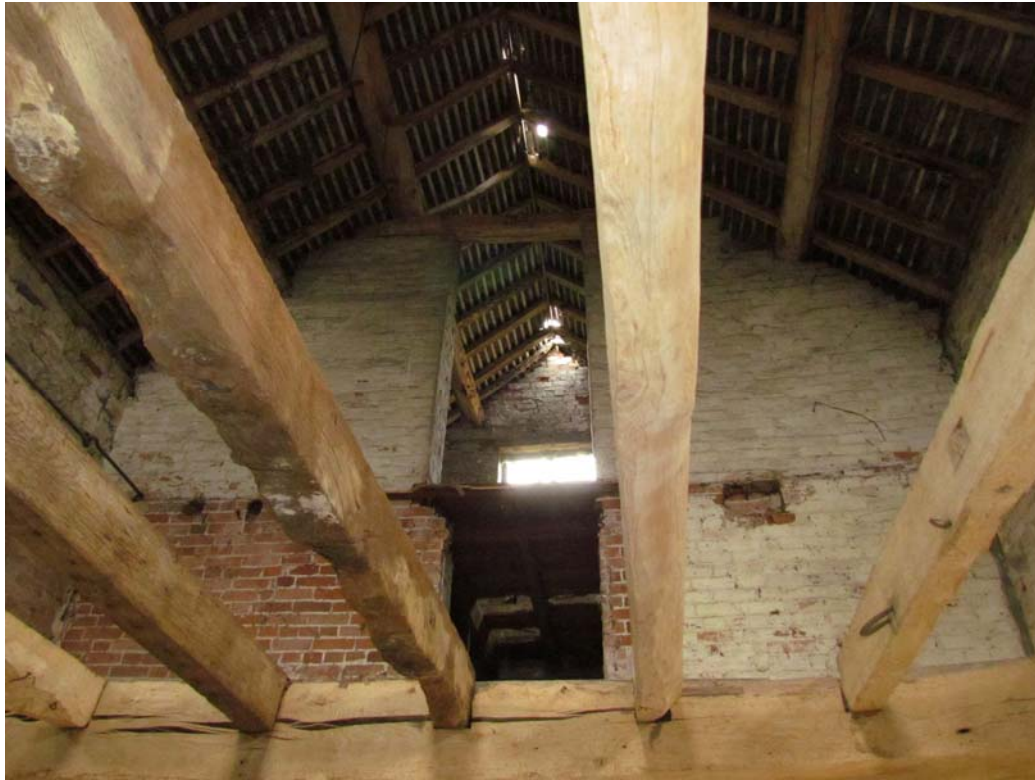
A wall continues from lower levels to the ridge at the southern end, creating a separate room on each floor accessed by an opening and with a timber floor. A beam runs across the top of the opening near the ridge.

Figure 33: View of Internal Wall at Bin and Loft Floor Level, Looking South.

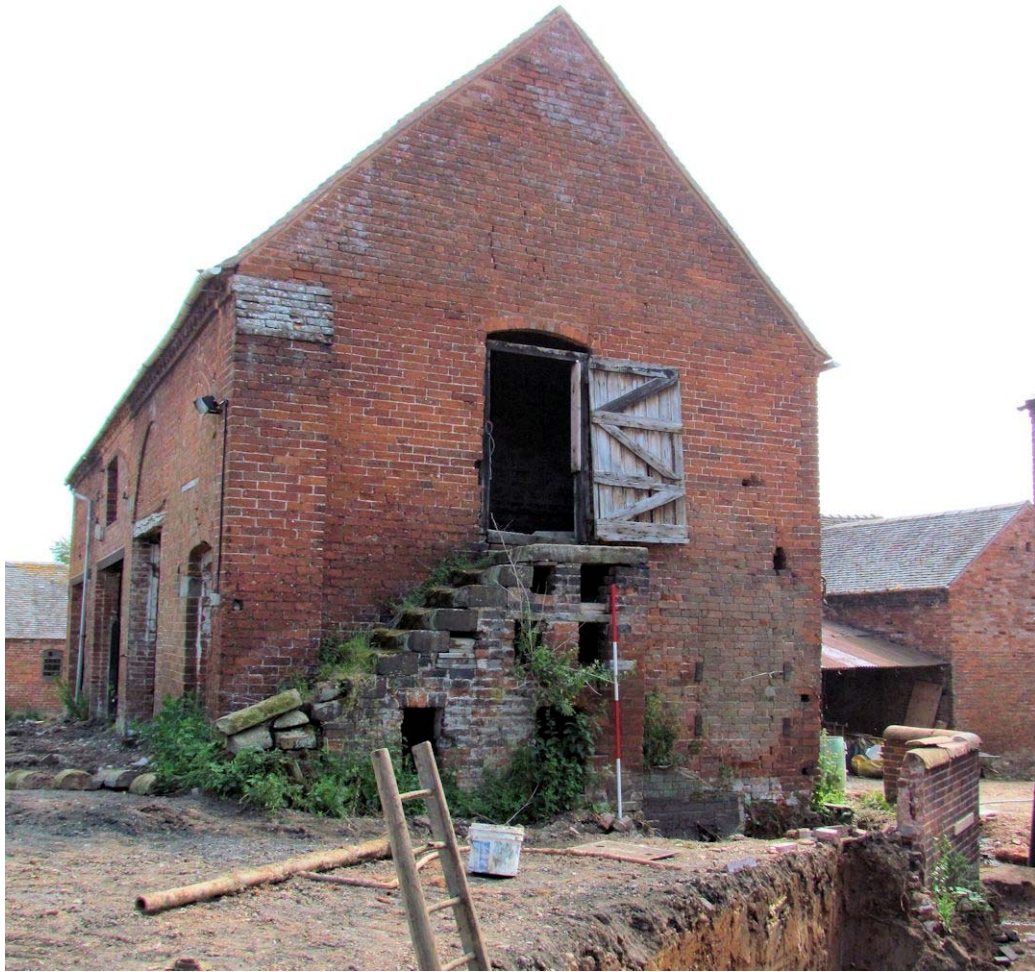
This elevation has a large brick pier capped with tiles on the western end, presumably to provide support for the building when bays 1 to 3 on the north-west elevation were open. A flight of brick-built steps with stone treads leads to a single-leaf door at first floor level with a timber surround. The steps contain openings for a dog kennel and poultry boxes.

Figure 36: South west Elevation, Looking North-east (Scale = 2m).

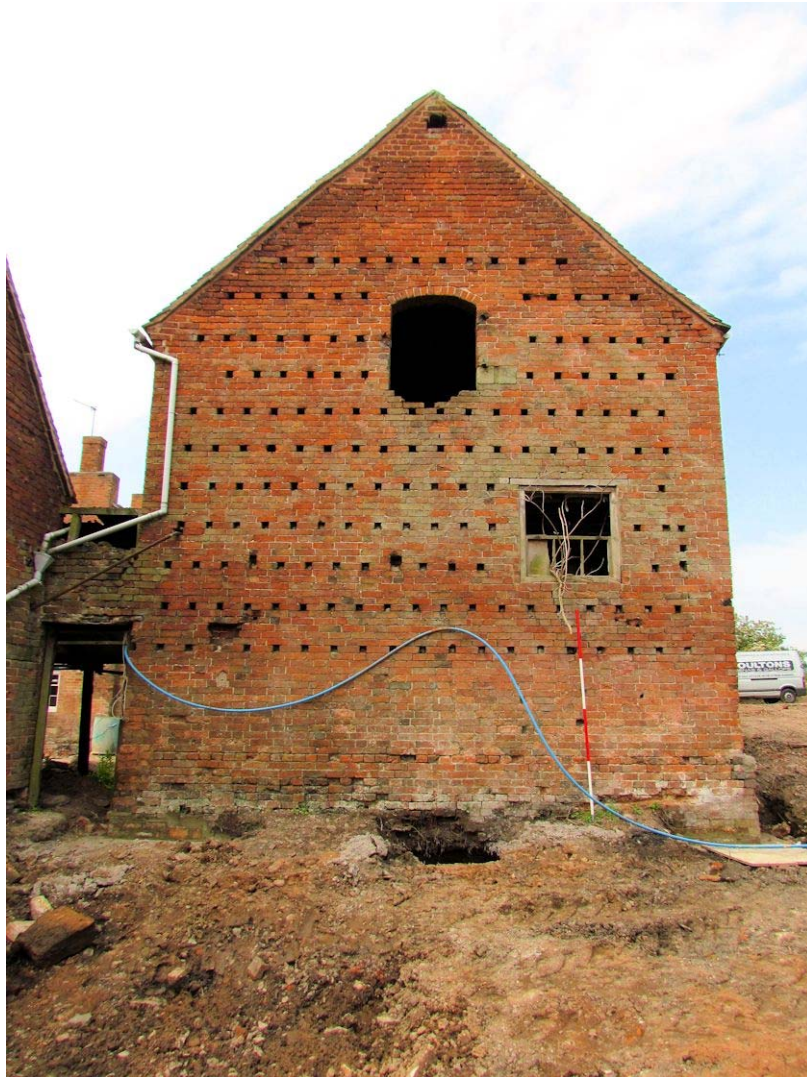
This elevation features regular lines of ventilation holes similar to those on the south-east elevation. There is a window with a timber frame at ground floor level and another in the centre at first floor level with a segmental brick head. On the east side is a brick-built link to Barn 2.

Figure 37: Barn 1, North-East Elevation, Looking South-west (Scale = 2m).

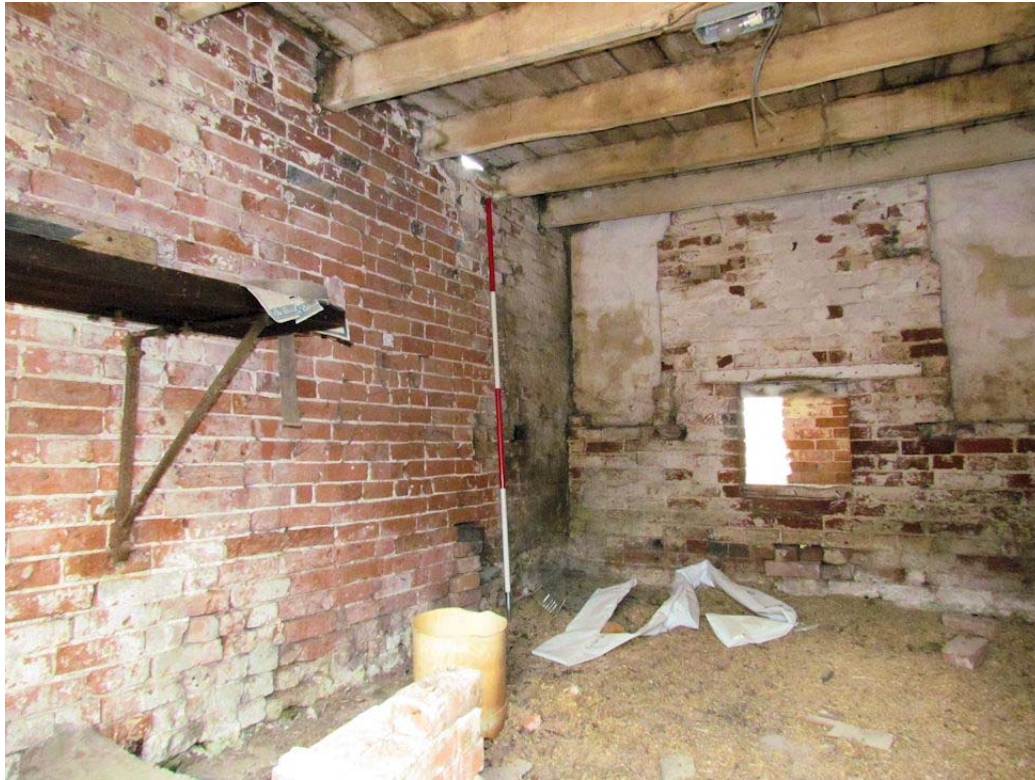
This bay was formed in the later 19th century when the exterior walls were infilled and a floor inserted to create a stable with hayloft above. There have been a number of periods of change in this bay which include an inserted wall at the northern end which is not jointed in. Two openings in this wall have been infilled later. A central opening at low level has long timber head and sill, possibly for a sliding hatch. A timber shelf on metal brackets survives on the south-west wall and the floor is concrete screed.

Figure 38: Interior of Bay 1, Looking West (Scale = 2m).

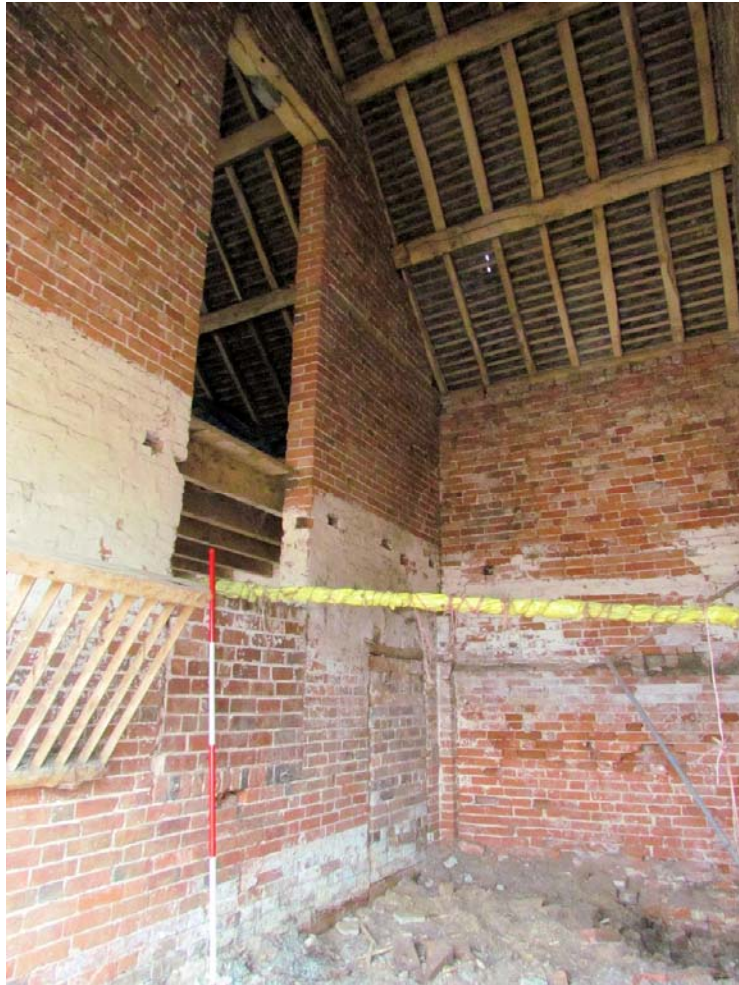
Bay 2 is a full-height bay with full-height brick partition walls to either side and a clear view of the hand-finished purlins have splayed joints entrenched into the partition walls. The underside of the tiles and torching can be seen. The long slot through to the former cart entry in bay 3 has a timber and brick head but has been partially infilled and two doors with timber heads on the east wall have also been infilled. Holes in the brick work may indicate a part floor which has been inserted and later removed. The bay may later have been used for stabling as there is a hay byre on the east wall. There is evidence of whitewashing on the walls and the floor has been removed.

Figure 39: Interior of Bay 2, Looking East (Scale = 2m).

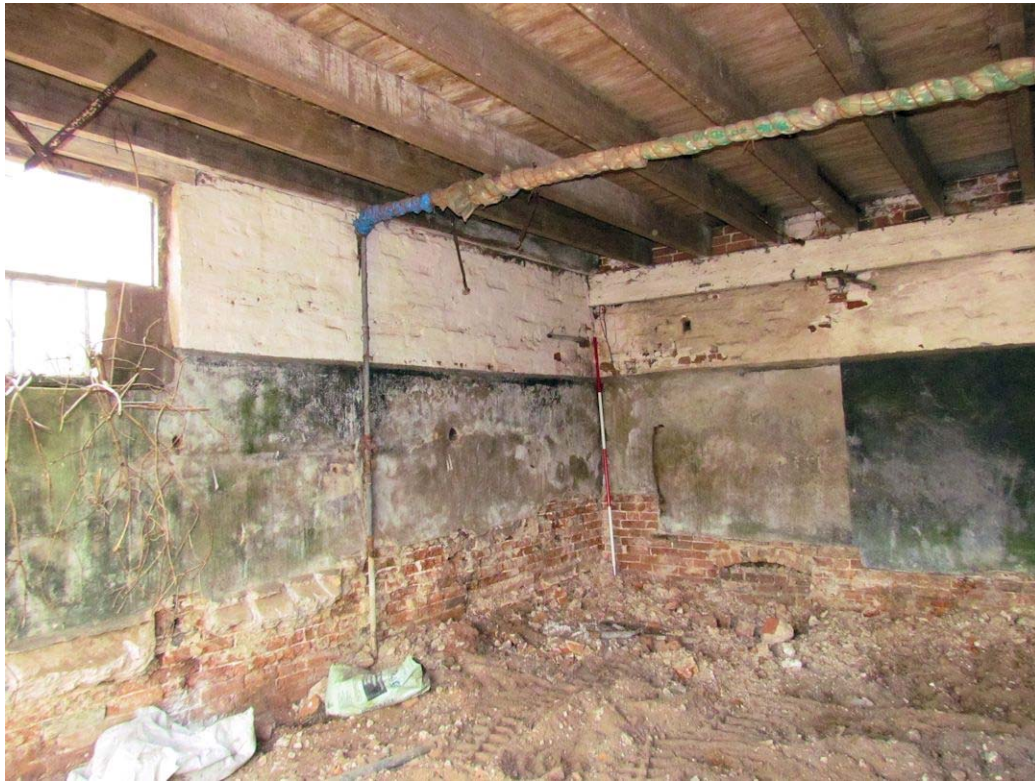
Bay 4 is very similar to bay 3, with the same wall coverings and inserted floor.

Figure 42: Interior of Bay 4, Looking East (Scale = 2m).

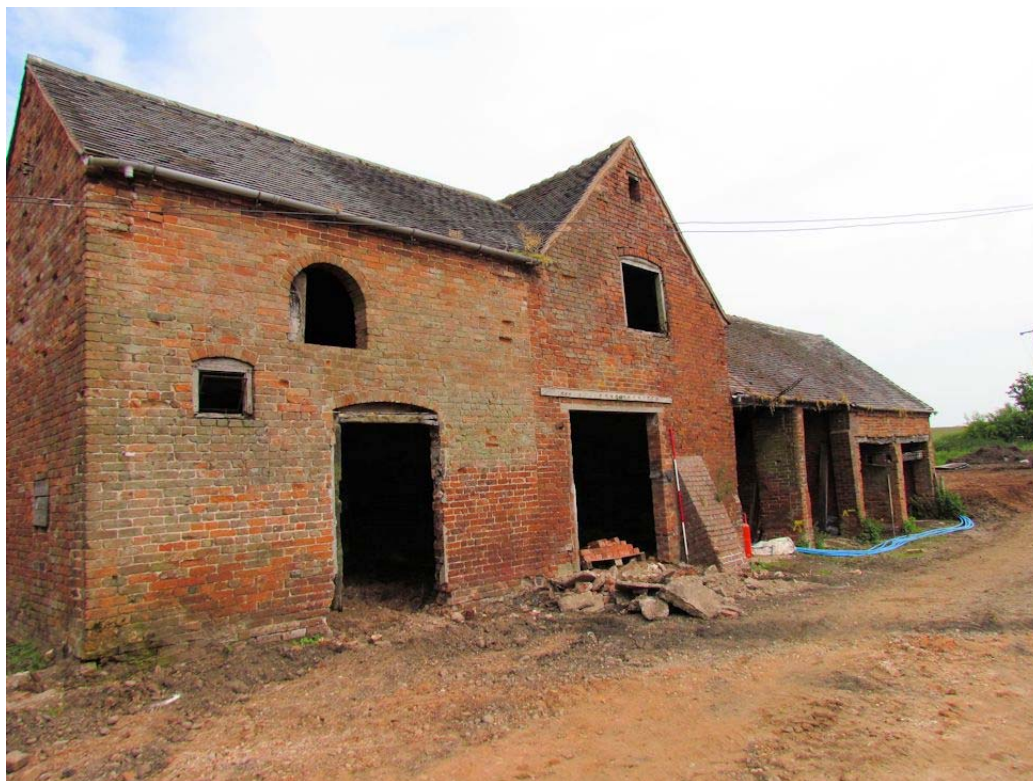
Bay 1 has a central door with a timber frame and a segmental arched head and a small similar window at the same level. Above is a round-arched pitching eye with a brick surround. Bay two has a modern opening which has been altered and has a concrete head. A short brick pier has been added to support the wall. Above is a square window with a timber frame and a segmental arched head.

Bays 4 and 5 appear to have been constructed as cart-sheds and are also in English garden wall bond, with full-width openings and heavy timber heads which appear to have been re-used. A floor has been inserted later. Bay 3 has double full-height and width openings separated by a massive brick column. The pier between bays 3 and 4 has been altered with modern brick.

Figure 43: South-east Elevation of Barn 2, Looking North (Scale = 2m).
