## The former Jubilee Pool, Newcastle-under-Lyme, Staffordshire

# Archaeological building recording and palaeo-environmental analysis

#### ARS Ltd Report 2015/114

July 2015

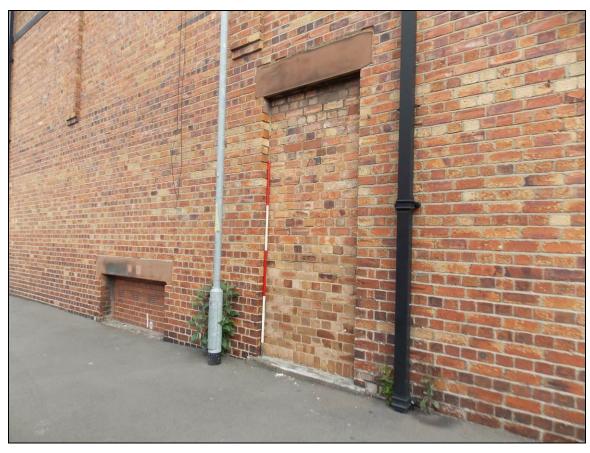
- 5.1.5 Towards the eastern end there is a doorway with a sandstone lintel decorated with a thin flat chamfered *intrados*. This doorway is now blocked with bricks. There are two low window openings with comparable lintels which would have acted as light wells for an internal underground gallery extending along the large swimming pool, although these are also blocked up (Plates 5 and 6). The eastern area of the elevation corresponds to a contemporary Boiler House which is dealt with the following sub-division.

Plate 6: Detail of blocked-up openings, looking north-west (scale 2m).

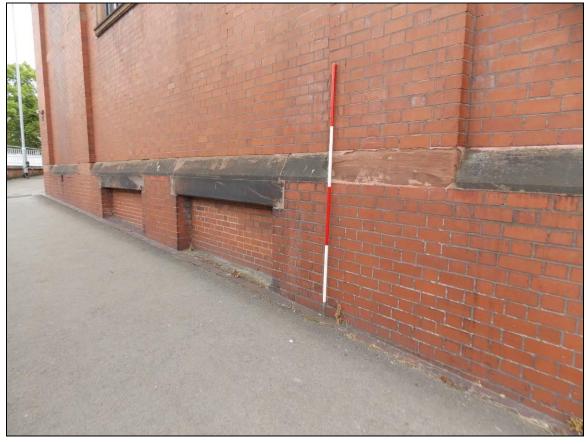
- 5.1.7 The west elevation along Barracks Road a section of the A 527– contains most of its primary masonry although pictorial records indicates that its original Dutch gable has now been modified with the insertion of a plain flat parapet. The present large windows are also later replacements with flat heads substituting original types with semi-circular arched heads as indicated by pictorial records aforementioned which are provided within the heritage assessment (Miller 2015). However, the lower section, side moulded cornices, pilasters and oculi are extant (Plates 9 15). It is built with machine-made standard reddish bricks bonded with grey lime mortar and laid in Flemish bond. It is composed of three recessed bays articulated by pilasters which spring from a continuous plinth topped with chamfered sandstone blocks. Within the central area of the plinth there are two light wells with sandstone lintels which would have lit the interior of an underground gallery along the large swimming pool inside the building.

Plate 14: Plinth with bricked-up light wells, looking north-east (scale 2m).

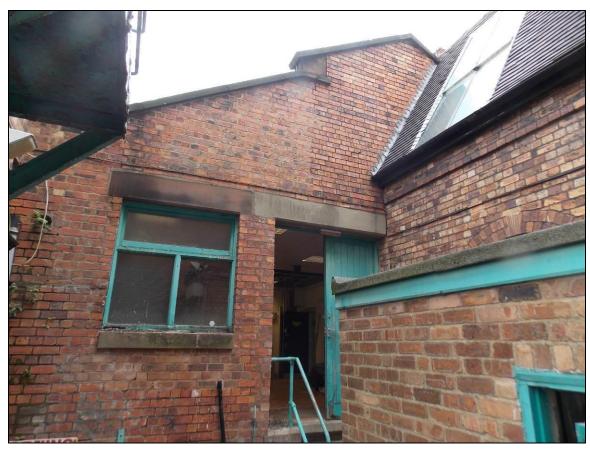
- 5.1.10 The construction consists of yellowish standard bricks laid in English bond. It contains a doorway for a cellar, which is gained through a straight staircase, and another for a laundry room which is accessed externally from a short straight staircase. There is a window opening adjacent to the main doorway to the laundry. Both of this openings contains sandstone lintels creating a continuous band. There is another window opening adjacent to the cellar's doorway which would have acted as a light well although the opening had been blocked up (Plates 16 and 17).

Plate 16: Gable wall within the east elevation, looking west.

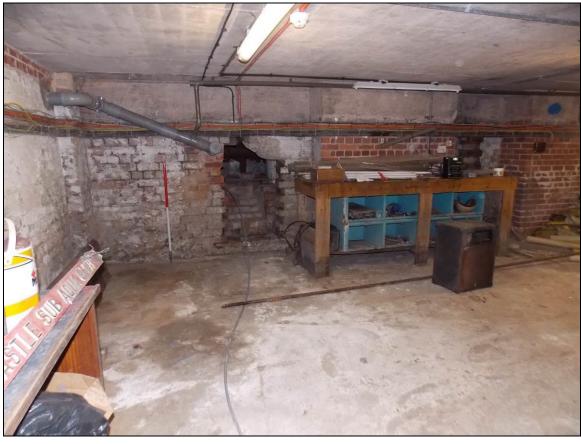
Plate 25: Western room with small aperture to the large pool underground gallery, looking west (scale 1m).

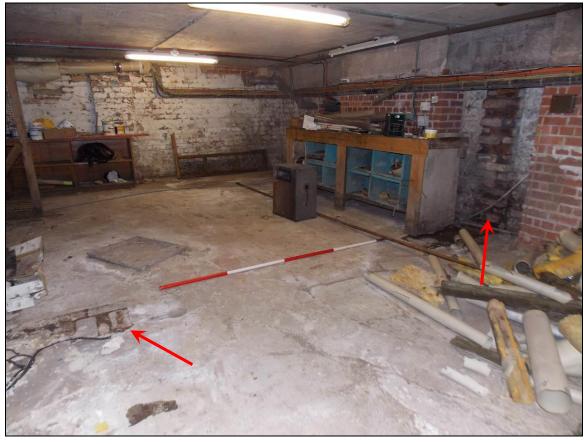
5.1.14 The western room is a larger L-shaped area with comparable fabrics to the eastern room although it is devoid of cast-iron columns. Instead, it contains concrete pillars supporting large concrete beams. Within the western wall there is a small aperture which leads to an underground gallery which extends throughout a large swimming pool within the southwestern area of the complex (Plate 25). The construction of the swimming pool appears to consist of its primary brickwork although the opposed walls of the gallery had suffered significant repair/rebuilt (Plate 26). Scars of primary partition walls were observed within the concrete floor and the west wall of the large western room (Plate 27). Towards the northern area the concrete structure leads to another underground gallery around the small swimming pool which also retains the original brickwork (Plates 28 – 30).

Plate 27: Western room with traces of earlier brickwork (arrows), looking south (scale 2m).

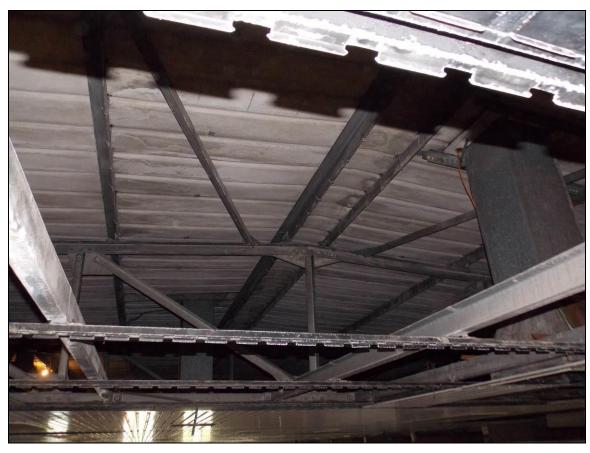
5.1.18 The first floor is accessed from the dog-leg staircase with landings, this is positioned within the main lobby. The staircase and associated stairwell are constructed with concrete and modern brickwork (Plates 46 and 47). An additional quarter-turn staircase is situated to the eastern end of the large swimming pool which leads to a corridor of the first floor. The staircase is made of cantilever concrete steps and plain metal balustrade (Plate 48). This upper floor occupies the northern side of the complex. The large pool has a false ceiling under an RSJ structure (Plates 49 and 50).

Plate 50: Detail of steel roof structure over the large pool, looking west.

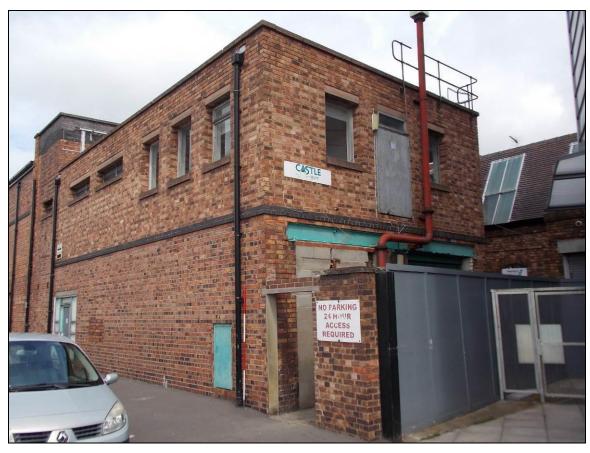
northern one contains a roller shutter. The upper floor contains three symmetrically arranged window openings with sandstone lintels and projecting sills that are equivalent to the larger openings within the south elevation. The central window opening has been modified into a fire exit doorway (Plates 60 and 61).

Plate 60: South and east elevations, looking north-west (scale 2m).

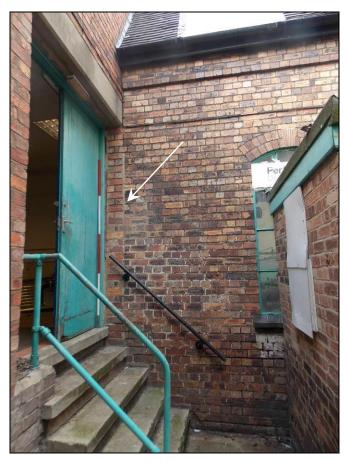
- 5.3.2 This brickwork consists of standard yellowish bricks laid in English bond which abuts the masonry of the former Jubilee Pool as indicted by a vertical construction joint within the westernmost end of the south wall (Plate 78). Indeed, this structure appears to have been constructed sometimes between the 1920s 1950s as indicated by cartographic records.

Plate 78: Detail of construction break (arrow), looking north (scale 2m).

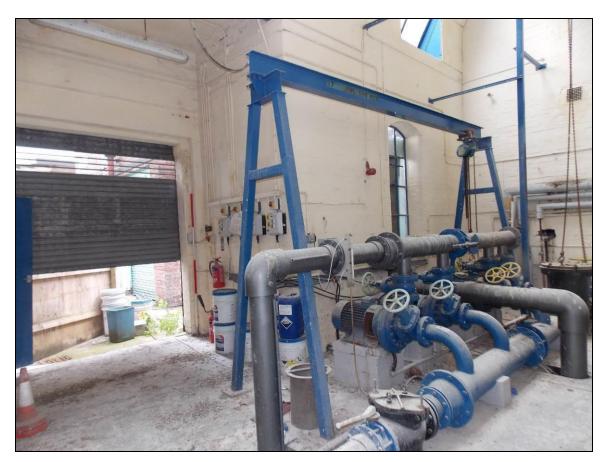
- 5.3.3 The interior of this building is occupied by a series of tanks, pipes, etc. that are part of the main plant. The floor is built with concrete, the walls are made of bricks and the roof structure consists of two RSJ north-light trusses. The west wall corresponds to an external primary wall of the former Jubilee Pool which contains four blocked-up window openings comparable to the types identified within the east wall of the laundry room (Plates 79 81). These openings would have been blocked up when the Filtration Plant was constructed.

Plate 79: Internal view of the Filtration Plant, looking south-west (scale 2m).

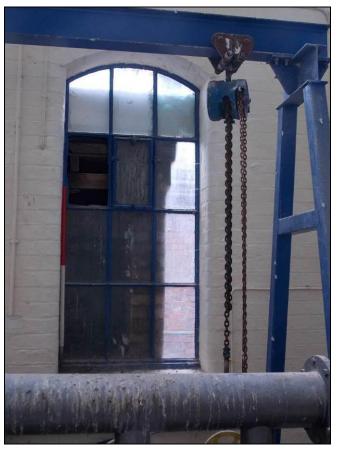
- 5.3.4 The external face of the partially blocked-up window was viewed from inside the extension (Plate 82). This was also examined inside the Filtration Plant and consists of a castiron frame of twelve lights whose upper row comprised segmental headed panes (Plate 83).

Plate 83: Internal view of the arched window, looking south (scale 1m).

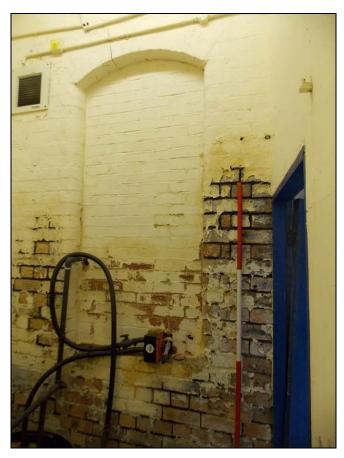
- 5.3.5 An equivalent window opening was identified within a small compartment immediately to the east of the roller shutter although the opening has been blocked with bricks (Plate 84).

Plate 84: Brick-up window opening within the eastern side of the south wall, looking south (scale 2m).
