# Yockings Gate Farm, Whitchurch, Shropshire

## Historic Building Assessment

**ARS Ltd Report 2016/76**

May 2016

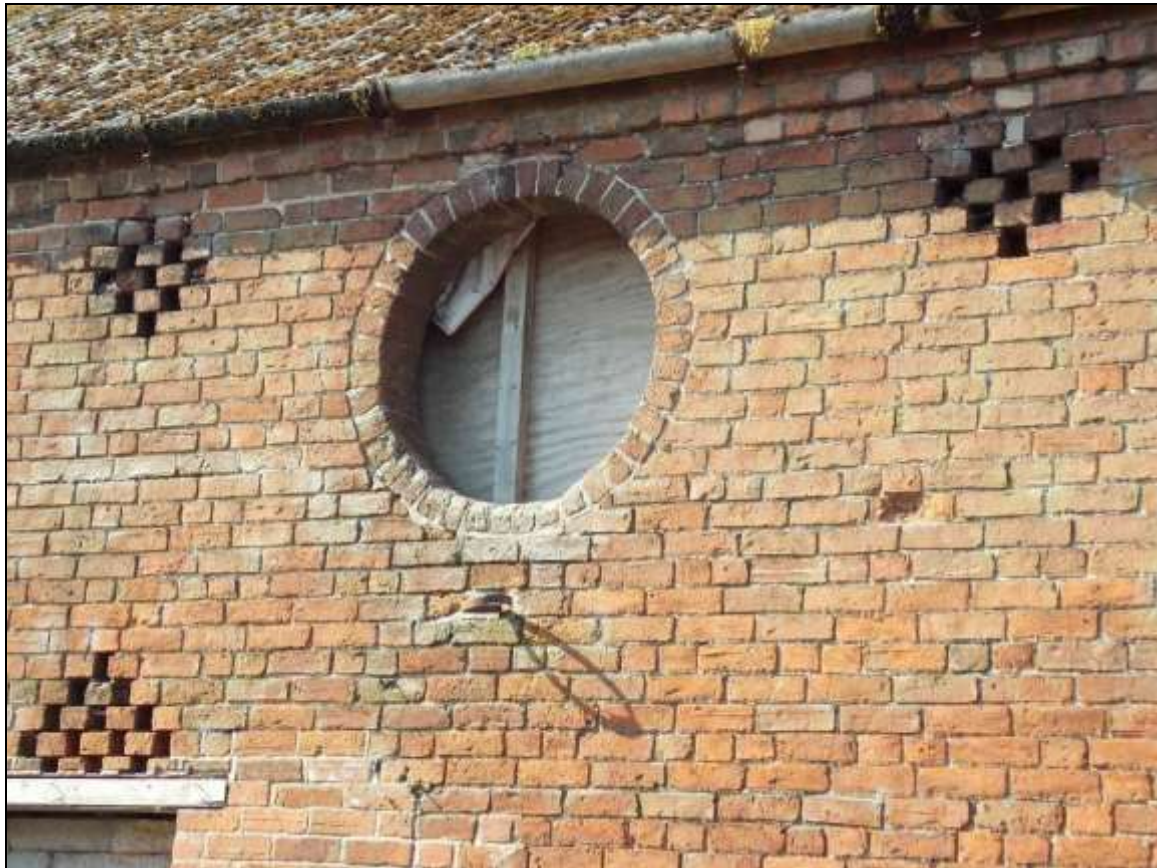
6.4.2 The south-east section of the north-eastern elevation along the access lane of the farm contains an integral oculus and several primary diamond-shaped vents arranged in two horizontal rows of which the upper one comprises smaller vents than the ones within the lower row (Plates 41 and 42). There is also a series of later inserted openings including doorways and windows. The cornice is composed of later brick courses which occasionally truncates the uppermost section of the vents. These would have been laid when the roof was re-built. The north-west section consists of a later refaced brick wall containing an

Plate 42: Detail of oculus and diamond-shaped vents within the north-eastern elevation.

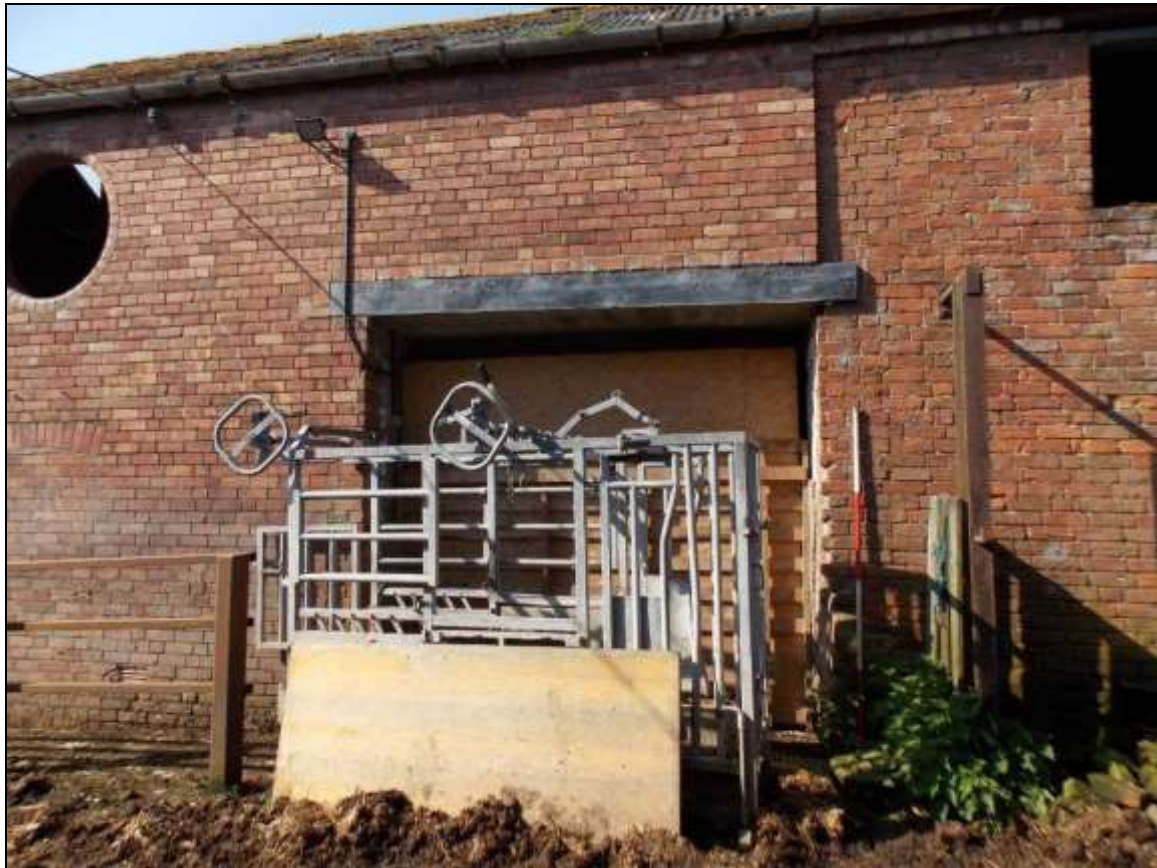
oculus and a large opening which leads to a passageway against Building C. The refaced wall projects up to 100mm and is built with machine-made orangey bricks (8½" x 4½" x 3") bonded with beige sandy mortar and laid in Flemish Garden Wall bond. Below the oculus there is a possible window opening bricked up with a flat arched head equivalent to the construction identified within Building A (Plate 43). The passageway appears to have been recently used to provide access to cattle into the courtyard. The north-western edge of the lintel, which is concealed with a timber plank, is inserted into the masonry of the adjacent Building C (Plate 44).

Plate 44: Gate for livestock leading to a large inserted passageway, looking south-west (scale 2m).

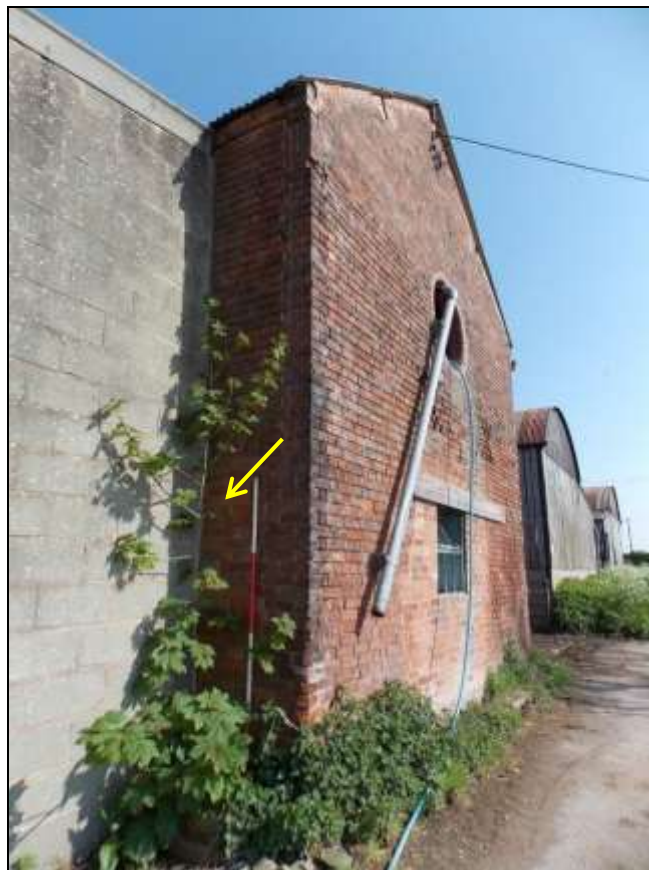
6.4.3 The south-western elevation which faces onto the courtyard is partially obscured by a modern lean-to extension (Building E). An inserted window opening with flat arched head, comparable to the one recorded in Building A, was identified towards the south-eastern edge although this had been blocked up possibly when the extension was erected against it (Plate 45). Further details of this elevation were observed from inside Building E including an almost undisturbed upper row of diamond-shaped vents (Plate 46). The corresponding vents facing onto the courtyard have been crudely blocked up with later bricks although these are clearly identifiable. This section of wall also comprises an inserted large doorway which would have contained a sliding door as indicated by the surviving rack above the lintel. This doorway leads to a milking parlour inside the ground floor. The wall also contains the passageway opening to the north-west and a blocked-up doorway with a soldier brick head towards the south-east (Plate 47). The bricked-up doorway might have been contemporary with the later rebuilt of Building A as indicated by the type of machine-made bricks employed to create the opening's head. Moreover, the wall also contains a large repaired/rebuilt section adjacent to the blocked-up doorway built with the same type of machine-made bricks.

Plate 45: Gable wall and blocked-up opening (arrow) within the south-western elevation (scale 2m).

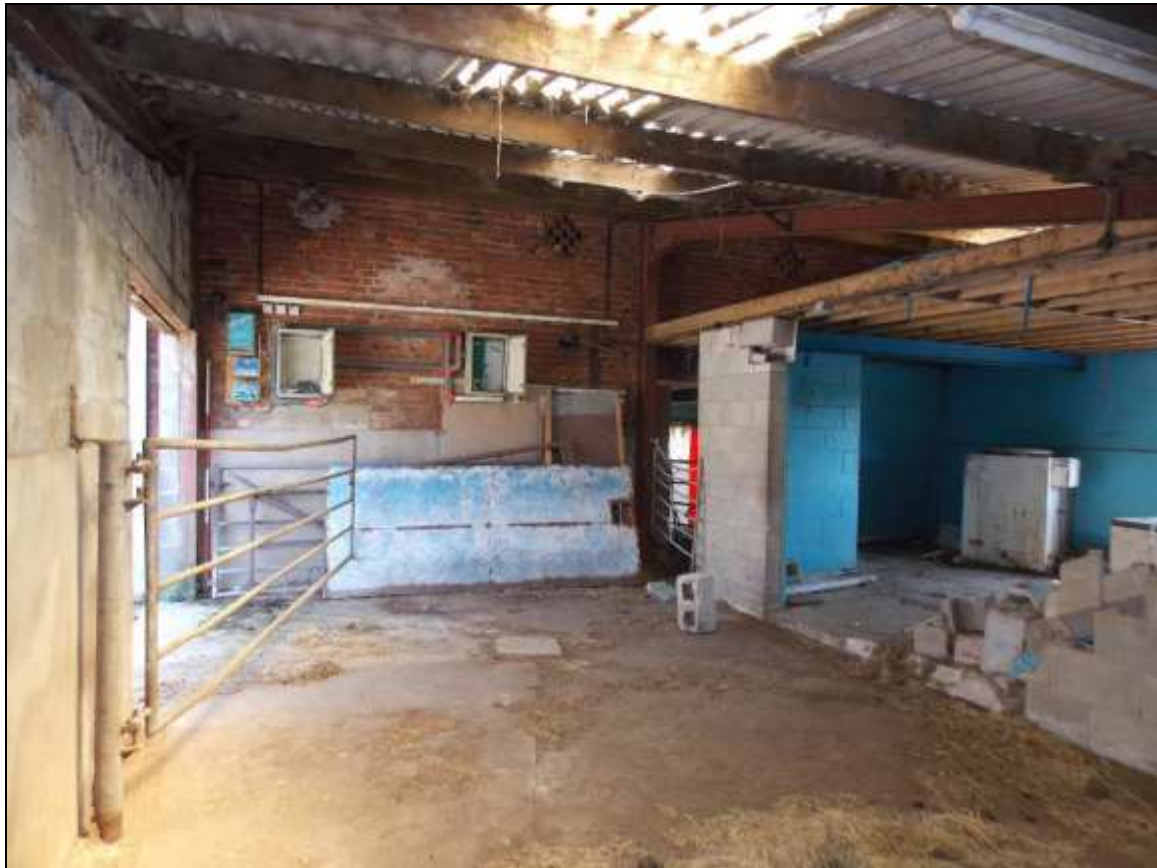
Plate 46: South-western elevation with diamond-shaped vents viewed from inside Building E (scale 2m).

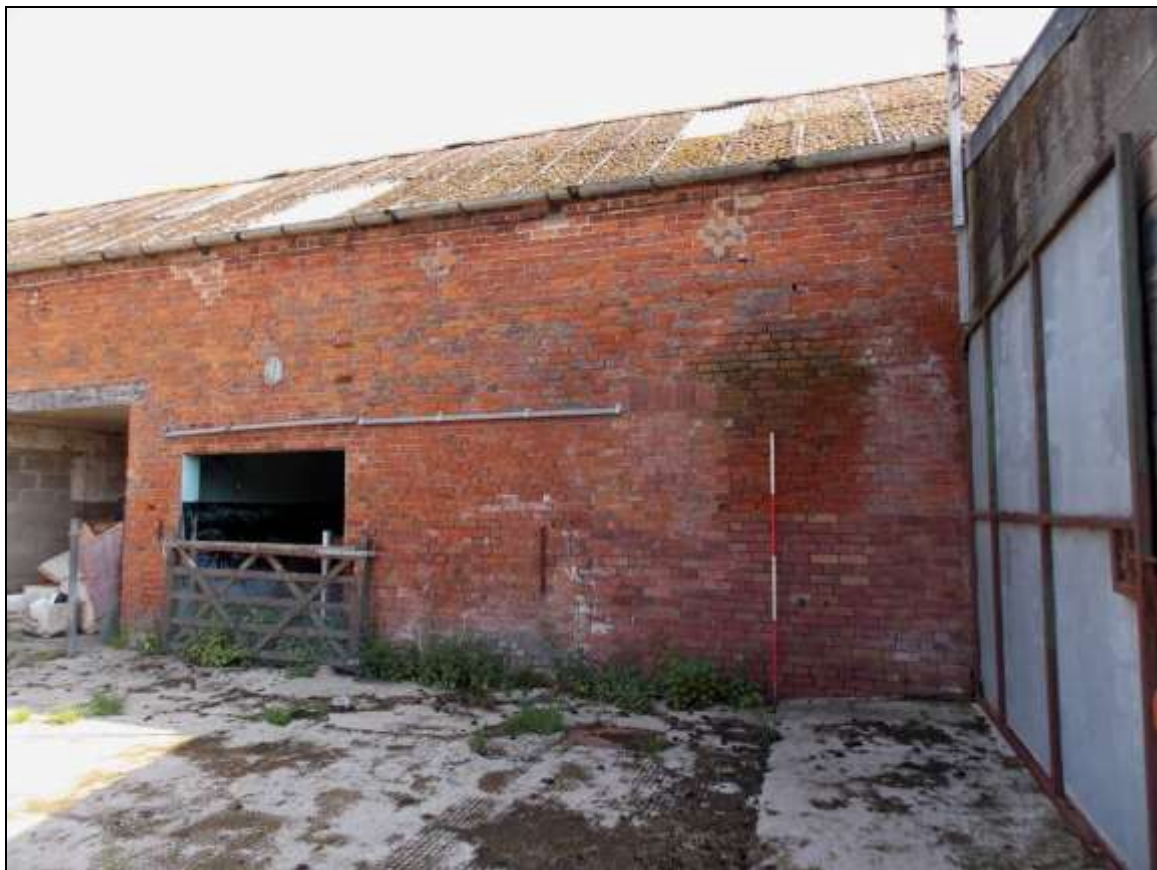
Plate 47: South-western elevation with blocked-up vents and a doorway (scale 2m).

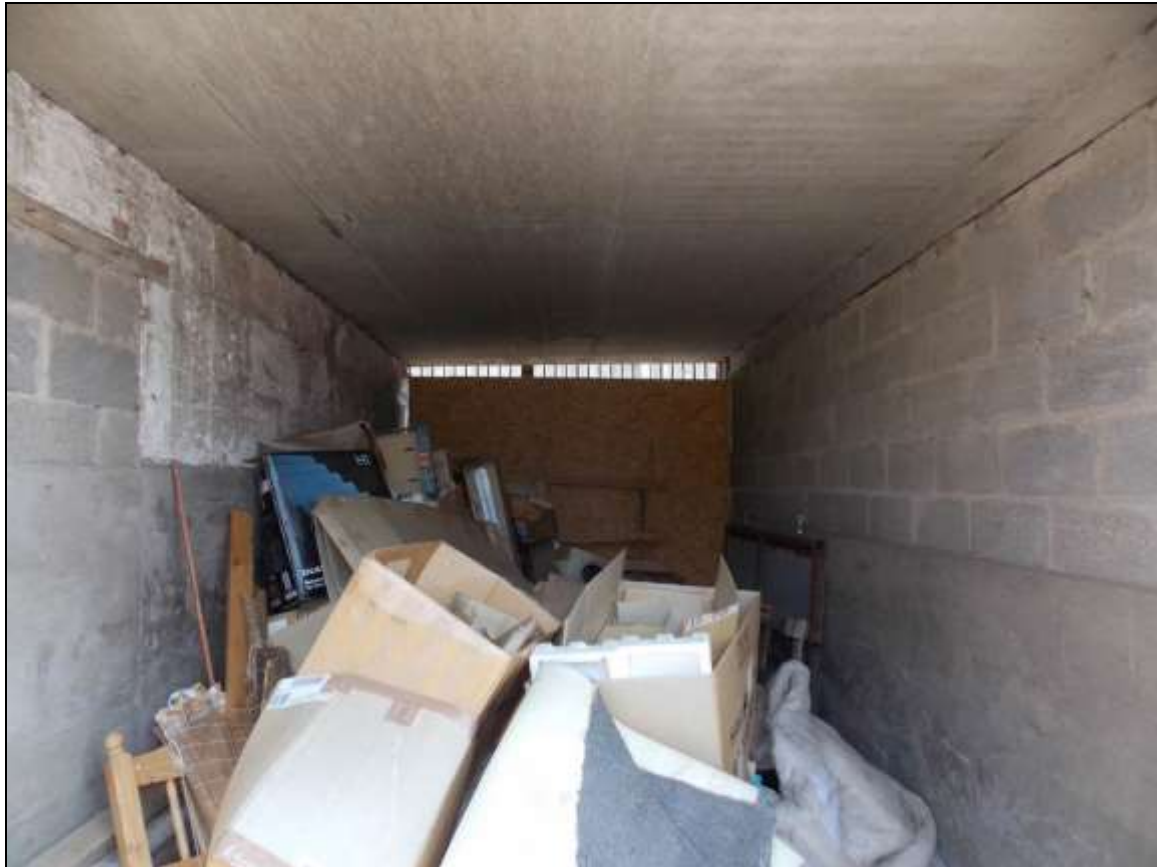
6.4.4 The passageway is built with a modern concrete block wall and the existing external gable elevation of the adjacent Building C which contains two doorways that have been blocked with concrete blocks (Plate 48). The milking parlour occupies most of the ground floor's space and contains part of the milking equipment. The general fabrics consist of render brick walls, a concrete floor and exposed bridging beams supporting later plasterboard. There is also a long brick-built pit with an overall depth of 950mm (Plates 49 and 50). The ceiling beams are sawn timber with narrow flat chamfered edges and contain inscribed shipping marks (Plate 51).

Plate 48: Internal view of the passageway of Building D, looking north-east.

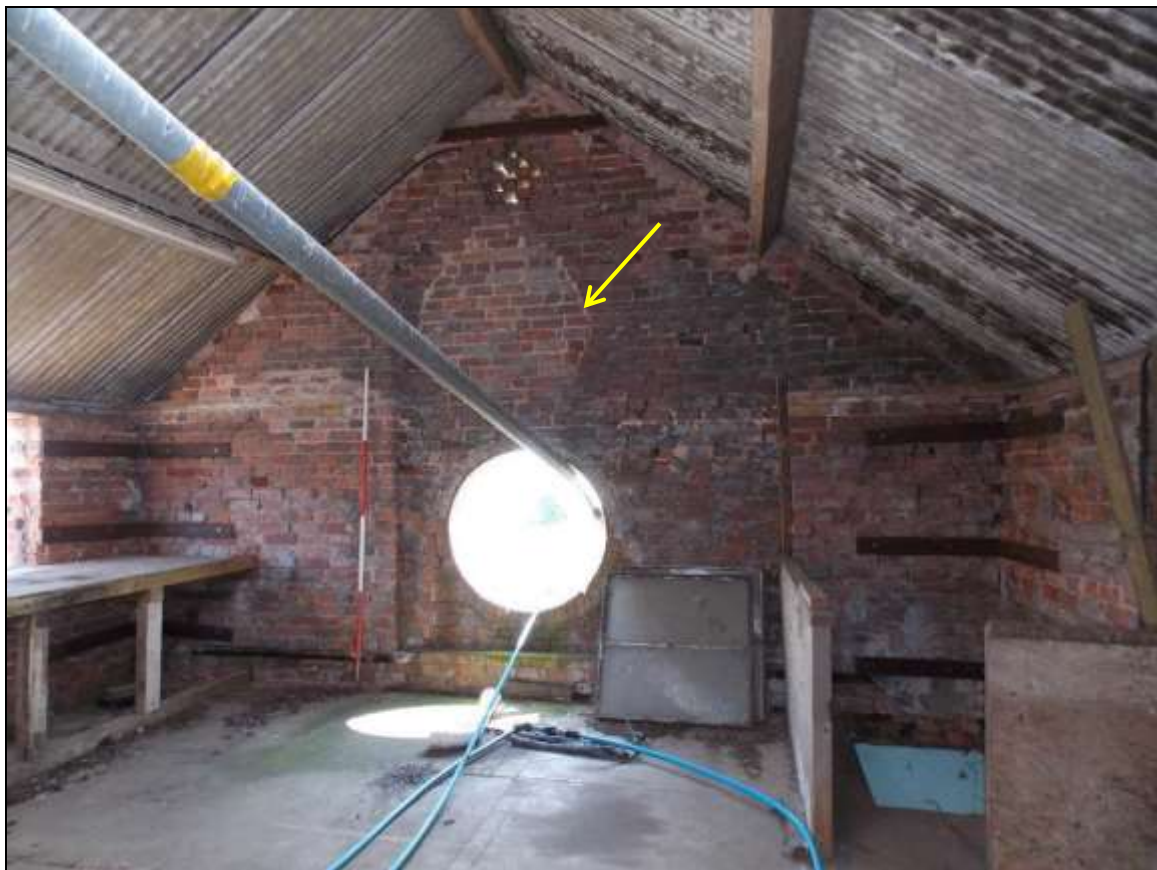
Plate 56: Gable wall with an inserted oculus which substituted a comparable opening above it (arrow).

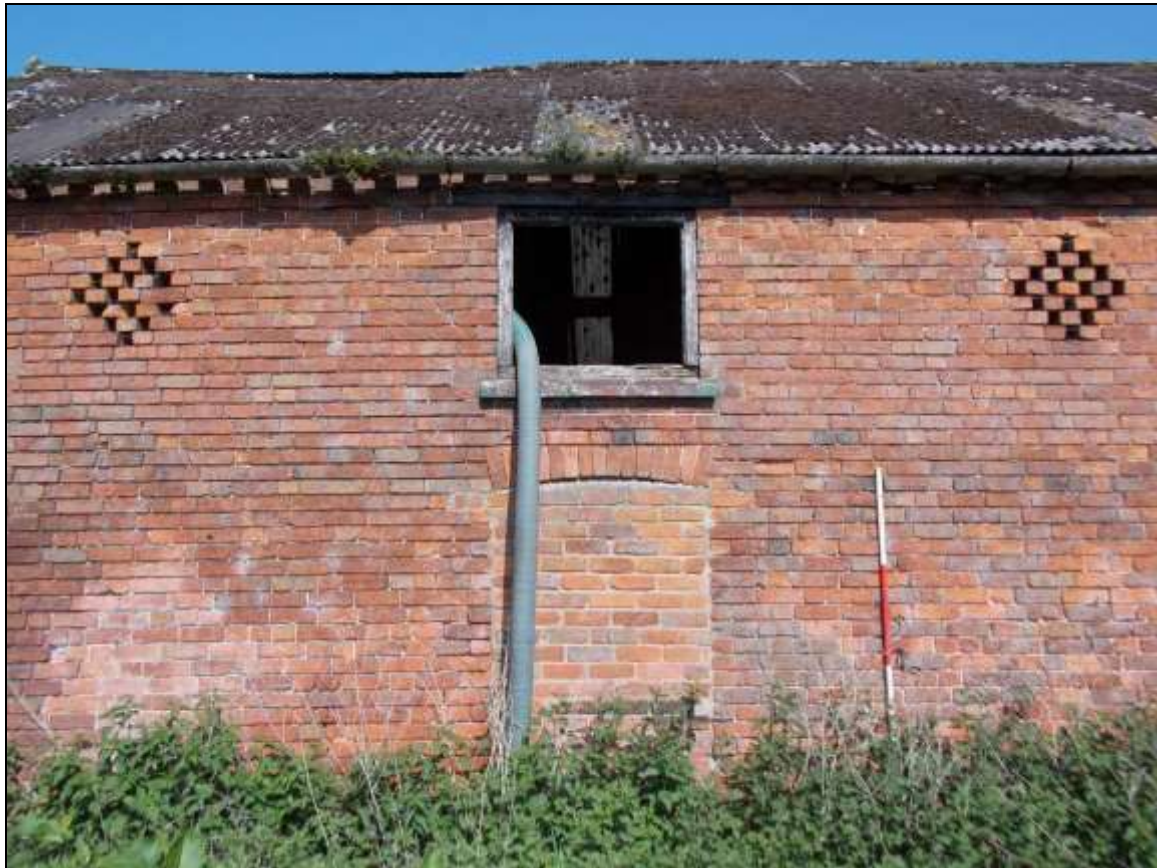
Plate 61: Blocked-up central doorway, looking north-west (scale 2m).

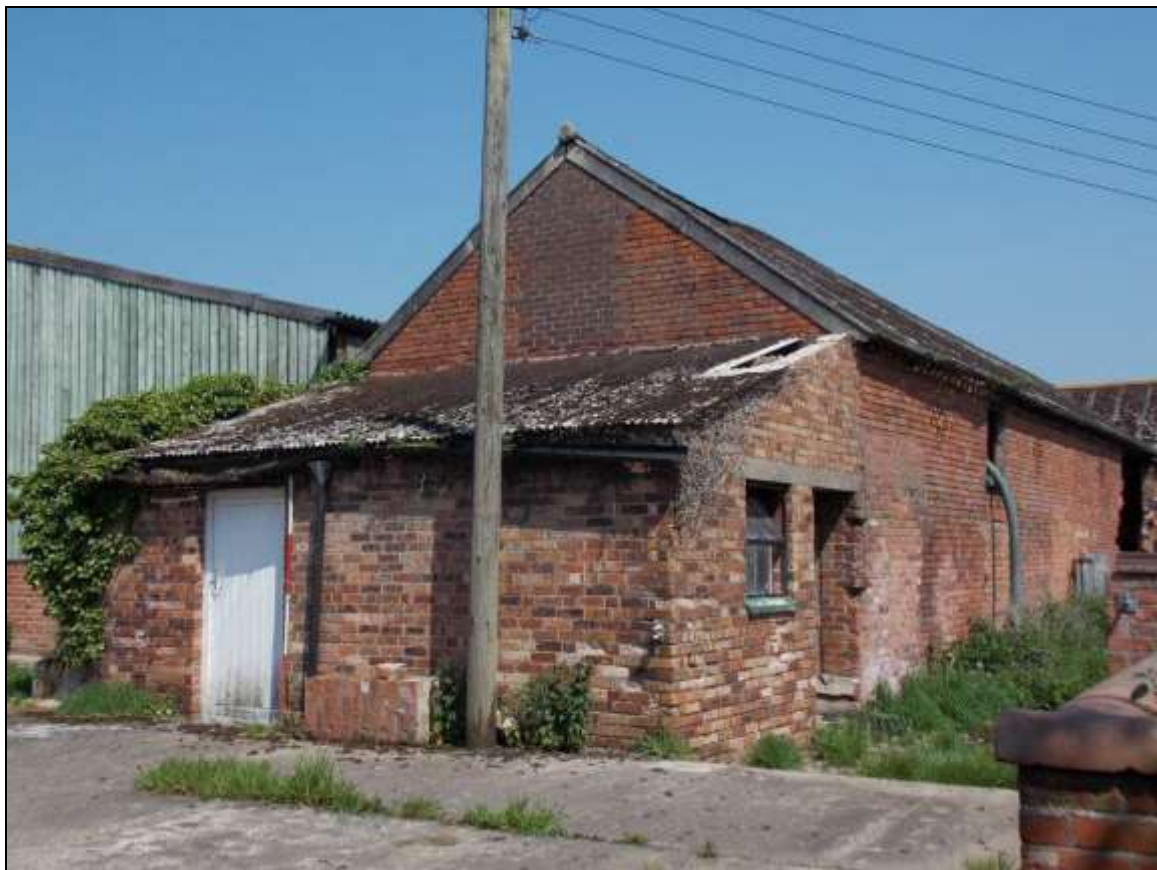
6.6.2 The south-western elevation is partially obscured by a later lean-to (Building I) and the gable above it appears to have been substantially repaired with darker coloured bricks (Plate 62). The corresponding side wall of the entire wing has been removed and is now opened up to a large modern steel warehouse whose stanchions support the wall plate with additional brackets (Plate 63).

Plate 62: Gable wall of Building F and later lean-to extension Building I, looking north-east (scale 2m).

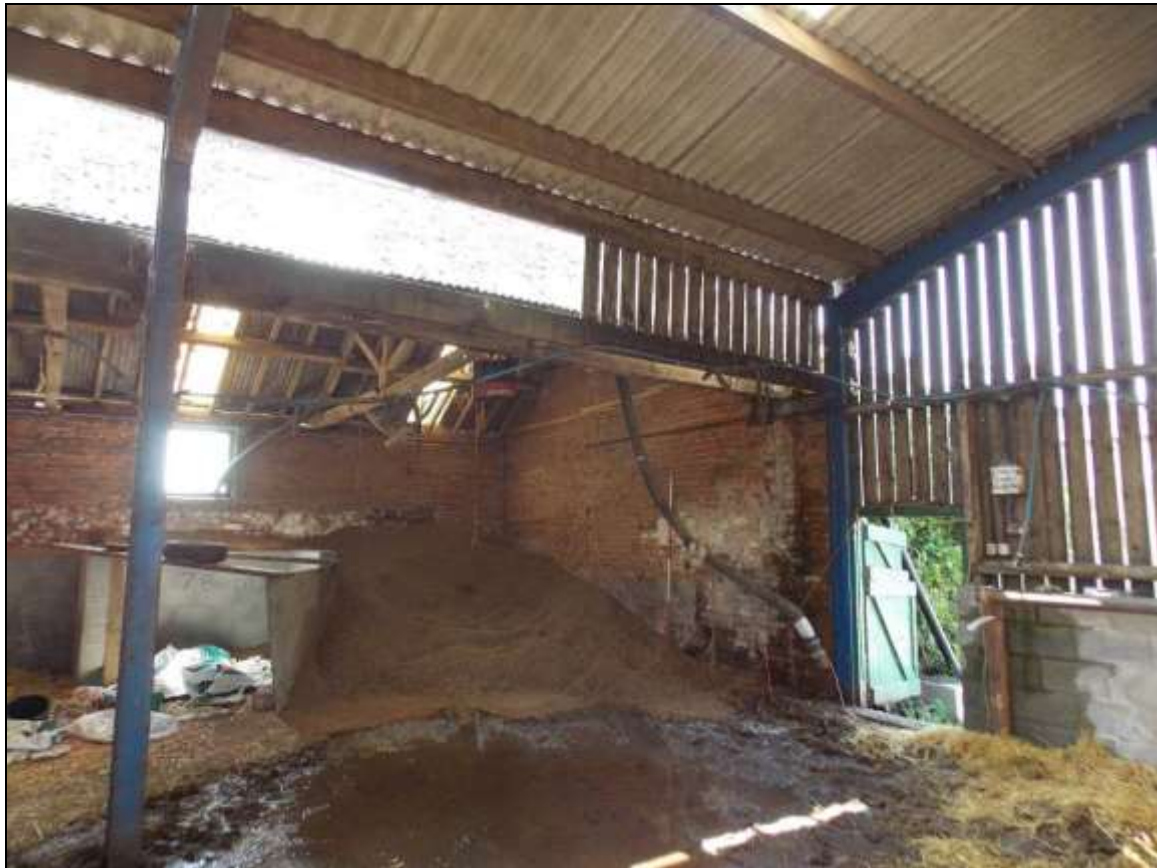
Plate 63: South-western end of Building F, looking south (scale 2m).

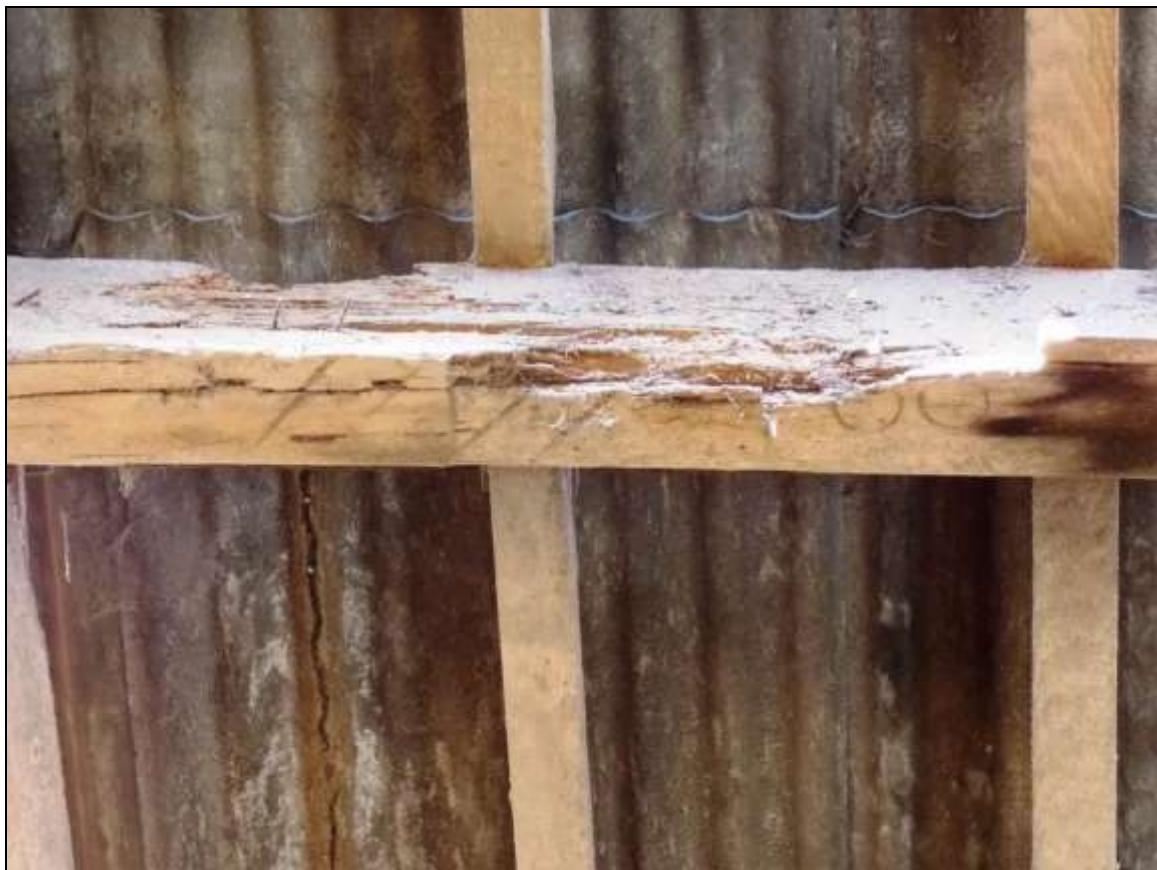
6.6.3 Internally it is an opened space where animal is stored. The general fabrics consist of partially rendered brick walls, a concrete floor and exposed roof trusses (Plate 64). The division between this range and the contiguous Building G would have consisted of a brick gable wall which has been removed. Testimony of the removed gable wall can be discerned within the internal wall which contains a clear vertical scar with partially hacked off bricks. Moreover, the removal of this wall involved the construction of improvised timber trusses supporting the corresponding purlin extremities which would have formerly been sustained by the gable wall. Apart from the *ad hoc* end truss, the range comprises two slender king-post trusses with raking struts and pegged joints carrying four tiers of butt purlins staggered at joint with principal rafters and supporting the common rafters which are attached to the wall plates with bird mouth joints (Plate 65 and 66). The tie-beam of the south-western truss has split across it (Plate 67). The upper faces (looking south-west) of the trusses contain the pegs' heads and associated carpenter's assembly marks (Plate 68). Shipping marks were also identified within one of the side purlins despite some root damage (Plate 69).

Plate 69: Shipping mark within a side purlin of Building F.

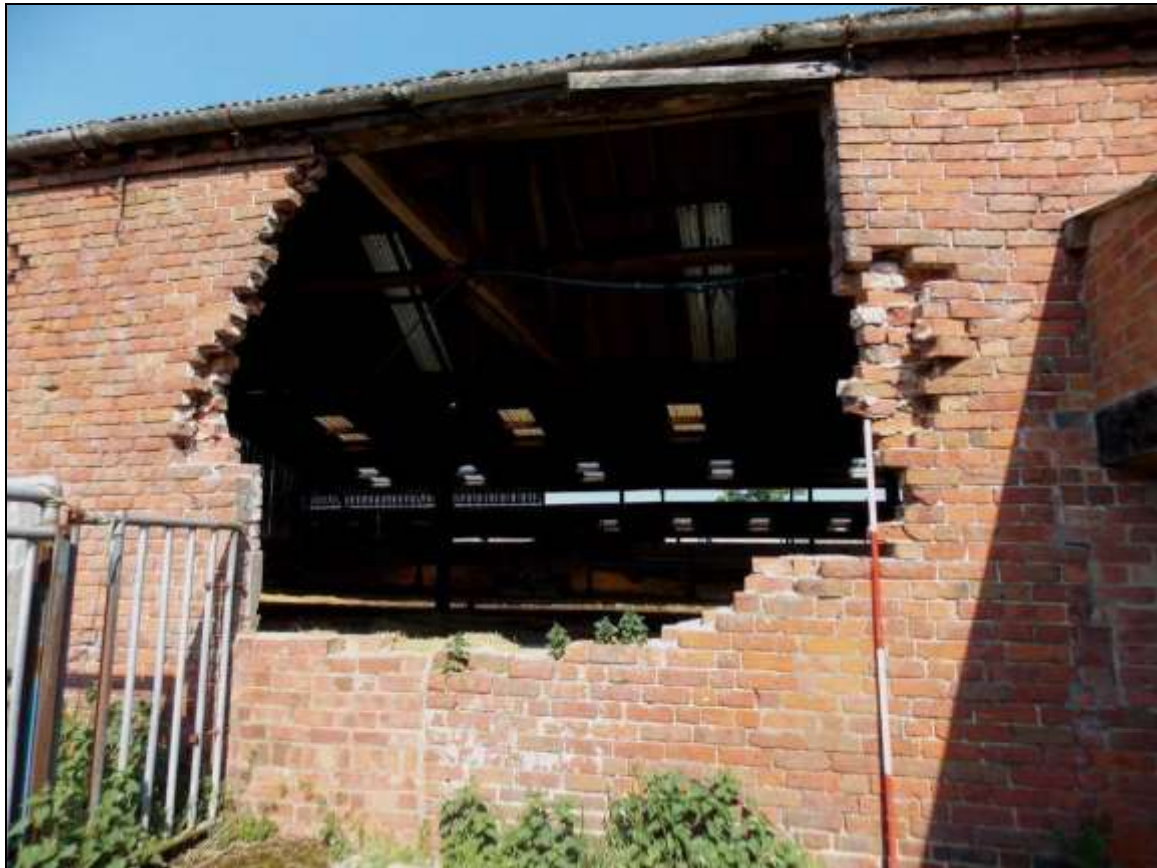
6.7.1 Building G consists of the north-eastern range of the SW/NE wing of the L-shaped merged complex. The south-eastern elevation facing onto the courtyard seems, at first glance, the same construction as the adjacent Building F (Plate 70). However, internal evidence discussed in the preceding building indicates that these are two merged structures built with the same type of bricks and laid in the same style and including comparable diamond-shaped vents. The wall has been modified with the insertion of later openings and is now partially destroyed around the central area where a large hole exists between the jamb of a former window opening and a blocked up doorway (Plate 71 and 72).

Plate 71: Partially destroyed wall with remnants of a former window and a blocked-up doorway (scale 2m).

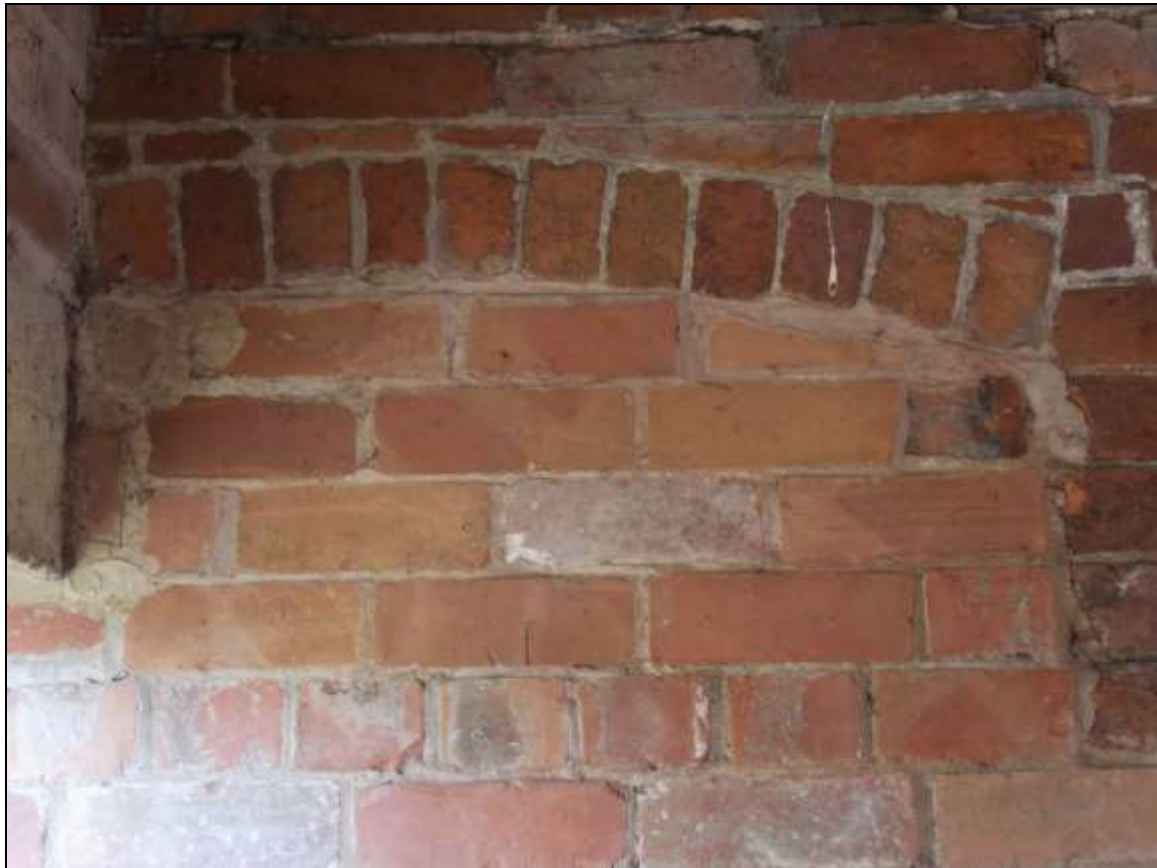
6.7.2 There are two inserted window openings with segmental arched heads created with a single course of headers. These window openings are now blocked with bricks (Plates 73 and 74). Of note is a slightly unclear jagged joint above the head of the south-westernmost window opening whose position matches the irrefutable internal division between these two buildings (Plate 74). The north-eastern end of the façade is mostly obscured by a later lean-to structure (Building H).

Plate 73: Blocked-up window opening abutted by Building H, looking north-west.

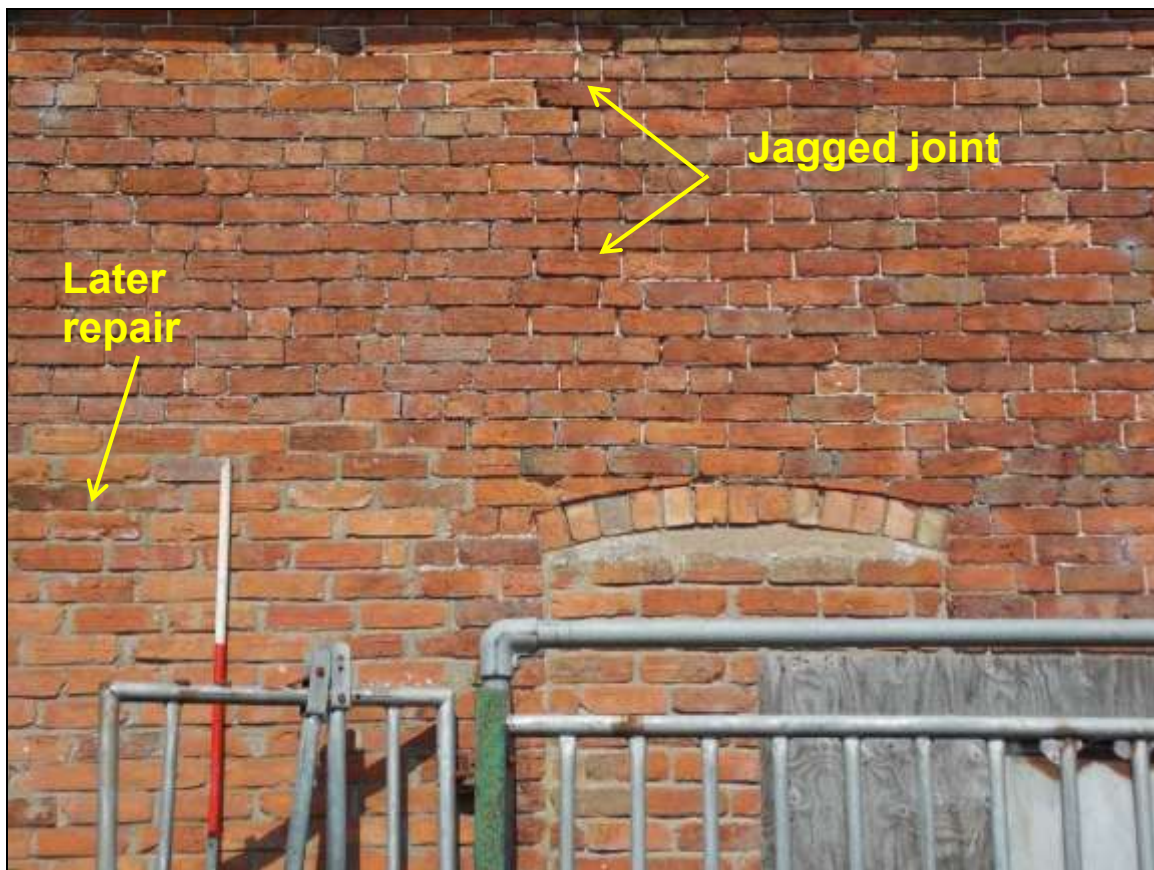
Plate 74: Blocked-up window opening and unclear jagged joint above the segmental head (scale 1m).

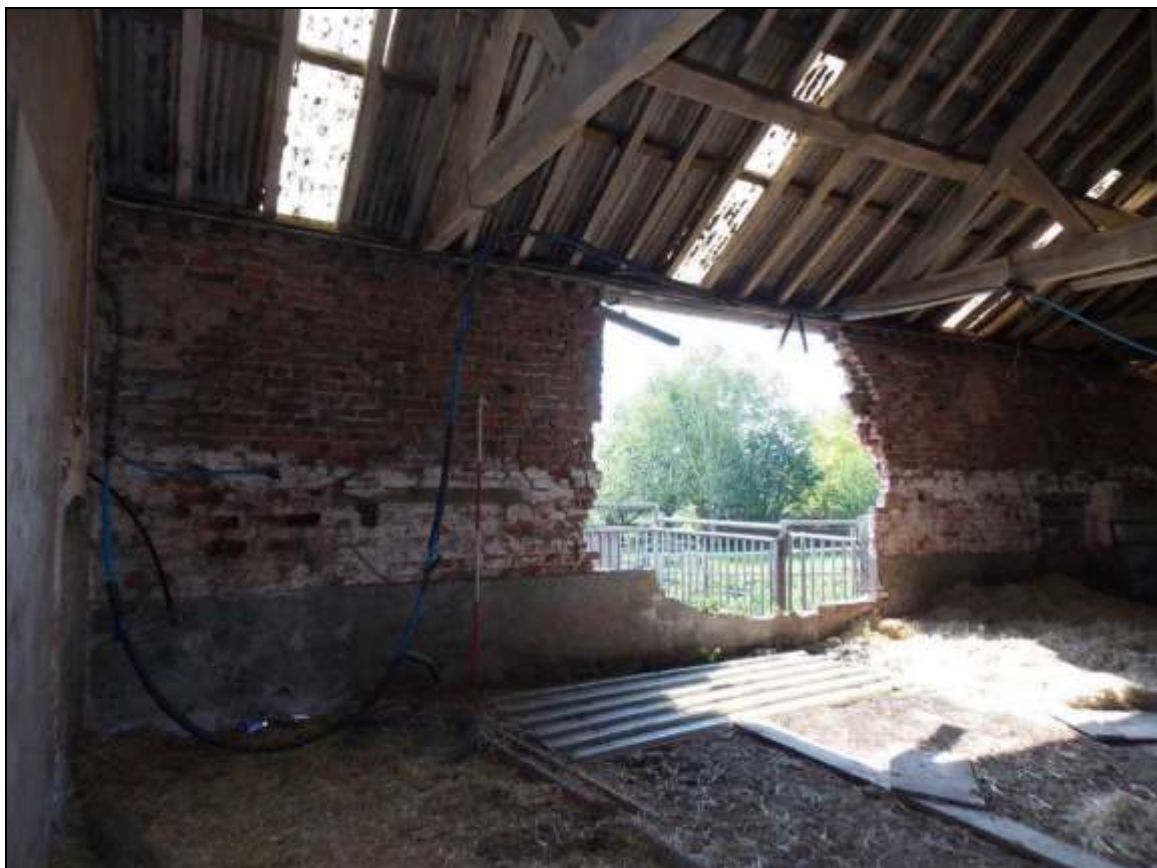
6.7.3 Internally it is an opened space with partially rendered brick walls, a concrete floor and exposed roof trusses (Plate 75). The division between this range and the contiguous Building F would have consisted of a brick gable wall which has been removed. Testimony of the removed gable wall can be discerned within the internal wall which contains a clear vertical scar with partially hacked off bricks above the segmental head of the inserted window (Plate 76). Moreover, the removal of this wall involved the construction of improvised timber trusses supporting the corresponding purlin extremities which would have formerly been sustained by the gable wall (Plate 77). Apart from the *ad hoc* end truss, the range comprises two sturdy king-post trusses with raking struts and pegged joints carrying two tiers of trenched purlins supporting the common rafters. The upper faces (looking north-east) of the trusses contain the pegs' heads and associated carpenter's assembly marks (Plates 78 – 81).

Plate 75: Internal view of Building G with partially demolished wall, looking south-east (scale 2m).

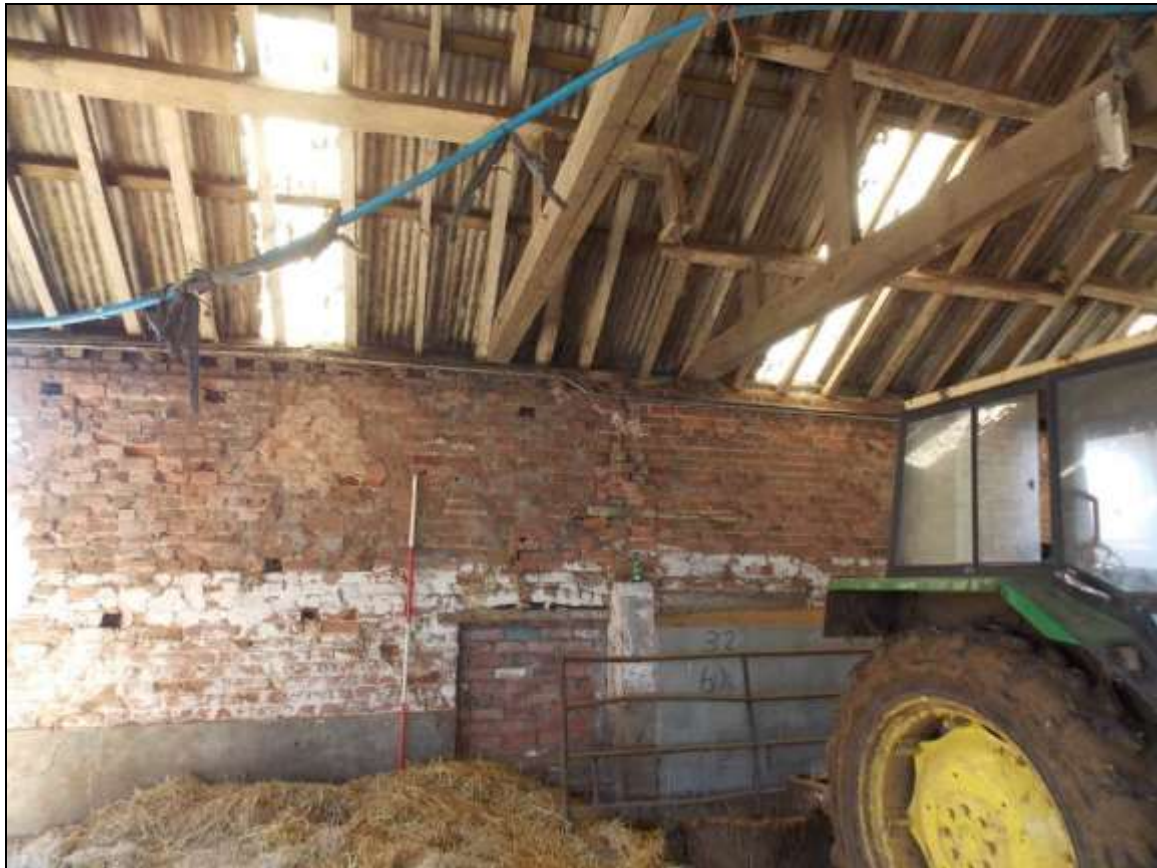
Plate 76: Vertical construction scar (arrow) and improvised trusses above it, looking south-east.

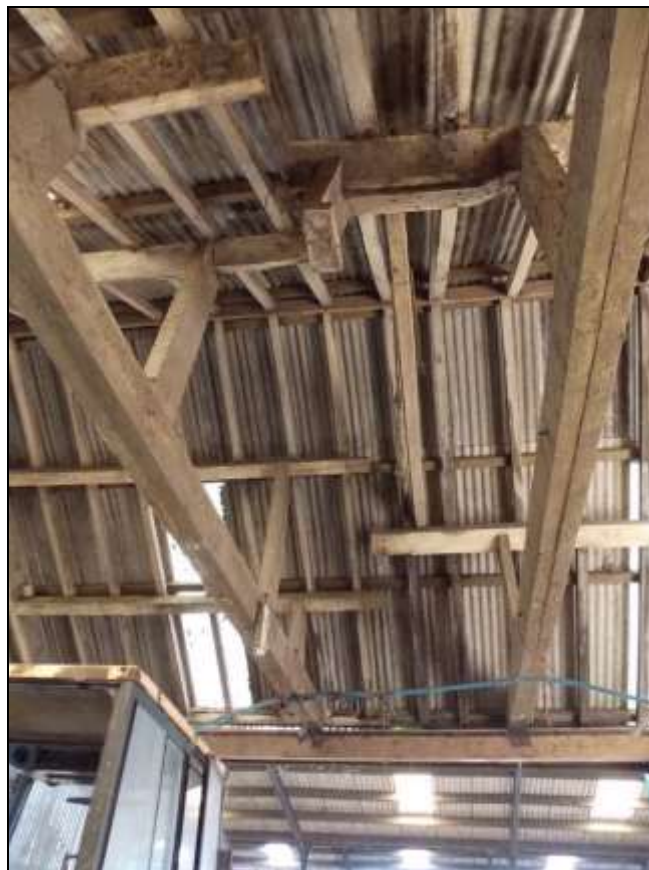
Plate 77: Detail of improvised trusses supporting the edges of side purlins of Buildings F and G.

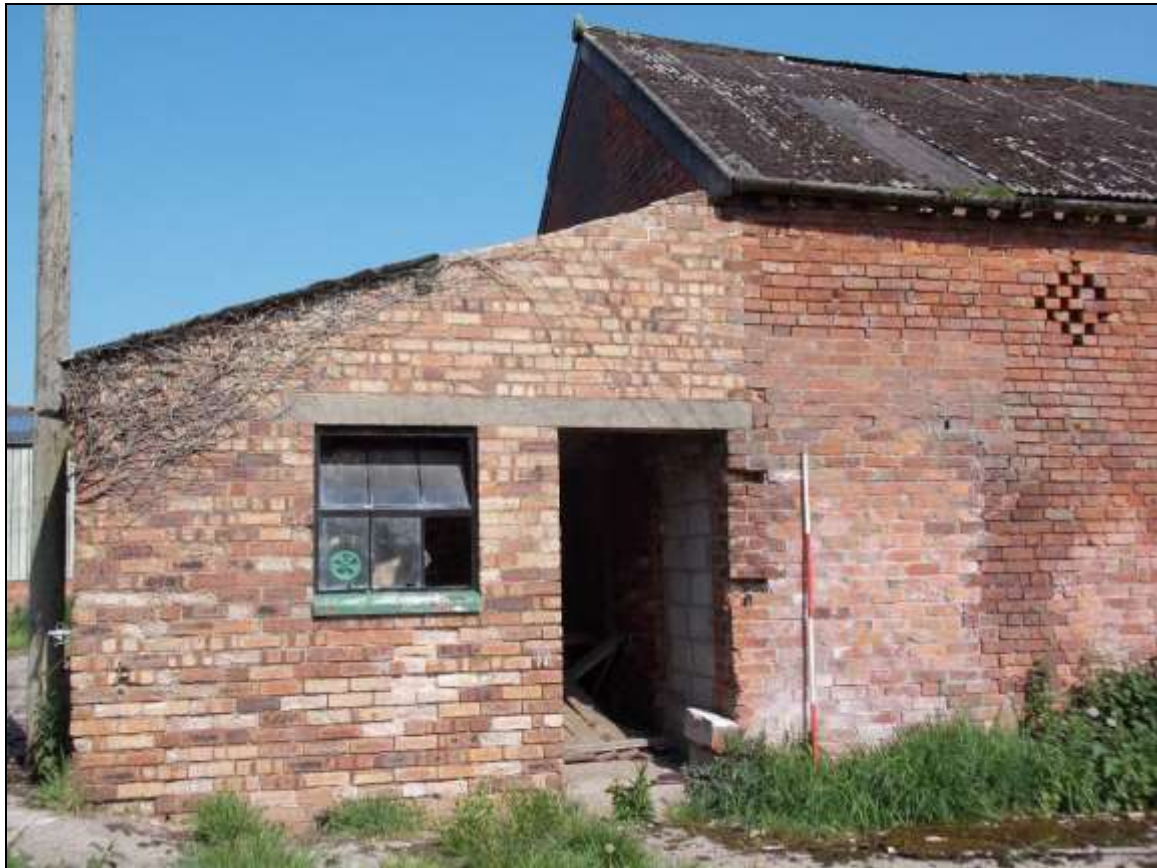
6.9.1 Building I is another small lean-to which abuts the gable wall of Building F and is built with modern bricks and an asbestos roof. Internally it consists of a passageway which leads to two separate small rooms with concrete floors and partially rendered walls (Plates 85 – 88). This structure was also erected in the mid-20<sup>th</sup> century and has no historic significance or architectural merit.

Plate 86: Doorway facing onto the courtyard, looking north-west (scale 2m).

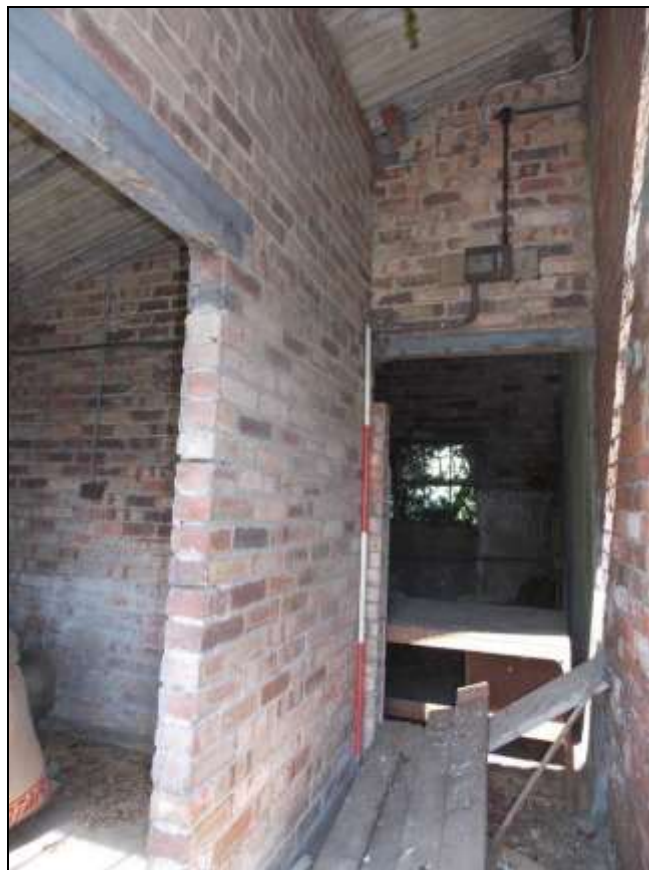
Plate 87: Passageway of Building I, looking north-west (scale 2m).

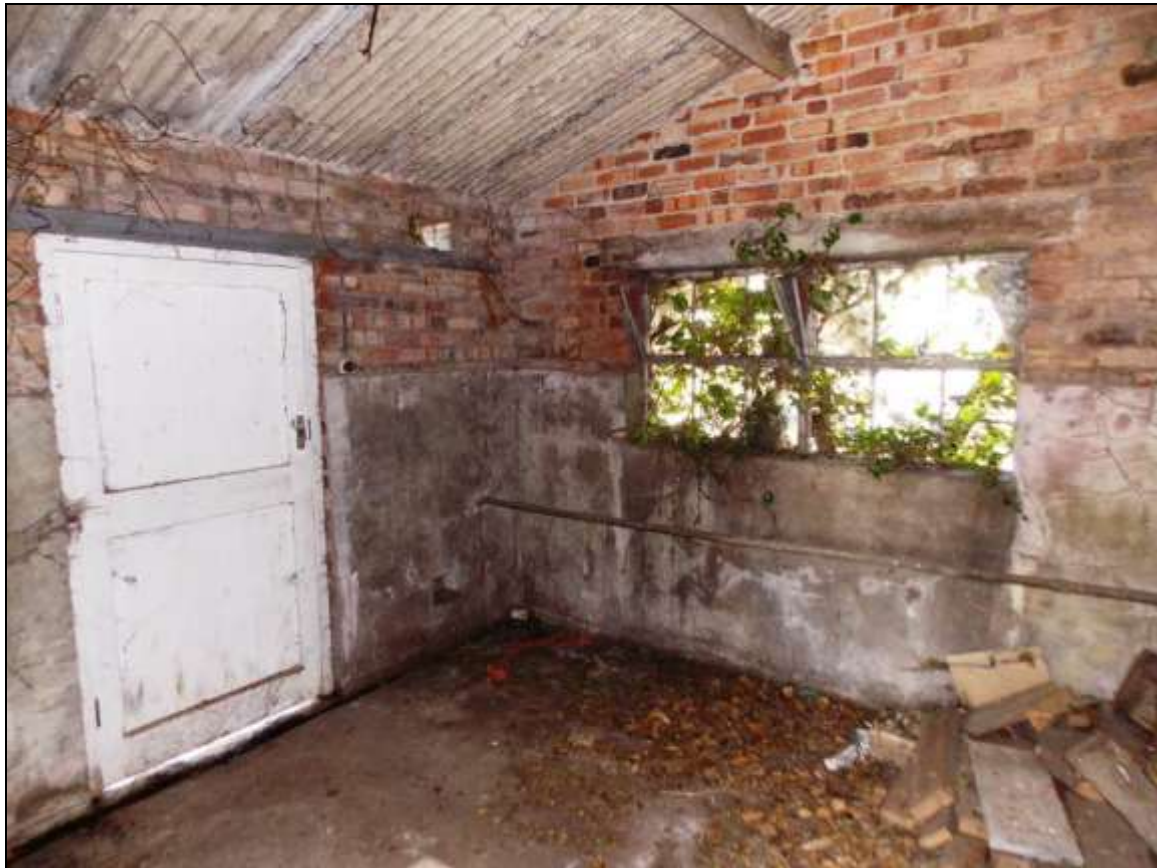
Plate 88: North-western room of Building I.
