**An Archaeological Assessment
and Photographic Building Recording at the
Balmoral Hotel, Newcastle upon Tyne.
Heritage statement.
Part B, Listed Building Appraisal**

Archaeological Research Services Ltd Report No. 2008/57
July 2008

**Heritage statement.
Planning application.
Part B, Listed Building Appraisal.**

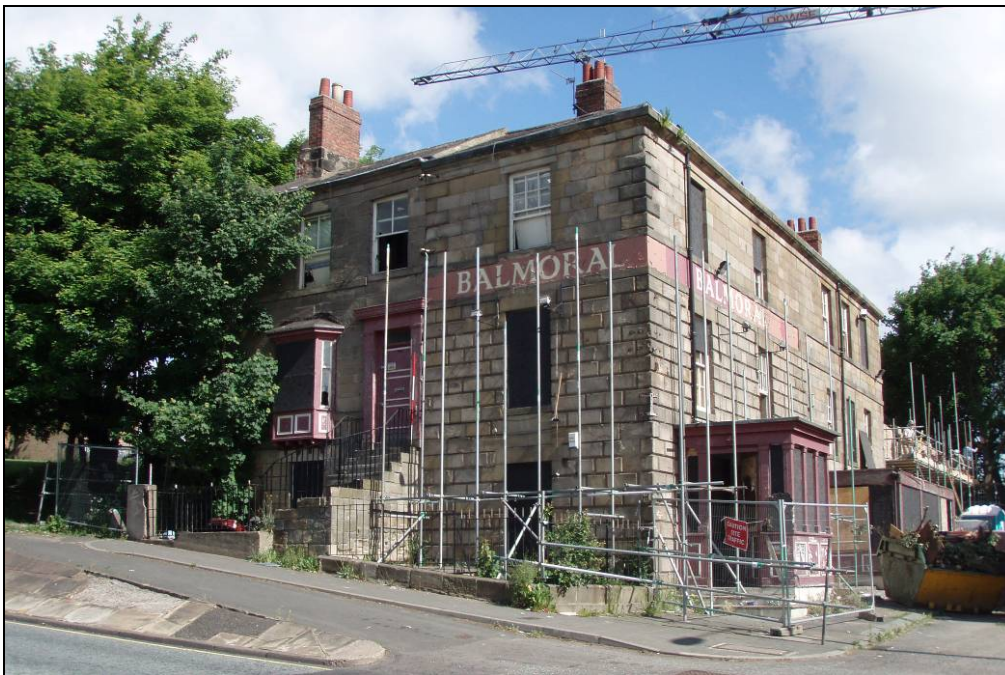
Fig 1. Balmoral profile shot showing south and east elevations.

The windows to the south elevation (fig. 1) are present on 3 floors. The 2nd floor windows are again of the sash design. To the western side of this elevation the windows differ from the rest as these windows only contain 4 panes of glass (fig. 7). This is a later developed technique which indicates a Victorian date as at this time glass manufacture became more proficient allowing for larger panes to be used. To the eastern side of this south elevation the single window (fig. 8) is of the same design as the eastern elevation. 12 lights, separated by wooden transom and mullion bars. The window is wooden framed. Narrow sandstone lintels are built into the structure of the hotel. The cills are not only associated with the windows but are part of the string course which runs the length of the building.

- 2.4.6. All windows are to be replaced as they are rotten and badly damaged. Replacements are all to be sash, in wood, highly sympathetic to the existing as per the architect's drawings and the schedule of works.
