# An Archaeological Desk-Based Assessment at Chowdean Lodge, Low Fell, Gateshead

Archaeological Research Services Ltd  
Report No. 2009/21  
March 2009

# **An Archaeological Desk-Based Assessment at Chowdean Lodge, Low Fell, Gateshead.**

**Archaeological Research Services Ltd Report 2009/21**

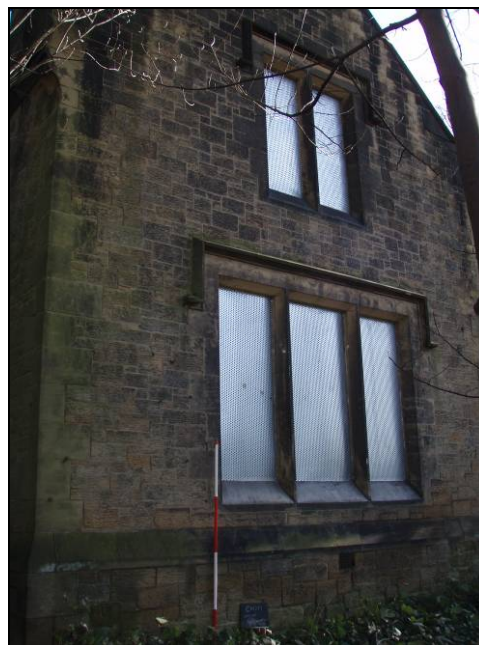
Fig. 17 Exterior west elevation central.

5.1.3. The central section of the west elevation (Fig. 17) has the same detailing as the southern section. The northern section of the western elevation (Fig. 18) has the same detailing as with the rest of the elevation but only two windows to the ground floor. The western elevation of the stable block is unremarkable and largely hidden by foliage (Fig. 19).

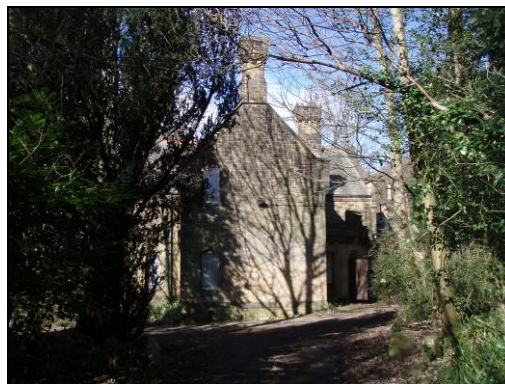
Fig. 20 Exterior south elevation, central section

The central section of the southern elevation (Fig. 20) has two narrow windows framed in sandstone, one to the ground floor and one to the first floor. There are

no remarkable architectural details on this elevation other than the large chimney on its roof. The western section of the southern elevation (Fig. 21) has a singular window on the ground floor.

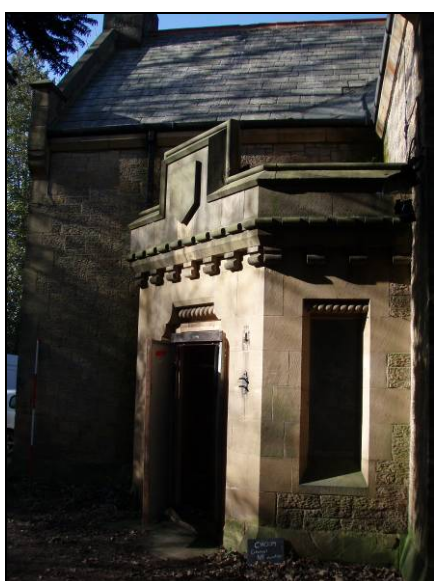
Fig. 23 External east elevation, porch.

Upon visiting the site, the most notable feature of the building is its prominent ornate ashlar doorway/ entrance porch (Fig. 23) which is to the south of the eastern elevation. Featuring mock battlements and rope mouldings above the windows and doors it also has a large shield inset (which is replicated indoors). The eastern elevation (Fig. 24) has four windows to the ground floor and three to the first floor. The southern most window on the first floor has been converted into an emergency fire escape. All windows are framed by sandstone blocks.

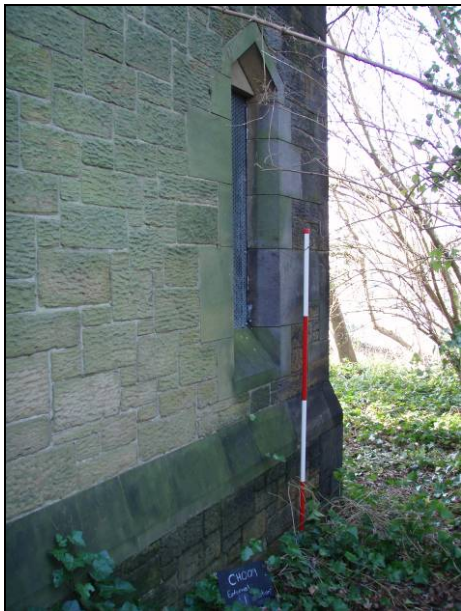
Fig. 25 External north elevation.

The north facing elevation is difficult to access due to the high level of tree cover and foliage, as a result only the western most extent of the north elevation was photographed. This elevation (Fig. 25) consisted of two narrow windows, one to the ground floor and one to the first floor. Each window has a sandstone frame with a unique point above which does not appear on other windows on the property.

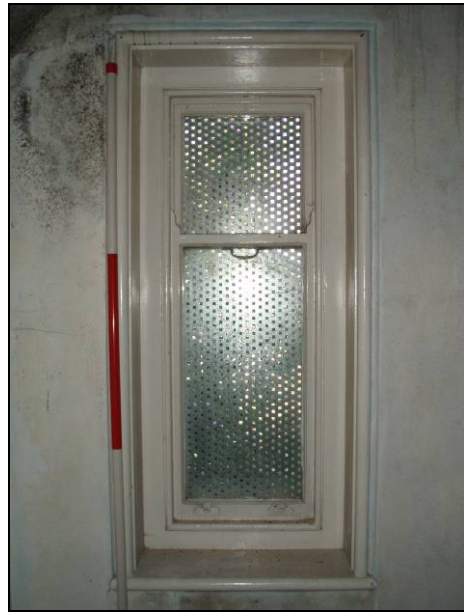
Fig. 40 Small sash window in Room 8.

This room has the same skirting as the other rooms but no coving or dado rail. A fire place and surround are present with a tiled hearth. There are two sash windows (Fig. 41) on the western elevation and a single sash window to the north (Fig. 40). The walls in this room were badly damaged through the leaking roof. Damp and rot are evident and have made the plaster come away from the walls. The flooring has also suffered through the damp damaging the skirting and floor boards. The room has a large wood panelled door

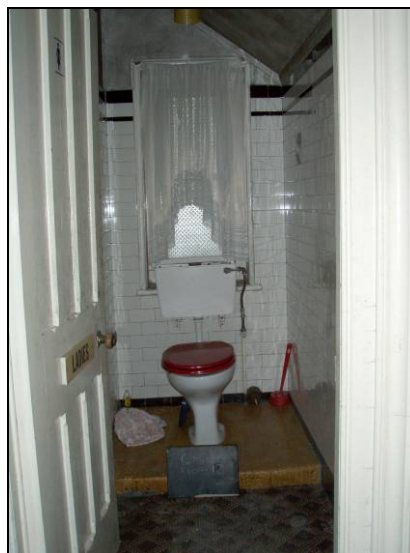
Fig. 46 Toilet Room 12

Room 12 is a small toilet room, with a sloped ceiling and tiled walls (Fig. 46) there is a small sash window on the eastern elevation.
