**An Archaeological Building Recording  
of Trinity House and 1, 2, 3 Trinity Chare, Broad  
Chare, Newcastle Upon Tyne.**

**Archaeological Research Services Ltd Report No. 2009/52**  
August 2009

**An Archaeological Building Recording  
of Trinity House and 1, 2, 3 Trinity Chare, Broad Chare, Newcastle  
Upon Tyne.**

**Archaeological Research Services Ltd Report 2009/52**

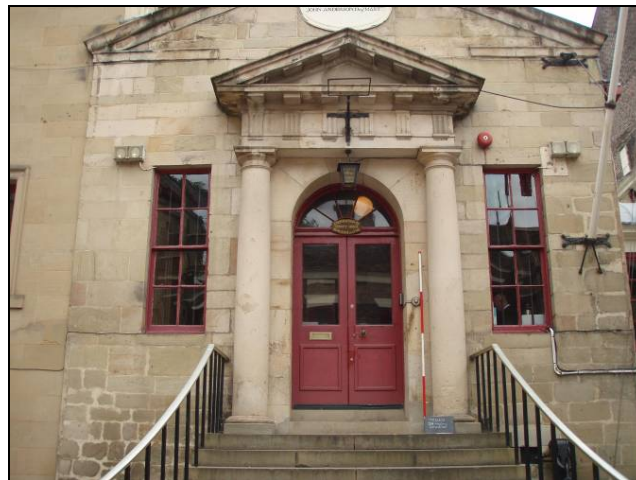
Fig. 3 South West facing elevation

The south west elevation of Trinity House is constructed of large ashlar stone sets. A central entrance way (Fig. 4) is framed by sandstone columns with ornate moulding above. A plain wooden door with two lights is topped with an arch of five lights. Either side of the sandstone pillars there are two sash windows each having eight lights, with wooden transoms, mullions and frames (Fig. 4). The roof is pointed with moulded edges.

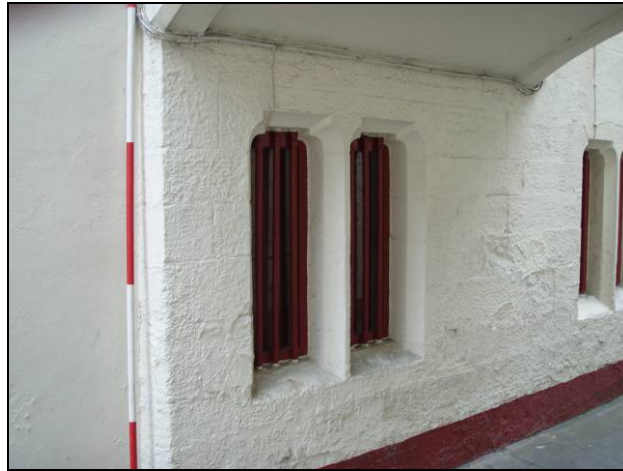
Fig. 5 South East facing elevation

A render has been applied to this elevation and has been painted white with red edging, although the ashlar underneath is still visible in pattern in the central section (Fig. 6). The ground floor has two small pointed arched doorways with

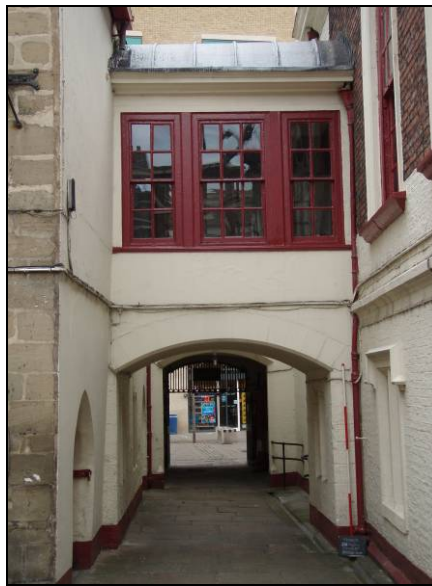
Fig. 6 South East facing elevation

wooden doors. The central part of the elevation has two sets of two windows (Fig. 6). Each light is barred and has wooden frames and a moulded sandstone surround.

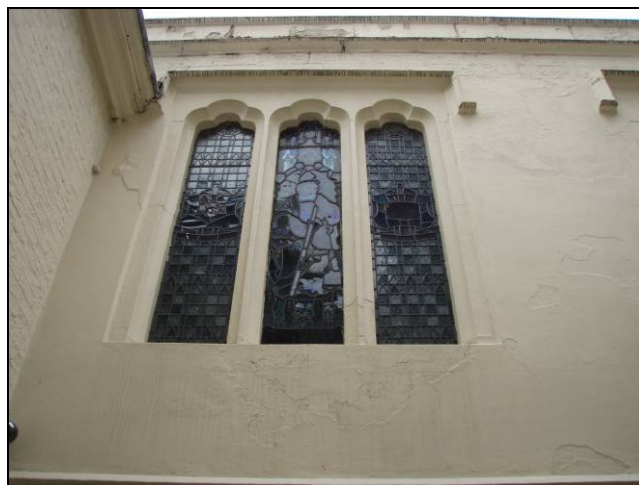
Fig. 7 Entrance passage with first floor bridge

- 4.2.1. The first floor of this elevation includes the arched walkway (Fig. 7) which has three sash windows and a sloped, lead-lined roof. Within the gap between the two archways, ornate windows are positioned facing each other on the south east and north west elevations (Fig. 8). These windows comprise of stained-glass lights with leading, and moulded sandstone surrounds. The guttering of the roof (first floor) is moulded from lead and is in a state of poor repair. (Fig. 26)

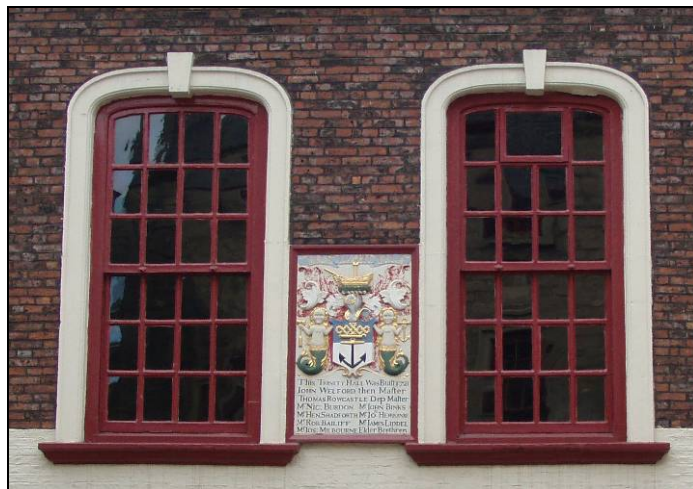
Fig. 9 North West facing elevation

This wing of Trinity house is constructed from brick. The ground floor has been rendered and painted white to match the portions of building constructed of sandstone, with exposed brickwork on the first floor. The ground floor has two small windows, one of which is blocked off; the other has a replacement light within the wooden frame and a moulded sandstone surround. The ground floor of this elevation also has a tunnel leading through to the rear of the building. The first floor has five large sash windows (Fig. 10), each containing 24 smaller lights with wooden transoms and mullions and decorative stone surrounds. A cill topped with lead runs the length of this elevation (Fig. 25) acting as a 'drip strip', or water run off. This cill is in a poor state of.

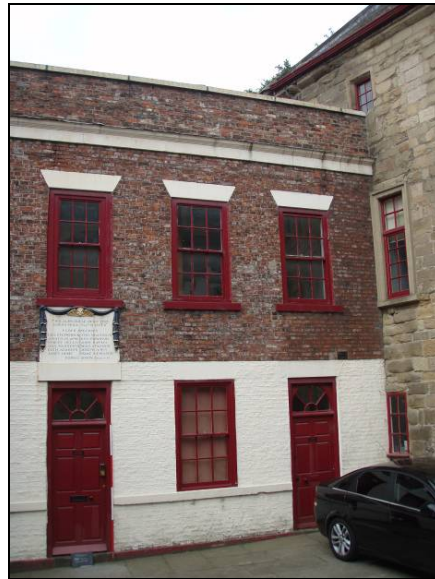
Fig. 12 North East facing elevation of Trinity Chare

This elevation is of the same construction as the north west elevations of Trinity House; white rendered brickwork on the ground floor and exposed brickwork above. The first floor has three doorways each with wooden doors and glass lights above. There are two windows, one either side of the central door. These sash windows have 12 individual lights separated by wooden transoms, mullions and wooden frames. The windows and doors each have a sandstone lintel (Fig. 14).

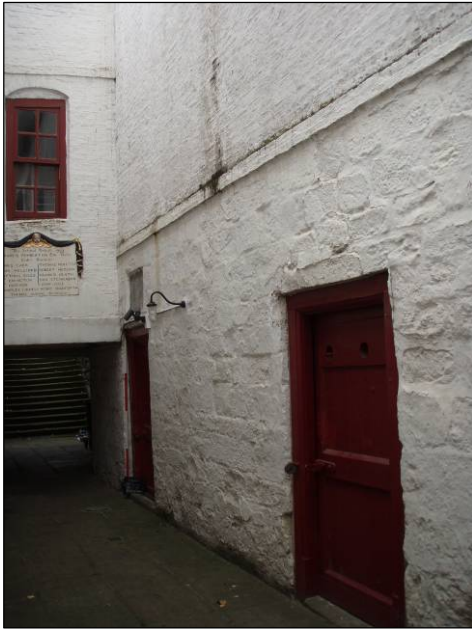
Fig. 17 South East facing elevation of stair case

The access passage to the rear of the buildings cuts through the north-west elevation of Trinity House north west facing elevation. The rear elevations of these buildings are, as with frontages, brick-built with a white render over it. Three large wood framed doorways line the wall but each have a modern replacement wood panelled door. A window sandstone surrounded and three lights is present on the ground floor with modern metal bars running across as later edition (Fig. 20). Two small sash windows are positioned one above the other on the first and second floor of the bridged portion of the building over the alleyway (Fig. 19). Towards the rear of the alley, closest to Trinity Chare, there are exposed sandstone lining the stairs. A small recessed window (now bricked up and barred Fig. 17) appears to be of an earlier date to the rest of the brick-built structure.
