An Archaeological Building Recording at Bay Tree Farmhouse, Rodsley, Derbyshire

ARS Ltd Report 2010/11
February 2010
Oasis I.D. archaeol5 – 72283

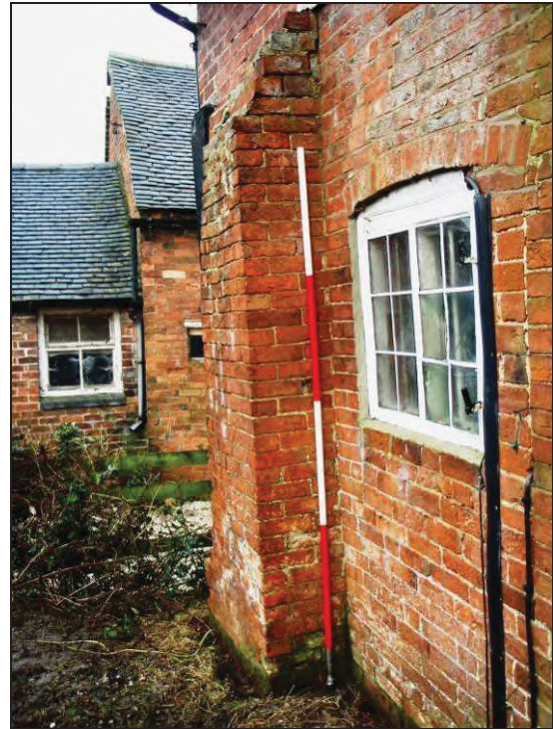
- 4.7 There is a small timber casement window with twelve lights which is inserted within a former blocked-up window opening with segmental arched head (Fig. 8). The blocked-up window opening is similar to the existing ones in the central and southern end of the elevation which may suggest that the nogged brick wall, within the timber-framed structure, is contemporary with the main southern extension.

Figure 8: Detail of the chimney and inserted window (scale 2m)

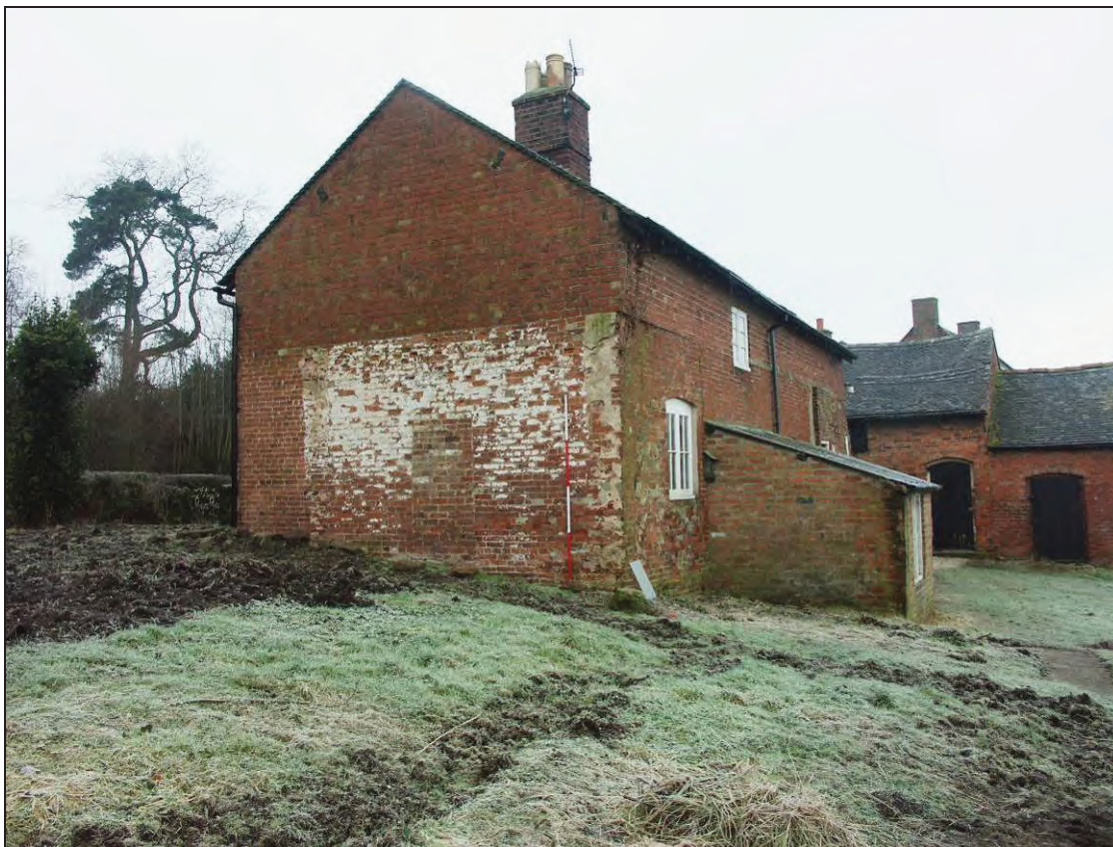
- 4.15 The south elevation is rather plain with a central doorway blocked with bricks which would have connected room G-4 with a brick structure abutting this wall of which brick scars are still perceivable (Figs 19 and 20). The former structure is also highlighted with the remains of lime wash in the brick wall. There is no sign of the former structure's roof as the top section of the current wall and gable were added later once the former structure was dismantled.

Figure 19: General view of the south elevation (scale 2m)

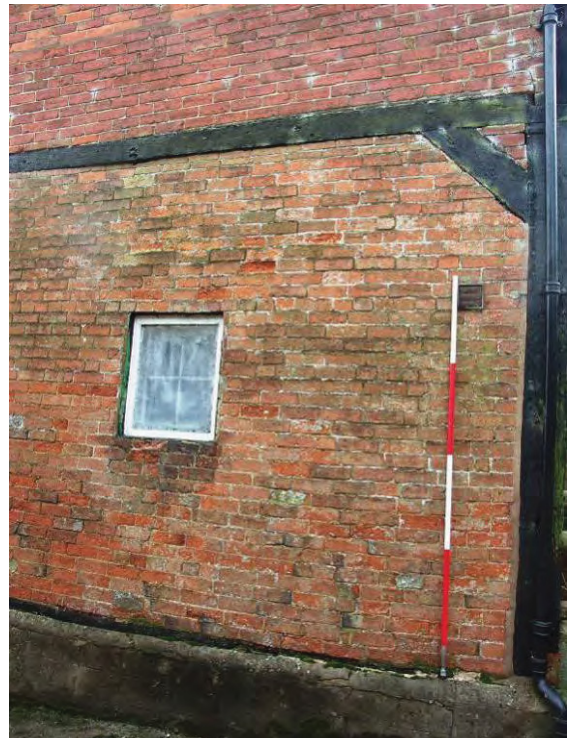
- 4.16 The north elevation is also fairly plain however; it has further *in situ* elements of the original timber-framed house. These consist of the principal posts tenoned in a wall sill, which is highly rotten, and supporting a wall plate reinforced with two straight up braces and two small iron braces (Figs 21 – 23). Both posts have empty peg's holes for a former rail. The wall plate and braces also have peg holes for studs which had been removed and replaced by the current nogged brickwork which is consistent with the side walls of the northern bay. There is a small fixed window within the nogged brick wall.

Figure 22: Detail of timber post, brace and wall plate

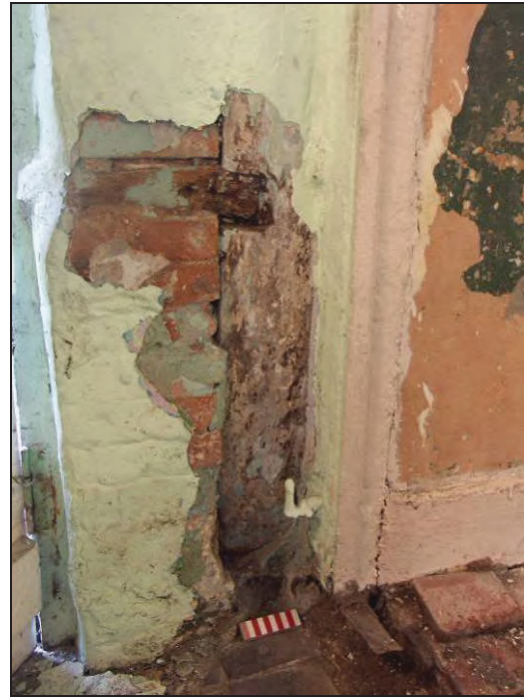
- 4.22 The southern wall has surviving elements of the original timber-framed house consisting of the wall rail and studs which are covered with paint (Fig. 26). The sill is missing and has been replaced with bricks. There is a doorway which leads to room G-3 on the southern wall and another doorway in the partition to room G-2.
- 4.23 Removed peg holes filled with cement can be seen on top of the south-east principal post (Fig. 27). The peg holes might have been the joint of a brace which had been removed. The post is in good condition however it is inclined due to earlier structural movements (Fig. 28).

Figure 28: Inclined S-E post in room G-2

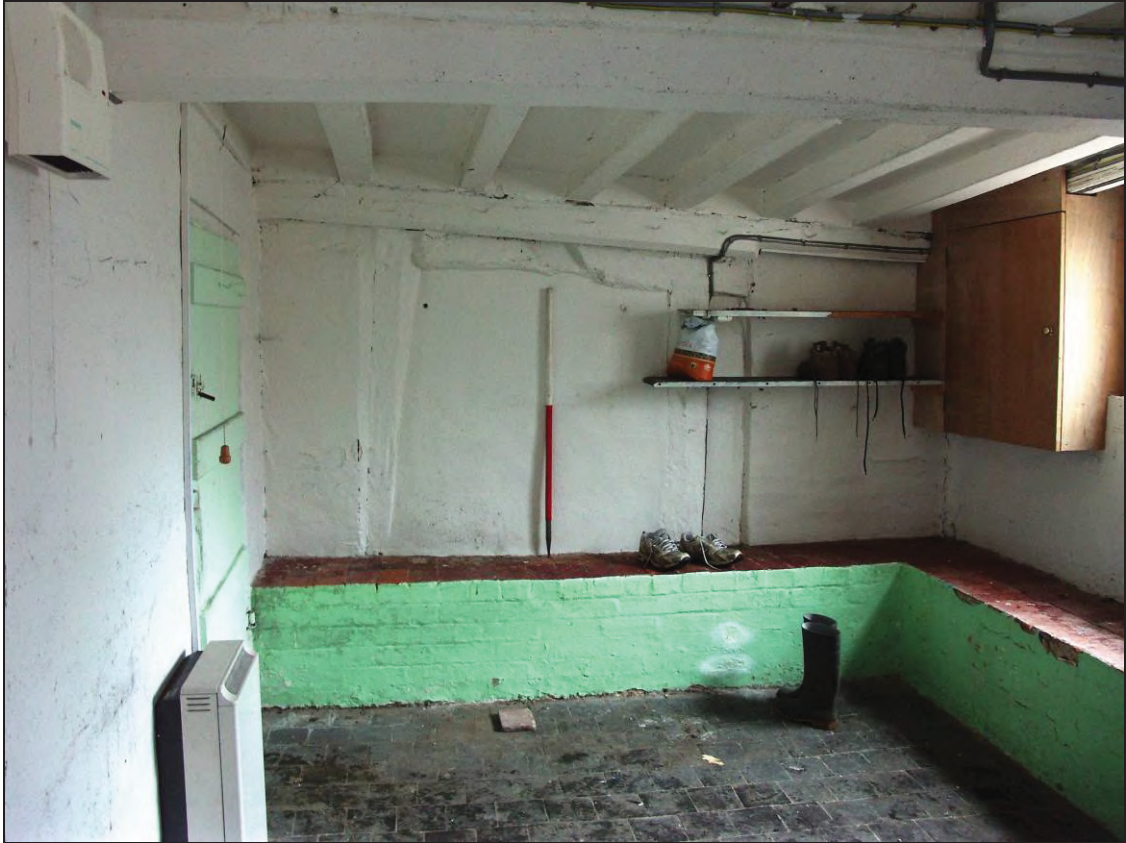
- 4.24 Room G-2 is situated on the north-western end of the building and is currently used as a disabled toilet. Its overall dimensions are 4.20 metres in length (north/south), 3 metres in width (east/west) and is 2 metres in height. The ceiling is a continuation of the adjacent room G-1 with the east/west timber bridging beam and north/south joists. The south wall also has surviving painted timber rails and studs of the original timber-framed house (Fig. 29). The central rail has a recessed housing for a tension brace and the western end had been cut to accommodate a doorway which is now blocked with bricks. There is a stud detached from the rail as a result of previous structural movement (Fig. 30). The east/west half timber beam abutting the southern wall has a scarf joint which is also slightly separated as a result of former movement.

Figure 29: Surviving timber frame on the south wall of room G-2 (scale 1m)

- 5.25 The remains of the timber-framed structure should be preserved and areas of advanced wet-rot decay restored. The only surviving wall panel on the ground floor between rooms G-1/G-2 and G-3 should also be retained without any alterations. However, the current plaster covering this wall in room G-3 may be causing damp problems to the timber and thus its preservation may be improved with the removal of the plaster and conservation treatment to the timber-framing. This would entail the exposure of the only internal surviving Post-Medieval timber-framed wall which would provide significant historical value and character to the house. The removal of the plaster could also be undertaken inside rooms G-1 and G-2, although the latter

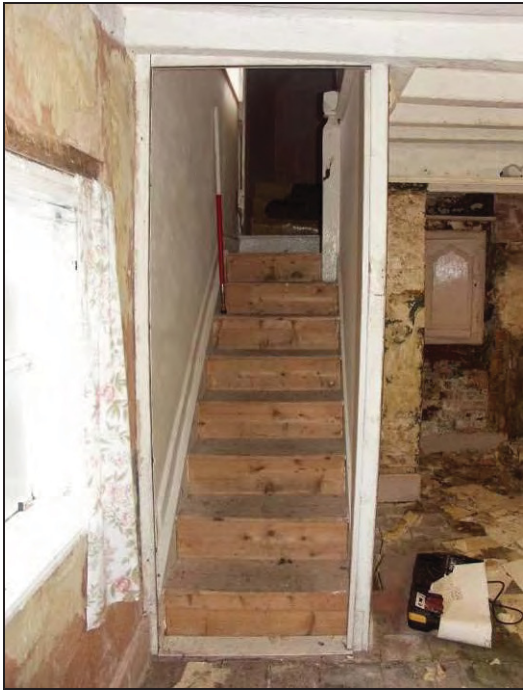
- 4.31 The staircase is a later repair built with soft-wood treads and raisers with a plywood panel on the side (Fig. 41).
- 4.32 The floor level has been raised c. 150mm and is made of red quarry tiles laid with cement over a make-up layer of sand (c. 100-200mm thick). This might have been carried out at a later stage in order to gain greater insulation as the brick walls lack damp proof courses or membrane. Indeed, the original tiles in rooms G-1 and G-2 are laid with mortar but the raised tiles are laid with cement over sand and thus suggest a later date. Moreover, the raised floor has cement skirting throughout the room which is not contemporary with the main construction of the house.

Figure 41: Staircase to the upper floor (scale 1m)

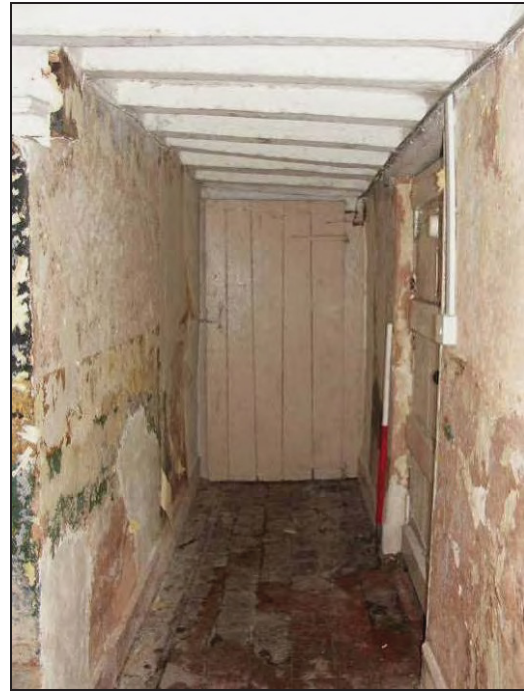
- 4.33 There are two internal doorways to rooms G-1 and G-4. The former is positioned within the north wall and have no door and the latter is situated at the end of the passageway which has a ledged timber door with iron strap hinges (Fig. 42). The basal section of this door has been sawn off reducing its original size which might have been undertaken in order to accommodate the altered level of the current floor. The passageway is built with bricks but has a timber post and mid rail (1.15 metres high). It is possible that the passageway might have extended north towards room G-2, creating a lobby with a doorway for this room as a kitchen division; and leading to room G-2 through the blocked-up doorway.

Figure 42: Western passageway (scale 1m)

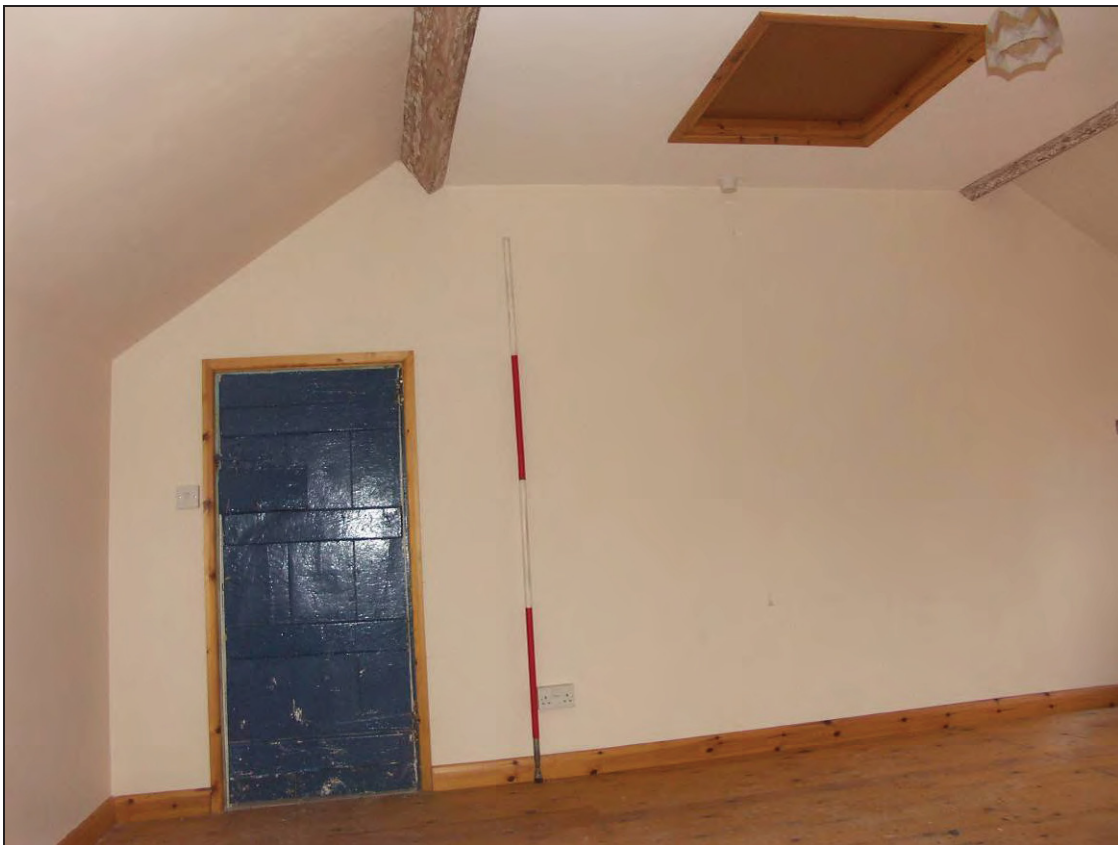
- 4.39 Room F-1 is located in the northern end of the Farmhouse and is a bedroom. It measures 5.20 metres in length (east/west), 4.10 metres in width (north/south) and is 2.36 metres in height. This room is accessed from the passageway through a ledged timber door with iron strap hinges on the south wall (Fig. 52). The entire room has been recently renovated with plaster boards and tongue-and-groove wooden floor (Fig. 53). The ceiling has exposed rafters and angled sides. There is a hatch which allowed inspection of the roof structure which consists of common rafters joint with a ridge board and supported by two tiers of side purlins joint with a collar (Fig. 54). The entire roof structure, including the battens supported by the common rafters, appears to be a later re-build.

- 4.40 The northern end of the side purlins have been recently repaired with bolted steel plates under the timber. The room is lit by a timber casement window with rat-tail stay and fastener situated under the dormer.

Figure 52: Room F-1 with ceiling hatch, looking south (scale 2m)

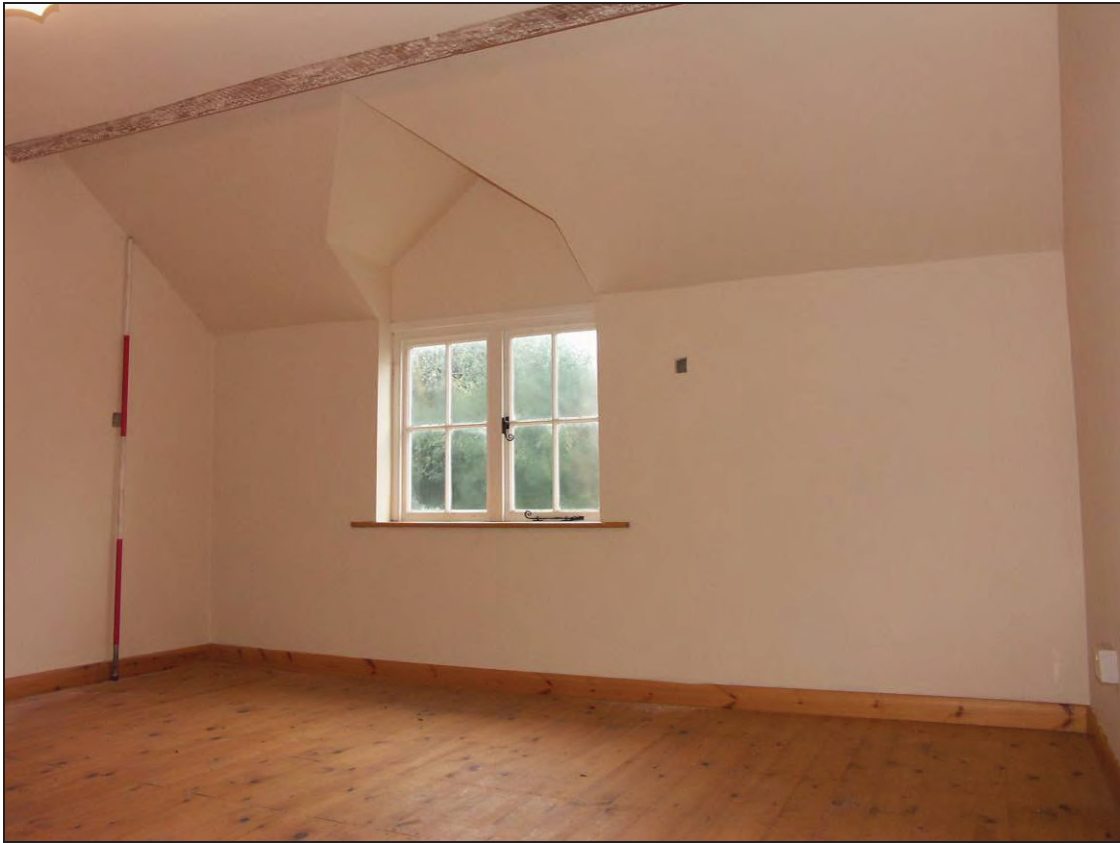
Figure 53: General view of room F-1 with new plaster board walls and floor boards (scale 2m)

- 5.22 The present roof appears to be a replacement of the original structure which might have taken place around the same time. More recent alterations are the current windows which are clearly modern replacement and the addition of plaster boards and floor boards in room F-1.

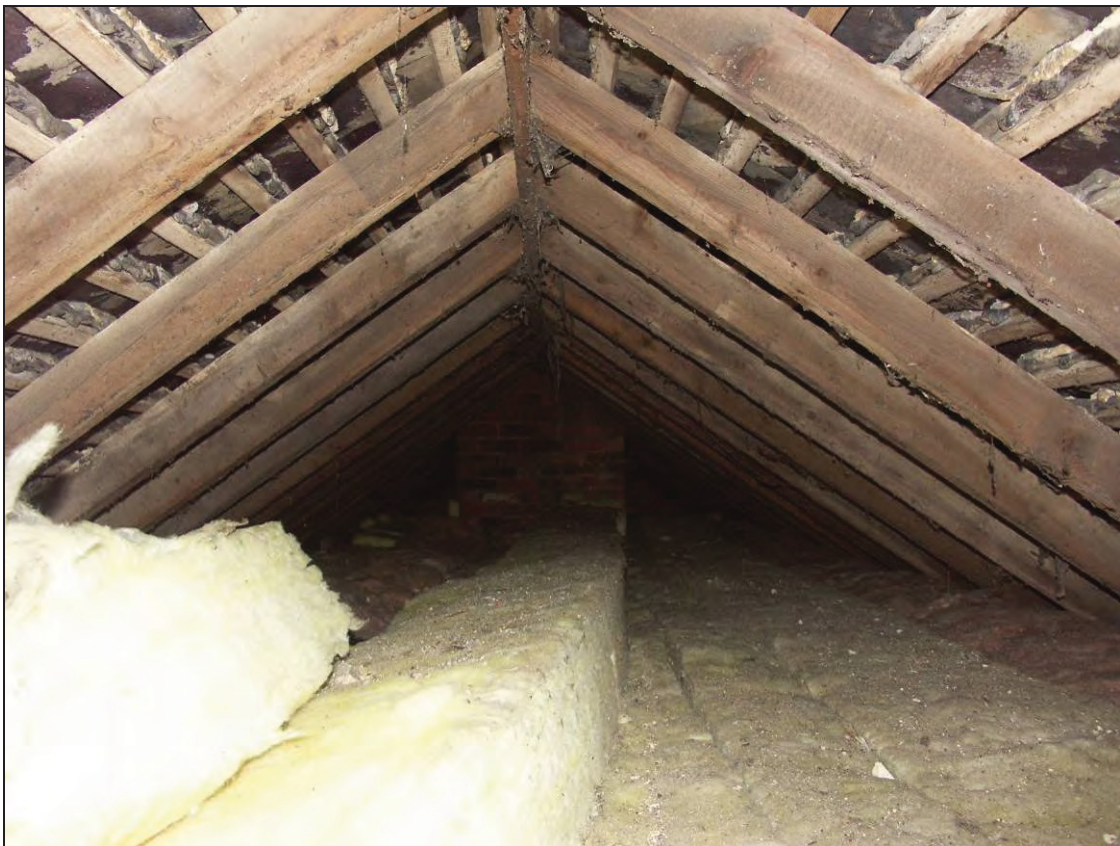
Figure 54: Inside the roof structure, looking south

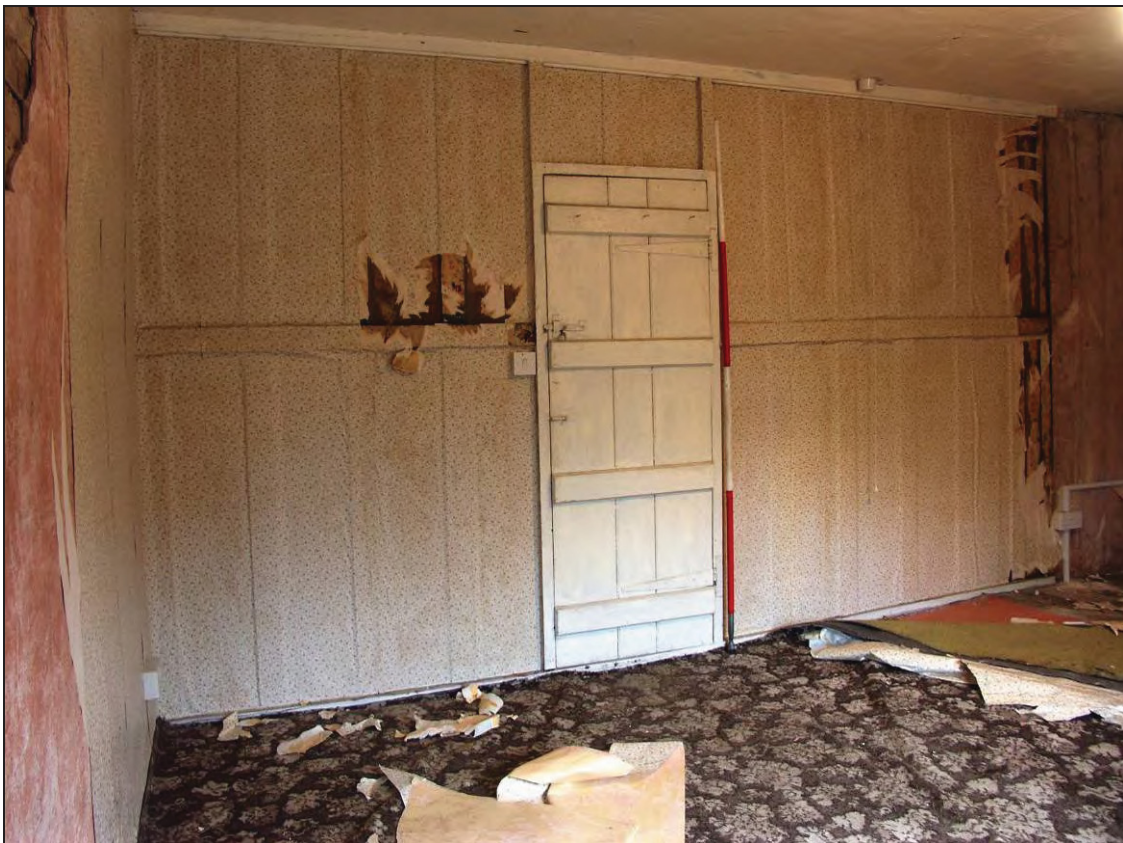
- 4.41 Room F-2 is located in the centre of the Farmhouse and is another bedroom. It measures 4.60 metres in length (north/south), 3.65 metres in width (east/west) and is 2.40 metres in height. This room is accessed from the passageway through a ledged timber door with iron strap hinges on the eastern wall panelling (Fig. 55). The panelling is covered with wall paper and this side has a muntin reinforcing the vertical rails.

Figure 55: Wood panelling with doorway to the passageway, looking east (scale 2m)

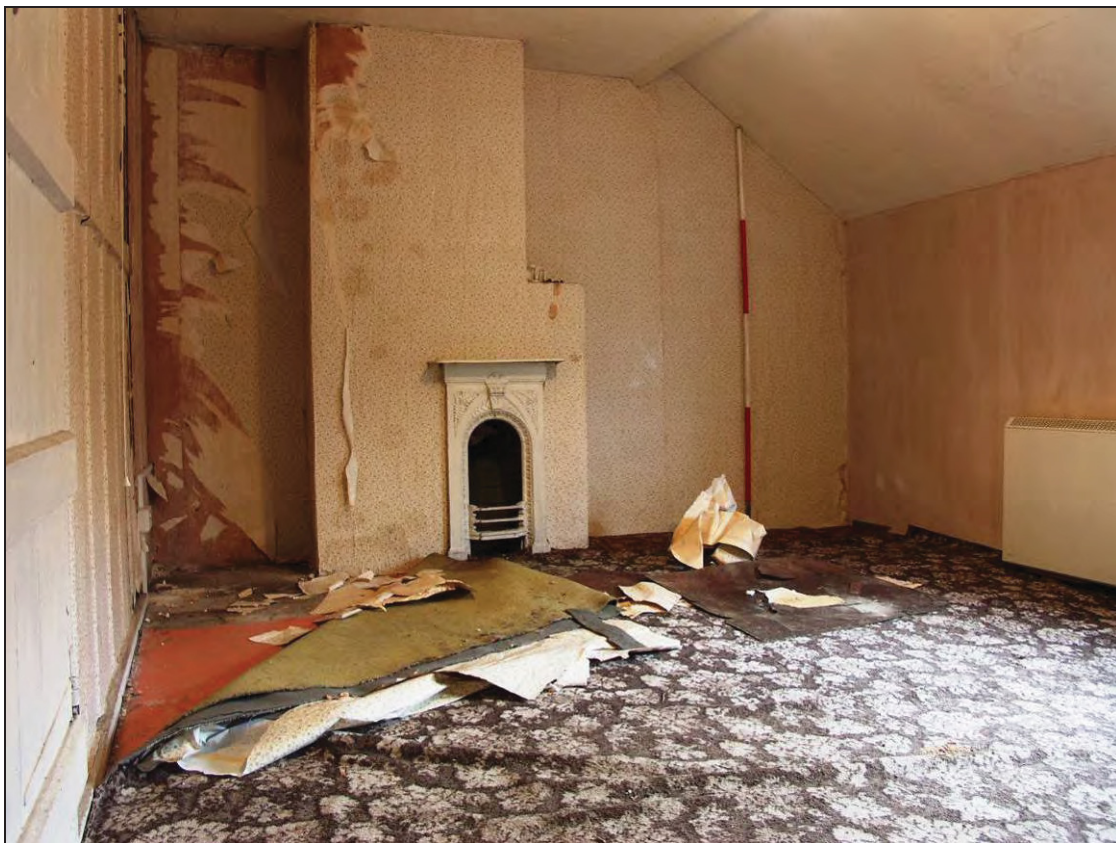
- 4.42 This room has a central fire place incorporated within the brick chimney breast on the south wall (Fig. 56). The brick wall is covered with plaster and wall paper. The ceiling is made of lath-and-plaster with angled sides and the floor consists of lime ash cemented screed which appears to be a later replacement of timber boards.

Figure 56: Room F-2 with central cast-iron fire grate, looking south (scale 2m)

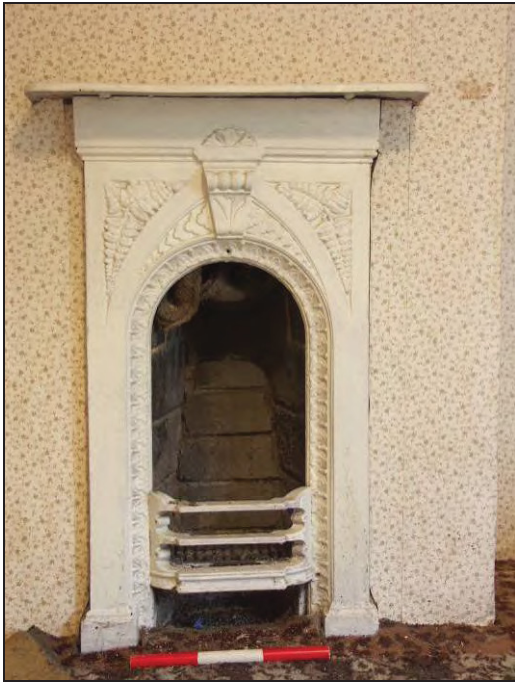
- 4.43 The room is lit by a timber casement window with rat-tail stay and fastener situated under the dormer (Fig. 57). The fire place has a cast-iron fire grate with fire bricks (Fig. 58). The wall plaster is crumbling in several areas of the northern wall which revealed a former doorway which is now blocked with bricks (Fig. 59). This doorway would have connected this room with the adjacent room F-1 prior to the insertion of the wall panelling creating the current passageway.

Figure 58: Detail of cast-iron fire grate (scale 300mm)

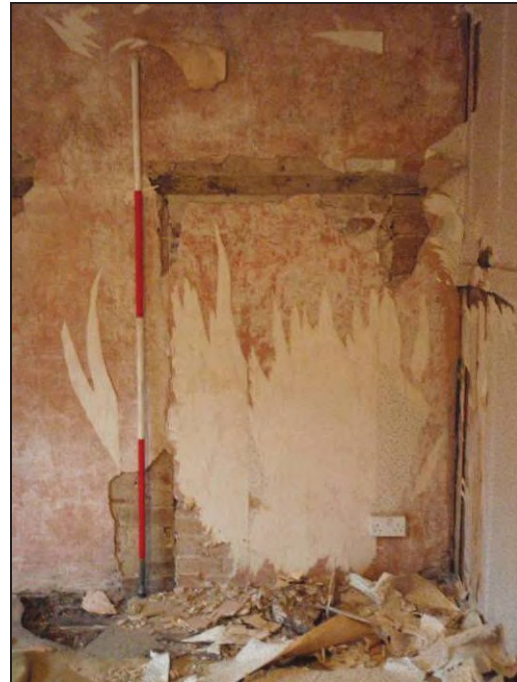
Figure 59: Former doorway on the northern wall

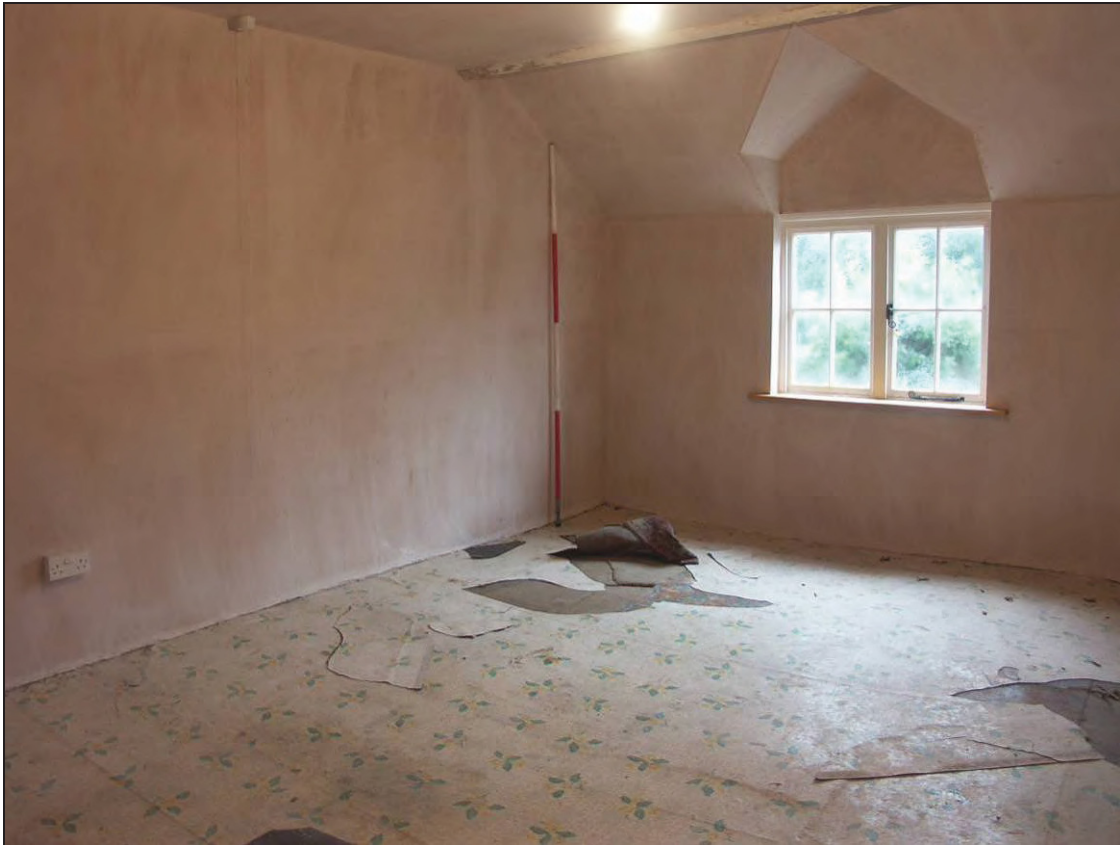
- 4.44 Room F-3 is located in the southern end of the Farmhouse and is also a bedroom. It measures 5.20 metres in length (east/west), 3.70 metres in width (north/south) and is 2.45 metres in height. It has similar structural arrangements and fabrics as the adjacent room F-2 although the walls have been recently rendered with plaster (Fig. 60). The screed floor is in poor condition with several fissures (Fig. 61). The room is lit by a timber casement window with rat-tail stay and fastener situated under the dormer. It has an equivalent central cast-iron fire grate which is part of a back-to-back fire place (Figs 62 and 63).

Figure 60: General view of room F-3, looking south-west (scale 2m)

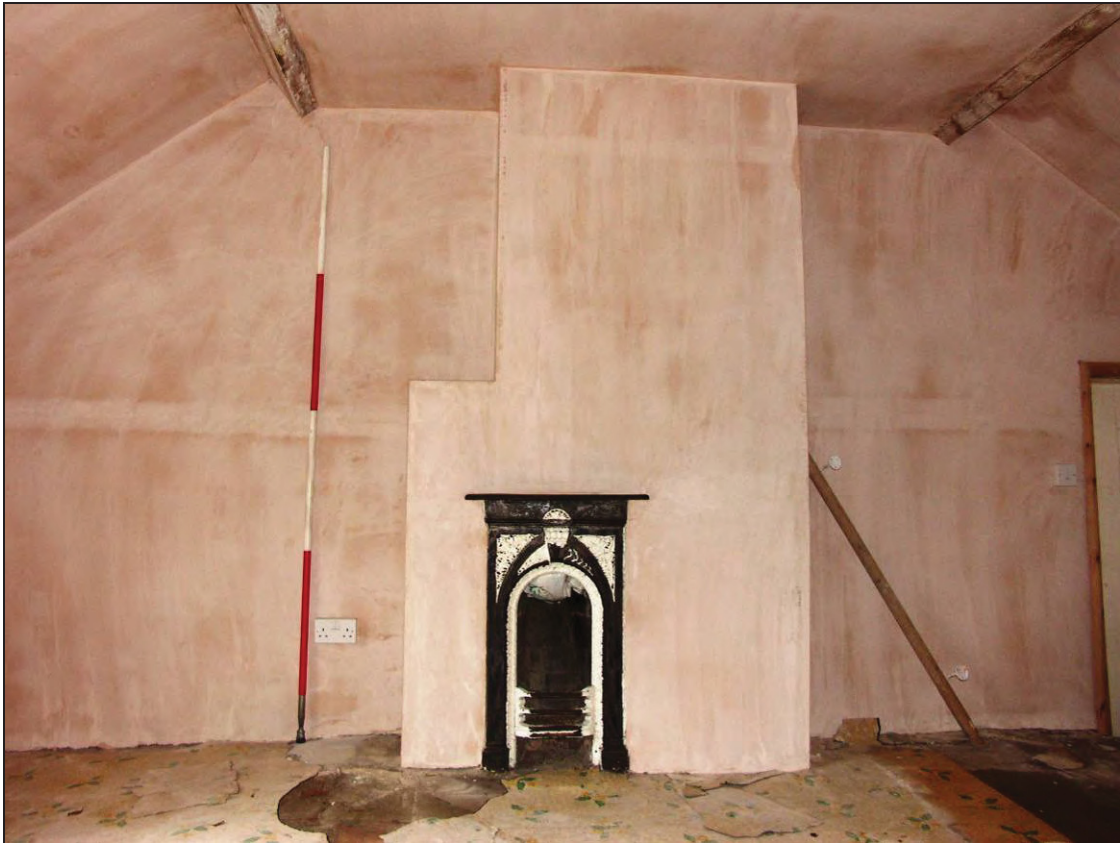
Figure 62: Central cast-iron fire place, looking north (scale 2m)

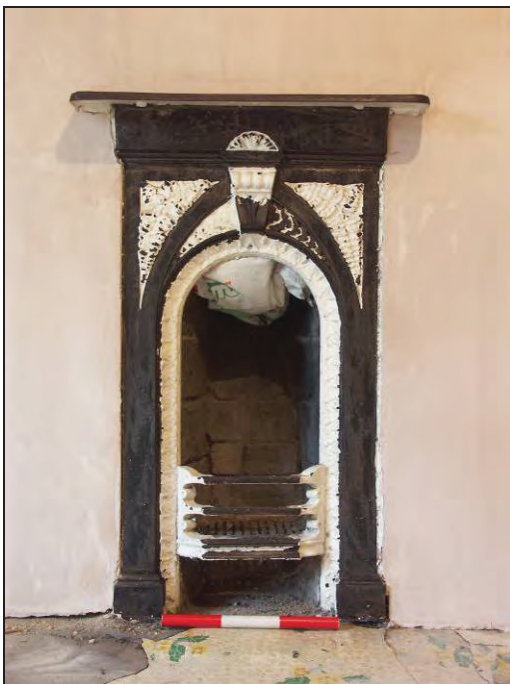
Figure 63: Detail of cast-iron fire grate (scale 300mm)

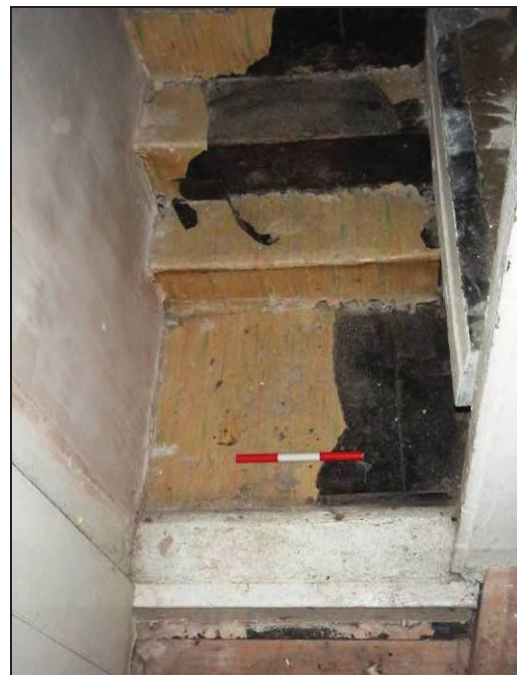
- 4.45 This room is accessed from the staircase through a ledged timber door with iron strap hinges on the north wall. The staircase has a landing and two steps inside the room which appear to be original (Fig. 64). The landing would have accommodated the movement of a door which would have opened inwards. Thus, the primary access to the adjacent room F-2 might have been from a doorway adjacent to the chimney breast in the same alignment as the blocked-up doorway between rooms F-1 and F-2. However, the wall plaster may be obscuring the putative doorway behind it and thus it cannot be established.

Figure 64: Detail of landing (scale 300mm)
