An Archaeological Building Recording at Stublach Grange Farm, Stublach, Cheshire

ARS Ltd Report 2010/44July 2010

In July 2010 Archaeological Research Services Ltd were commissioned by Storengy UK to undertake an Archaeological Building Recording at Stublach Grange Farm near Lach Dennis, Cheshire, prior to the proposed demolition of the building.

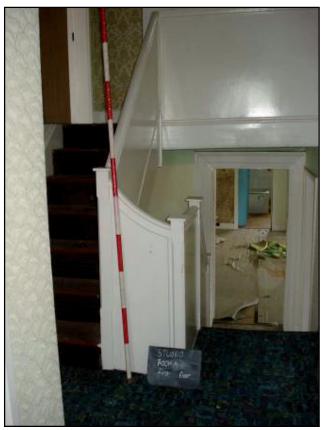
Fig- 25 Room 9

This corridor is split over two levels. The lower level has access to Rooms 10, 11, 12 and 13 while the upper level has access to Rooms 14, 15 and 16 as well as providing staircase access to the second floor.
