**An Archaeological Building Recording of
Thorburn's Yard, South Street, Seahouses,
Northumberland.**

Archaeological Research Services Ltd
Report No. 2011/5
January 2011

An Archaeological Building Recording of Thorburn's Yard, South Street, Seahouses, Northumberland.

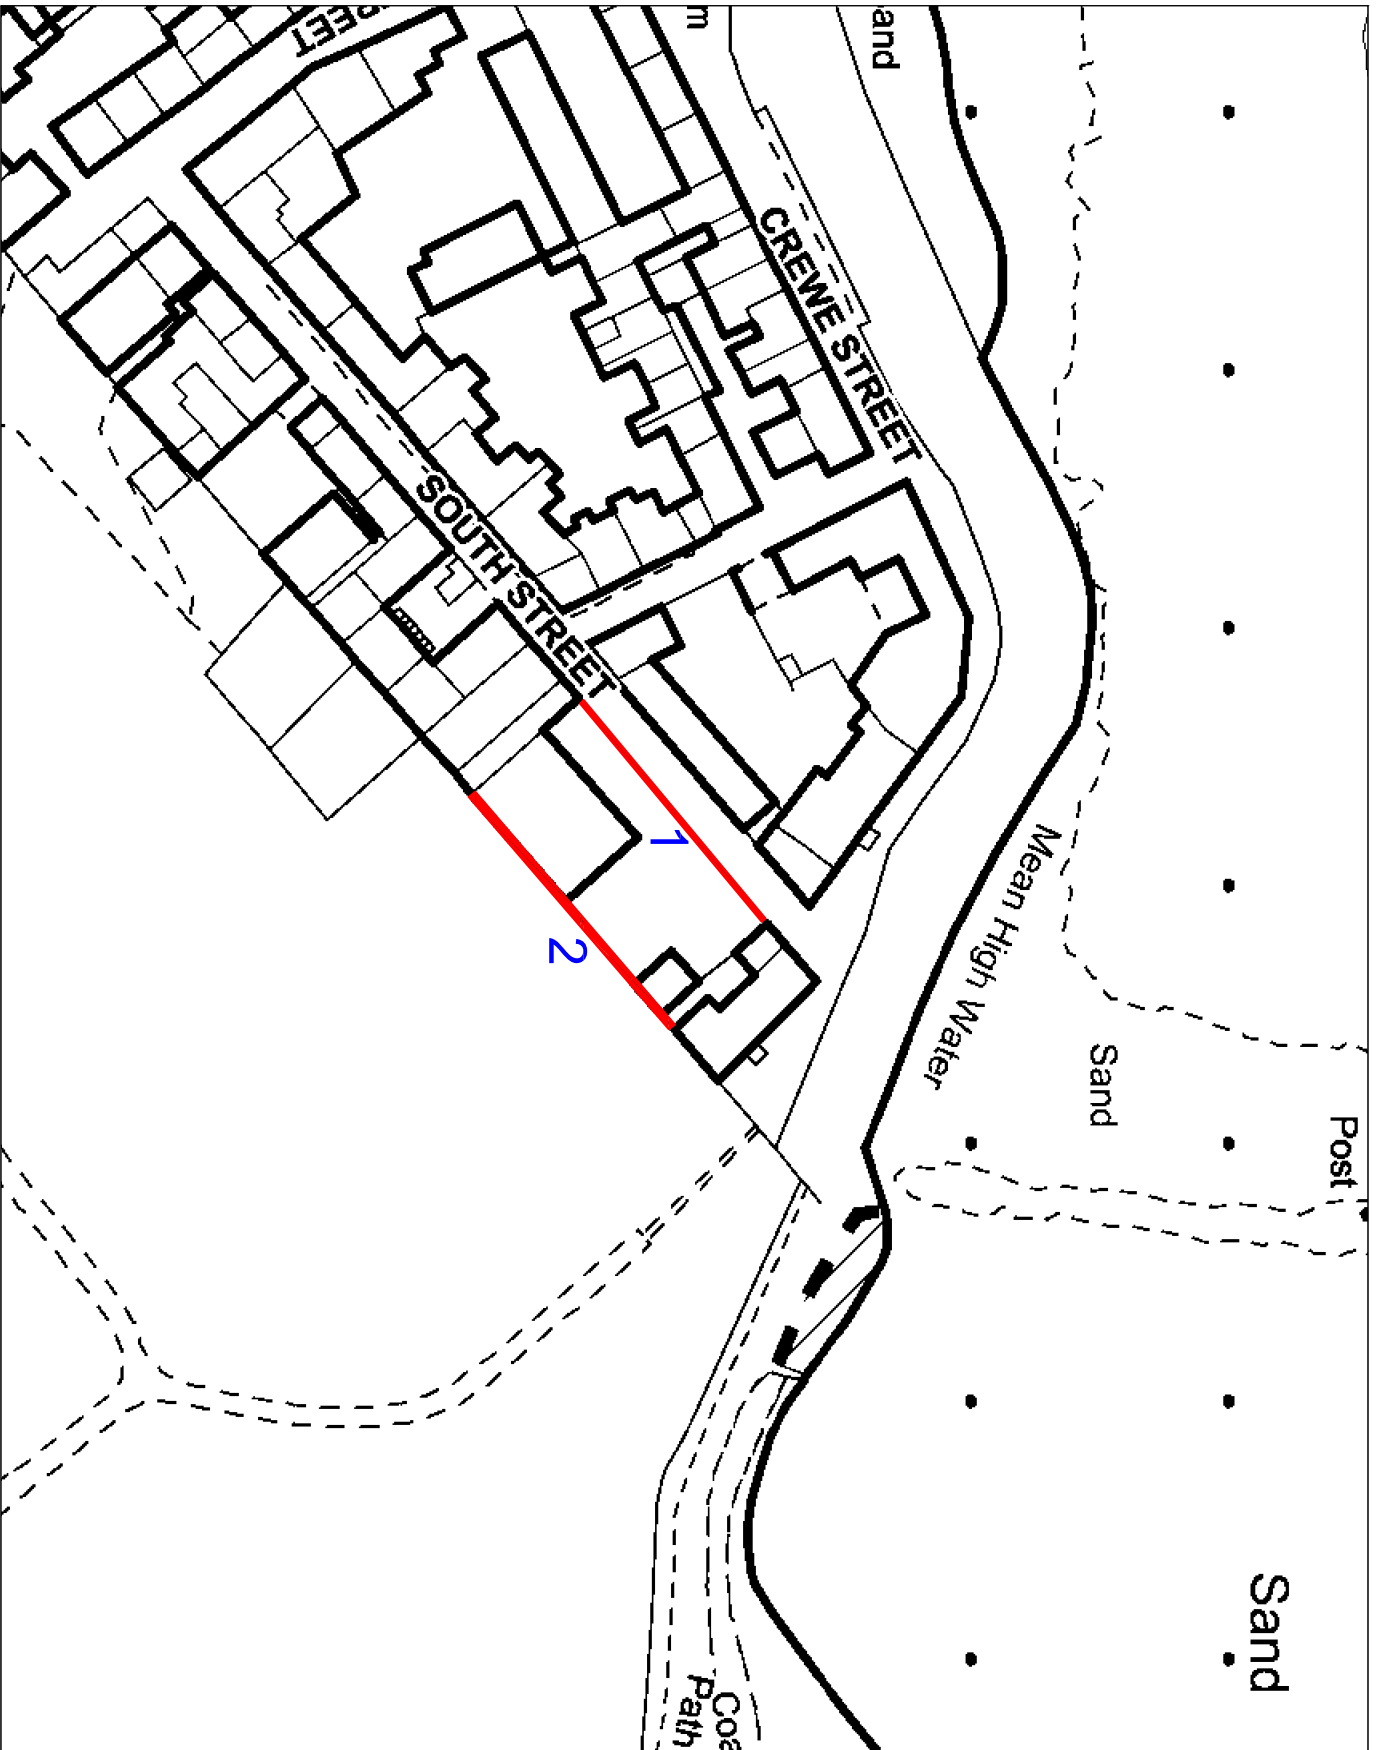
Figure 2.

- 3.1. The survey took place at the Thorburn's Yard, South Street, Seahouses, on Thursday 6th January 2011 and was carried out by Daniel Amat. A plan showing the walls recorded has been provided in the appendices of this report to accompany the photographic recording. The walls appear to be the remnants of buildings which occupied the site as early as the 1860's, which would explain the various entrance and window openings.

Site location and walls
