**BRITNED PROTOCOL IMPLEMENTATION**

**Archaeological Evaluation of a Previously Unreported Wreck at KP~121.910**

**Report Ref: 64496.03**

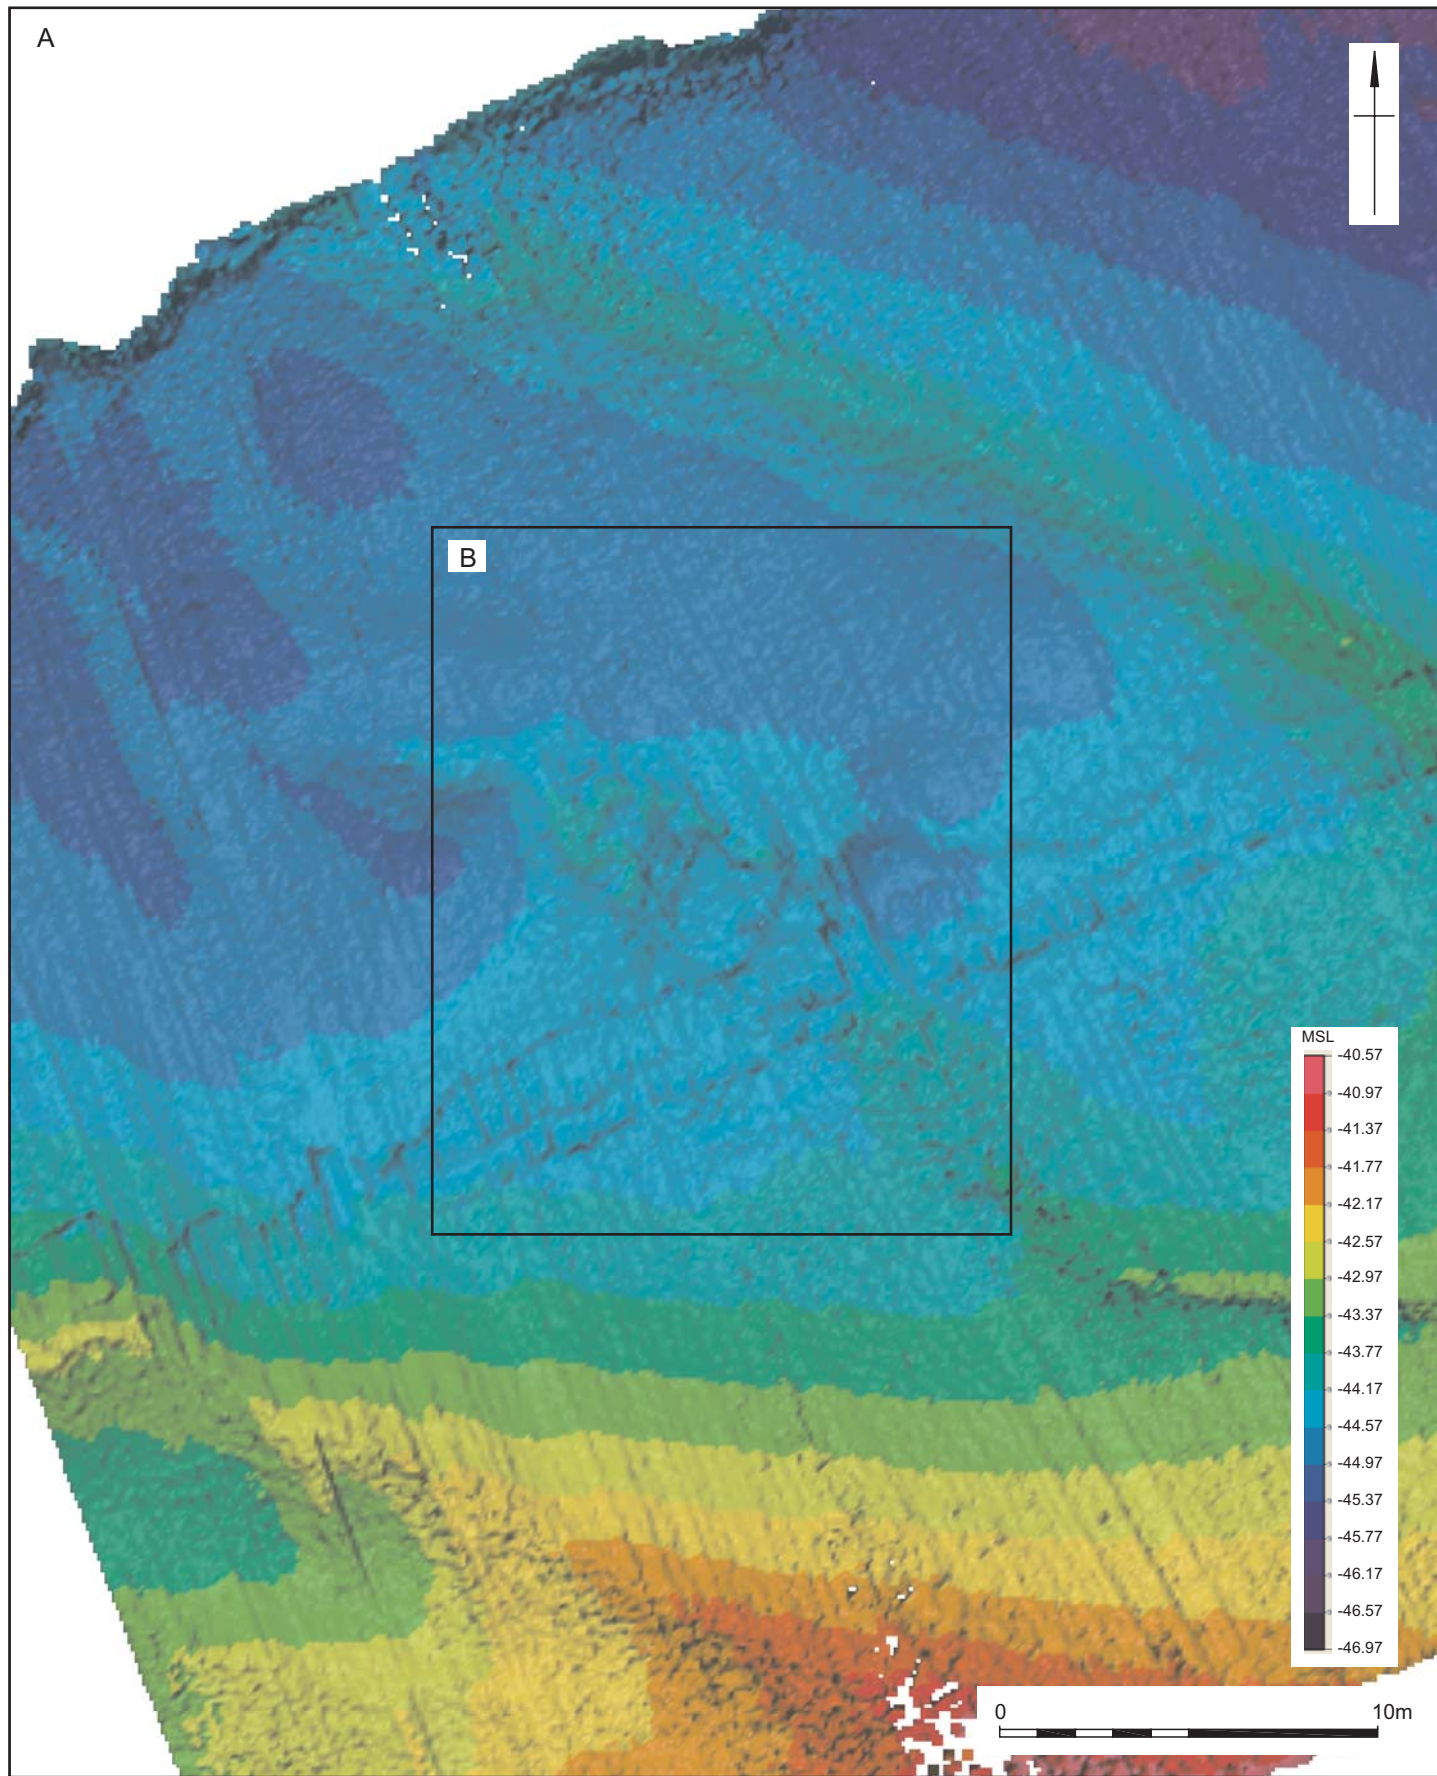
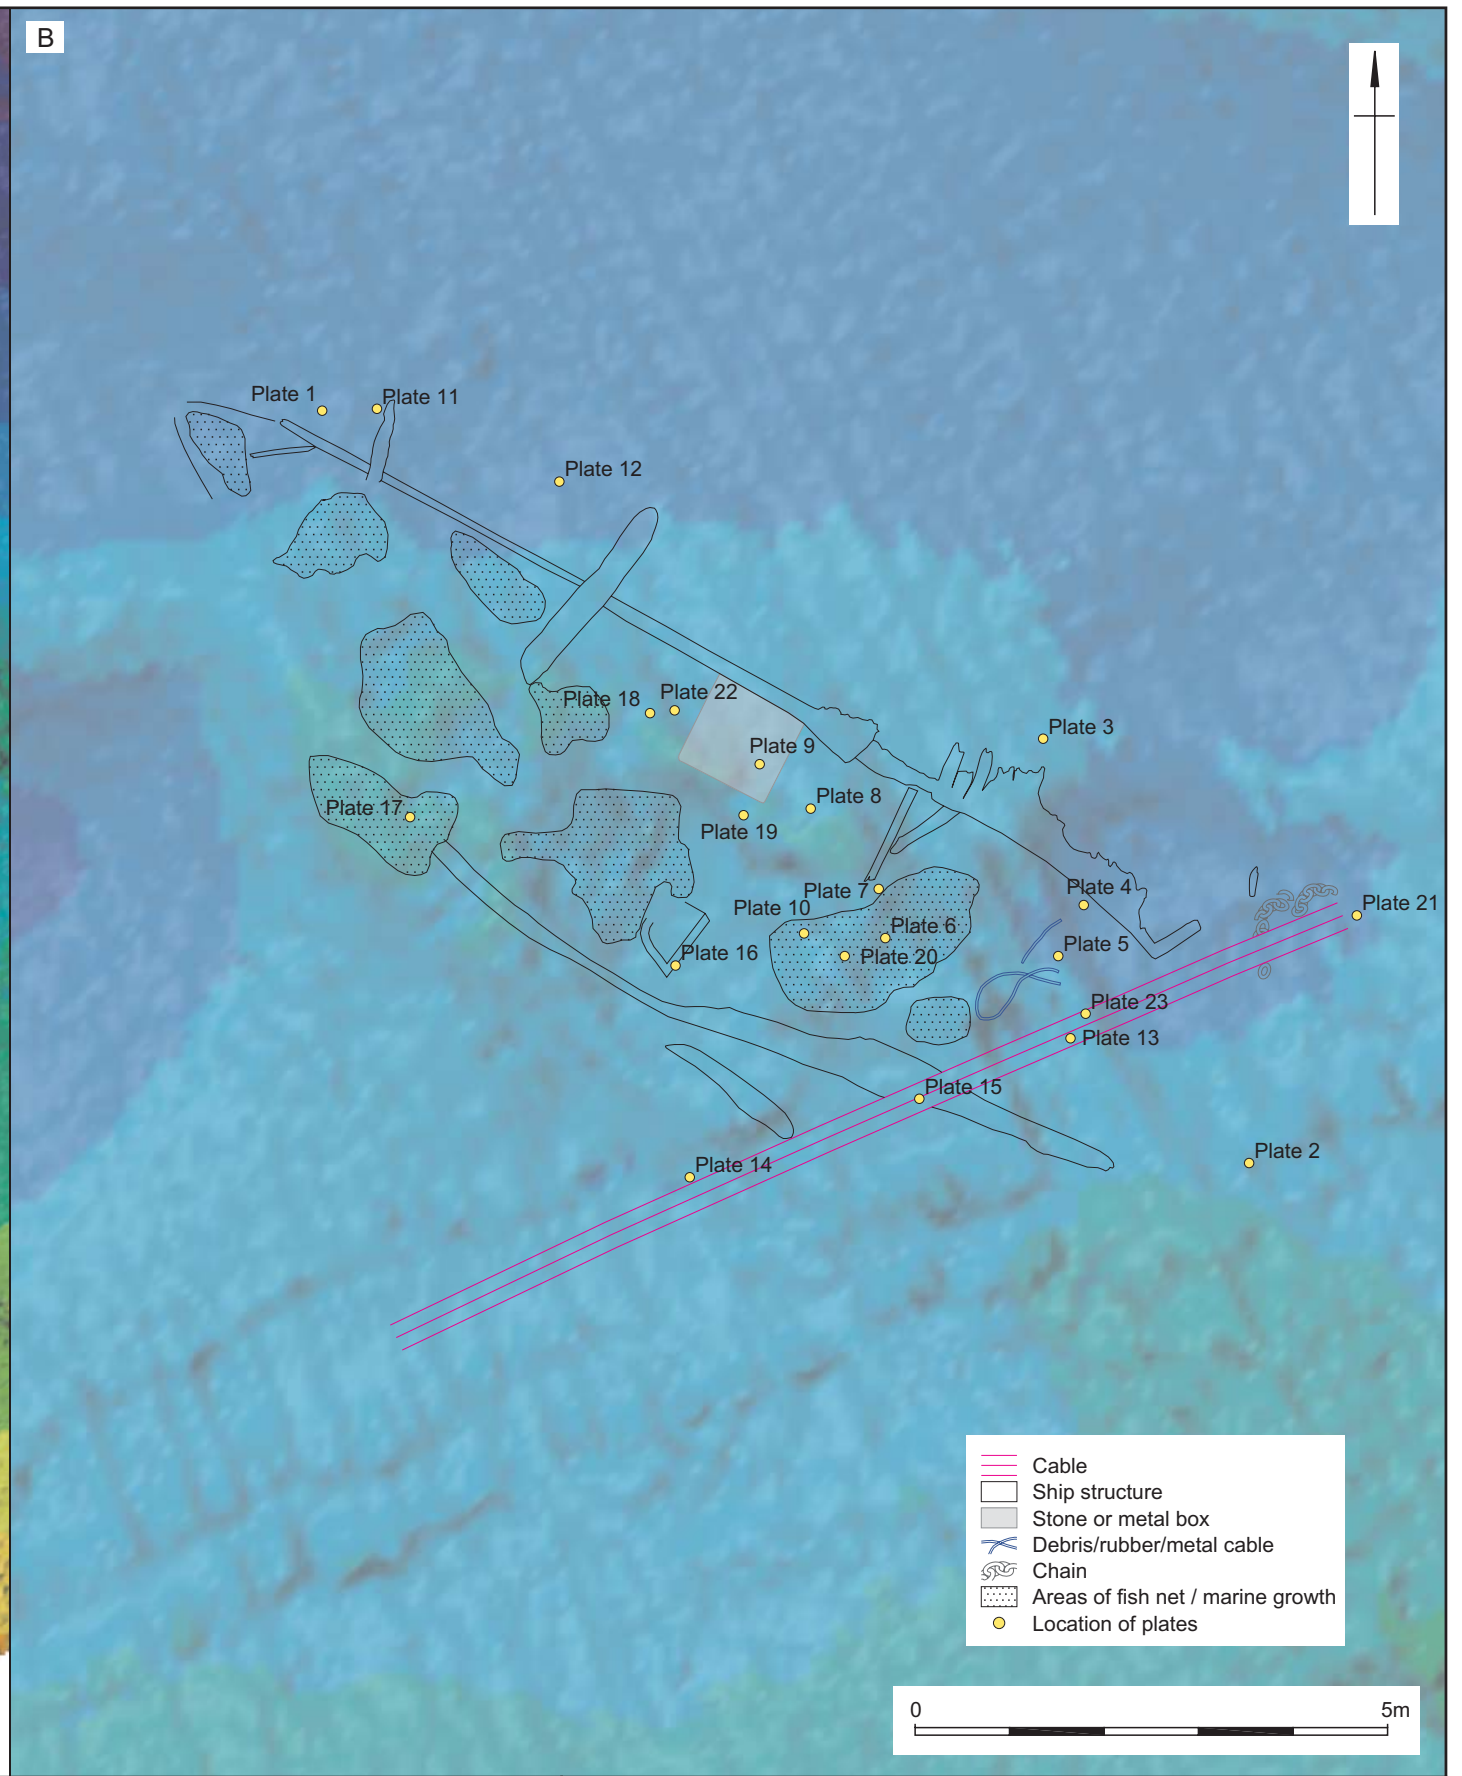
The wreck extends over an area at least 13.2m north-west/south-east by 5.6m north-east/south-west and comprises a small, lightly built wooden vessel that probably dates to the late 19<sup>th</sup> or 20<sup>th</sup> century. Although there was no evidence for the function of the vessel, based on its size and build it could have been a small fishing or recreational boat. Another possibility is that it was used as a World War II patrol or service boat. The wreck is in fairly poor condition, and the exposed hull timbers are broken and/or eroded.
