HANSON HOUSE  
SNYDALE ROAD  
NORMANTON  
WAKEFIELD  
WEST YORKSHIRE

Historic Building Recording

**Planning Application Ref: 07/00704/FUL & 07/00705/LBC**

74352.02\_BDG\_V0\_3

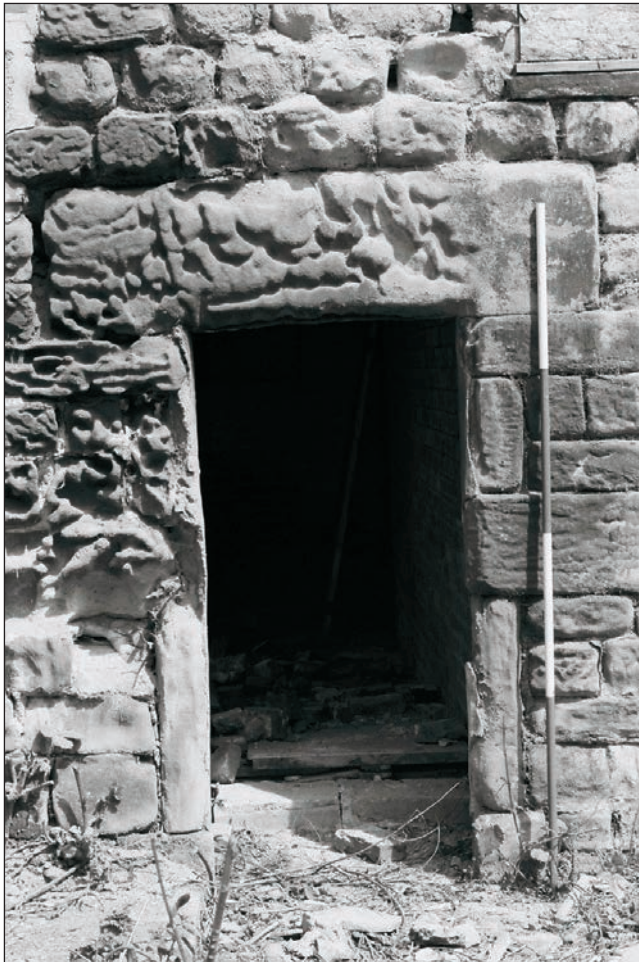
Plate 14: Detail of doorway, west elevation of the barn, Building 1 (Film 02.03)

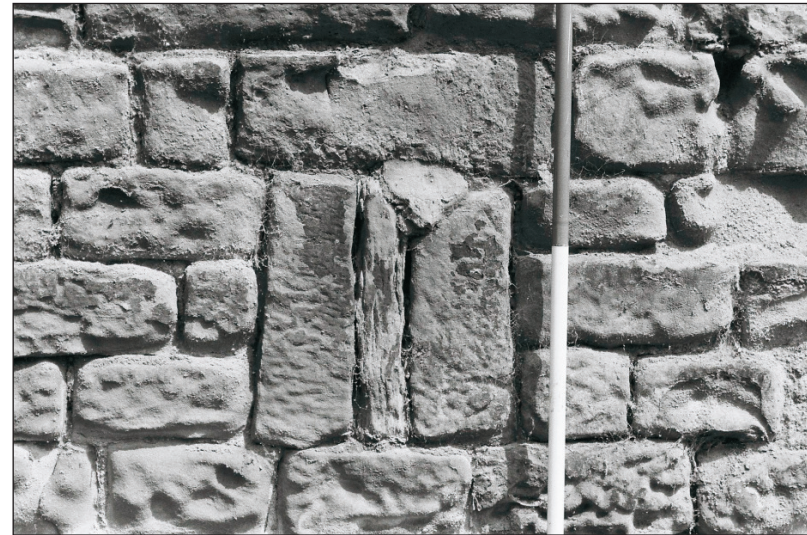
Plate 15: Detail of blocked breather slit, west elevation of the barn, Building 1 (Film 02.05)

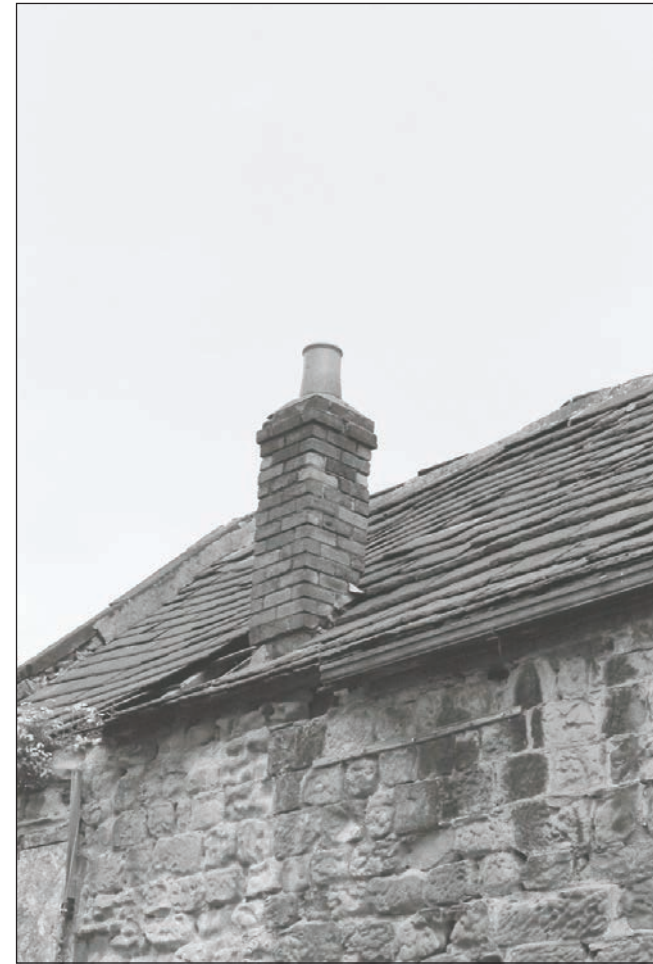
- 5.2.4 The stonework of the elevation was in a poor condition and as a result areas had undergone heavy repointing, and rendering. The roof was pitched with stone tile covering, finished with coped gable ends with moulded stone kneelers (**Plates 18, 19**). Projecting through the western pitch of the roof was a small brick chimney (**Plate 17**).

Plate 17: Detail of brick chimney, west elevation of the barn, Building 1 (Film 02.14)

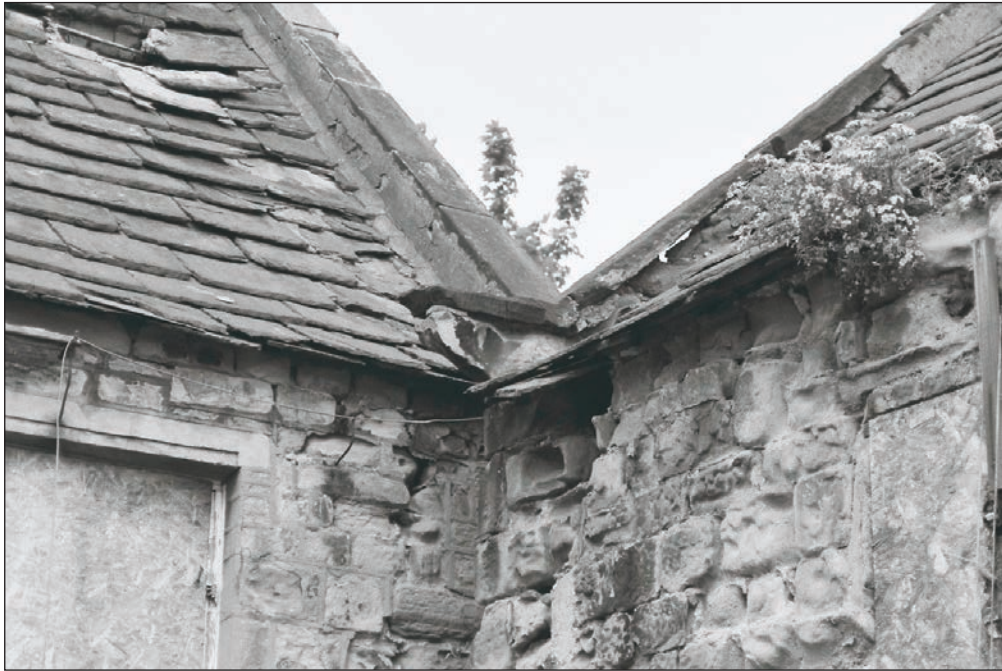
Plate 18: Detail of stone kneeler, north end of the west elevation of the barn, Building 1 (Film 02.10)

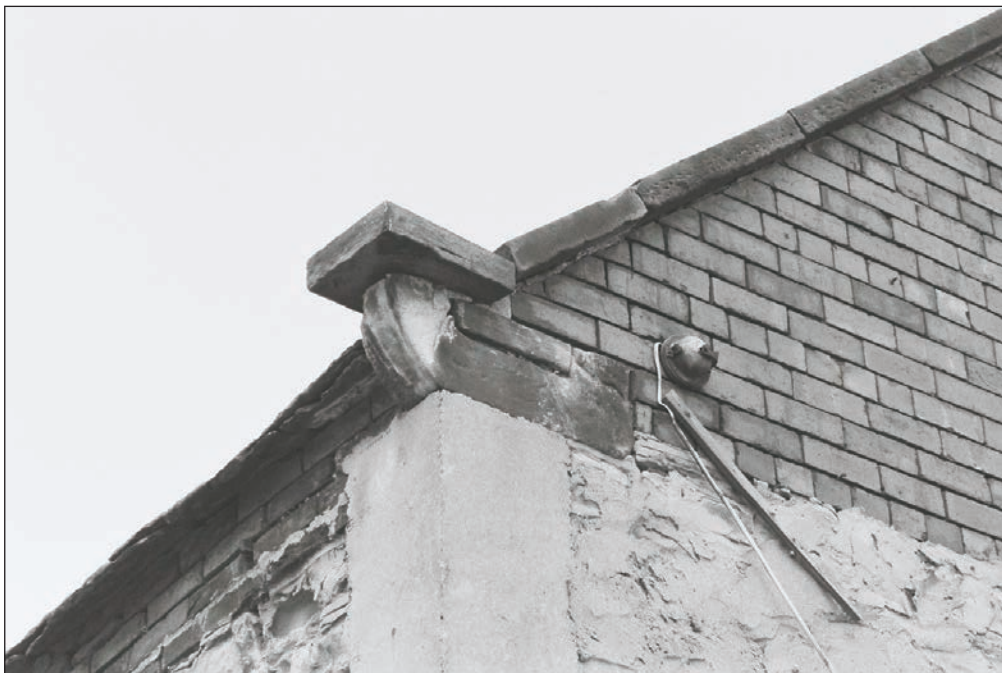
Plate 19: Detail of stone kneeler, south end of the west elevation of the barn, Building 1 (Film 02.08)

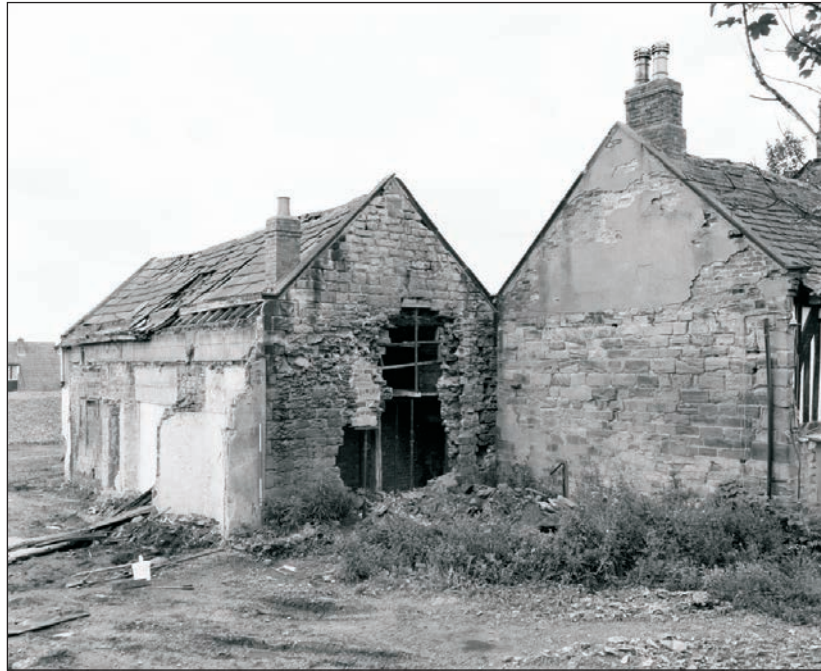
- 5.2.5 The stone north gabled elevation had partially collapsed due to heavy erosion, exposing the brick dovecote interior of the building, re-used timber tie beam, and timber first floor structure (**Plates 20, 21**).

Plate 20: General view of the north and east elevation of the barn, Building 1 (Film 22.05)

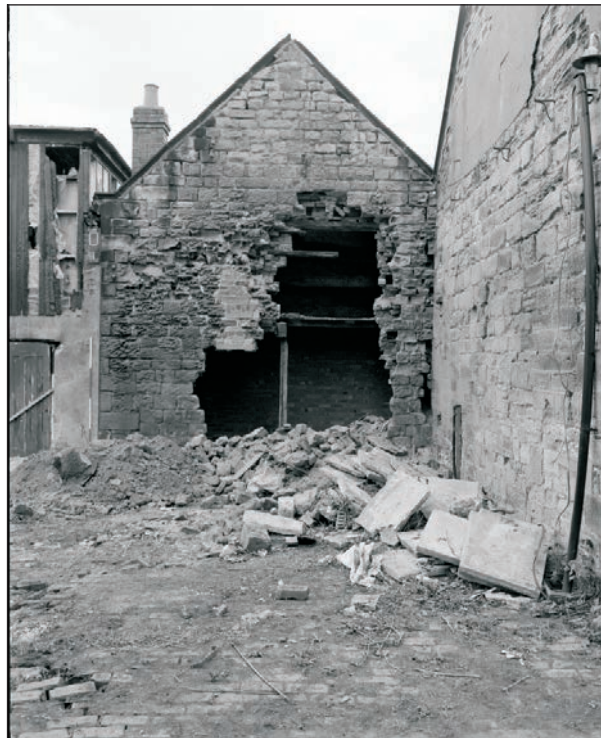
Plate 21: General view of the north elevation of the barn, Building 1 (Film 07.08)

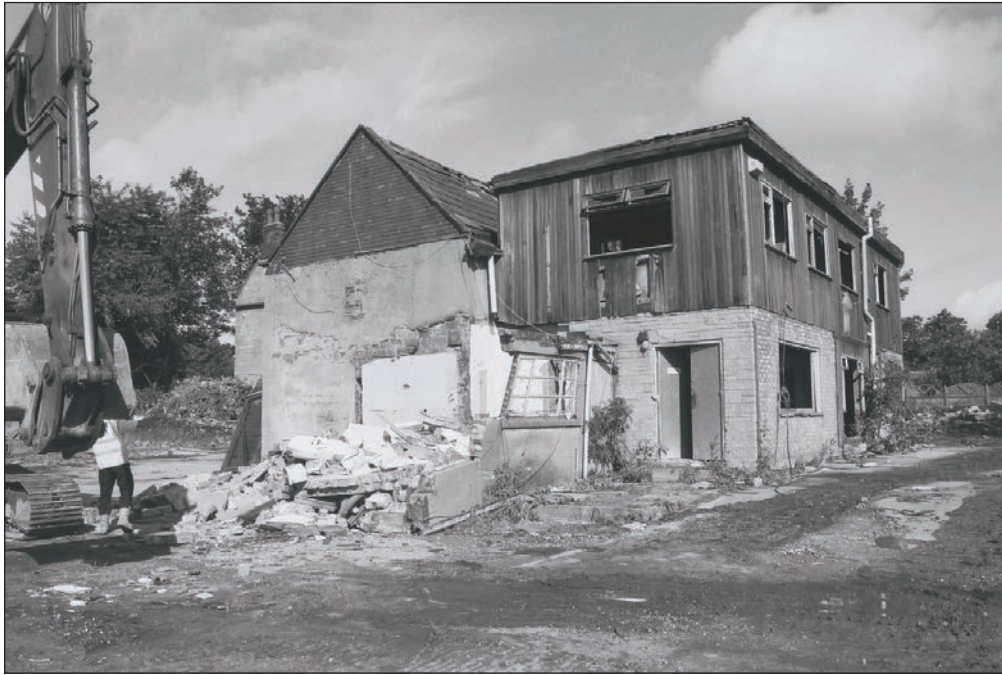
- 5.2.6 To the east of the barn was a modern 20<sup>th</sup>-century addition (**Plate 22**), which was demolished during the works exposing the east elevation of the building (**Plate 23**). The elevation had areas of modern plaster from the later extension, especially covering the north end of the elevation. At ground floor was an inserted doorway connecting the barn with the modern extension. There was also a blocked breather slit and three blocked windows. The first floor also contained three blocked windows. Positioned at the north corner of the elevation was a small brick chimney, similar to that in the west elevation (**Plates 24, 25**). Located beneath the floor of the modern extension a stone built well was exposed, which would have served the farmstead (**Plate 28**).

Plate 22: General view of the south elevation and modern extensions of the barn, Building 1 (Film 18.02)

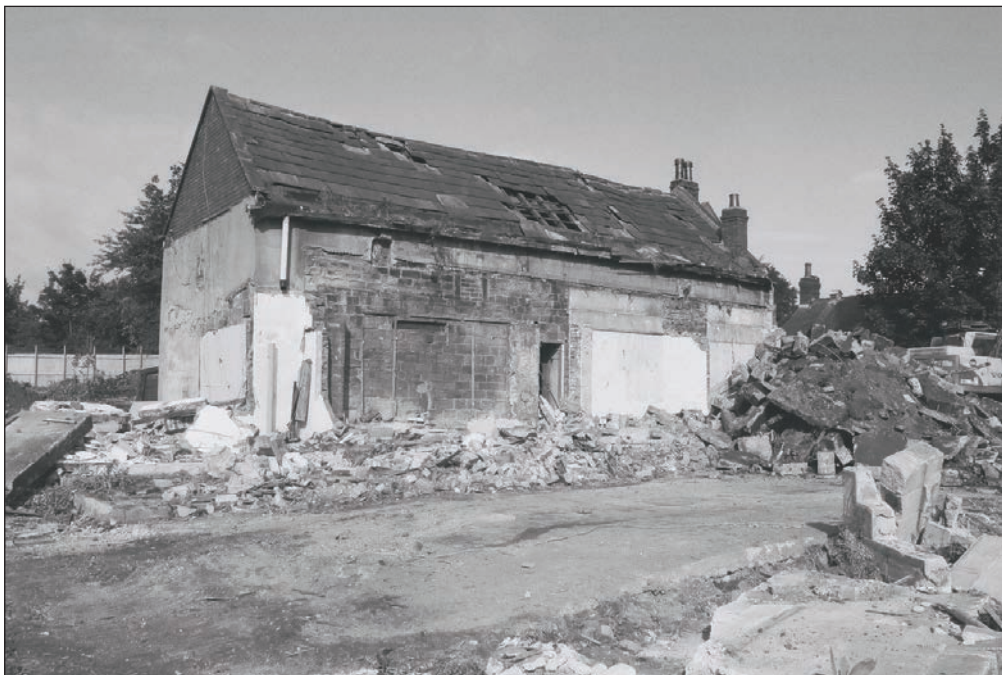
Plate 23: General view of the barn, Building 1 after the demolition of the modern extensions (Film 18.27)

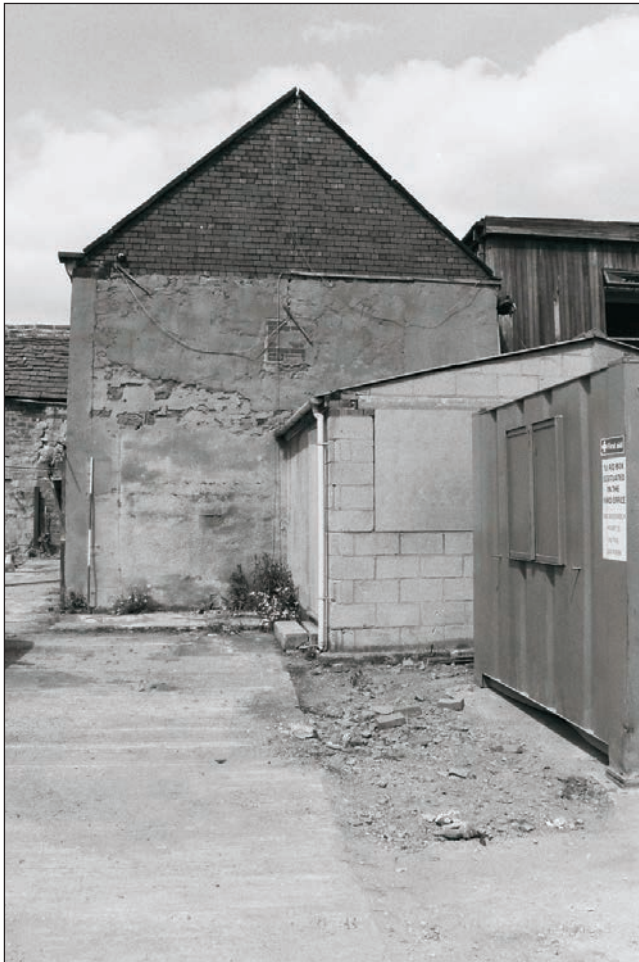
- 5.2.7 The south elevation was constructed of rendered stone. At ground floor there was a blocked doorway, blocked breather slit and a centrally positioned high window had been blocked with brick, whilst the outer skin of the gable had been rebuilt with modern brick (**Plates 26, 27**).

Plate 26: General view of the south elevation of the barn, Building 1, with extensions (Film 02.34)

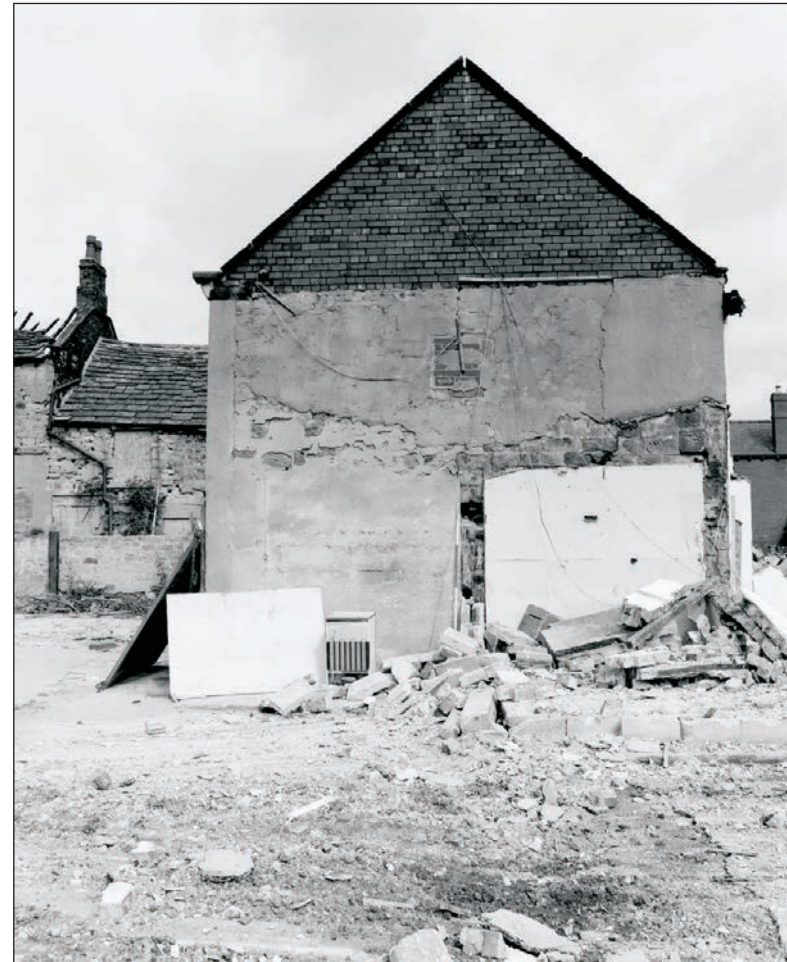
Plate 27: General view of the south elevation of the barn, Building 1, after the demolition of the extensions (Film 20.03)

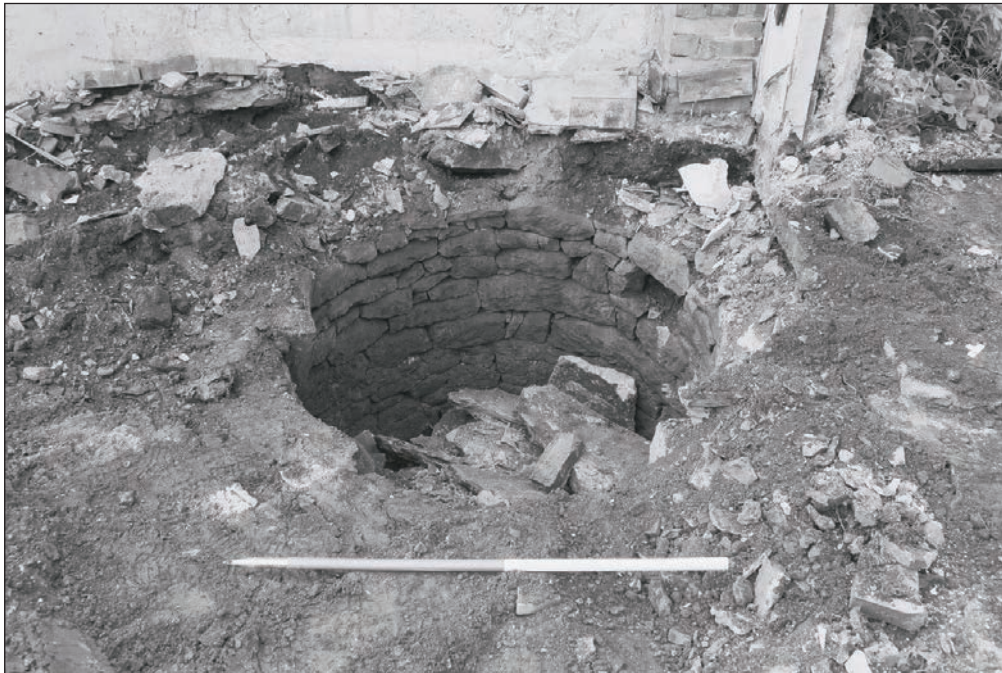
Plate 28: View of exposed well beneath removed modern extensions of barn, Building 1 (Film 21.04)

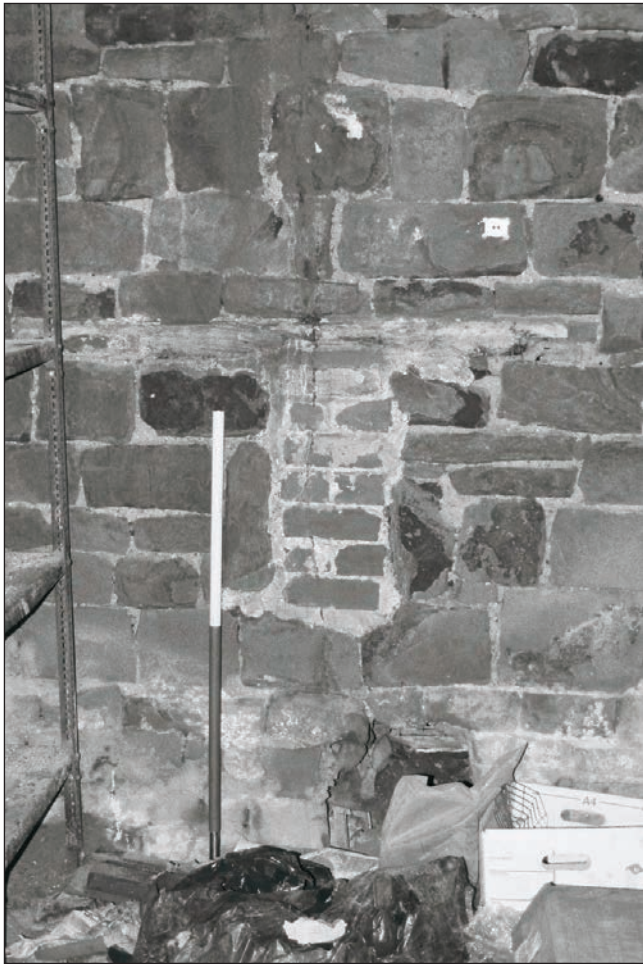
Plate 35: Detail of blocked breather slit, east wall of G1, Building 1 (Film 03.22)

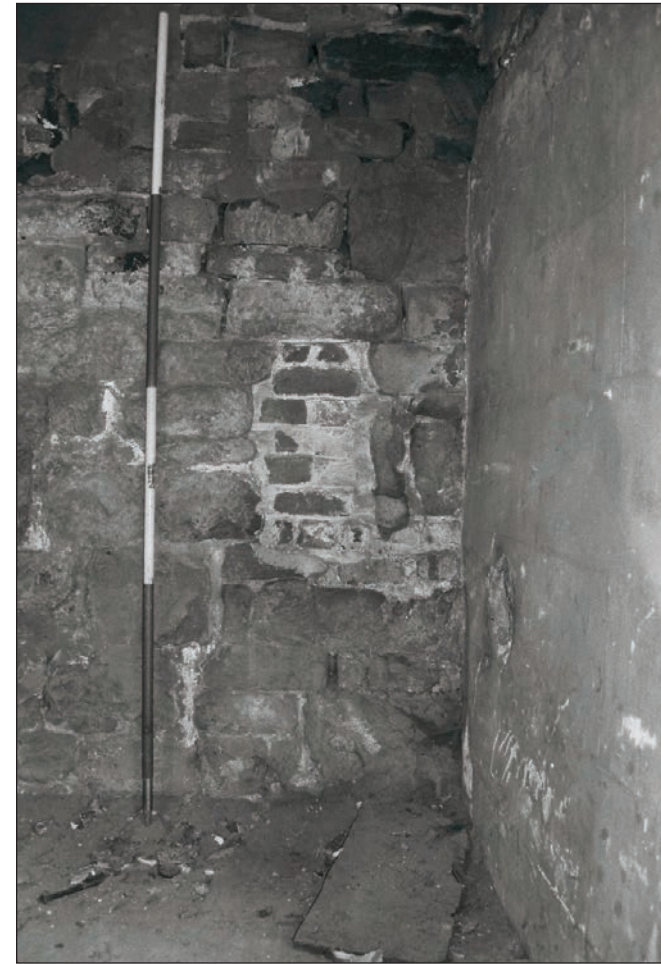
Plate 36: Detail of blocked breather slit, south wall of G1, Building 1 (Film 24.05)

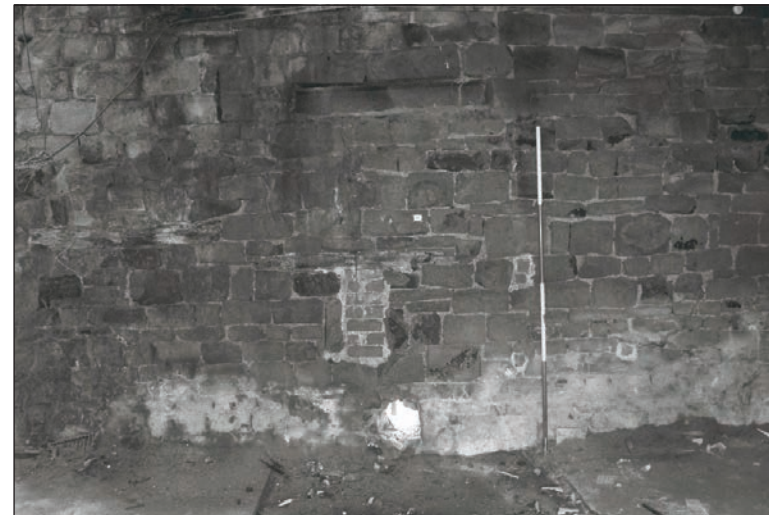
Plate 38: Detail of blocked breather slit, east wall of G1, Building 1  
(Film 24.09)

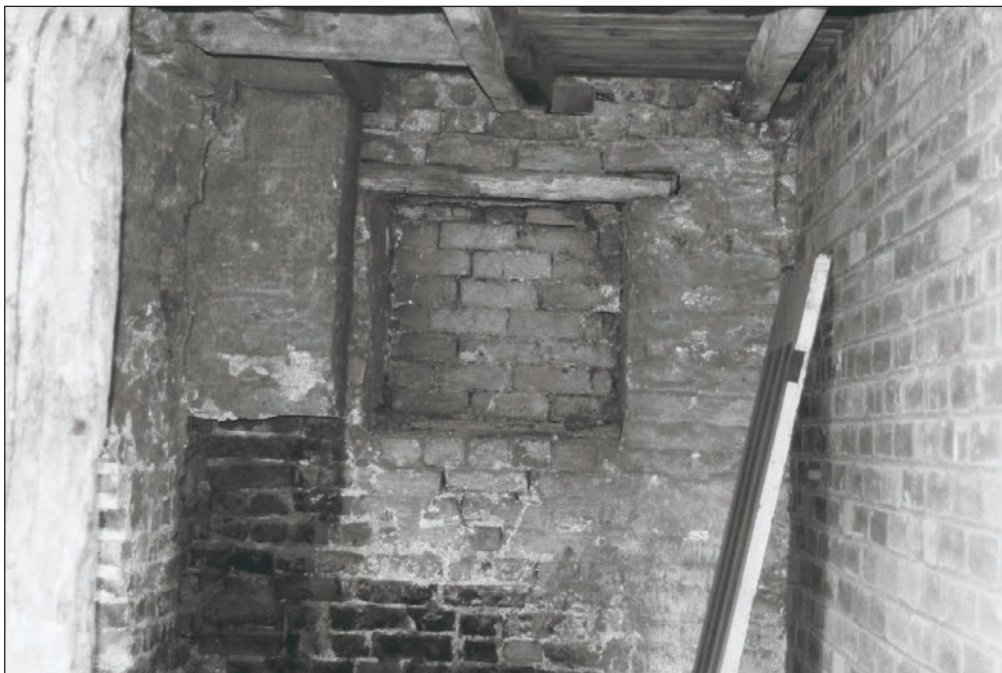
Plate 40: General internal view of G3, Building 1, showing blocked window and flue (Film 03.32)

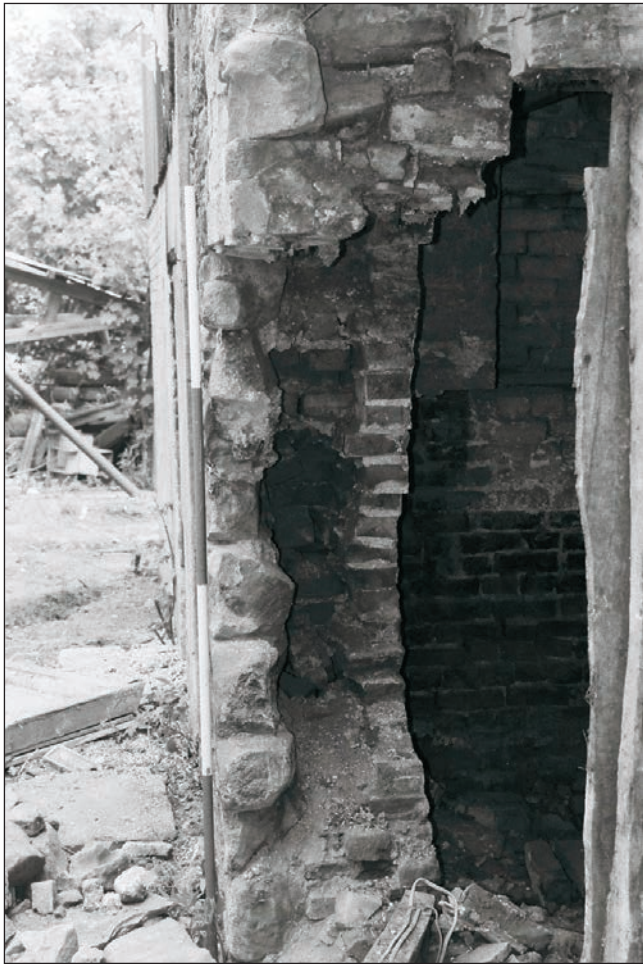
Plate 41: Detail of fabric of the north wall of G3, Building 1 showing inserted inner brick (Film 02.01)

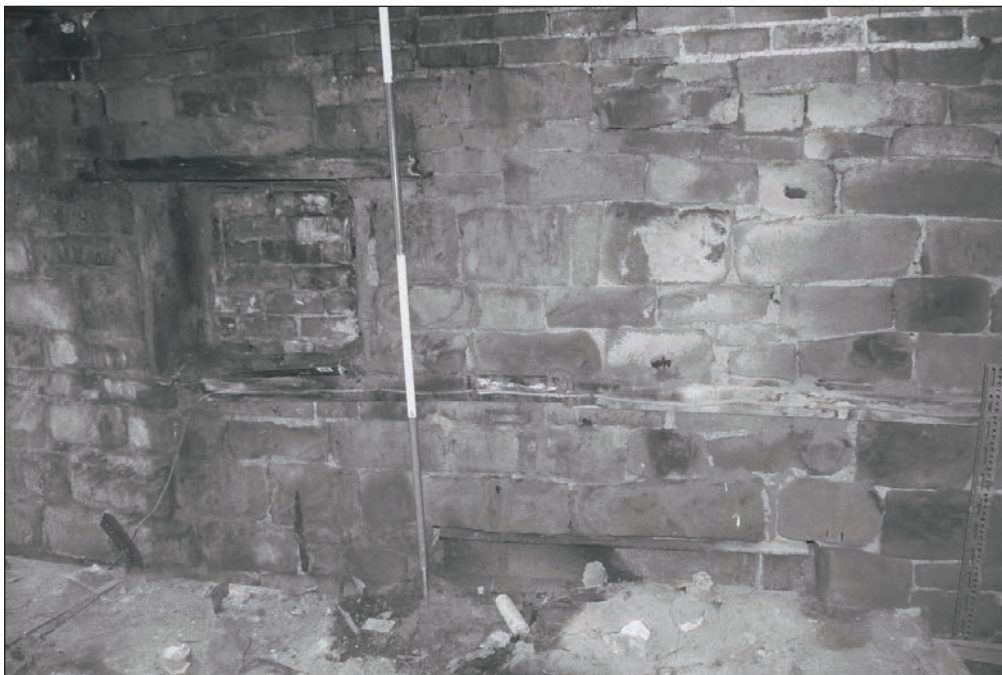
Plate 50: Detail of blocked window and inserted RSJ lintel, east wall of F1, Building 1 (Film 18.36)

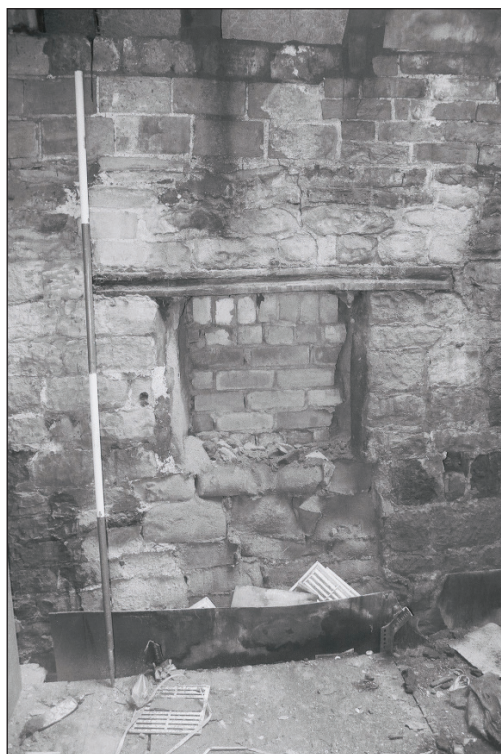
Plate 51: Detail of blocked window, east wall of F1, Building 1 (Film 18.34)

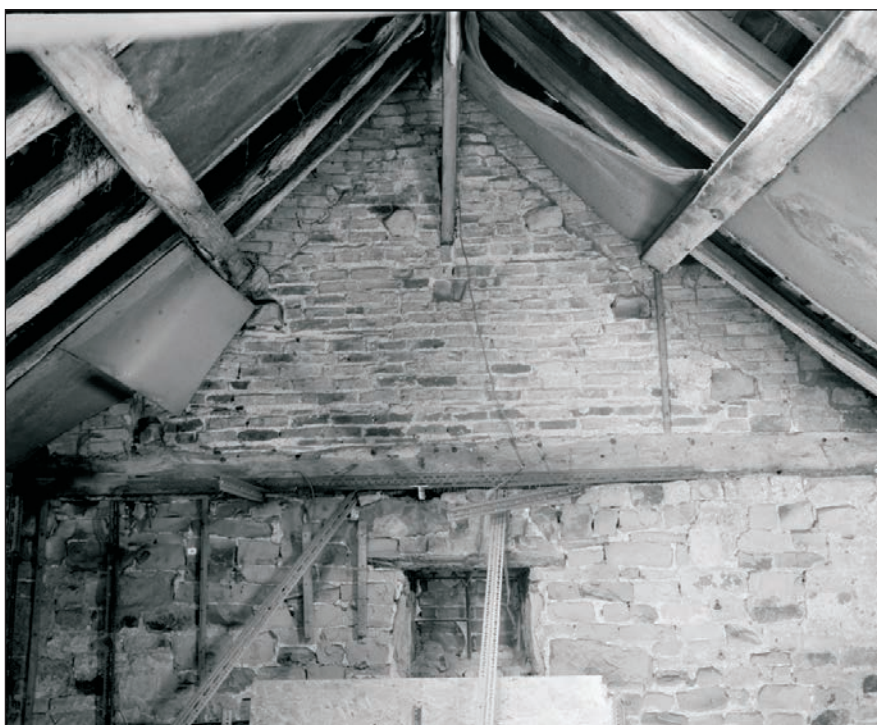
bays, of which the northern bay had a brick dovecote structure inserted within it. At the time of survey the southern two bays (G1) contained modern shelving units, which also created the first floor above (F1), with stairs situated at the southern end of the building. These units obscured much of the fabric of the building. The space was photographed and recorded further after their removal during the watching brief (**Plates 29-51**). Many of the openings had been altered in some way from their original form. It is difficult to say whether a first floor was originally present within the building. Although there are blocked joist holes within the phase 2 brick wall dividing the northern bay from the southern two, there were no obvious joist holes within the south wall. This indicates that the central bay had contained a first floor at some point, possibly supported by timber uprights dividing the southern and central bay. The roof of the building had been raised using brick, with clear joints within the south gable (**Plates 52, 53**). This was likely undertaken when the brick dovecote was constructed within the north bay.

Plate 52: View of raised roof, south gable of F1, Building 1 (Film 20.02)

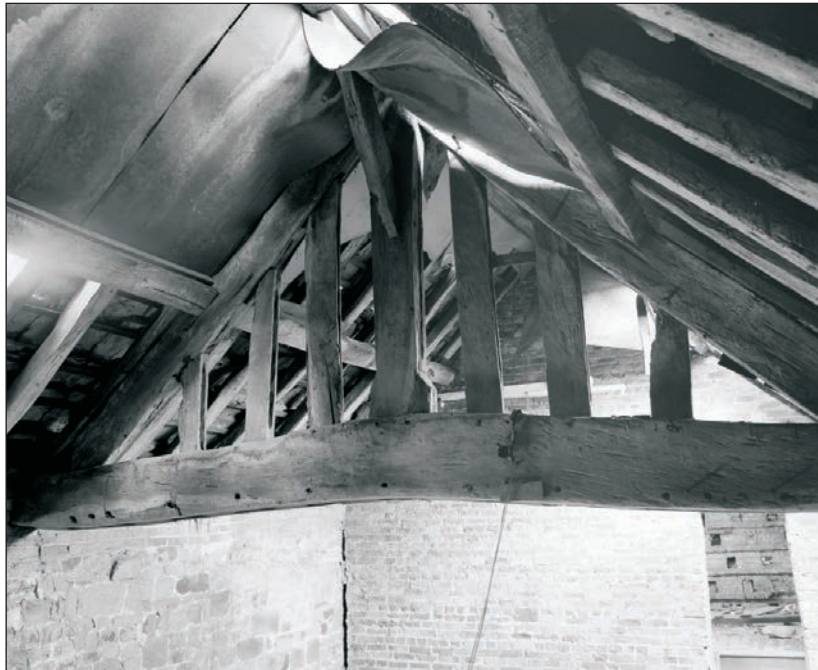
Plate 56: View of the timber truss, showing the lower face, F1, Building 1 (Film 19.10)

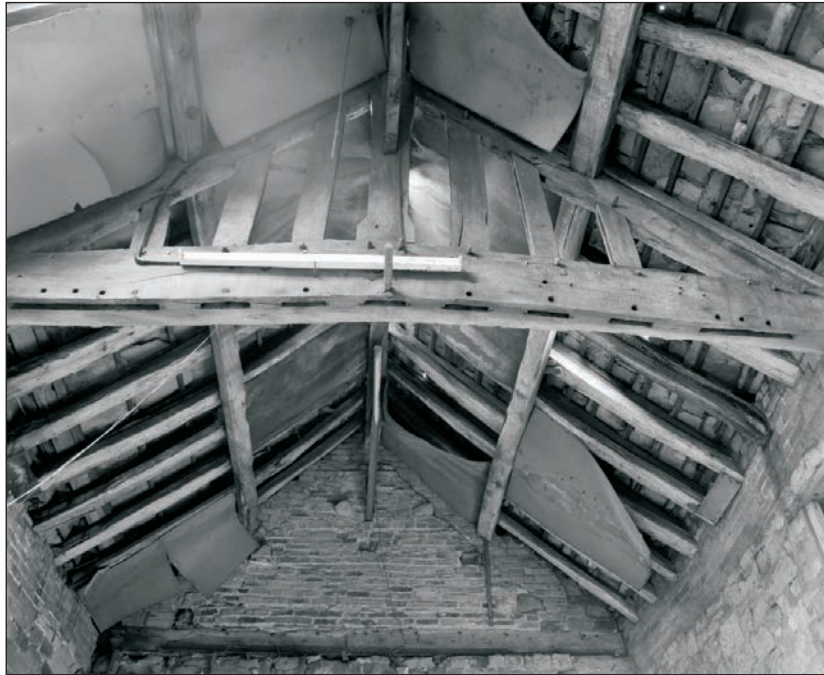
Plate 57: View of the timber truss, showing empty mortice joints on underside of tie beam, F1, Building 1 (Film 23.09)

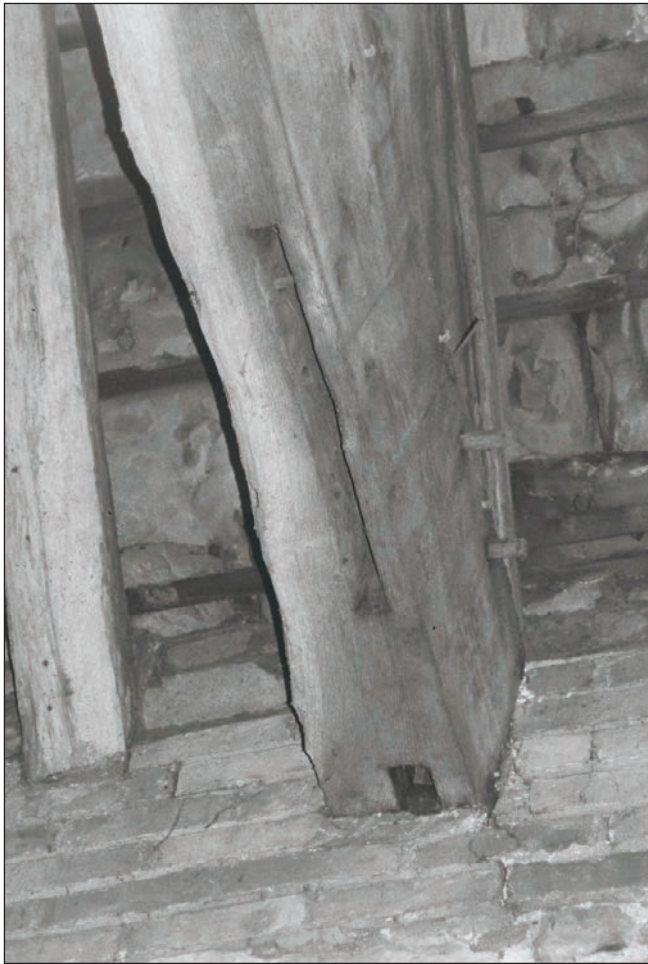
Plate 61: Detail of timber truss tie beam, with empty mortice joints and junction with wall, F1, Building 1 (Film 24.15)

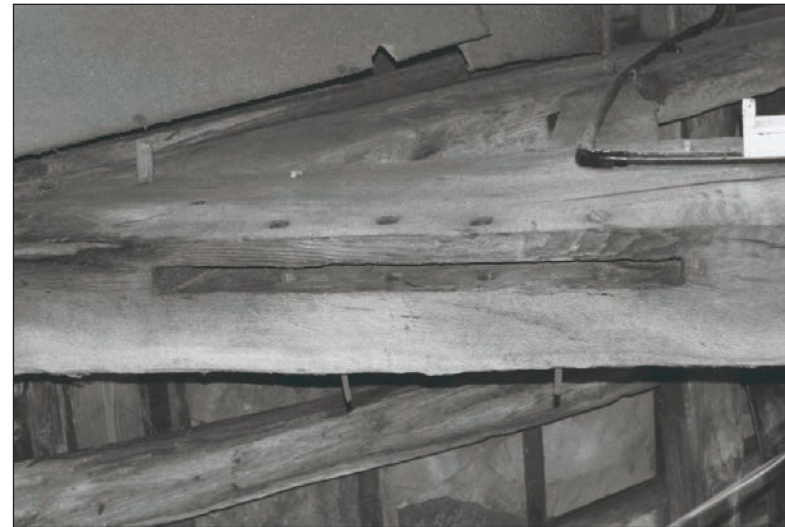
Plate 62: Detail of timber truss tie beam, with empty mortice joints on underside, F1, Building 1 (Film 24.17)

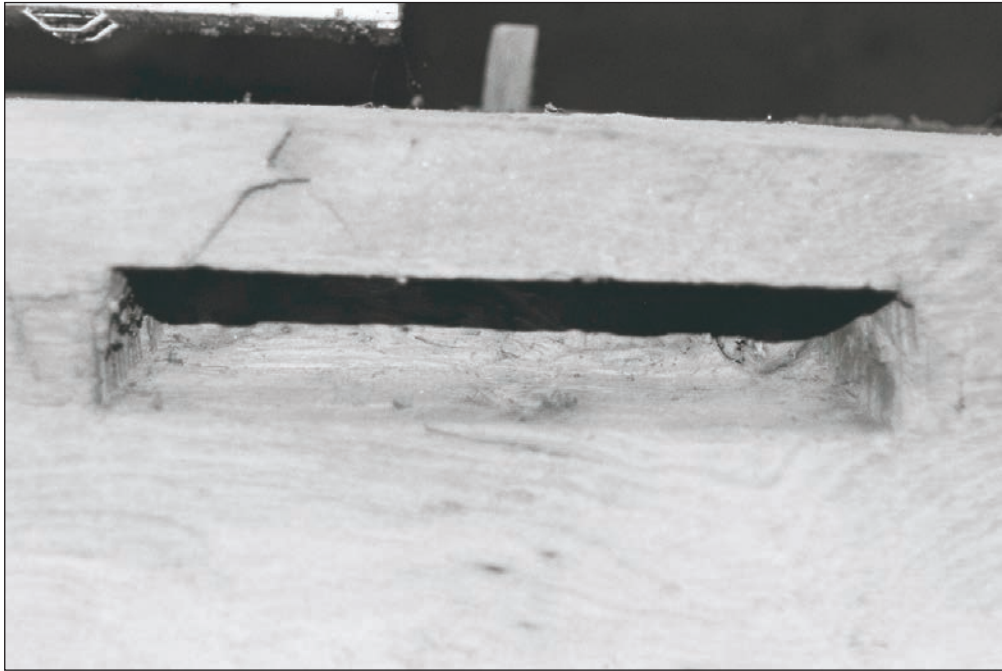
Plate 69: Detail of an empty mortise within the timber truss, F1, Building 1 (Film 06.13)

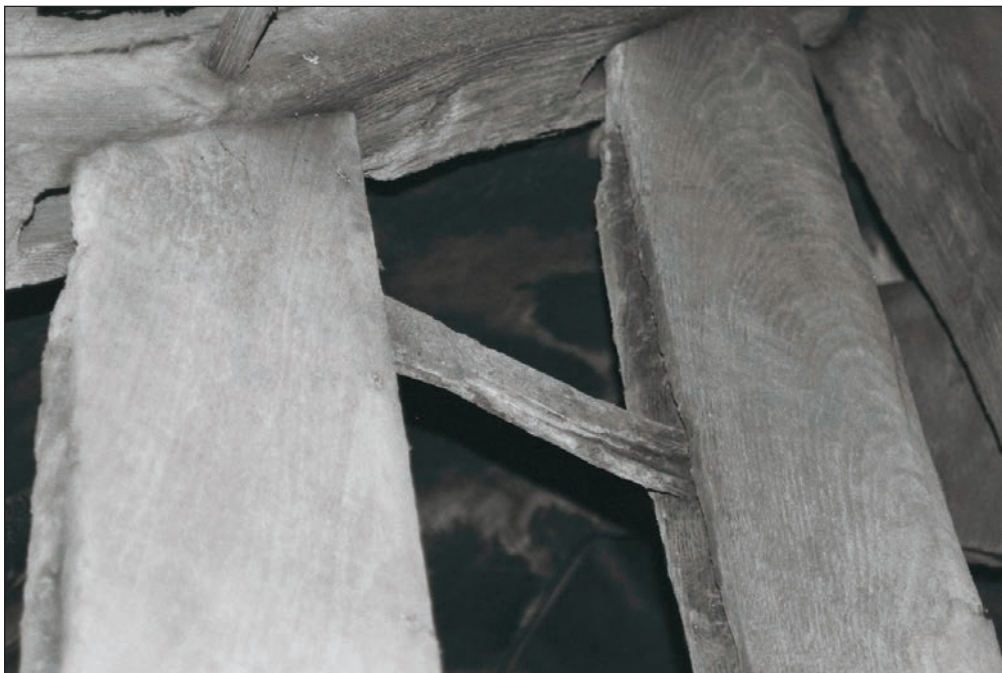
Plate 70: View of the timber truss, showing original lath infill and grooves within uprights for removed laths, F1, Building 1 (Film 06.14)

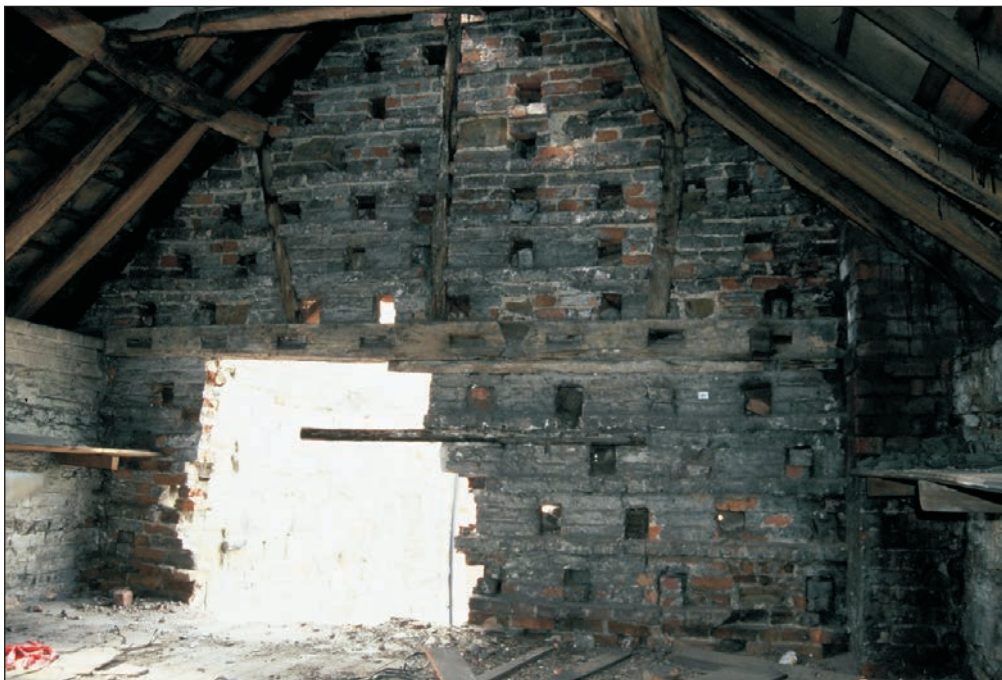
- 5.2.10 The northern bay of the building contained an inserted brick dovecote (**Plate 78**). This could be accessed via the ground floor doorway in the west wall. At ground floor the dovecote had been divided into two rooms (G2, G3) by a modern brick partition. Access into room G2 was created by an inserted doorway in the south wall of the dovecote. A chimney flue was located in the northeast and southwest corners of the dovecote, although the northeast chimney had been removed at ground floor. A timber beam and upright support carried an inserted floor above (**Plates 40-46**).

- 5.2.11 At first floor there was a single room (F2) accessed from an inserted door in its south wall (**Plate 78**). The nesting holes were positioned within the north wall, although some had been lost when the gable collapsed. A rotated tie beam set in the wall supported the gable (**Plates 78, 79 and 81**), which contained simple timber supports carrying the ridge piece and purlins of the roof. The inserted floor truncated the lower nesting holes in the wall. There was a blocked window within the east and west walls, and the early timber truss dividing the north and central bays had been infilled with brick when the dovecote was inserted (**Plate 82**).

Plate 78: General view of Dovecote, F2, Building 1 (Colour Slide 10)

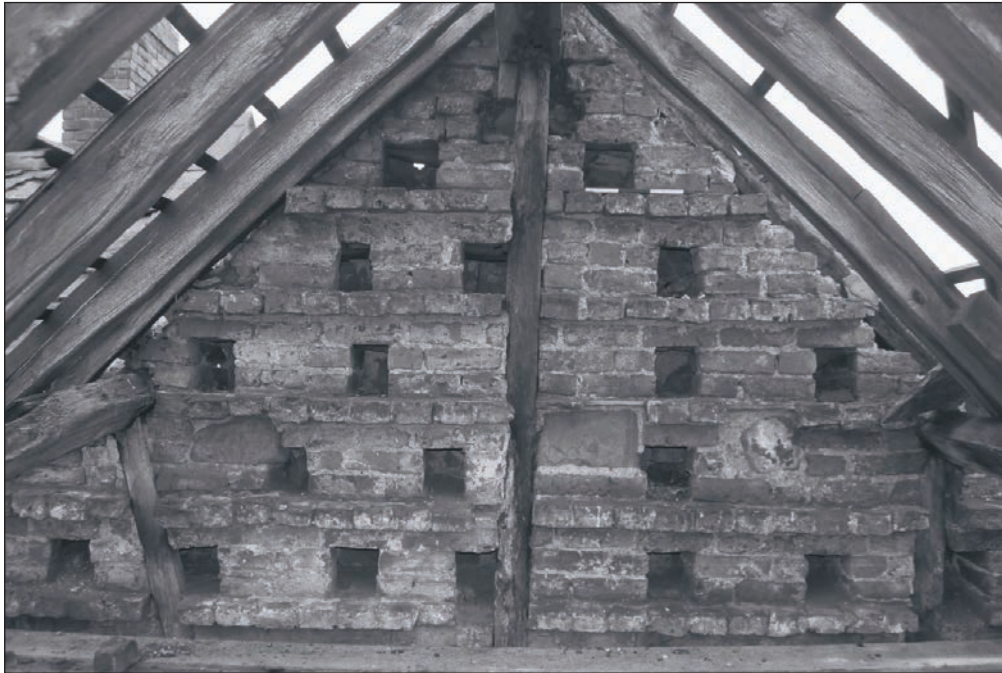
Plate 79: Detail of the upper dovecote north gable, F2, Building 1, during the watching brief (Film 39.35)

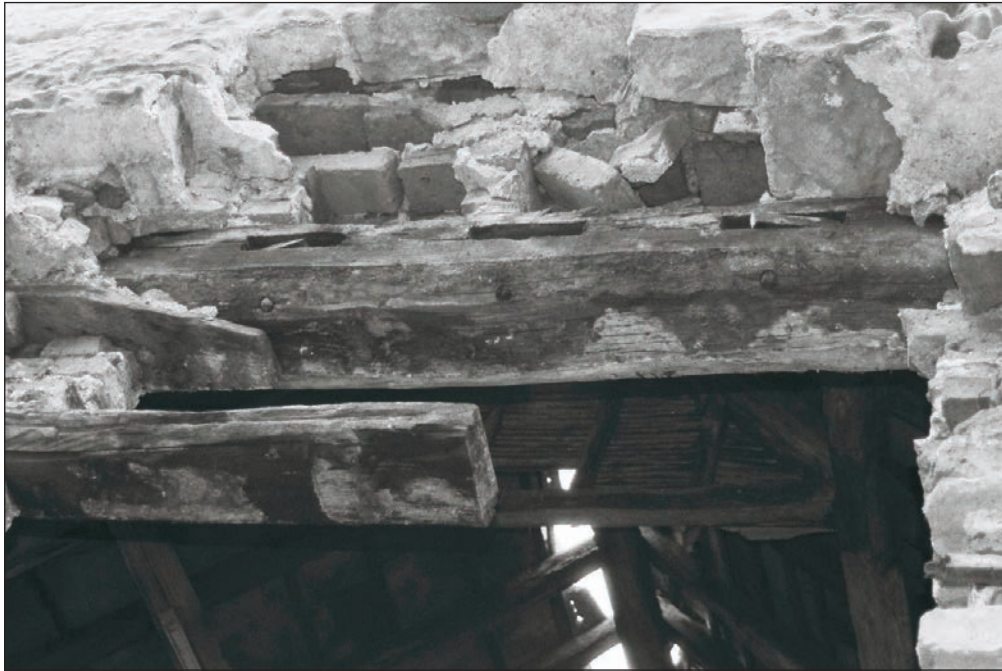
Plate 81: Detail of reused (and rotated) tie beam within the north gable of the dovecote, F2, Building 1 (Film 03.29)

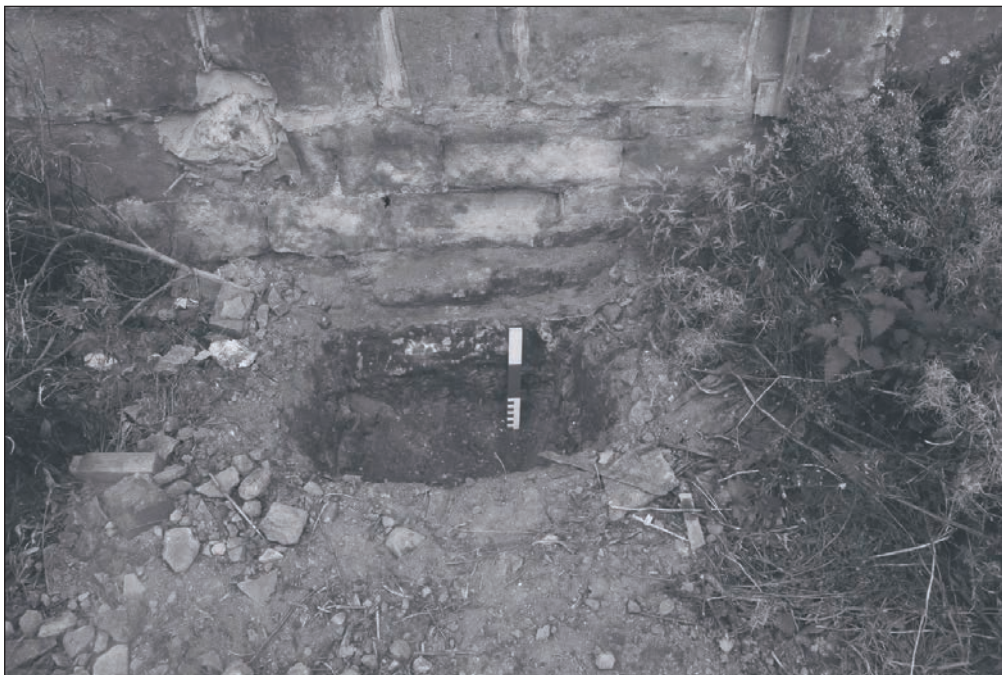
- 5.2.2 The eastern foundations of the structure were revealed in Test pit 1, which was excavated to a depth of 0.4m and revealed two courses of stone that were stepped out by 0.08m and 0.7m (**Plate 94**). No below ground foundations were seen in Test pit 2, where the western wall was constructed upon weathered sandstone (**Plate 95**).

Plate 94: General view of Test Pit 1, against the east elevation of Building 1 (Film 36.01)

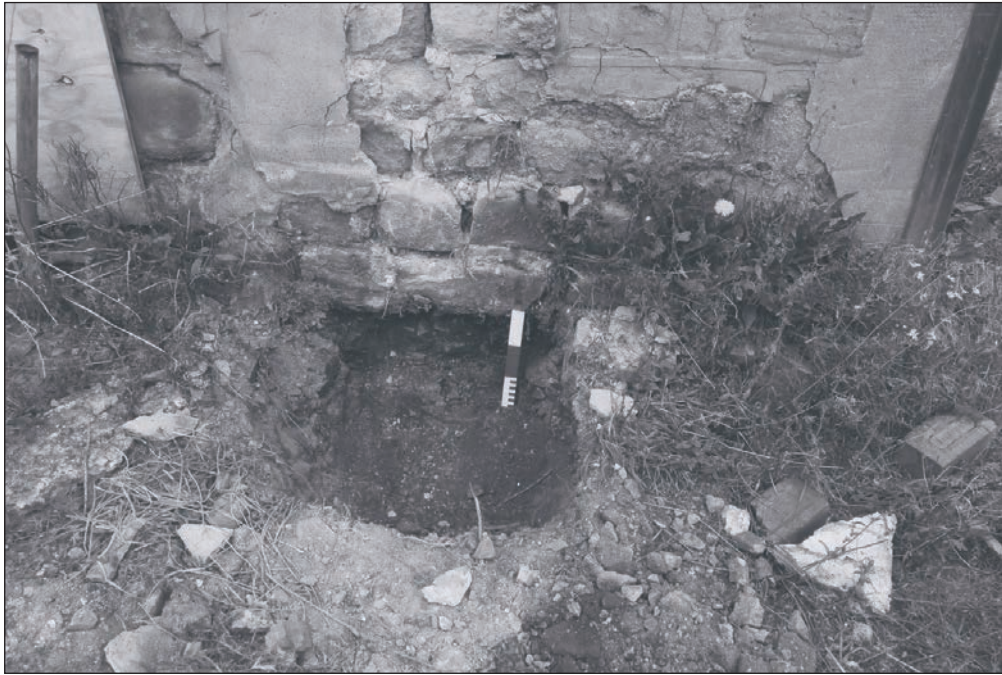
Plate 95: General view of Test Pit 2, against the west elevation of Building 1 (Film 36.04)

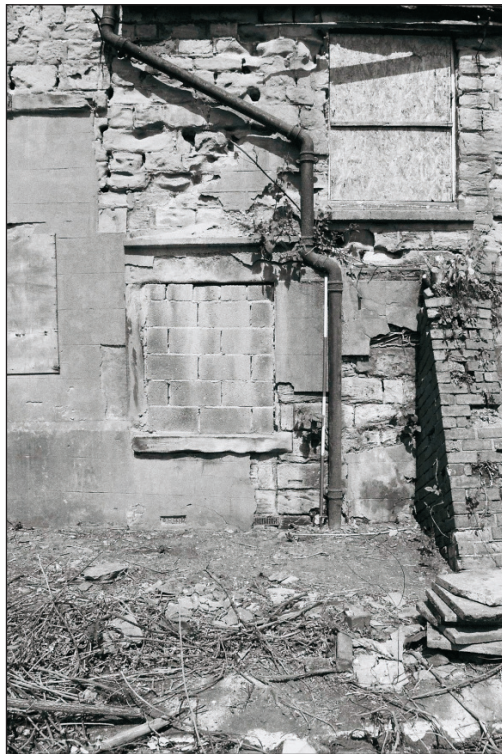
Plate 99: View of the west end of the south elevation of Building 2, showing the former doorway, and vertical joint with Building 3 (Film 01.24)

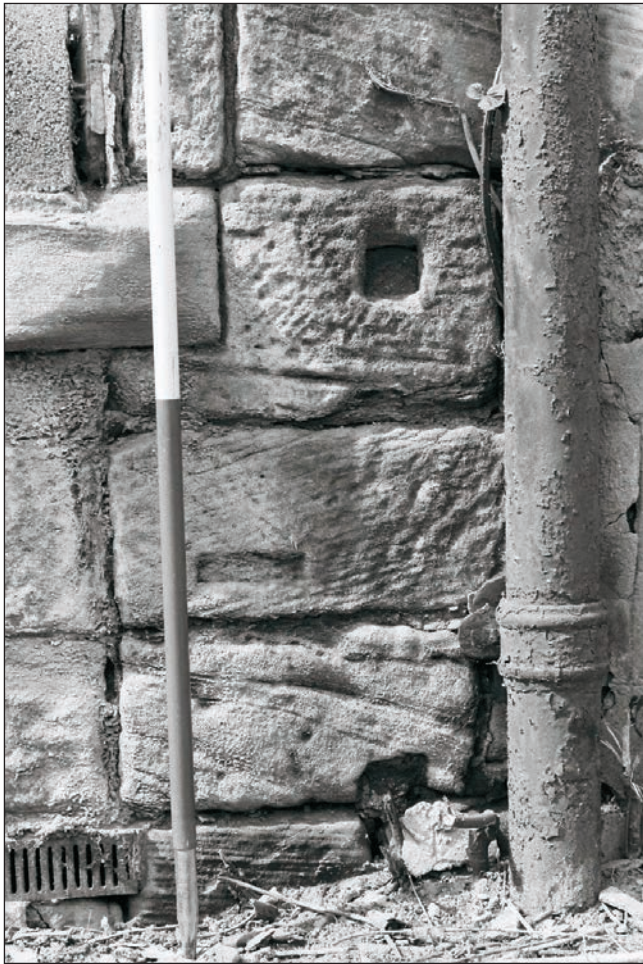
Plate 100: Detail of vertical joint of former doorway, south elevation of Building 2 (Film 05.07)

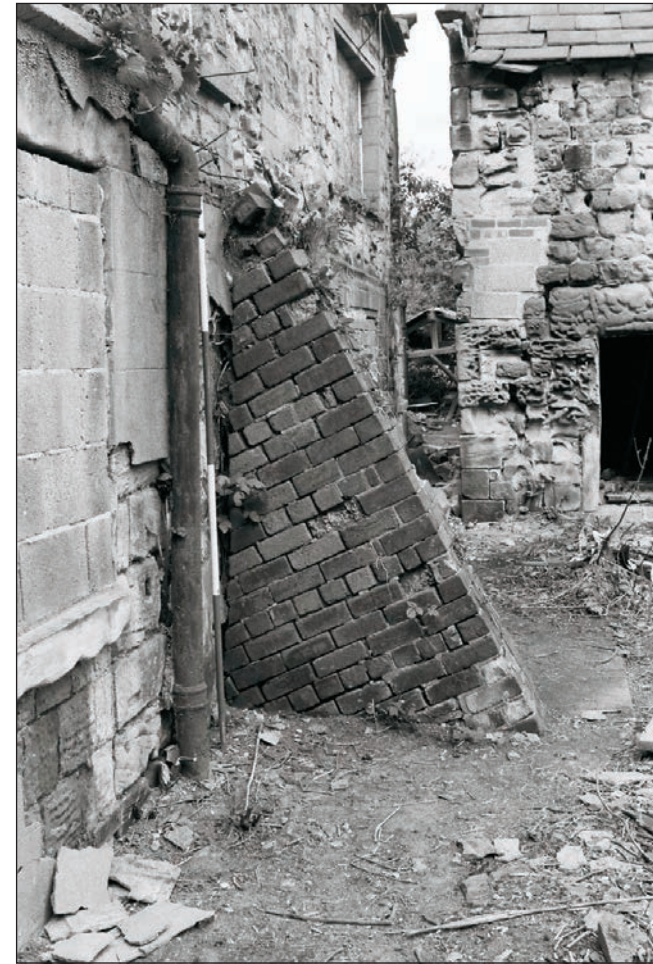
Plate 101: View of brick buttress, south elevation of Building 2 (Film 05.01)
