HANSON HOUSE  
SNYDALE ROAD  
NORMANTON  
WAKEFIELD  
WEST YORKSHIRE

Historic Building Recording

**Planning Application Ref: 07/00704/FUL & 07/00705/LBC**

74352.02\_BDG\_V0\_3

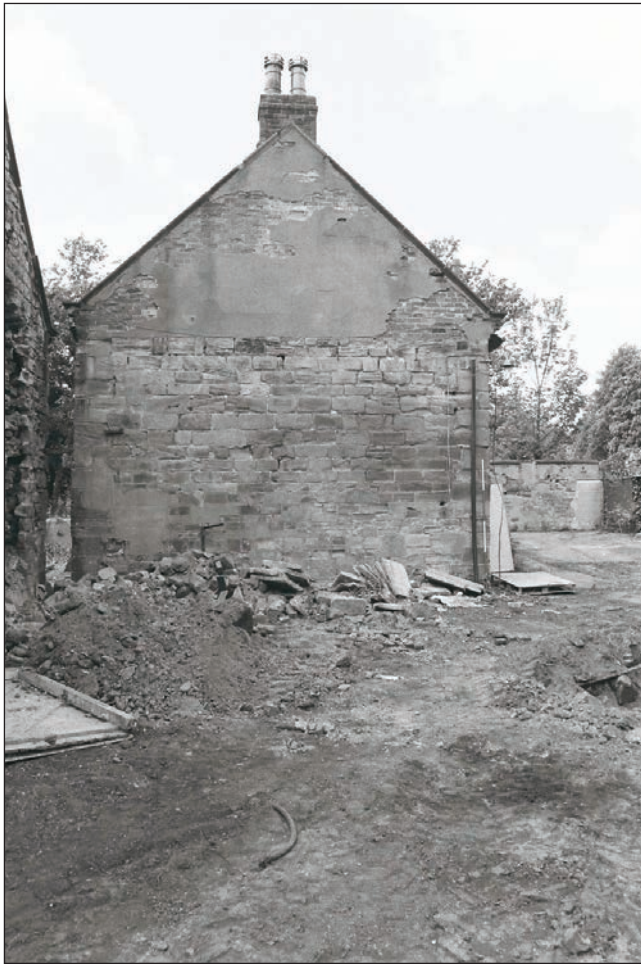
- 5.3.4 The east elevation of the building was constructed of coursed sandstone up to the eaves level, above which the gable was built of brick, and had been rendered (**Plate 104**). A tall brick chimney stack projected from the ridge line of the roof behind the gable, which was constructed to the same design as the chimneys within the later western wing of the house. The gable was finished with stone copings and stepped brick and moulded stone kneelers (**Plate 106**).

Plate 104: General view of the east elevation of Building 2 (Film 01.13)

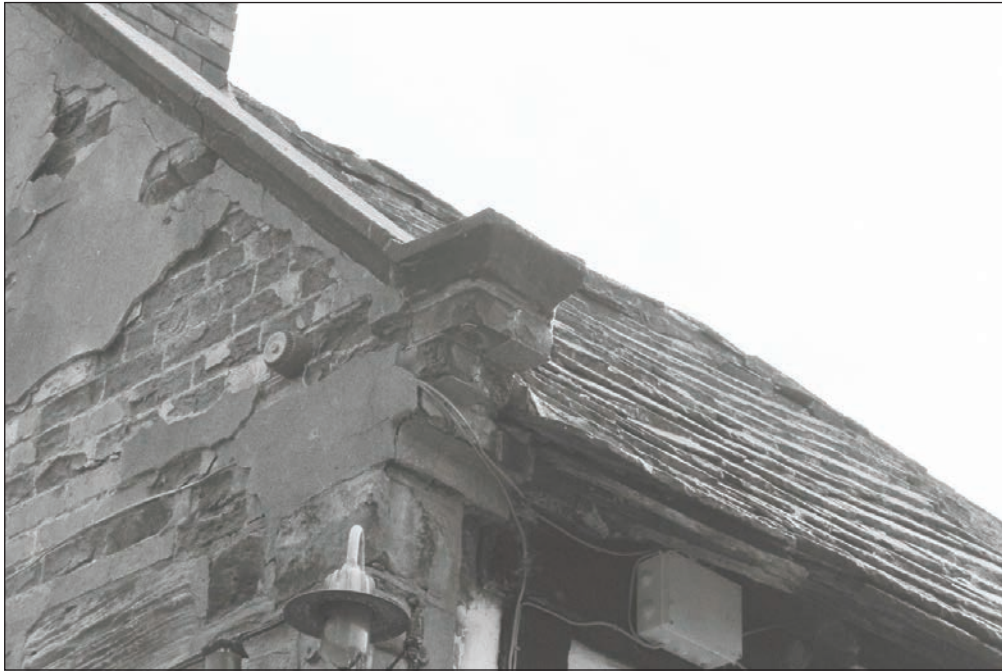
Plate 106: Detail of brick kneeler with stone coping, east gable and north elevation, Building 2 (Film 05.08)

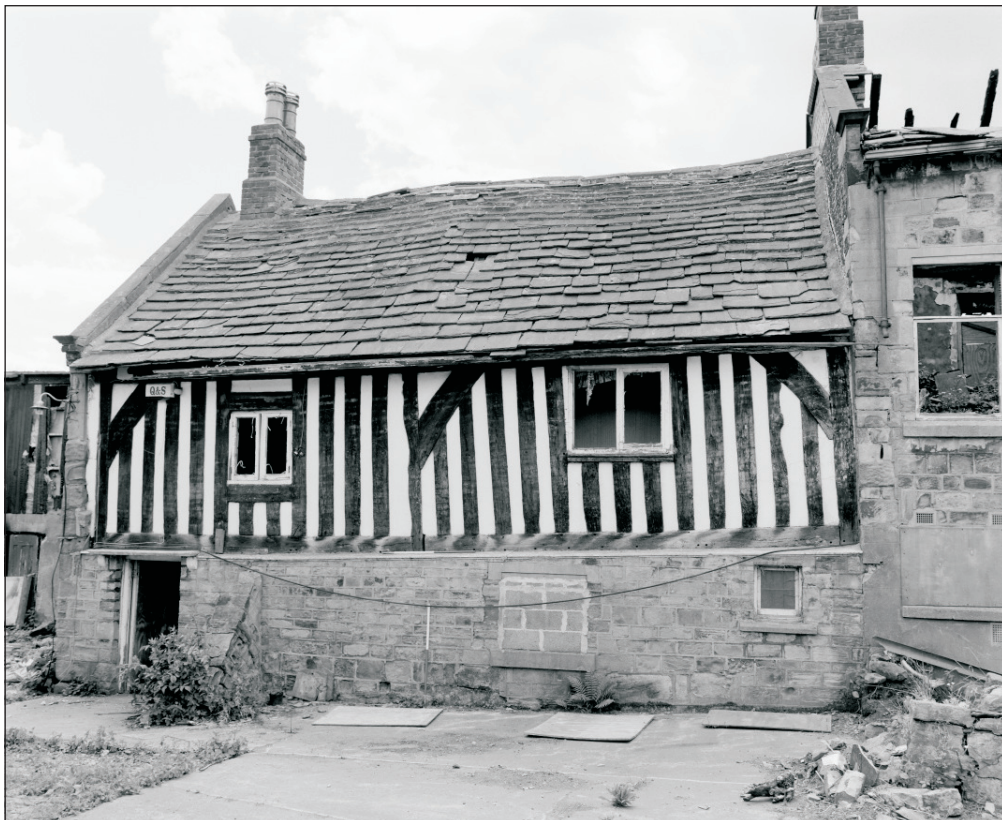
- 5.3.5 The north elevation of building 2 (**Figure 12 and Plates 107, 108**) contained the original timber framed close studding at first floor (mid-rail and above), along with a stone and plaster infill. This contained arched braces at each end of the building and one in the centre. Empty peg holes within the western post delineated the position of another brace to the west, indicating that the building continued for at least another bay to the west prior to the construction of the phase 3 wing (**Plates 116, 117**). The absence of further holes within the eastern post suggests the building never extended further in that direction (**Plate 112**).

Plate 107: General view of the north elevation of Building 2 (Film 13.02)

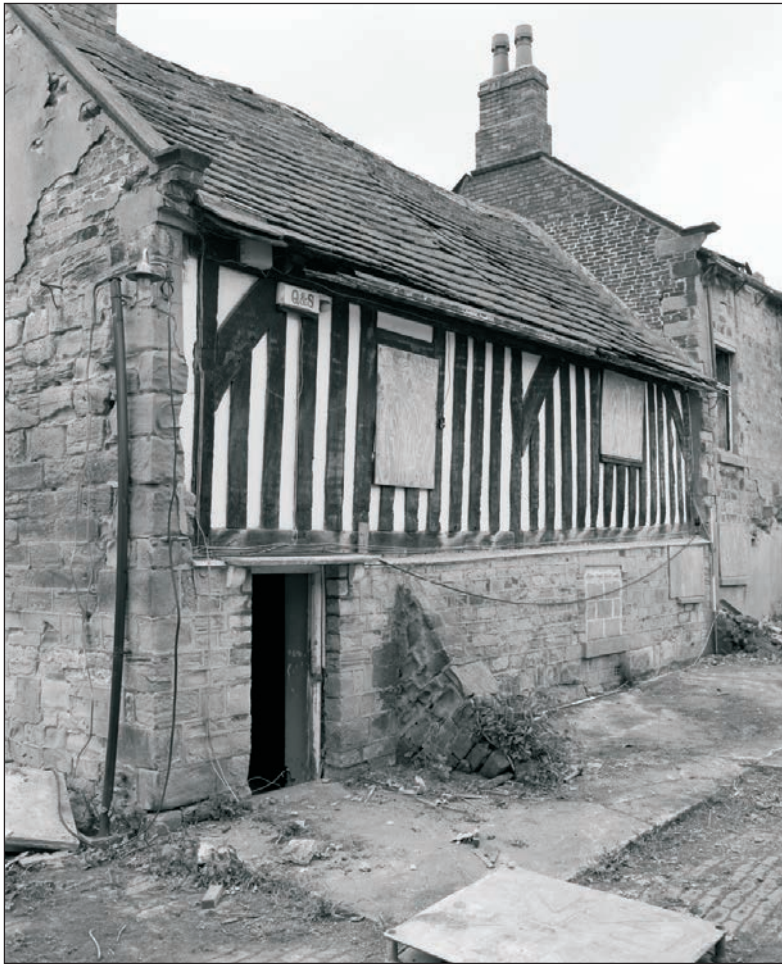
Plate 108: General view of the north elevation of Building 2 (Film 09.03)

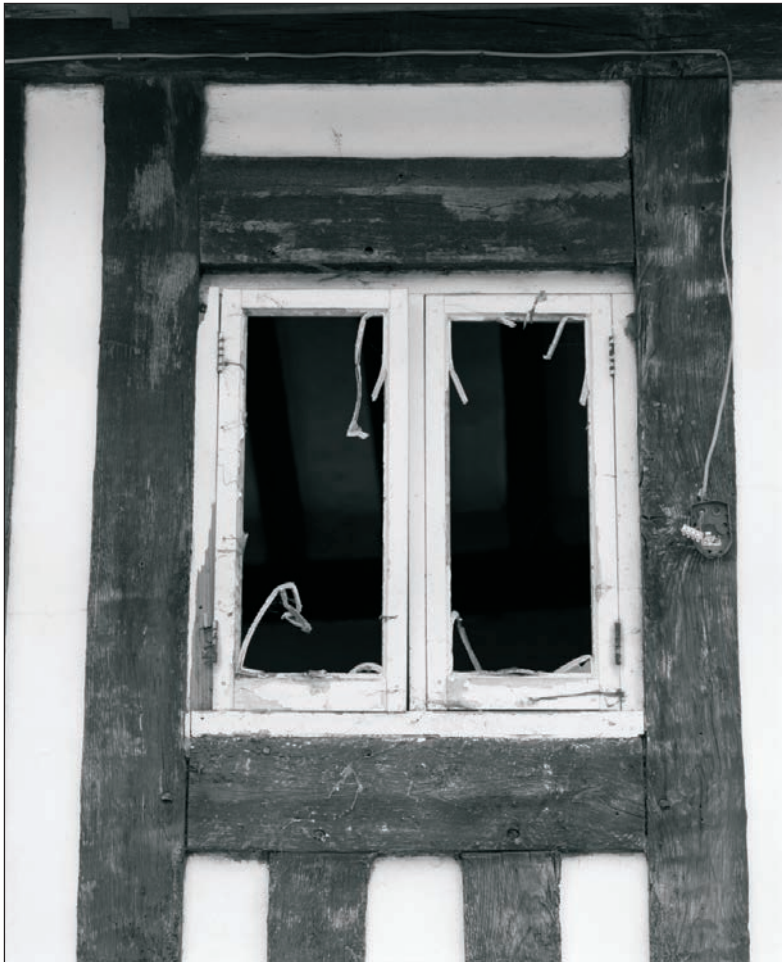
- 5.3.6 Centrally positioned within each of the two bays were original window openings with later replacement windows. The window to the east was positioned mid-way between the mid-rail and eaves, whilst the one to the west was higher, directly below eaves level (**Plates 107, 110, 111**). This difference in window height may be indicative of the internal form of the house. The lower window may suggest that the eastern bay was open to full height, and a lower window served to better light the high space. The higher window may indicate the former central bay to have always been floored, with the window respecting the internal floor height.

Plate 110: Detail of first floor window, eastern bay of the north elevation, Building 2 (Film 13.06)

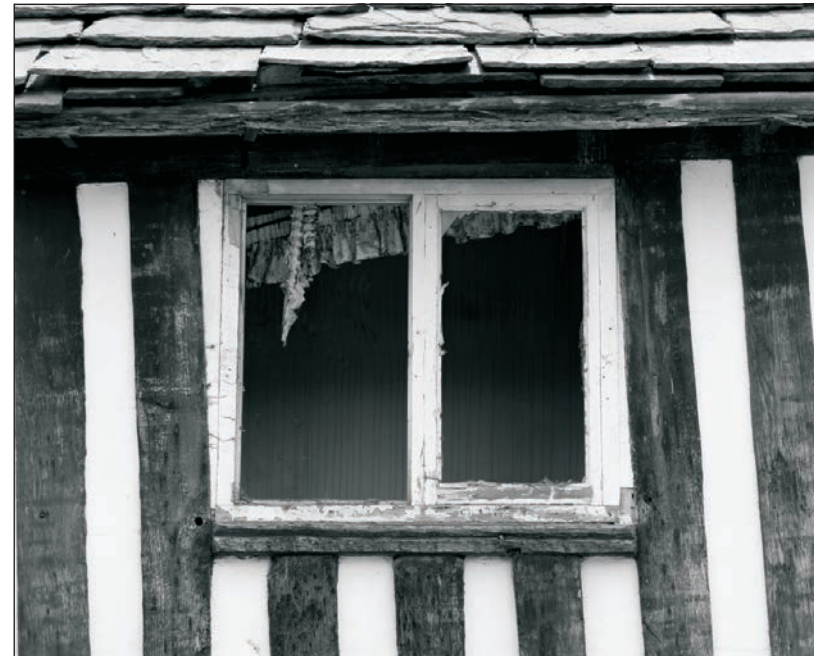
Plate 111: Detail of first floor window, western bay of the north elevation, Building 2 (Film 13.03)

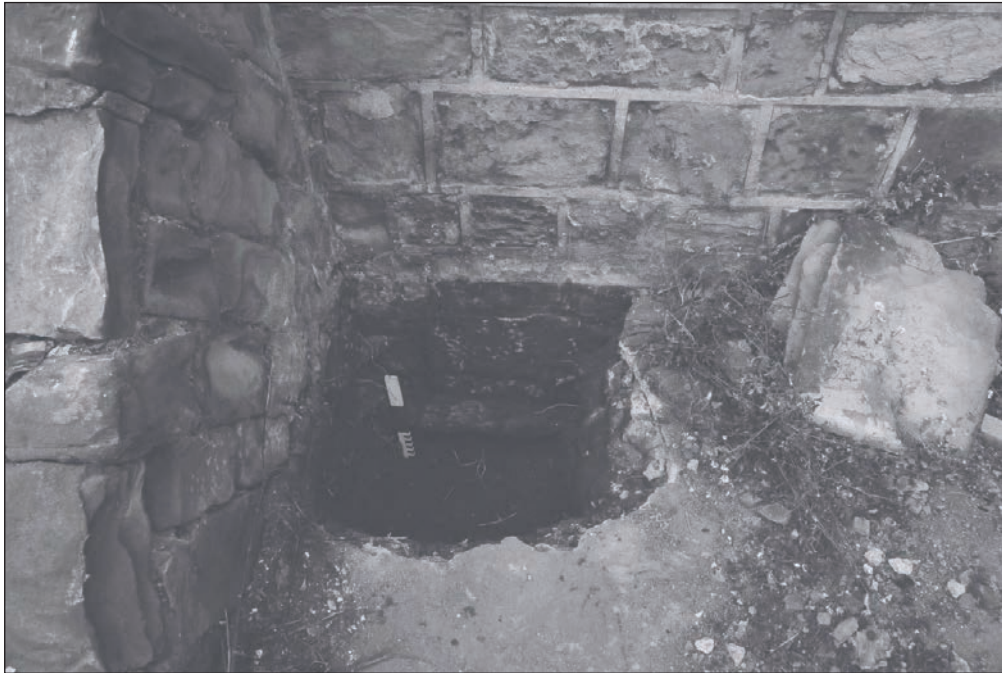
- 5.3.8 Test Pit 3 was excavated to a depth of 0.6m on the north side of Building 2. Three courses of sandstone foundations were revealed, which overlay a 0.8m stepped course that was set on a mixed clay deposit (**Plate 118**).
- 5.3.9 Test Pit 8 was located against the external face of the south wall, and revealed the footings of a raking brick buttress (**Plate 119**). The footings comprised 0.18m of bricks mortared onto yellow sandstone flagstones. The southern footings of Building 2 were seen to extend to 0.35m in Test pit 9 (**Plate 120**).

Plate 118: General view of Test Pit 3 against the north elevation of Building 2 (Film 36.06)

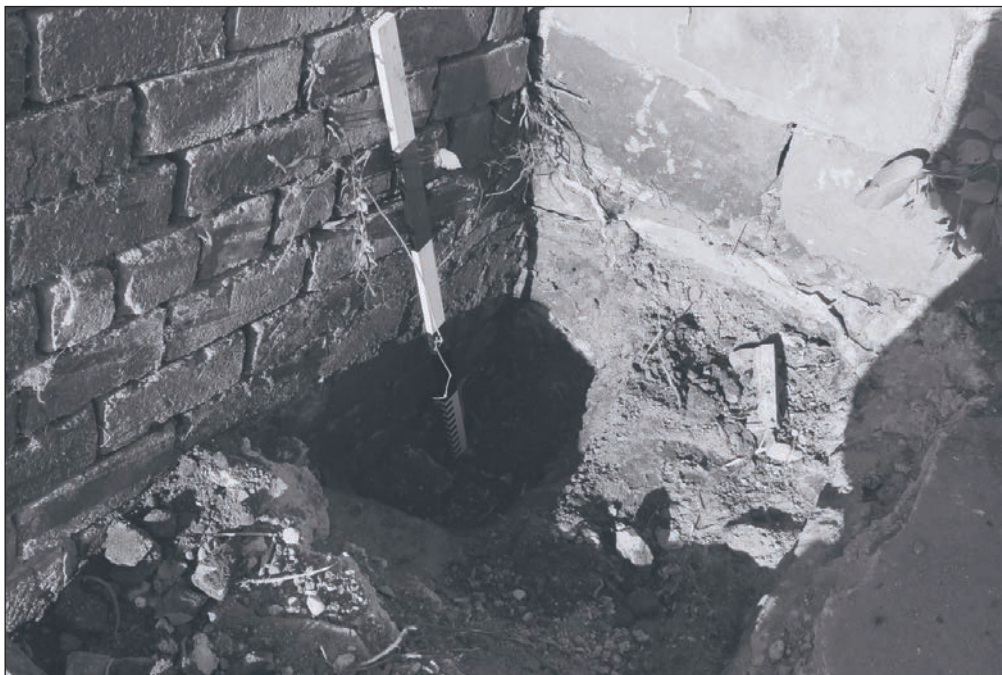
Plate 119: General view of Test Pit 8, against the south elevation of Building 2 (Film 35.23)

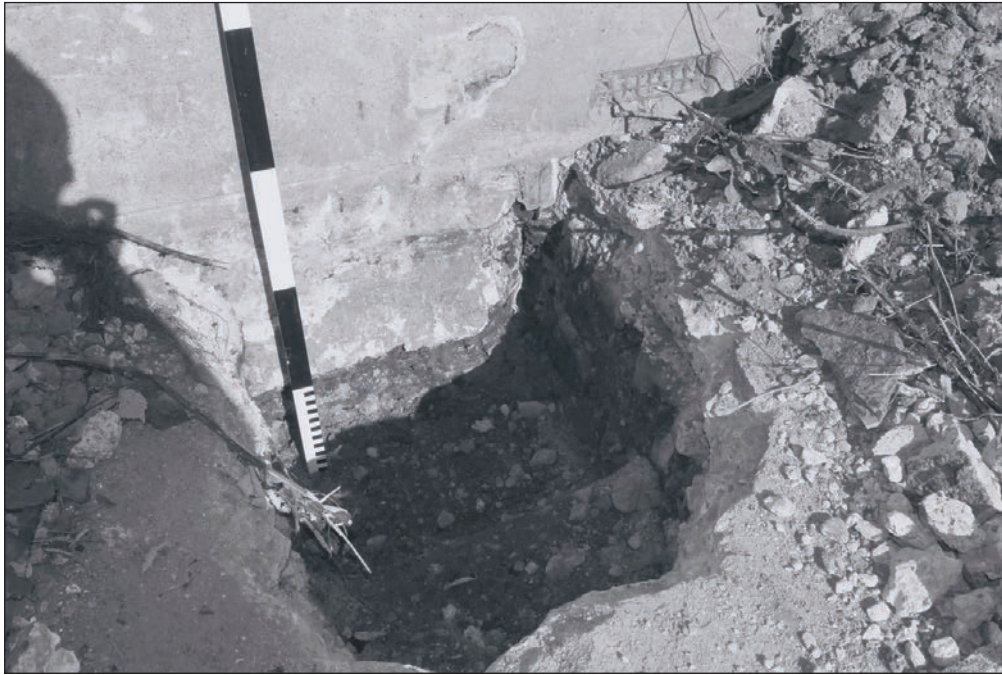
Plate 120: General view of Test Pit 9, against the south elevation of Building 2 (Film 35.24)

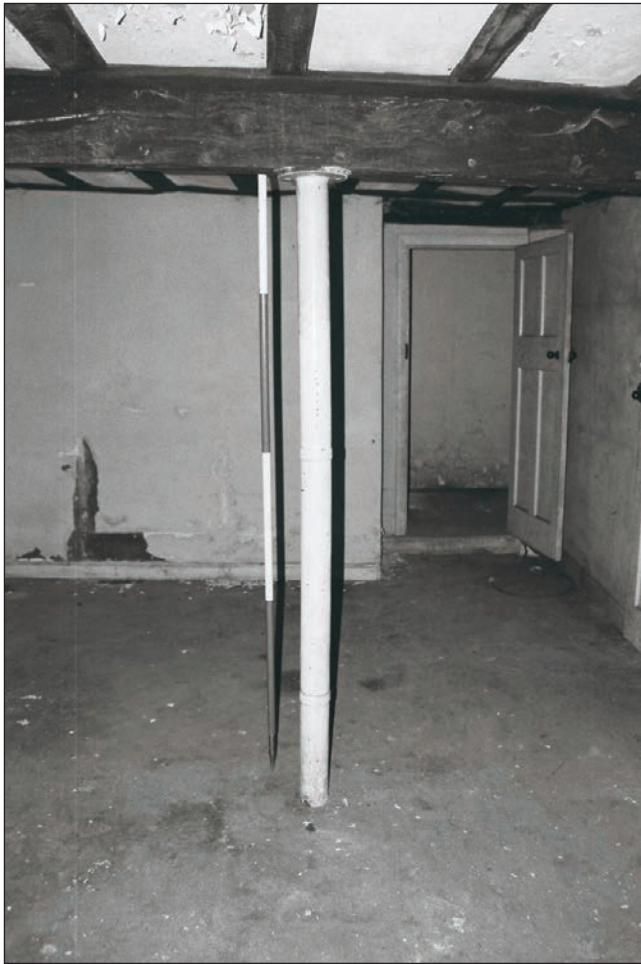
- 5.3.10 At ground floor, Building 2 contained 4 rooms or spaces (G1-G4; **Figures 8, 13 and 14**). The ground floor was accessed from the inserted doorway at the east end of the north wall. This opened into room G1 (**Plate 121**). Room G1 contained a large brick chimney breast against the east wall (**Plate 122**). The fireplace had been altered in the 20<sup>th</sup> century, having been partially blocked and a cast iron range cooker inserted (**Plates 129-132**). A small modern kitchen unit and sink was positioned within the southern alcove, adjacent to the chimney breast (**Plates 123, 127**). Running transversely overhead across the room was a large timber beam, supported by a central cast iron column (**Plates 128, 138**). This beam was the division between the

Plate 128: Detail of cast iron column, G1, Building 2 (Film 04.18)

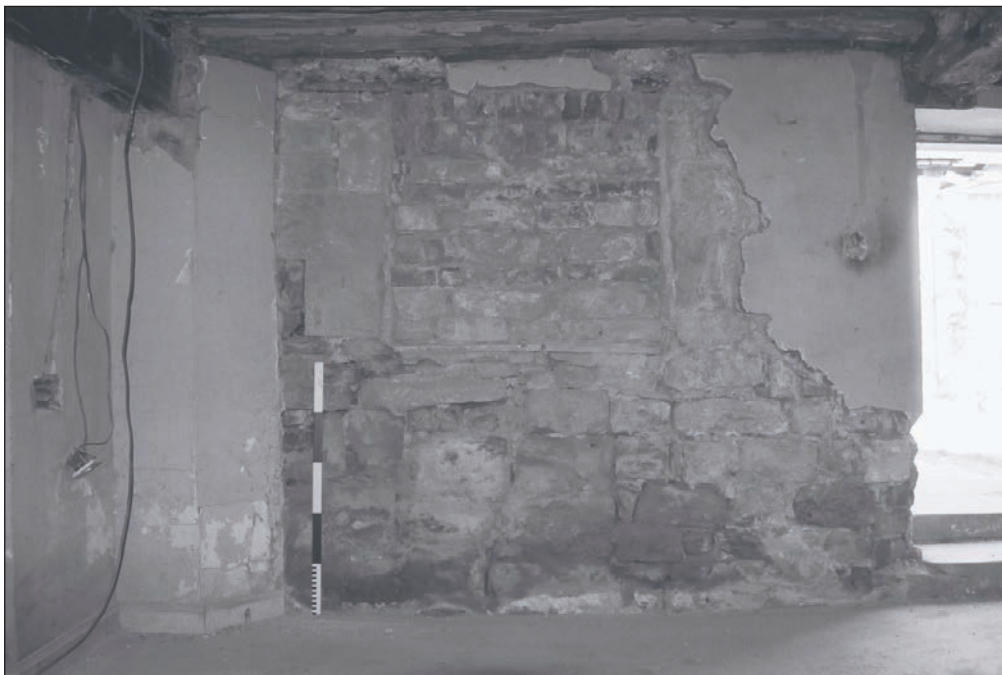
- 5.3.12 During the watching brief after the removal of plaster from the internal surface of the north wall, a blocked window (or possible door) was observed adjacent to the doorway (**Plate 133, 134**). This had been completely concealed externally.

Plate 133: Detail of exposed blocked window within the north wall of G1, Building 2, during watching brief (Film 35.31)

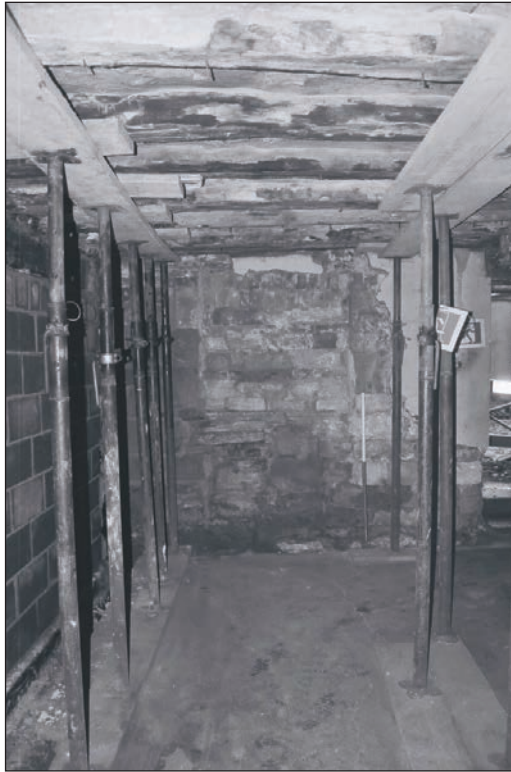
Plate 134: Detail of exposed blocked window within the north wall of G1, Building 2, during watching brief (Film 42.34)

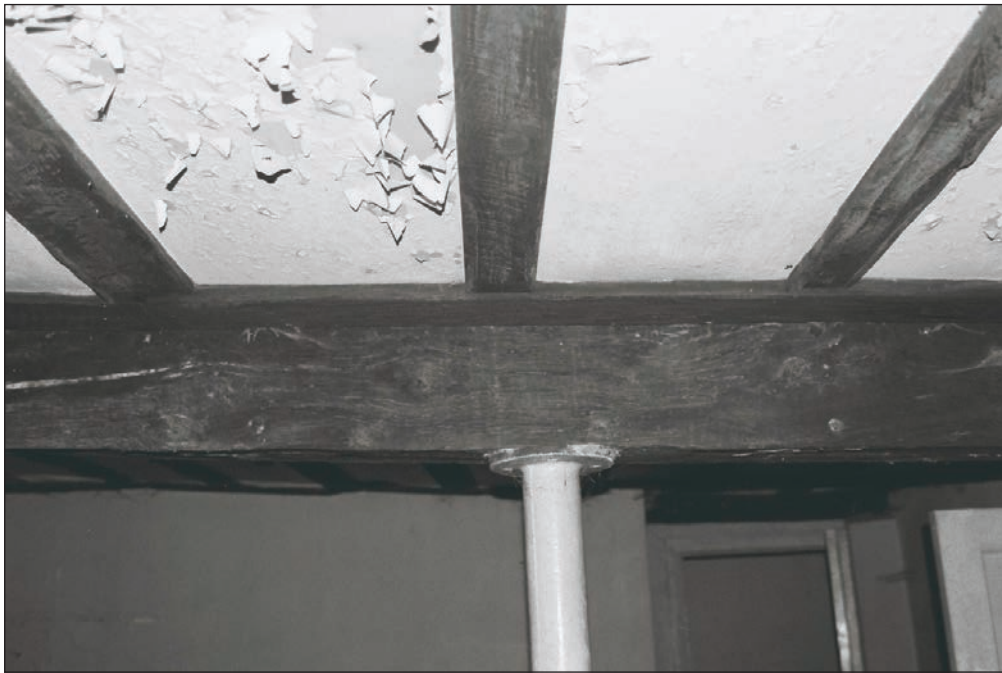
east and former central bays of the building. Located on either side of the beam were empty peg holes which corresponded to mortice joints on the underside of the beam for former close studding (**Plate 139**). In the centre of the beam there were no peg holes, indicating the position of an original doorway within the partition (**Plate 138**). This close studding had been removed and the cast iron column inserted to bear the weight of the floor above. Added brick piers against the north and south walls also supported the beam.

Plate 138: Detail of cast iron column and timber beam, G1, Building 2 (Film 06.07)

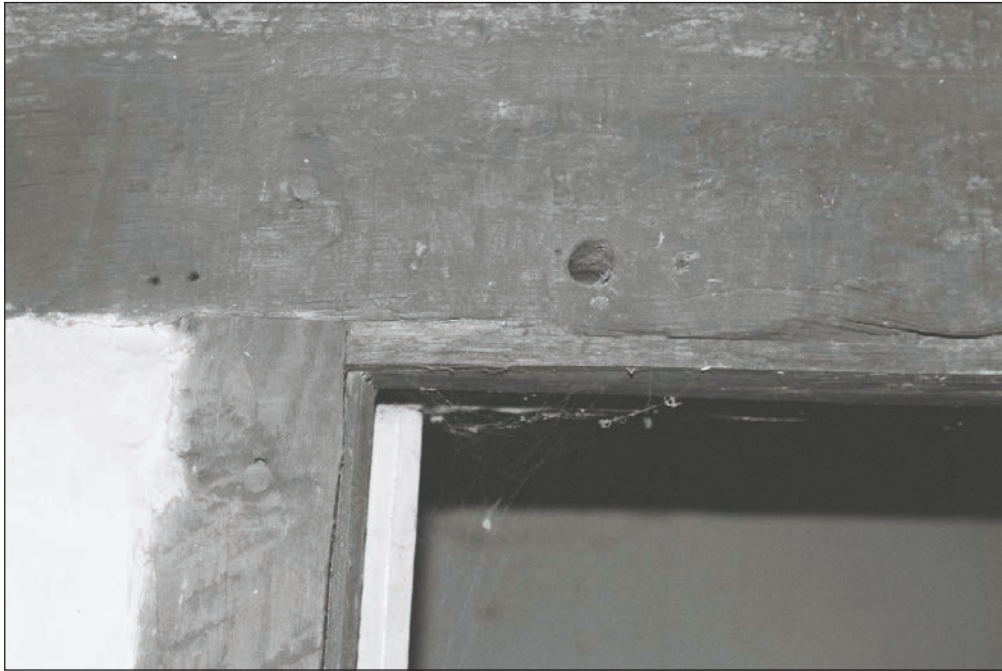
Plate 181: Detail of inserted doorway between F2 and F1 within close studding, Building 2 (Film 04.04)

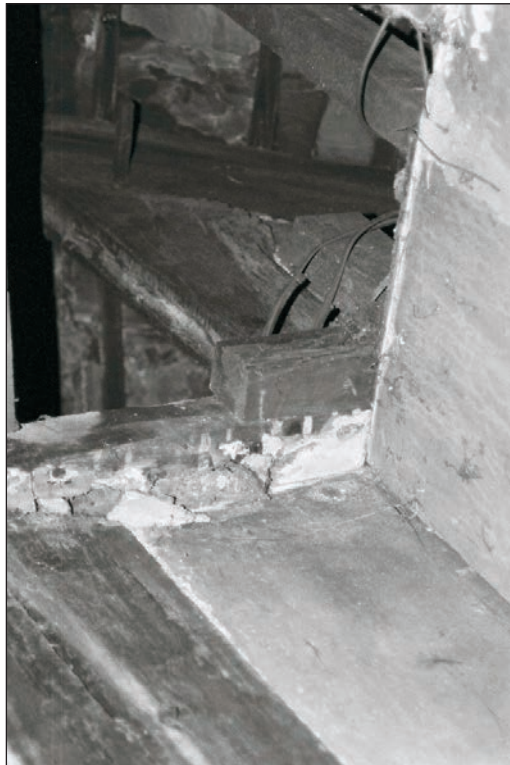
Plate 182: Detail of close studding partition above ceiling within F2, Building 2 (Film 04.01)

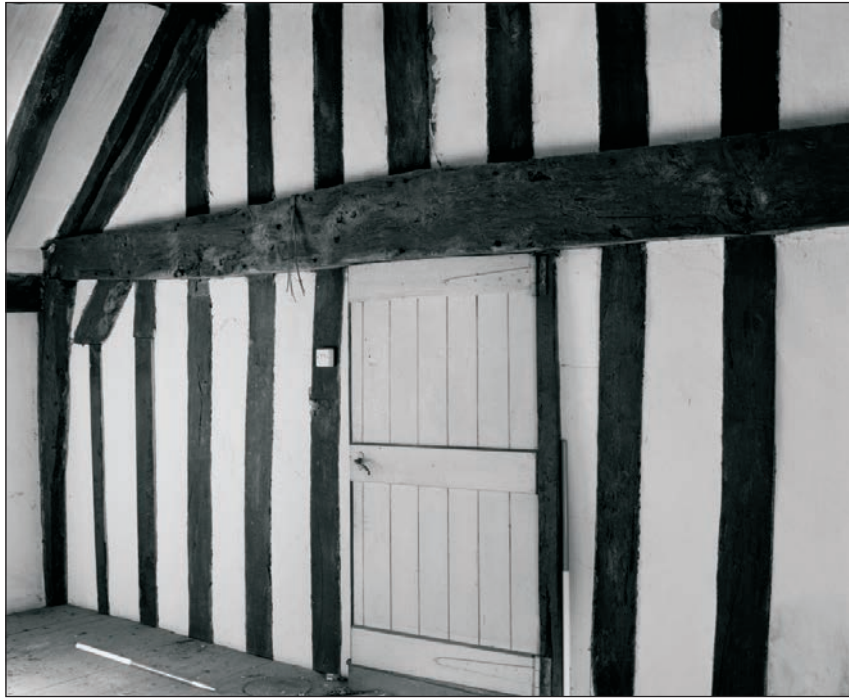
Plate 183: General view of F1, showing close stud partition, Building 2 (Film 16.05)

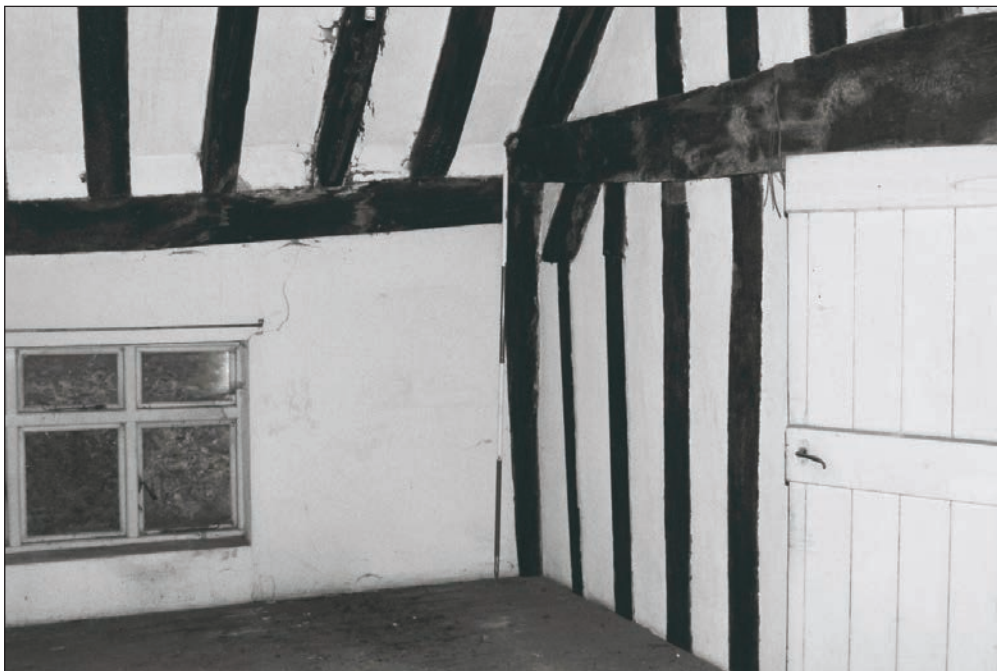
Plate 184: General view of F1, showing close stud partition, Building 2 (Film 05.30)

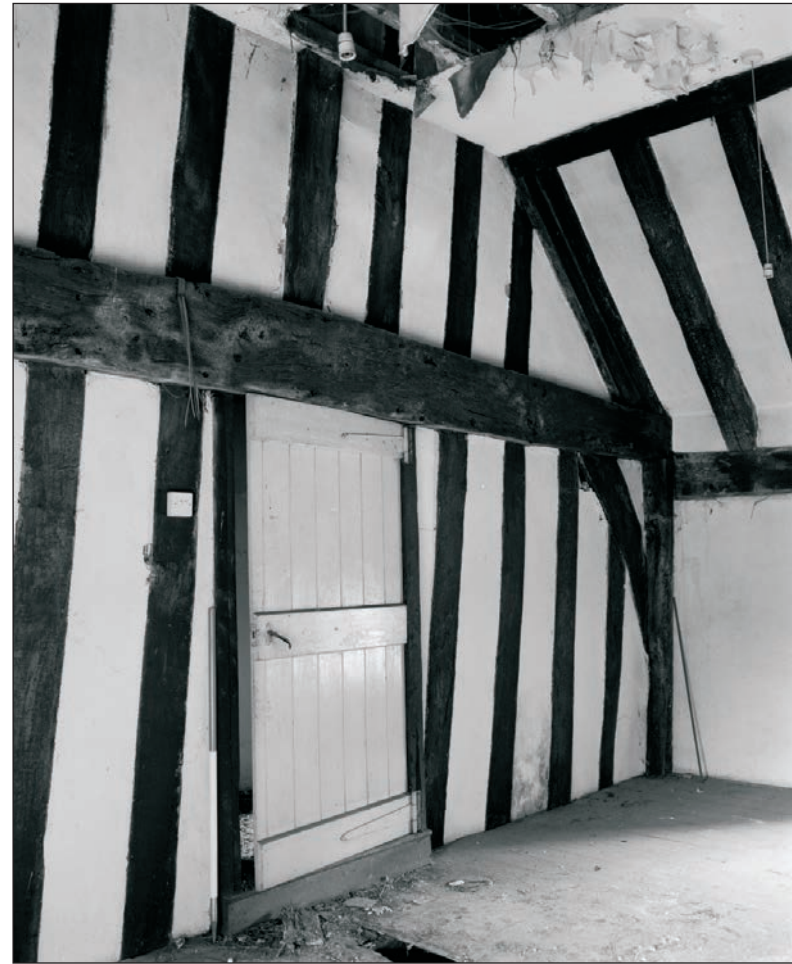
Plate 186: General view of F1, showing close stud partition, Building 2 (Film 16.07)

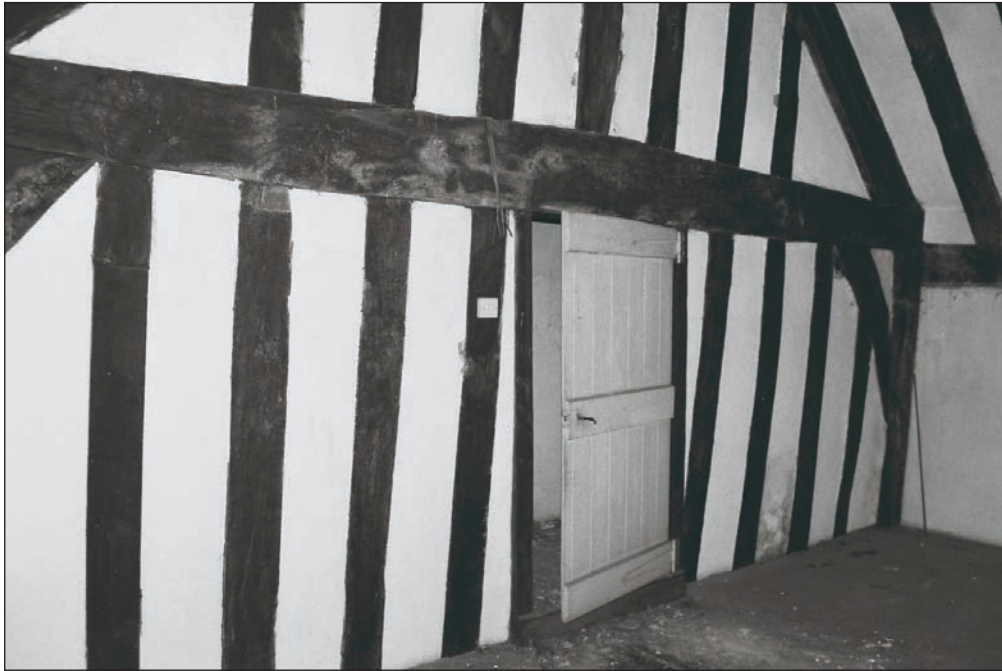
Plate 187: General view of F1, showing close stud partition, Building 2 (Film 06.02)

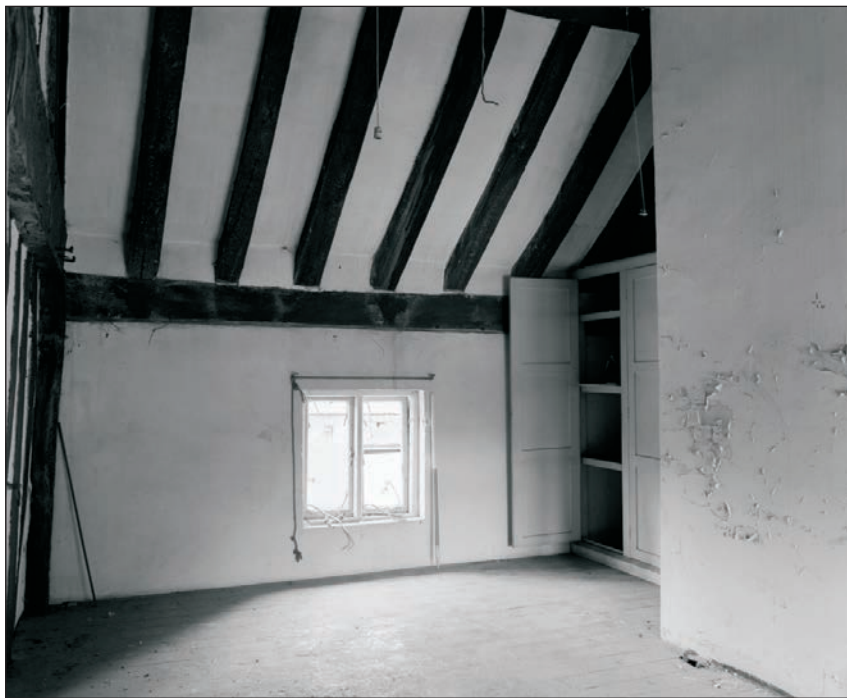
Plate 188: General view of F1, showing window to the north, Building 2 (Film 17.01)

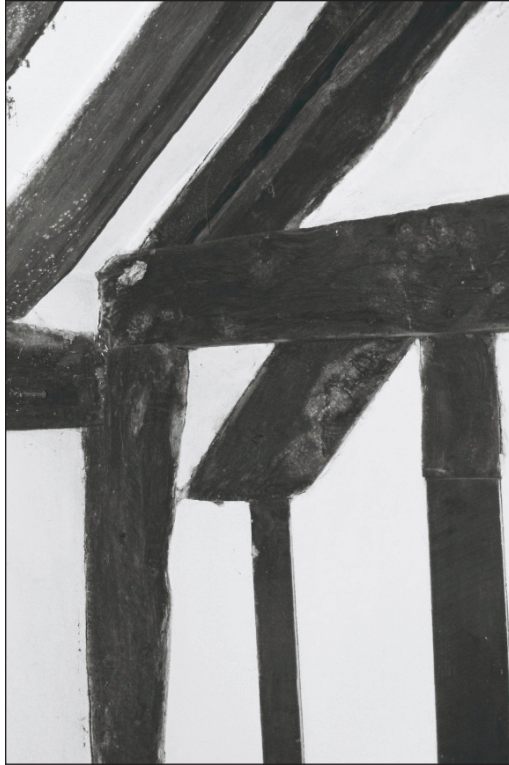
Plate 189: Detail of truncated arch brace, south end of timber partition, F1, Building 2 (Film 05.34)

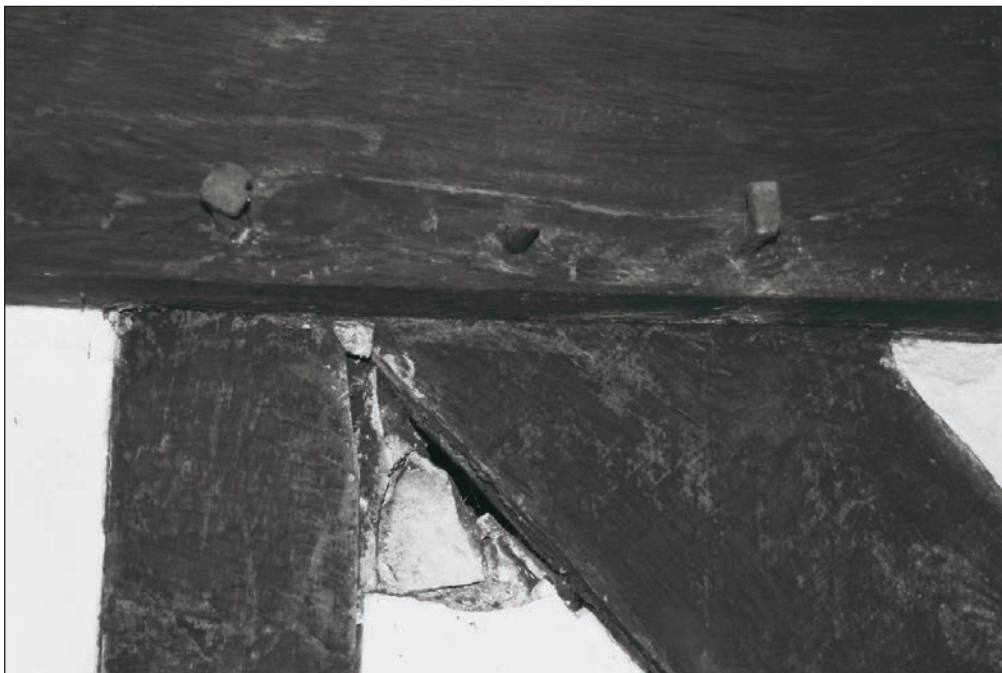
Plate 190: Detail of join between tie beam, arch brace and close stud, north end of timber partition, F1, Building 2 (Film 05.32)

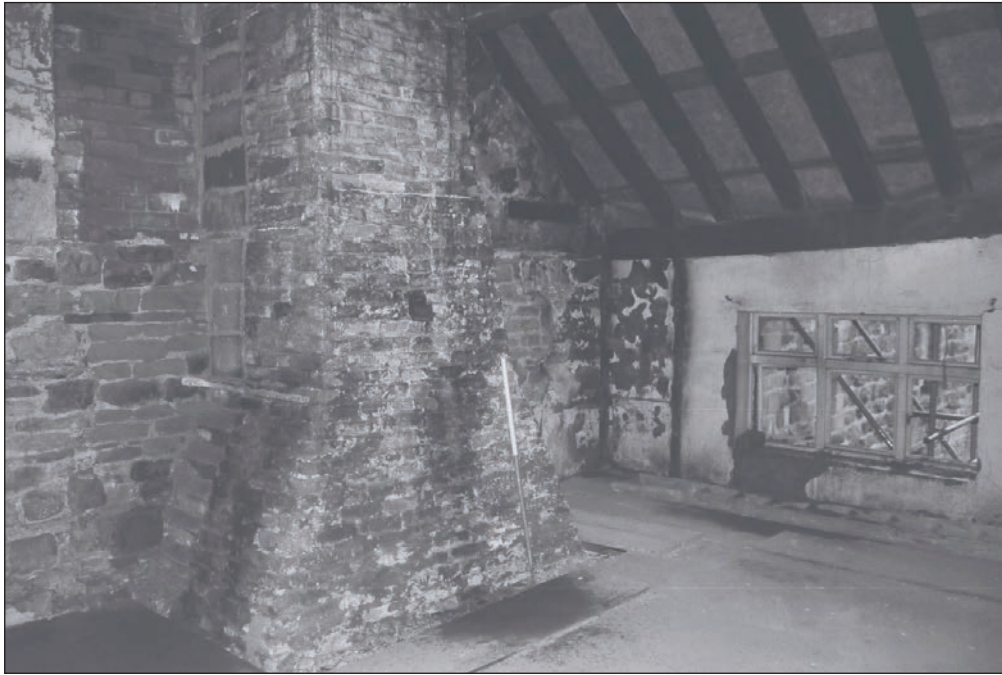
Plate 191: General view of room F1 during the watching brief, showing original chimney stack, Building 2 (Film 43.28)

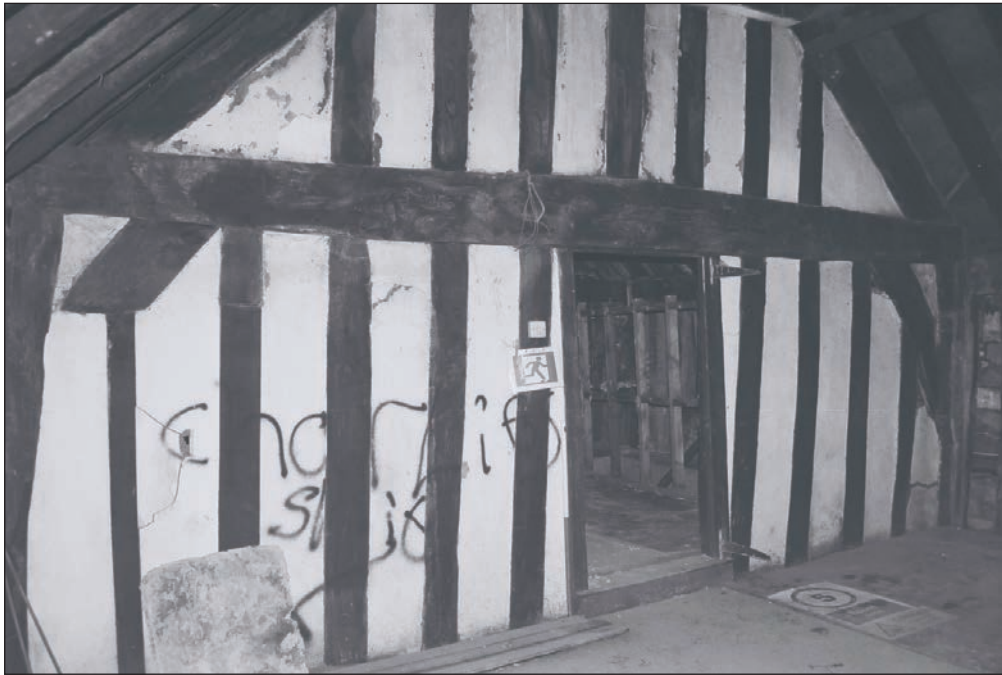
Plate 192: General view of F1 during the watching brief showing the central close stud partition, Building 2 (Film 43.14)

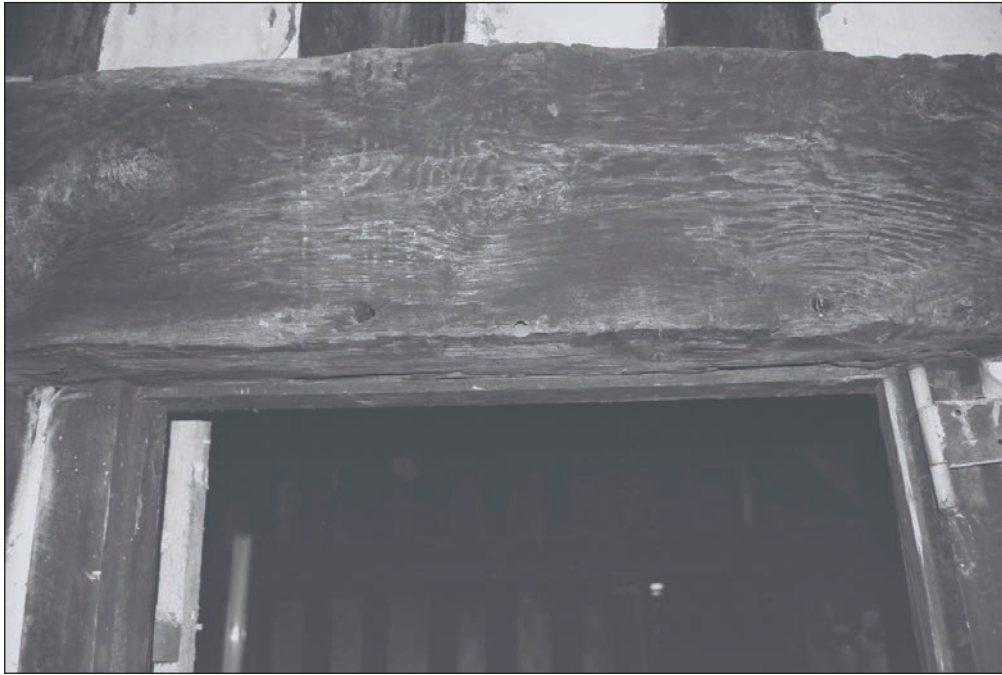
Plate 193: Detail of inserted doorway within the close stud partition between F1 and F2/3, showing empty peg and mortice holes, Building 2 (Film 43.12)

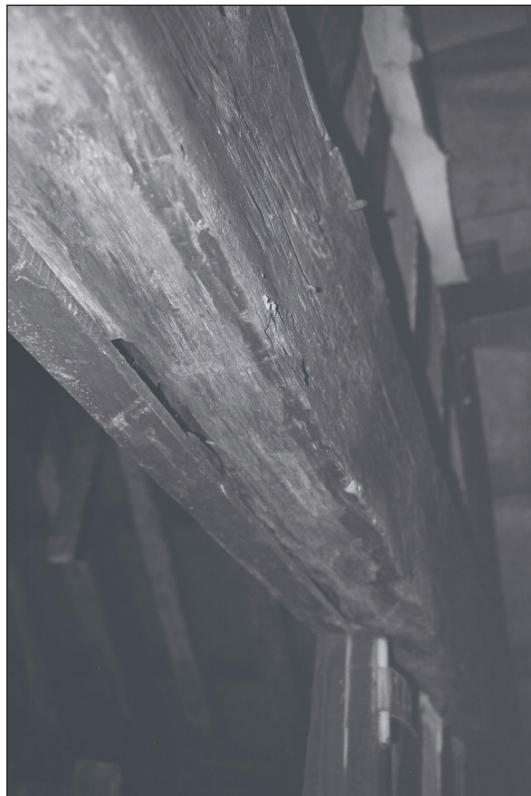
Plate 194: Detail of empty mortice holes in underside of tie beam of the central close stud partition, Building 2 (Film 43.10)

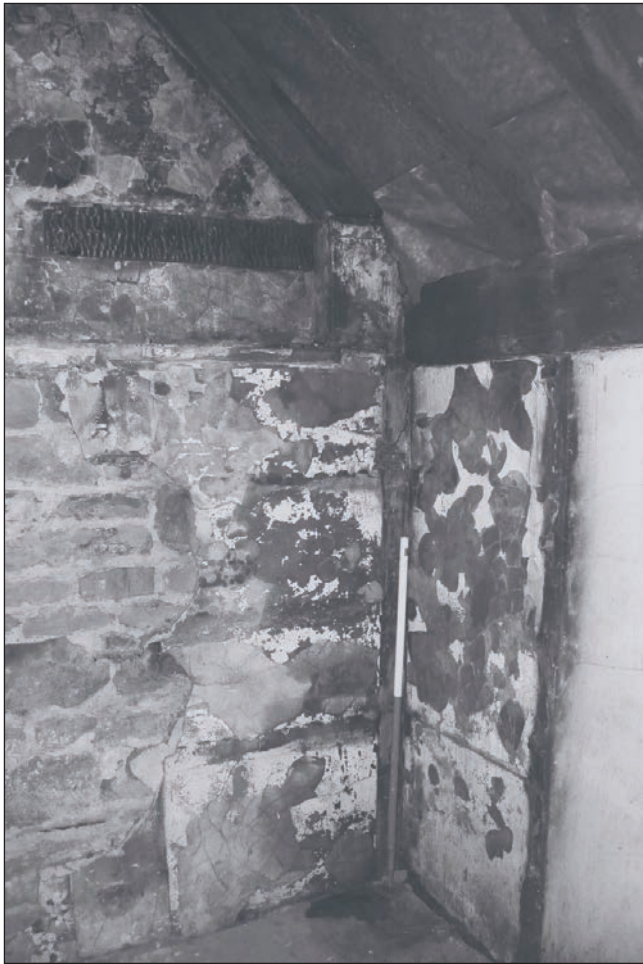
- 5.3.17 At first floor there were two main rooms, one in each bay, and a modern staircase and landing (F1-F3; **Figure 9, Plates 150, 178-182**). Room F1 (**Plates 183-200**) was located to the east and contained a stepped brick chimney stack which had been encased to ceiling height by later brickwork, possibly as a result of the chimney smoking (**Plate 191**). The partition with the landing F2 and room F1 comprised close studding with arched braces, tie beam and a King-Post truss above (**Plates 183, 184, 186, 187, 192**). The doorway into the room was an insertion, indicated by the empty peg holes and mortise joints within the tie beam above the doorway (**Plates 181, 193, 194**). There was no original access to this room at first floor level, which may have been an open end hall, or service bay, prior to a floor insertion. Original timber posts and close stud infills were exposed during the watching brief (**Plates 196-199**), whilst the removed south-eastern post was also recorded (**Plate 195**).

Plate 195: Detail of the southeast corner of room F1, Building 2, showing removed timber post and truncated tie beam and rafter (Film 43.08)

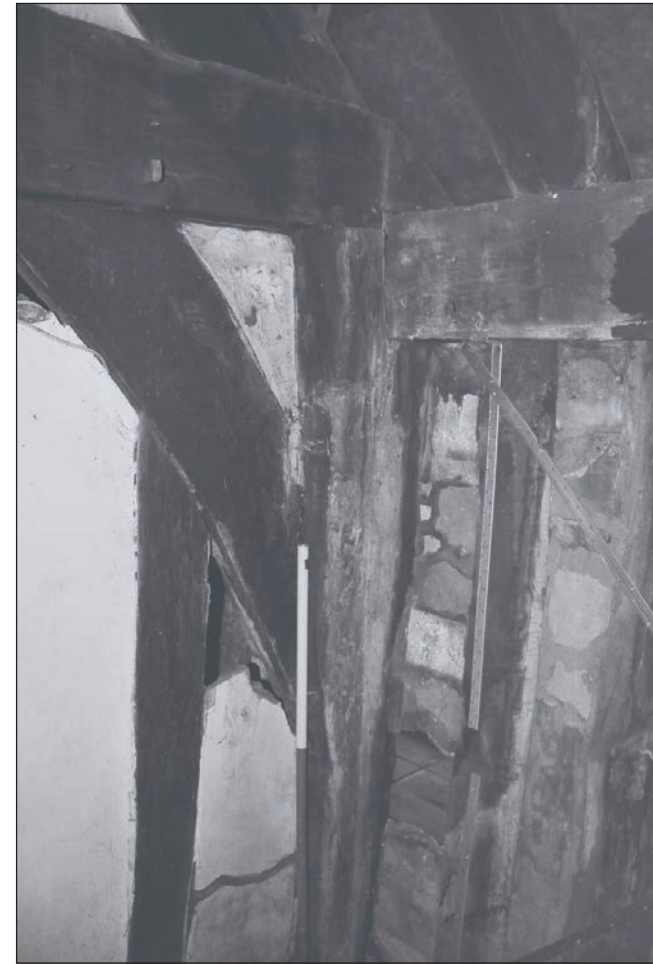
Plate 196: Detail of the central northern timber post and joints with the close stud central partition, F1, Building 2 (Film 43.16)

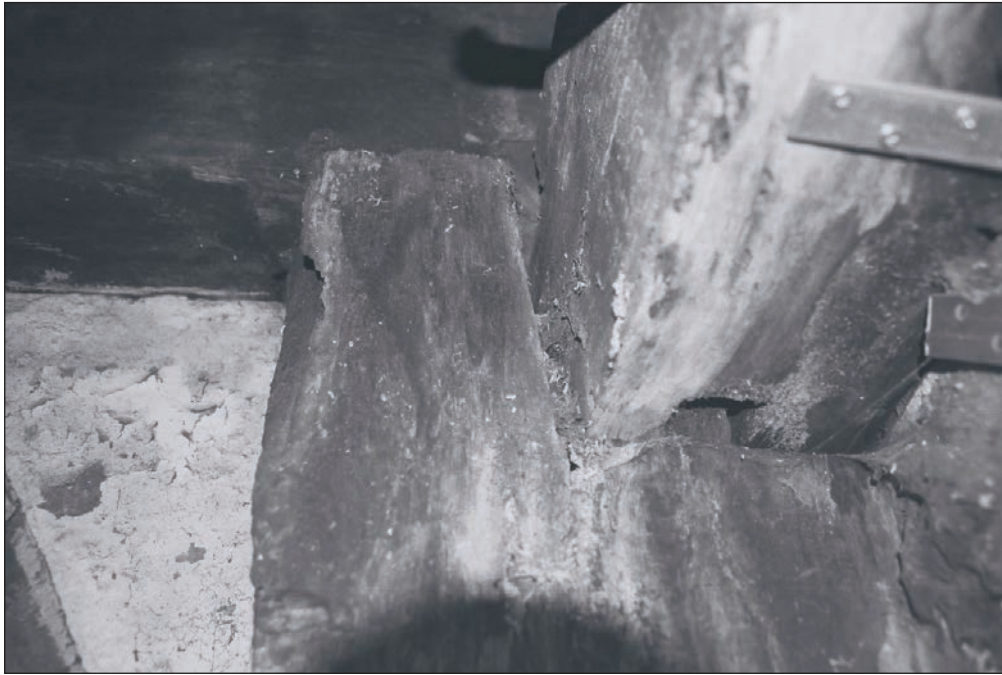
Plate 197: Detail of the central northern post joint with wall plate and tie beam, F1, Building 2 (Film 43.17)

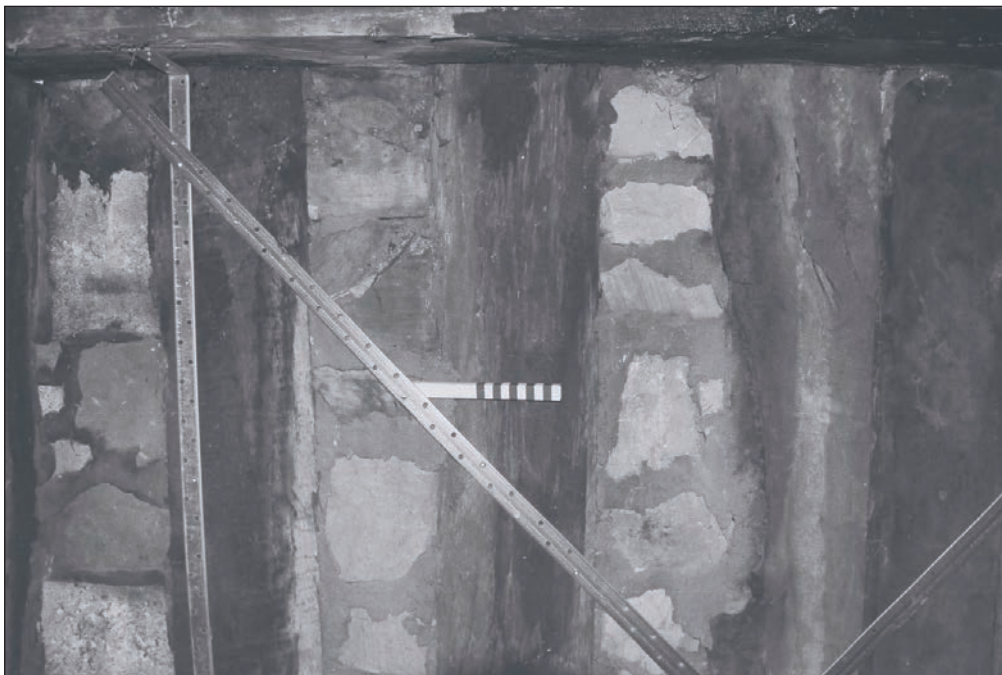
Plate 198: Detail of the original stone infills of the timber close studding of the first floor north wall, F1, Building 2 (Film 43.20)

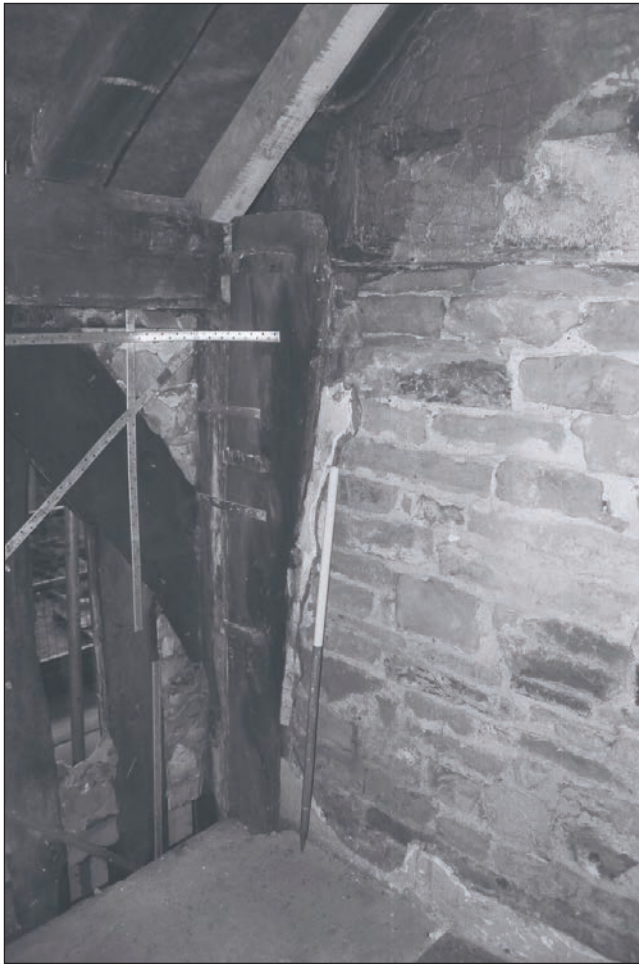
Plate 199: Detail of the northeast corner of F1 showing the exposed original timber post and join with the wall plate and arched brace, Building 2 (Film 43.26)

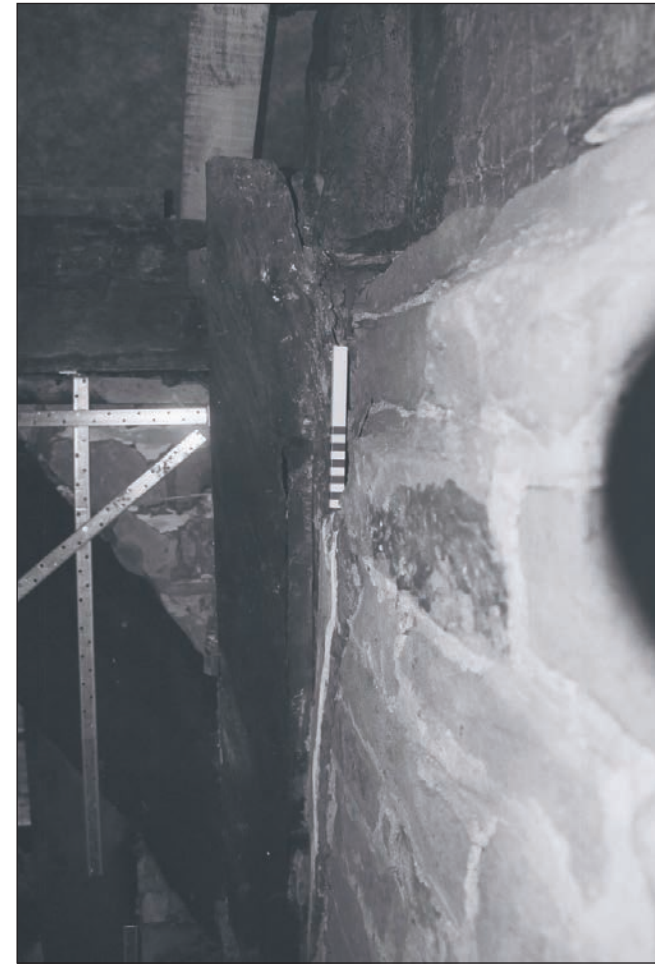
Plate 200: Detail of the northeast corner of F1 showing the exposed timber post with empty mortice hole, Building 2 (Film 43.24)
