HANSON HOUSE  
SNYDALE ROAD  
NORMANTON  
WAKEFIELD  
WEST YORKSHIRE

Historic Building Recording

**Planning Application Ref: 07/00704/FUL & 07/00705/LBC**

74352.02\_BDG\_V0\_3

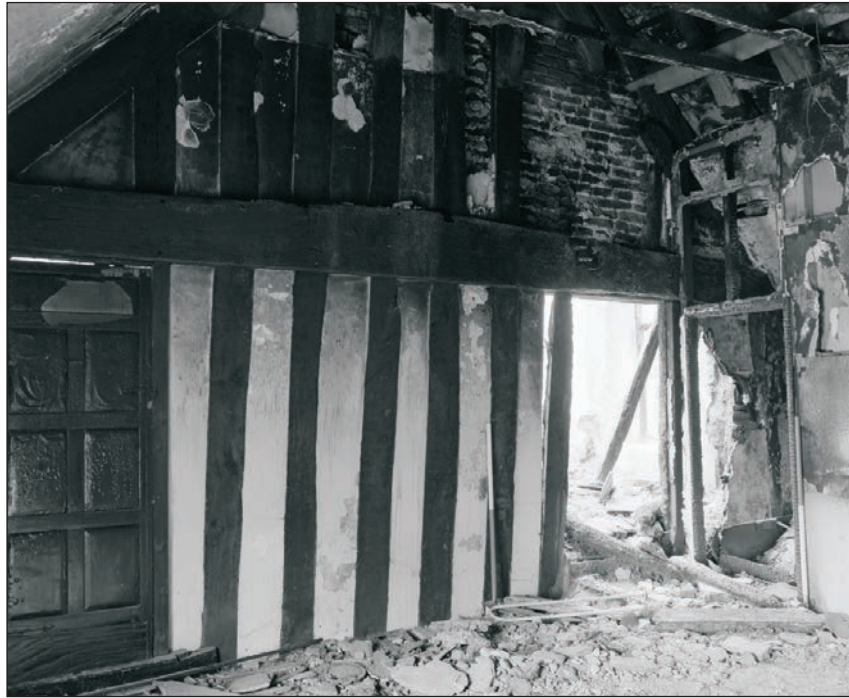
Plate 201: General view of F3, Building 2, showing close stud partition and inserted doorways to Building 3 (Film 15.05)

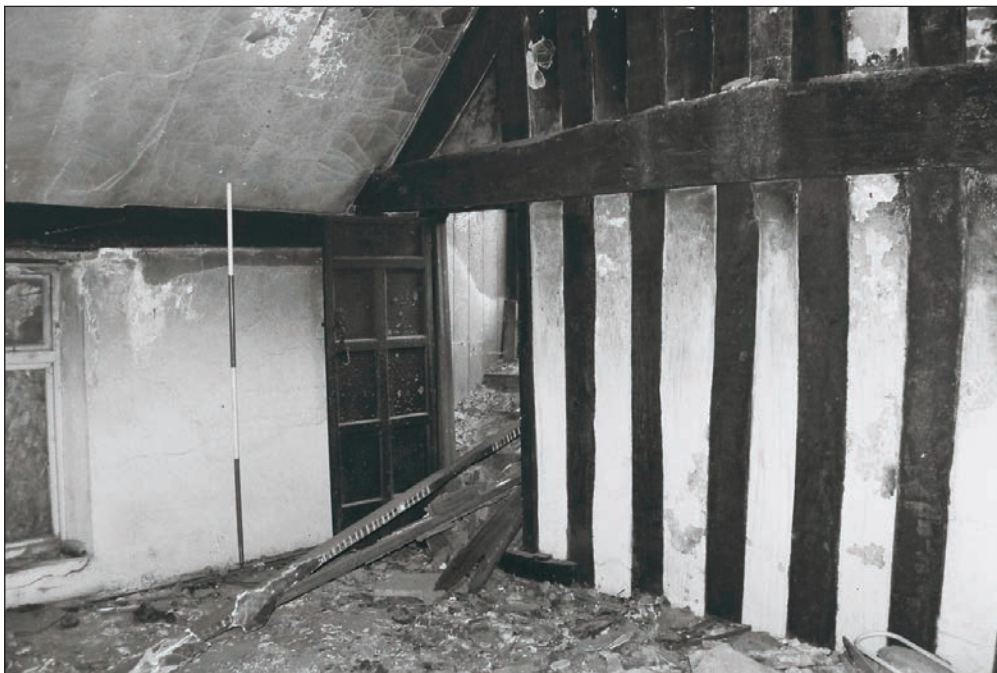
Plate 202: General view of F3, Building 2, showing close stud partition (Film 05.29)

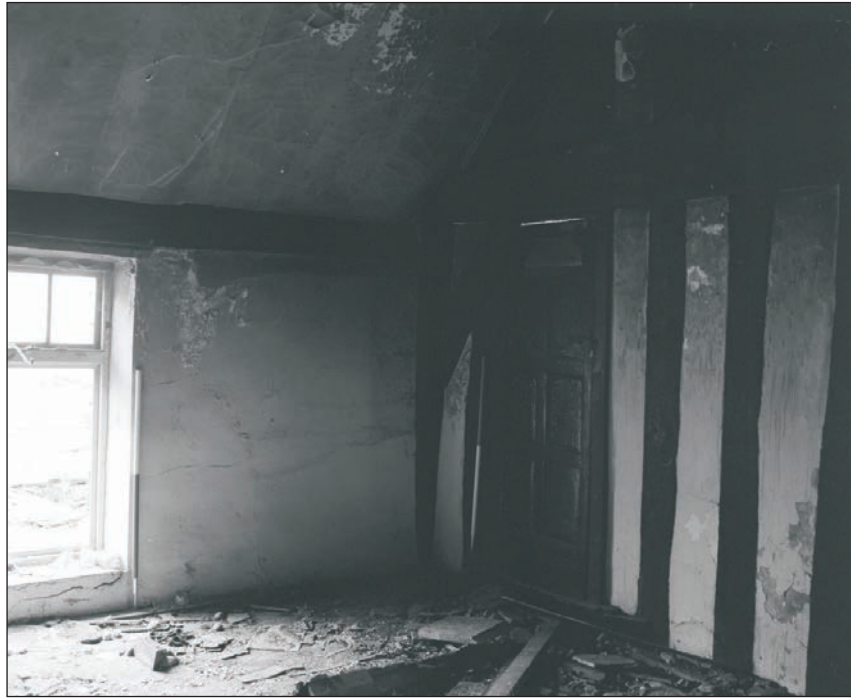
Plate 203: General view of F3, Building 2, showing close stud partition (Film 15.08)

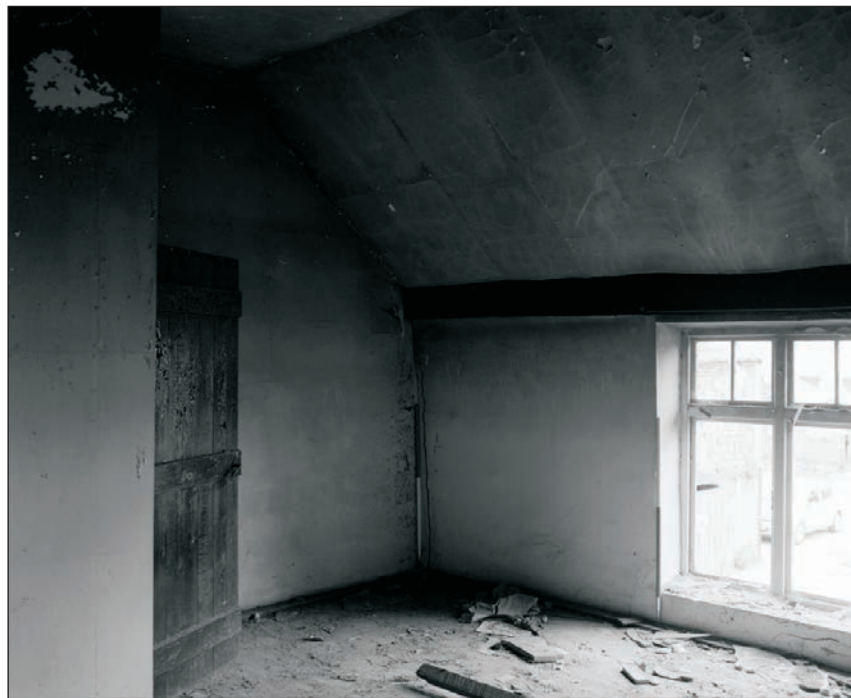
Plate 204: General view of F3, Building 2, showing window to the south and doorway from F2 (Film 15.10)

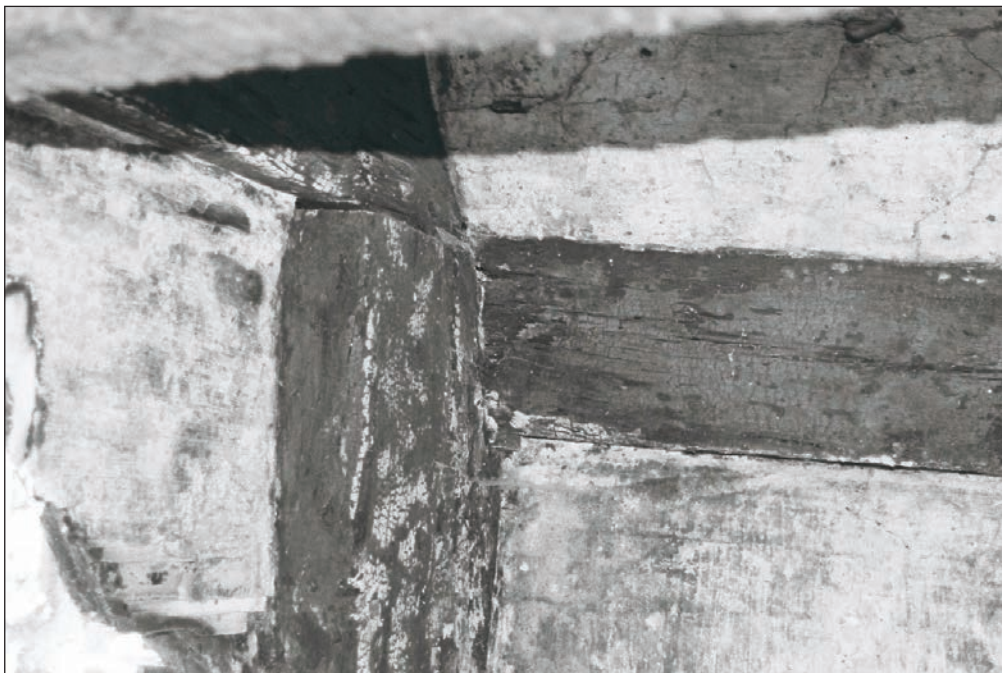
Plate 206: Detail of joint of tie beam, post and wall plate, northwest corner of F3, Building 2 (Film 05.21)

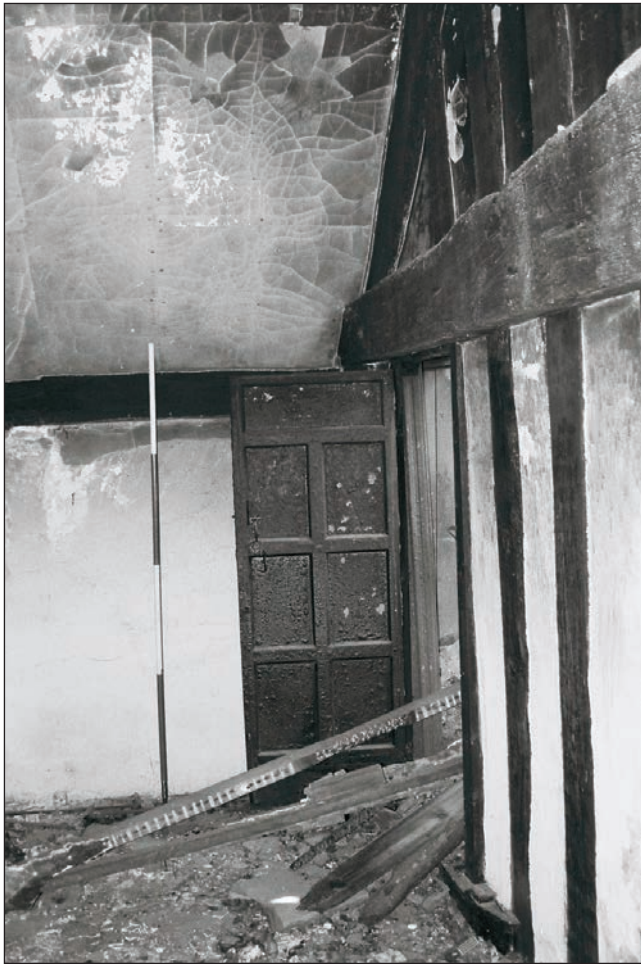
Plate 209: View of timber partition and inserted door, F3, Building 2 (Film 05.17)

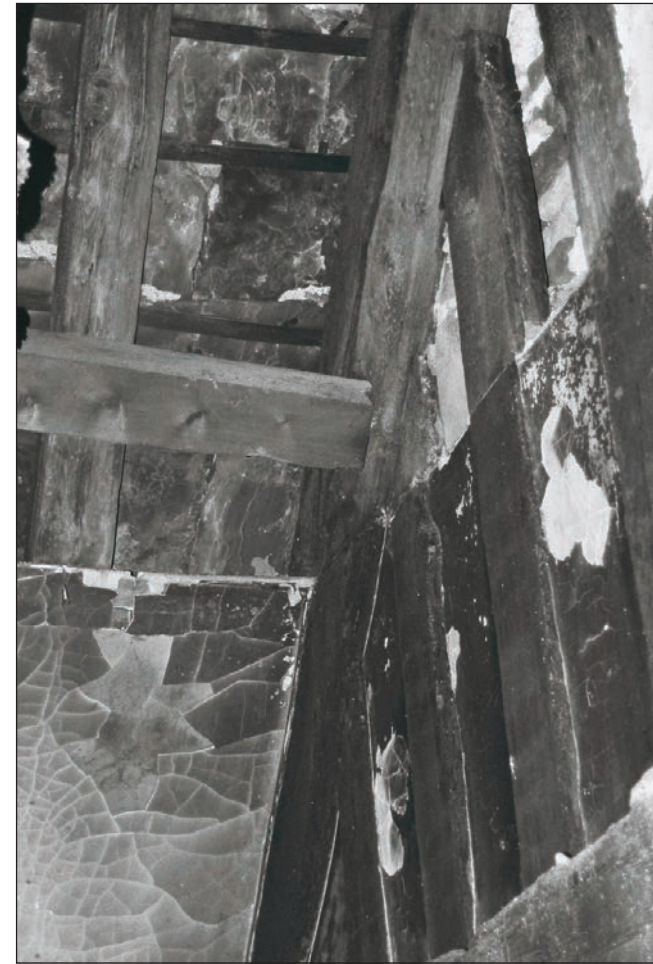
Plate 210: View of roof structure showing position of former ceiling, F3, Building 2 (Film 05.18)

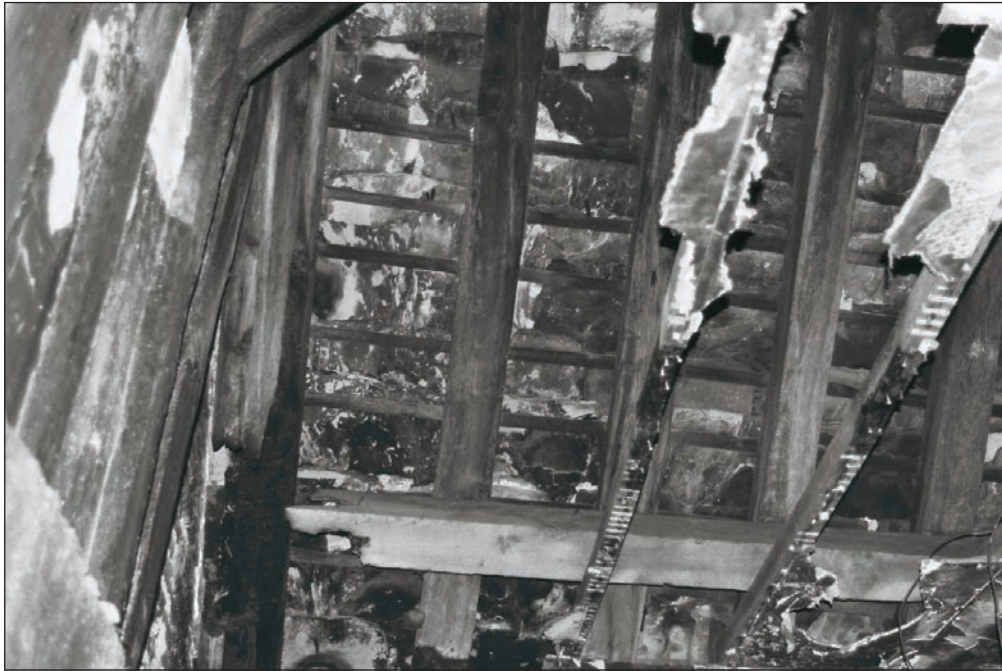
Plate 211: Detail of former ceiling and roof structure above, F3, Building 2 (Film 05.22)

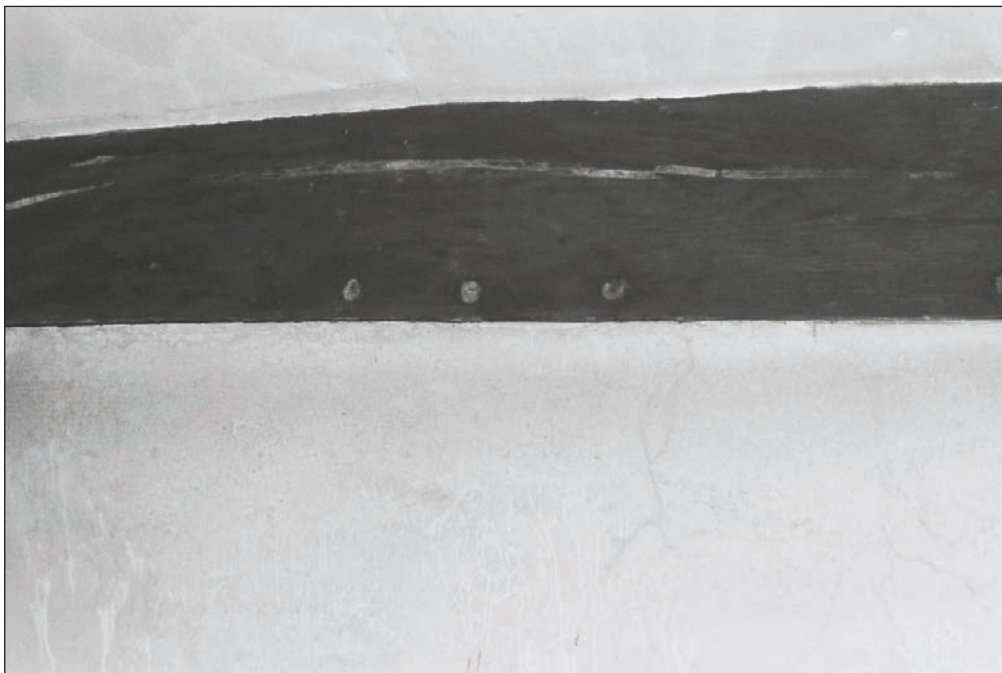
Plate 212: Detail of empty pegs from removed timber framing, wall plate to south wall of F3, Building 2 (Film 05.12)

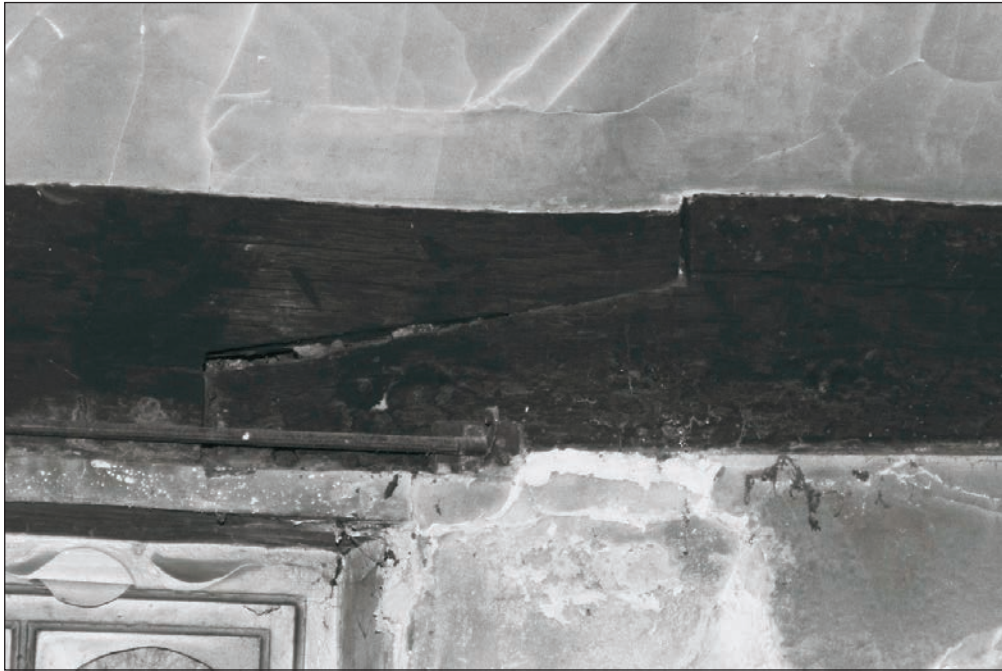
Plate 213: Detail of scarf joint within wall plate of south wall, F3, Building 2 (Film 05.14)

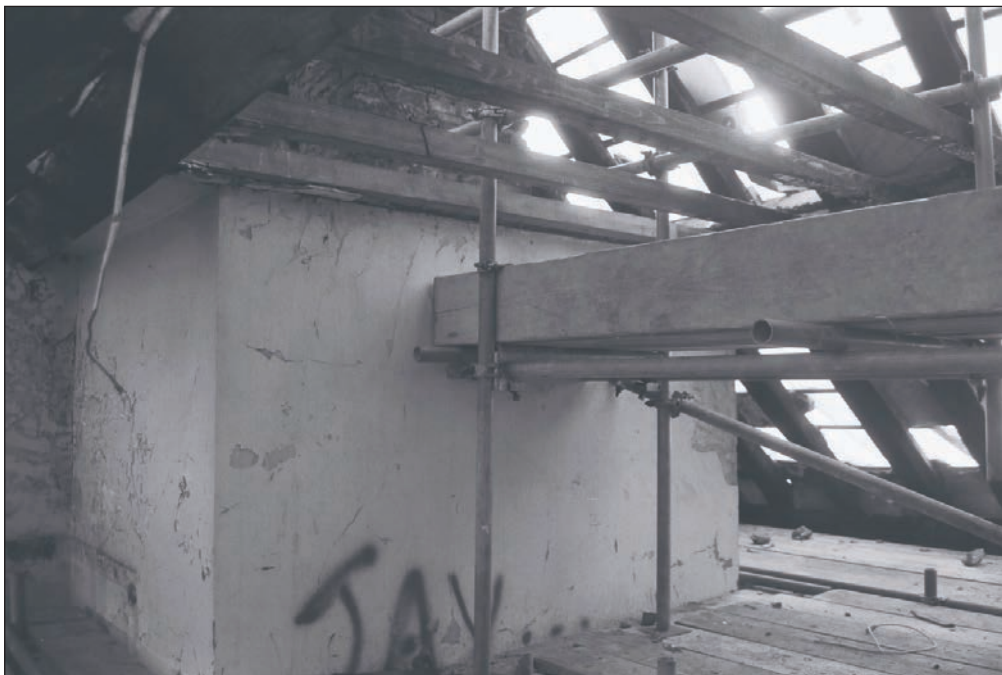
Plate 214: General view of ceiling and roof structure during watching brief, F1, Building 2 (Film 41.02)

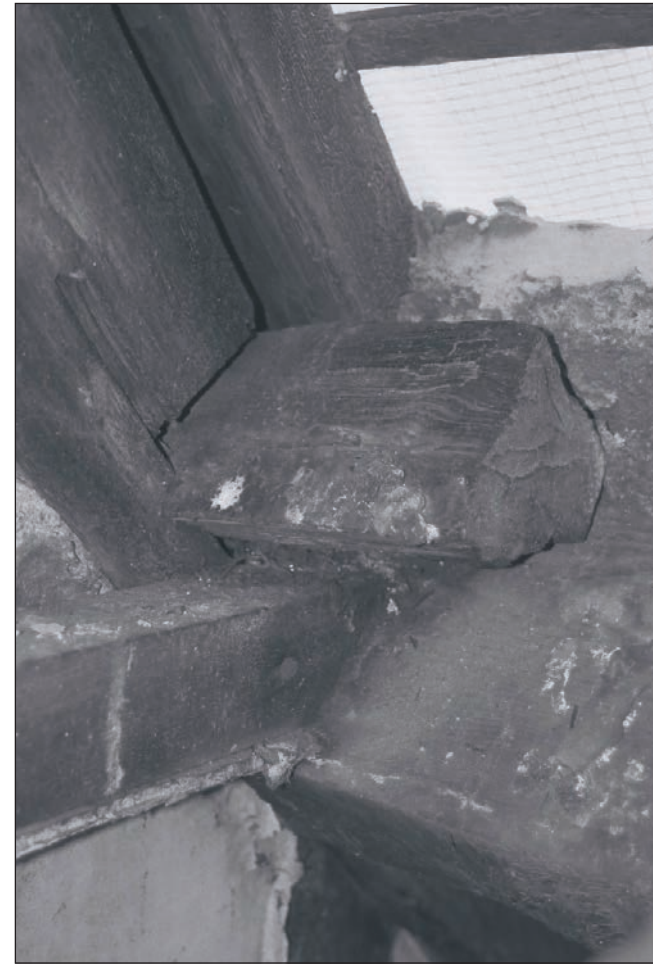
Plate 216: Detail of purlin and principal rafter, F1, Building 2 (Film 41.05)

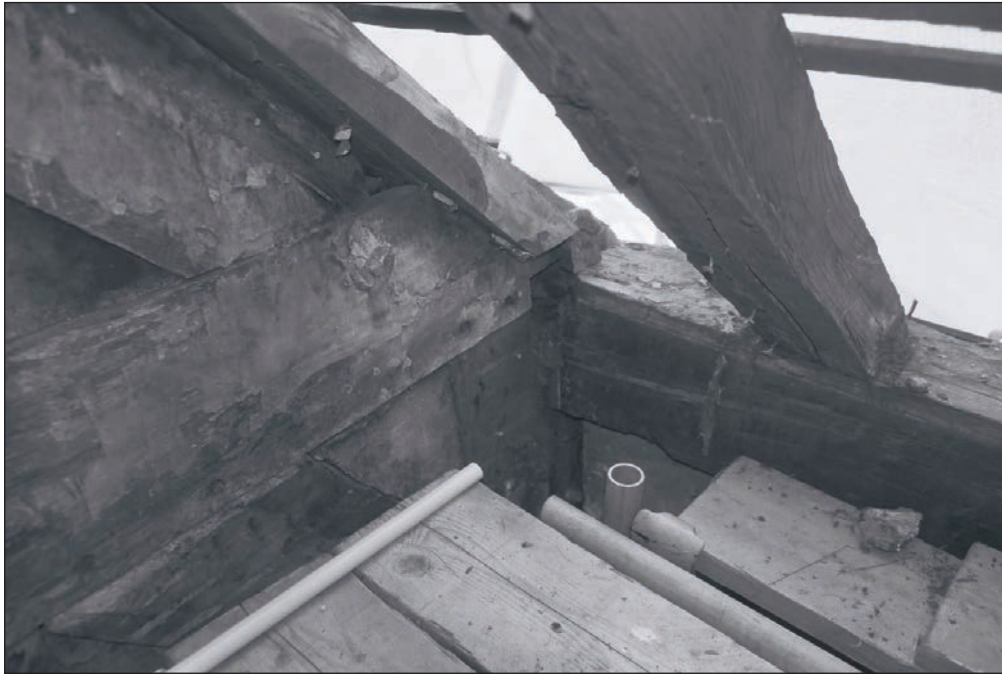
Plate 217: Detail of tie beam, wall plate, and post joint, northwest corner of F1, Building 2 (Film 41.18)

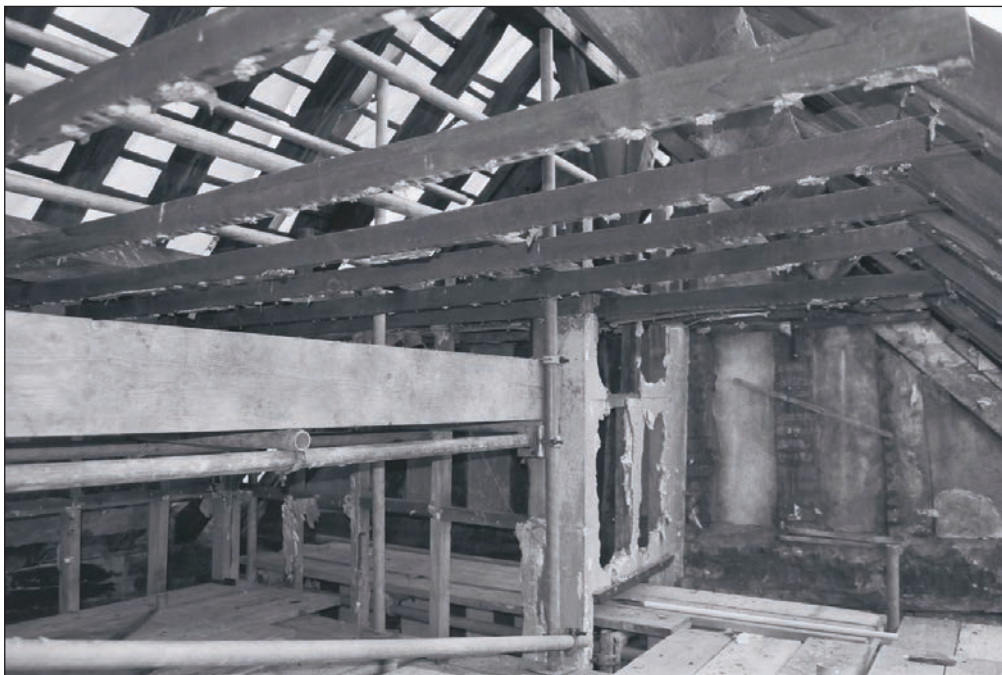
Plate 218: General view of ceiling and roof structure during watching brief, F3, Building 2 (Film 41.09)

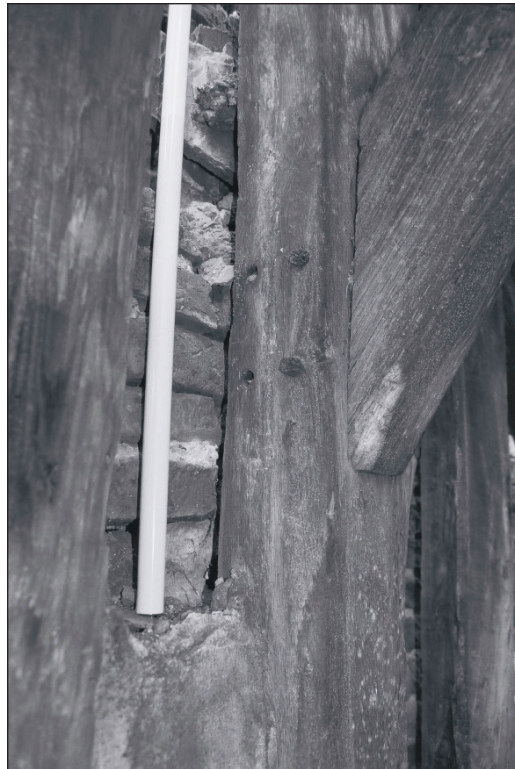
Plate 220: Detail of King-Post and ridge brace, showing empty peg holes to the west, F3, Building 2 (Film 41.13)

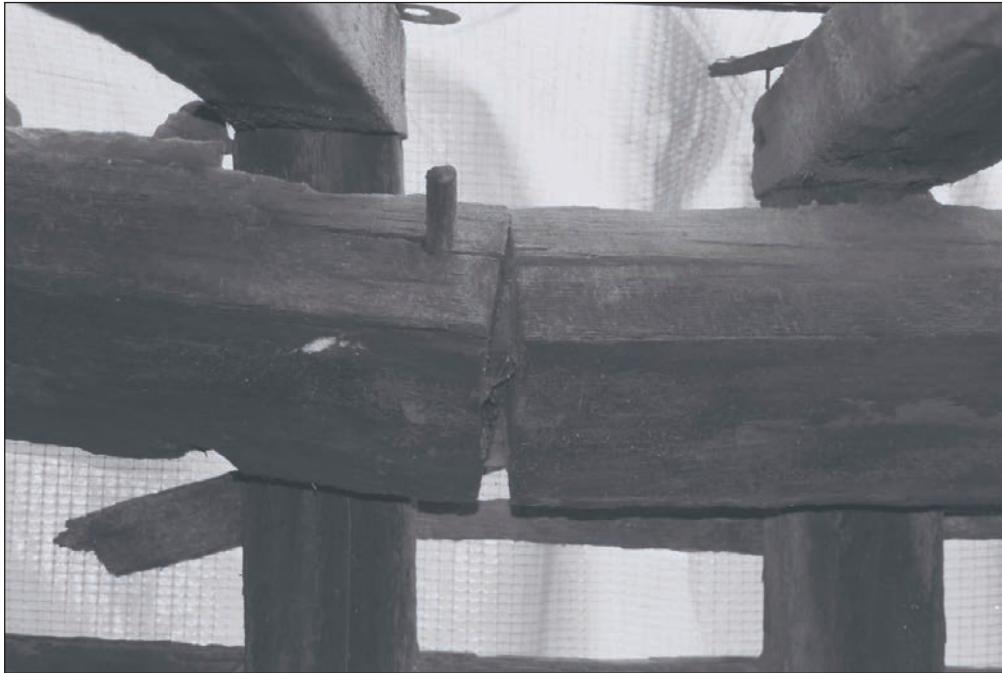
Plate 221: Detail of join in purlins, F1, Building 2 (Film 41.15)

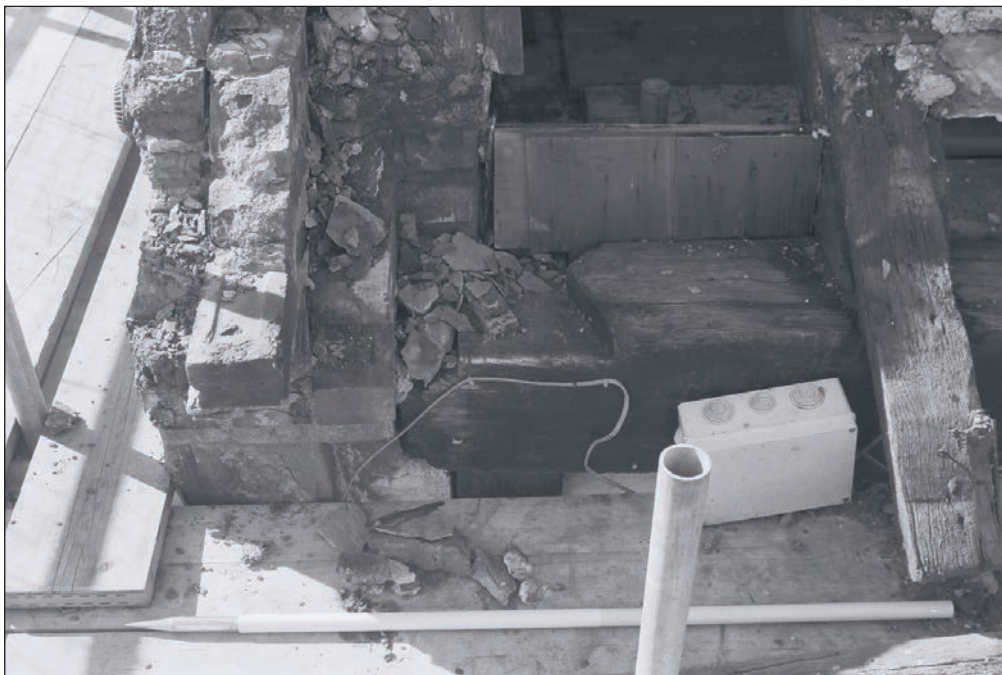
Plate 222: Detail of wall plate showing joint of removed principal rafter at east end of Building 2 (Film 41.07)

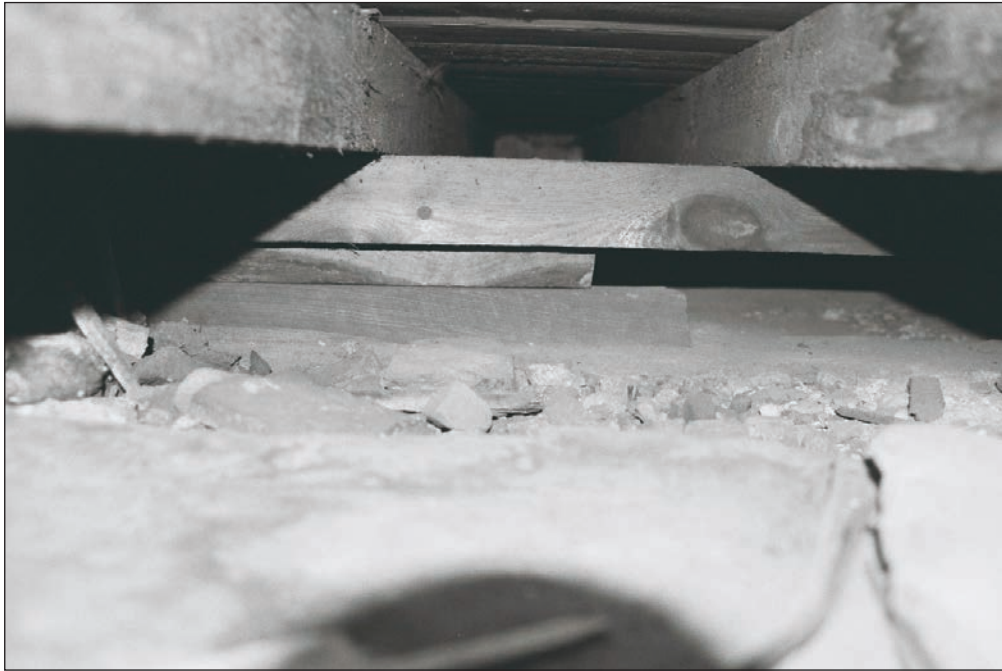
Plate 223: View beneath floorboards, F1, Building 2 (Film 06.01)

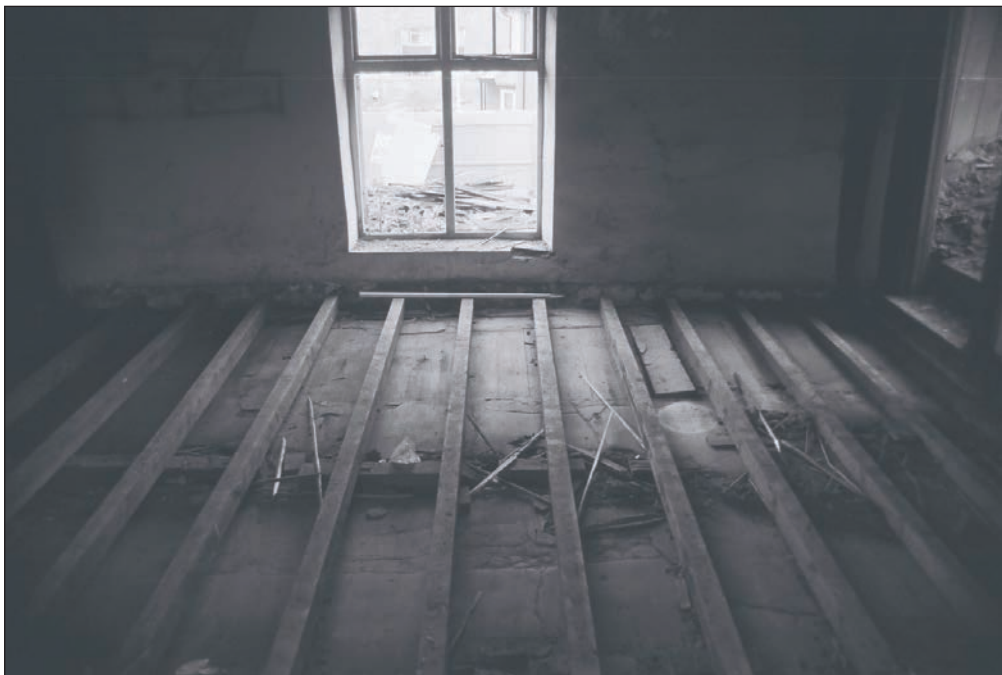
Plate 228: General view of lifted floor boards, F3, Building 2, showing limeash floor beneath and boarded area of original stair opening in floor (Film 40.03)

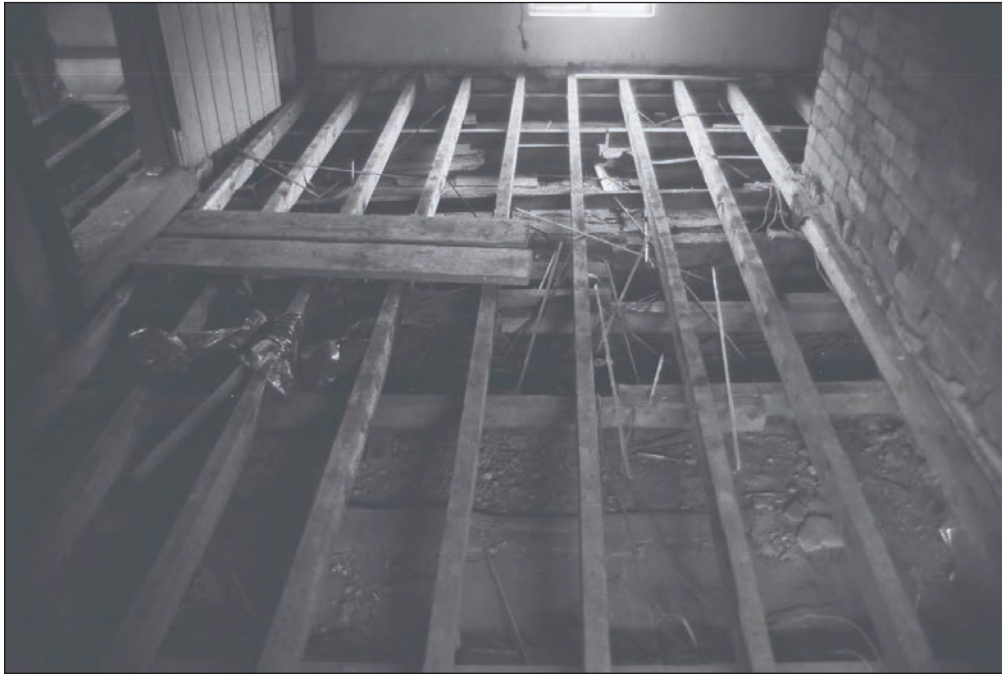
- 5.3.19 The watching brief on the first floor monitored the lifting of the modern floor boards, revealing an original lime-ash floor beneath. Within room F2/F3 the limeash sat directly on top of the laths between the joists as well as over the top of the joists. A boarded-over gap in the limeash corresponded with the original ladder opening within the floor, observed within the ceiling of G1 and G4 below (**Plates 224-225, 227, 228**). The floor within room F1 had been constructed slightly differently, with the limeash resting on the laths between the joists at a level flush with the top of the timber joists. Some slate tiles had been added to the lime-ash floor in order to level it (**Plates 226, 229, 230**). The whole of the floor across the building slumps downwards to the east.

Plate 229: General view of lifted floor boards, F1, Building 2 showing limeash floor beneath (Film 40.05)

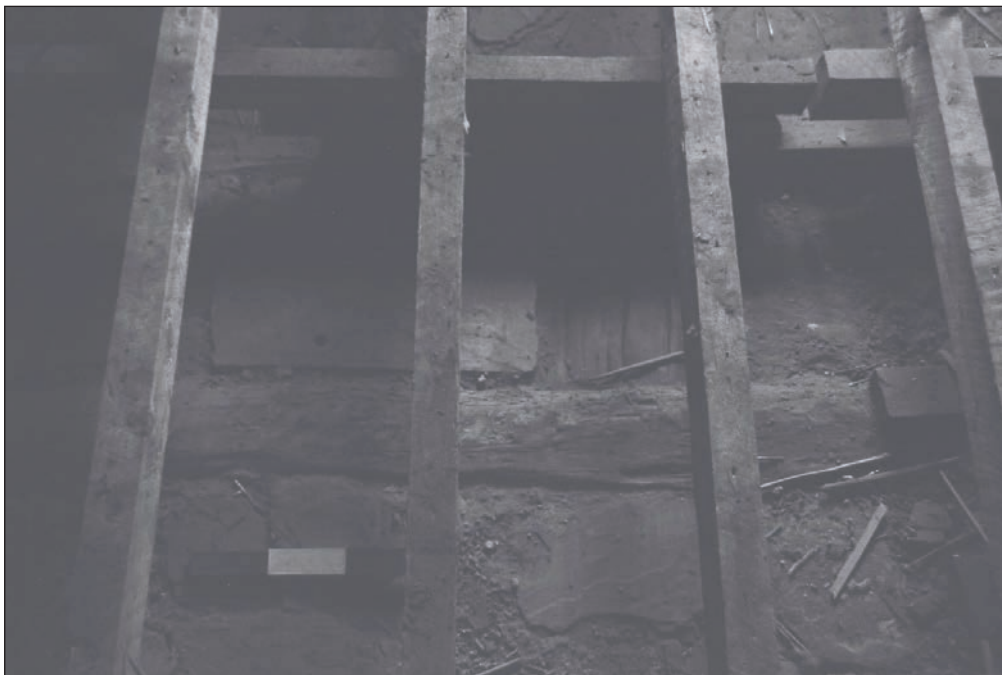
Plate 230: Detail of reused roof tiles on limeash floor beneath removed timber floor, F1, Building 2 (Film 40.07)

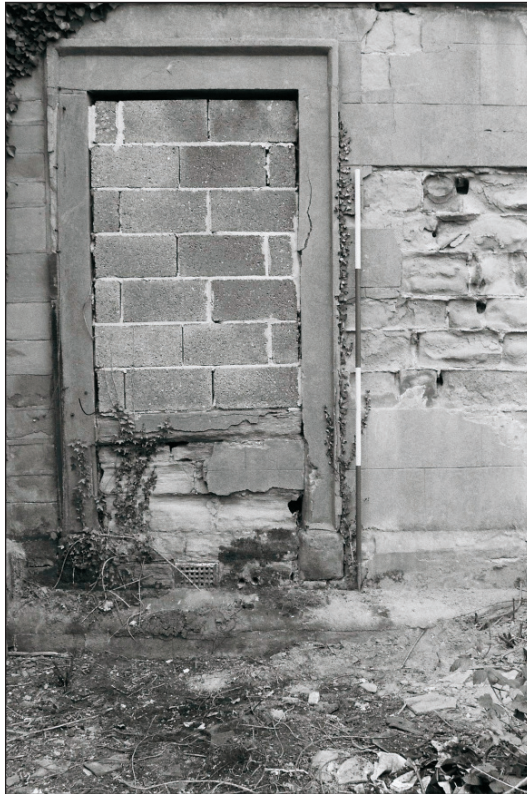
- 5.4.1 Attached to the medieval Building 2 to the east, and replacing its western bay, was a stone built wing, 'T'-shaped in plan (**Figure 8**), constructed between 1740 and 1760 (phase 3). Its roof and first floor had been almost entirely destroyed by fire. Its south elevation (**Figure 15 and Plates 234-238**) continued to the west from Building 2, beyond a vertical joint within the stonework (**Plate 235**). Its elevation comprised two elements with the tail of the 'T' to the east (Building 3), and a projecting gable of the cross wing to the west (Building 4). The former contained a doorway altered to a window (**Plates 236, 237**), and adjacent window at ground floor (both blocked), both with projecting stone surrounds, and a moulded stone pediment above the former doorway (**Plate 236**). A further small window was positioned at the east end. At first floor were two windows with original stone surrounds and replacement timber casements. Dividing the ground and first floor was a projecting stone string course. The building was taller than its adjacent earlier wing to the east, and contained a tall brick gable against it, with stone copings, kneeler and brick chimney stack.

Plate 237: Detail of former doorway, altered to window, south elevation of Building 3 (Film 05.05)

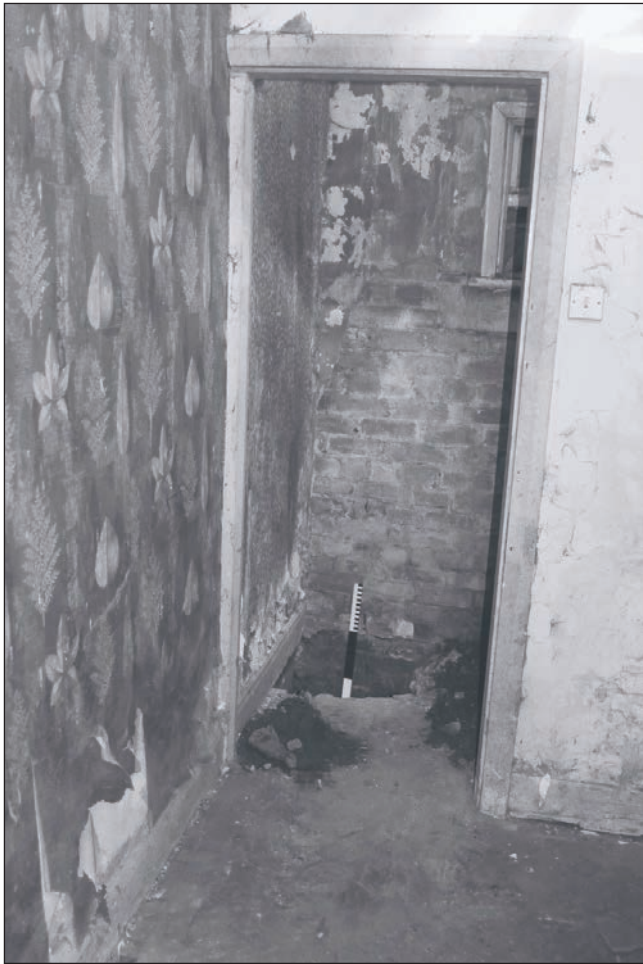
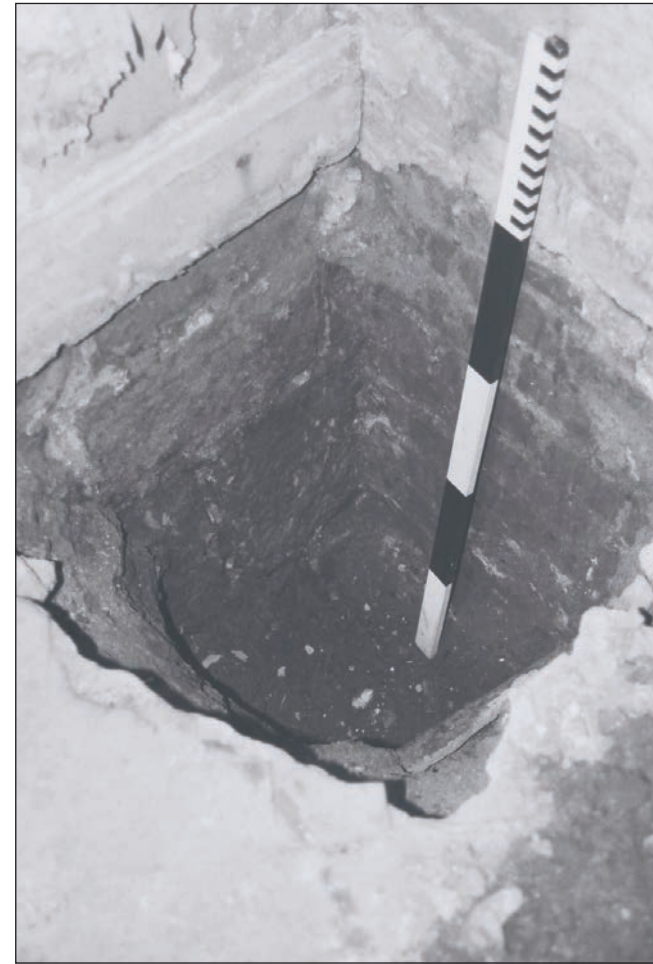
- 5.4.6 The eastern wall of Building 4 was revealed in Test Pit 6, and comprised coursed sandstone to a depth of 0.8m. The foundation was abutted by 9 courses of brick for modern addition room G4 (**Plates 250, 251**).
- 5.4.7 The northwest corner of Building 4 was revealed in Test Pit 7; the west wall was 0.35m deep and comprised sandstone slabs over stone slabs in a lime mortar (**Plates 252, 253**). The north wall comprised sandstone courses to over 0.75m depth. Test Pits 13 and 14 demonstrated a 1m difference in floor level between G4 Building 2 and G7 Building 3 (**Plates 254, 255**).

Plate 250: General view of Test Pit 6, northwest corner of G4, Building 3 (Film 35.02)

Plate 251: General view of Test Pit 6, northwest corner of G4, Building 3 (Film 35.04)

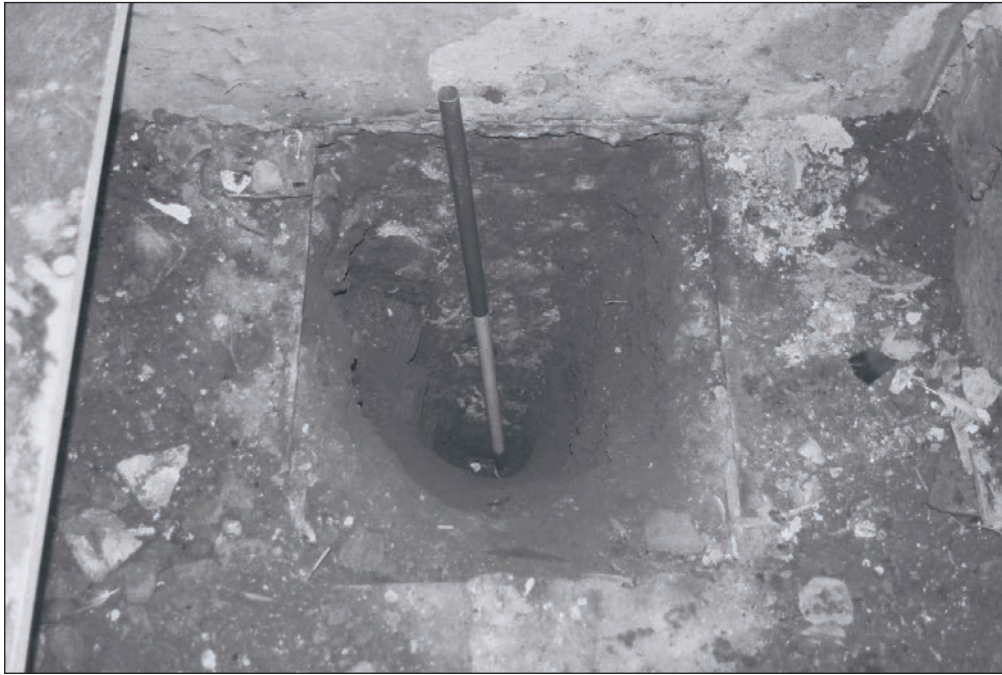
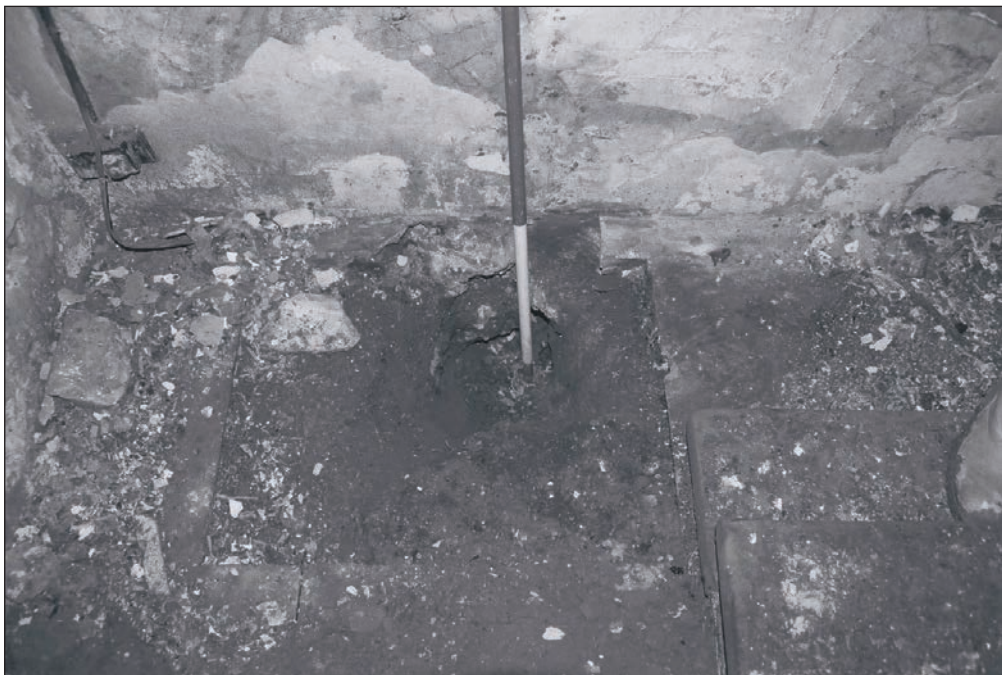
Plate 254: General view of Test Pit 13, southeast corner of G7, Building 3 (Film 37.23)

Plate 255: General view of Test Pit 14, northeast corner of G8, Building 3 (Film 37.19)

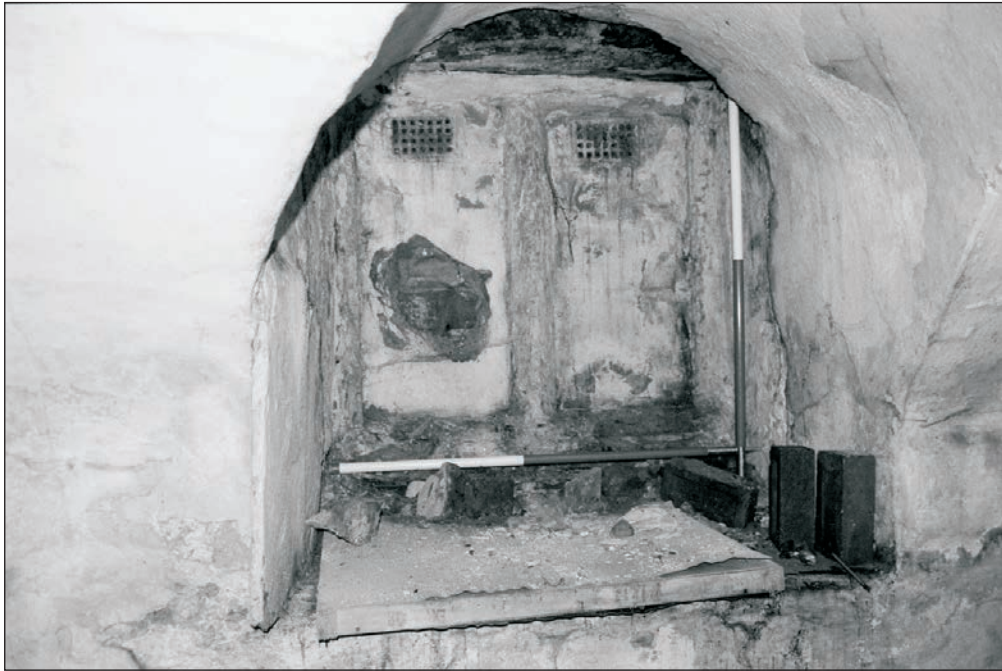
Plate 262: Detail of blocked window in west wall of room C2, Building 4 (Film 28.33)

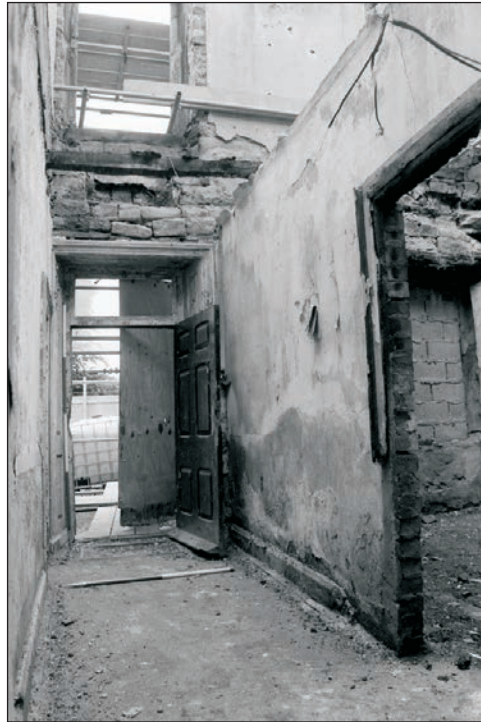
- 5.4.9 The ground floor comprised rooms G1-G8 (**Figure 8**). Within Building 4, the cross wing of the building, rooms G1 and G3 were divided by a central corridor G2 (**Plates 265, 266**). G1 was positioned to the north of the building and was rectangular in plan, with a brick chimney breast with modern replacement fireplace against the north wall. No internal details had survived within the room (**Plates 267-272**). The partition to the south contained timber framing with brick infills, with a central section having been rebuilt with modern bricks (**Plates 267, 268**). To the south of G2 was room G3; a rectangular room in plan with a corner fireplace to the southwest. The chimney breast was constructed of brick with a modern stone fronted fireplace replacement (**Plate 273**). The room had retained its timber panelling, which comprised three different types of panelling (**Plates 247-278**). It is believed that Types 2 and 3, attached to the north, east and south walls (**Plates 279-281**), was original, whilst that on the west wall (Type 1) was a modern replacement. Overhead timber beams supporting the floor above had remains of decorative moulded plaster (**Plates 282-284**). A central doorway within the east wall gave direct access to room G7, which was latterly used as a kitchen.

Plate 266: General view of hallway G2, showing main entrance, Building 4 (Film 29.33)

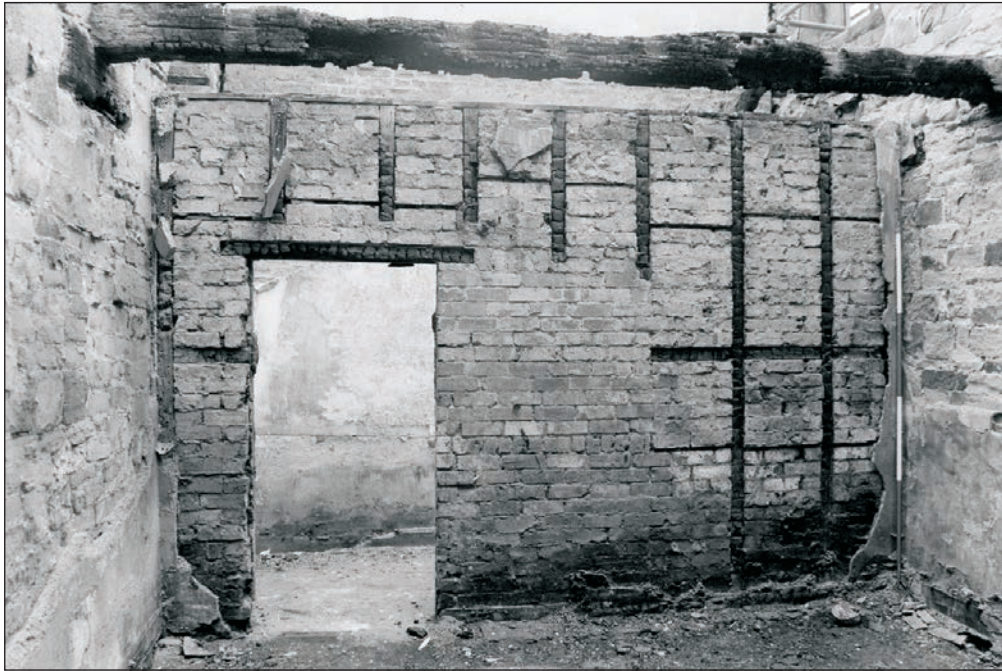
Plate 268: General view of room G1, showing altered south wall, Building 4 (Film 29.09)

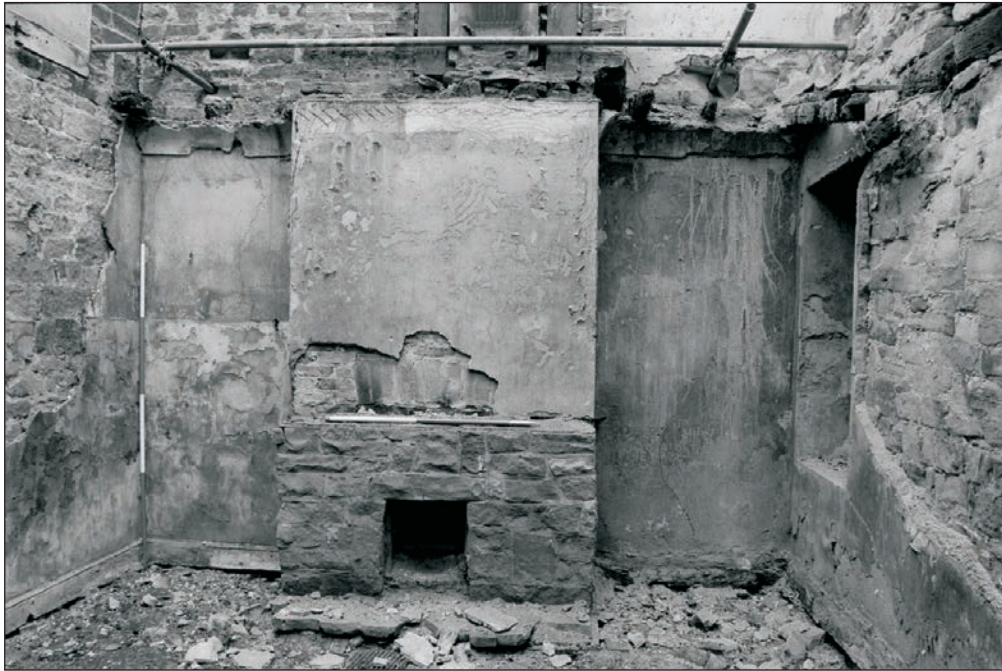
Plate 270: General view of room G1, showing altered fireplace, Building 4 (Film 29.13)

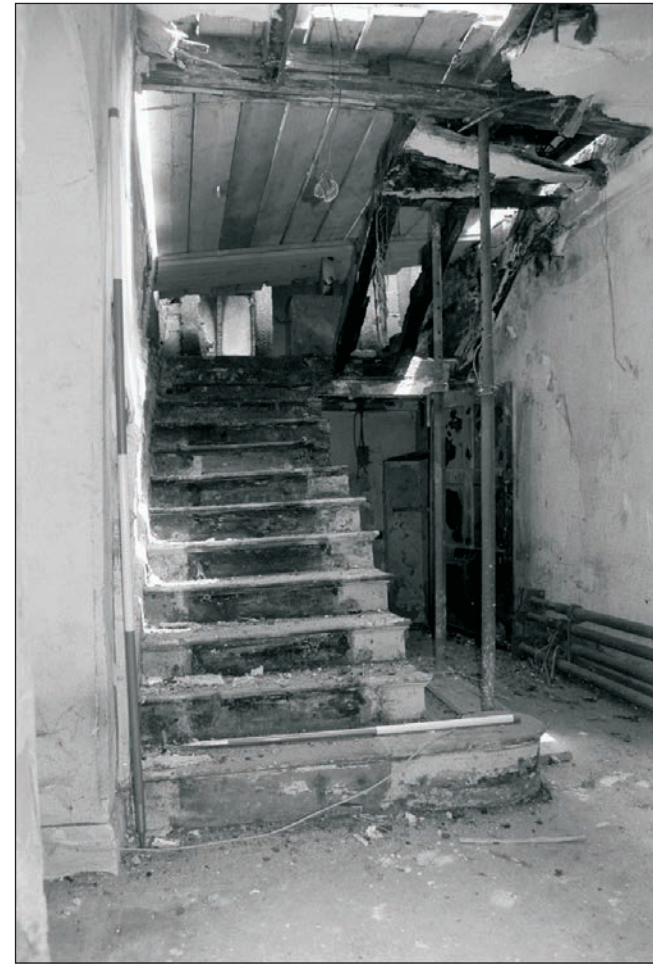
- 5.4.10 Leading from corridor G2 to the east, through an arched opening was a hallway (G6) with the remains of a timber dog-leg staircase to the first floor (**Plates 285-288**). A doorway at the east end of the hallway below the staircase led to the small cellar head, G8 (**Plates 256a-256c**). A small window served the space to the north. Recessed within the west wall of G6 was a small coat cupboard. To the north was an inserted arched opening (**Plate 289**) providing access to the phase 4 addition, with two rooms (G5 and G6) serving as a small rear lobby and W.C (**Plates 290, 291**).

Plate 285: General view of staircase and hallway G6, Building 3 (Film 28.11)

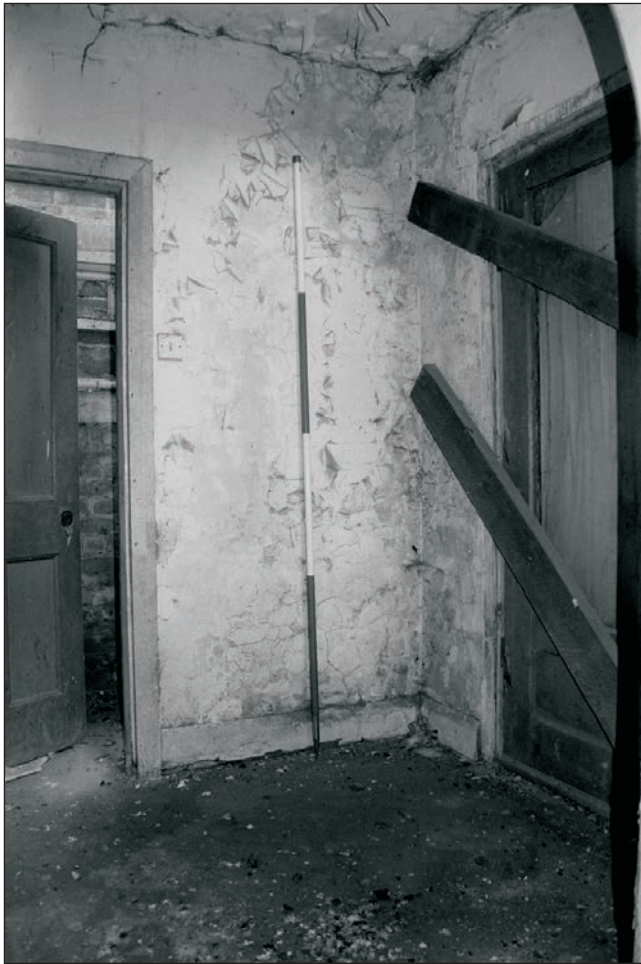
Plate 290: General view of room G5, Building 3 (Film 28.05)

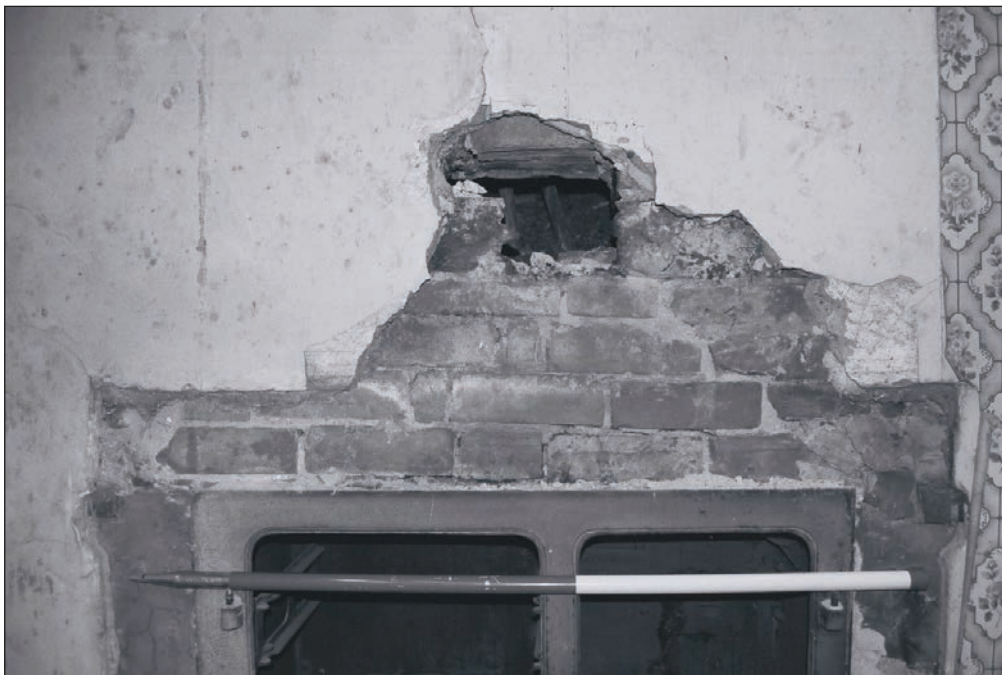
Plate 297: Detail of range and chimney breast, room G7, Building 3, showing range to be later insertion (Film 30.35)
