HANSON HOUSE  
SNYDALE ROAD  
NORMANTON  
WAKEFIELD  
WEST YORKSHIRE

Historic Building Recording

**Planning Application Ref: 07/00704/FUL & 07/00705/LBC**

74352.02\_BDG\_V0\_3

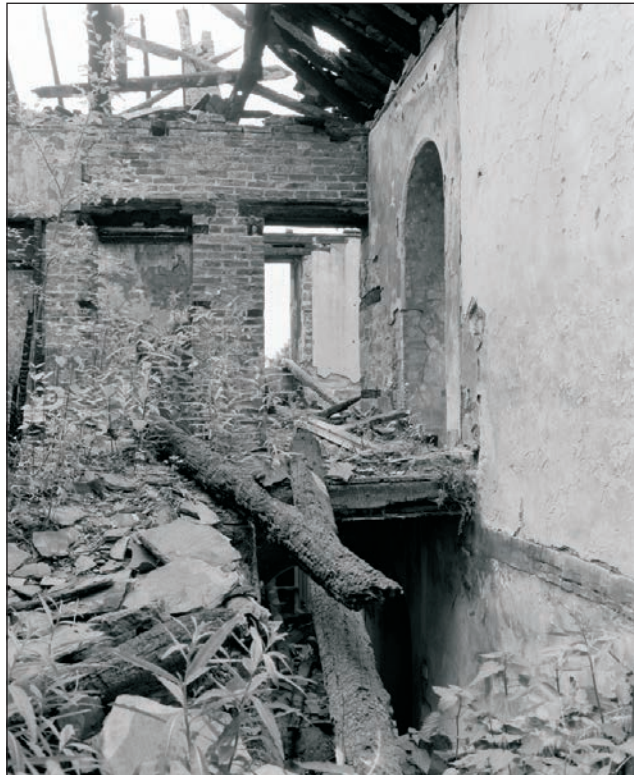
- 5.4.12 The first floor of Building 3 and 4 comprised a similar footprint to that of the ground floor (**Figure 9**). Most of the first floor had been destroyed by fire with very few features having survived. The cross wing Building 4 contained rooms F1 and F2. Room F1 was a large rectangular room with two windows to the west and a brick chimney breast to the north with a replacement fireplace (**Plate 299**). Flanking either side of the chimney breast were two recesses that may have been blocked windows. To the south of F1 was room F2; a smaller rectangular room with a window to the west, corner fireplace and recessed cupboard to the east. Access to both rooms was from an 'L'-shaped landing (F5) to the east. This had a window to the south and an inserted opening to the north, giving access to the later phase 4 rooms, F3 and F4. To the southeast was a smaller room (F6), which was also accessed from F5 and contained a blocked fireplace to the east and a window to the south. Within the east wall of the room was access to the first floor of the adjacent Building 2 via a small set of timber stairs and inserted doorway. To the northeast of F5 was the timber staircase. The dog-leg of the staircase (F7) also gave access to the first floor of the adjacent Building 2 through a doorway to the east. A window to the north lit the staircase (**Plates 300-309**).

Plate 301: General view of rooms F5 and F7, Building 3, from F3, Building 2 (Film 16.03)

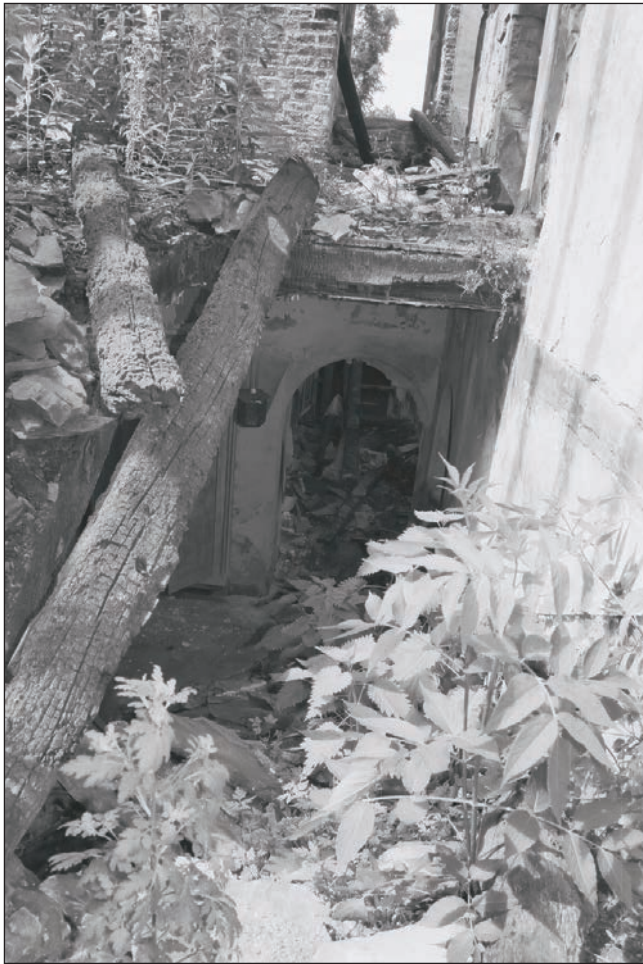
Plate 302: View down staircase from F7 to G6, Building 3, from F3 Building 2 (Film 12.09)

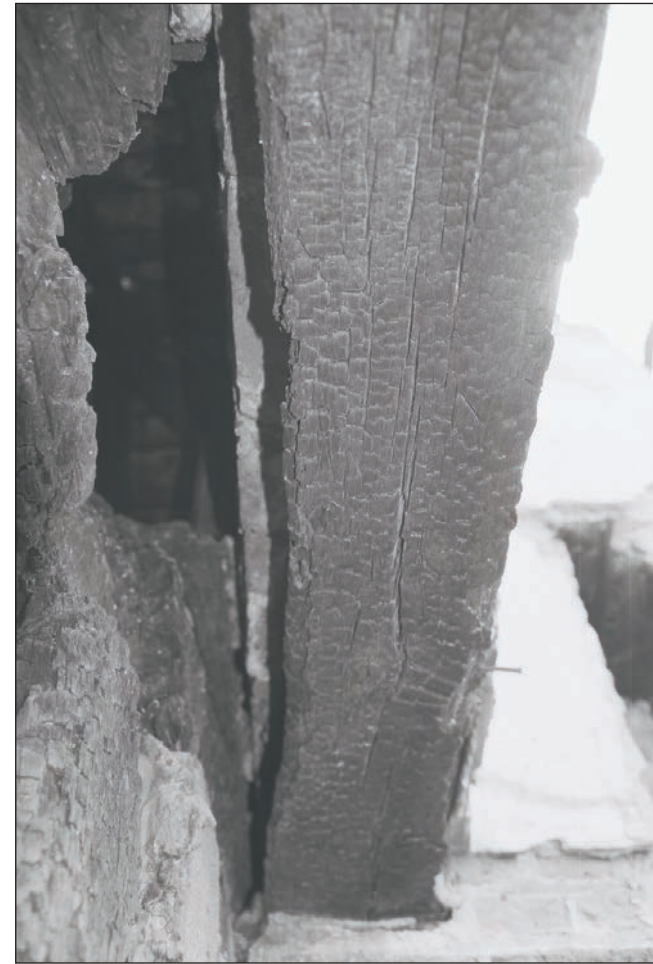
Plate 303: View of timber beam and join between Buildings 2 and 3 from F7, Building 3 (Film 12.02)

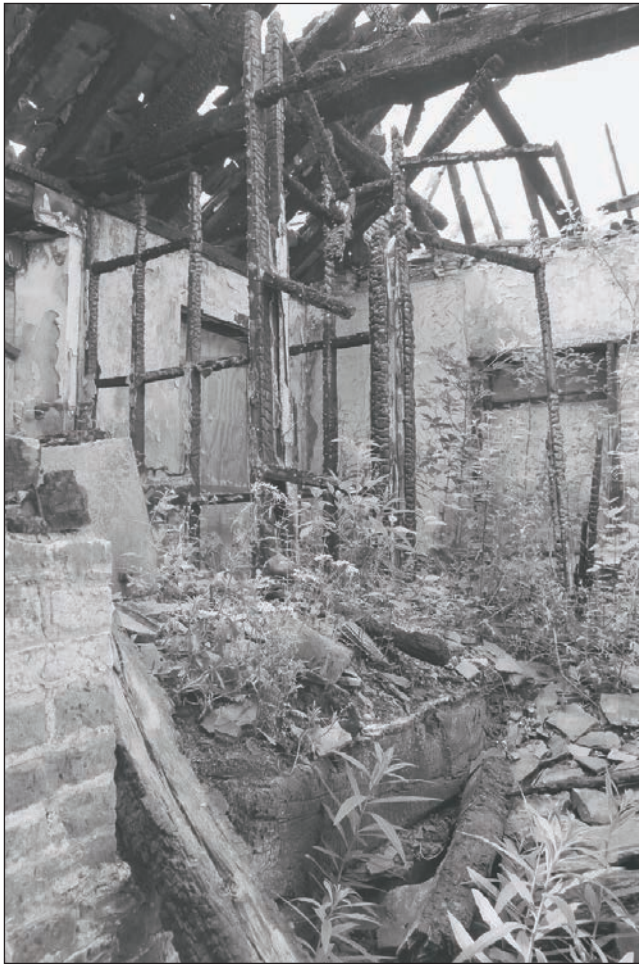
Plate 304: View of rooms F5 and F6, Building 3, from F3, Building 2 (Film 12.10)

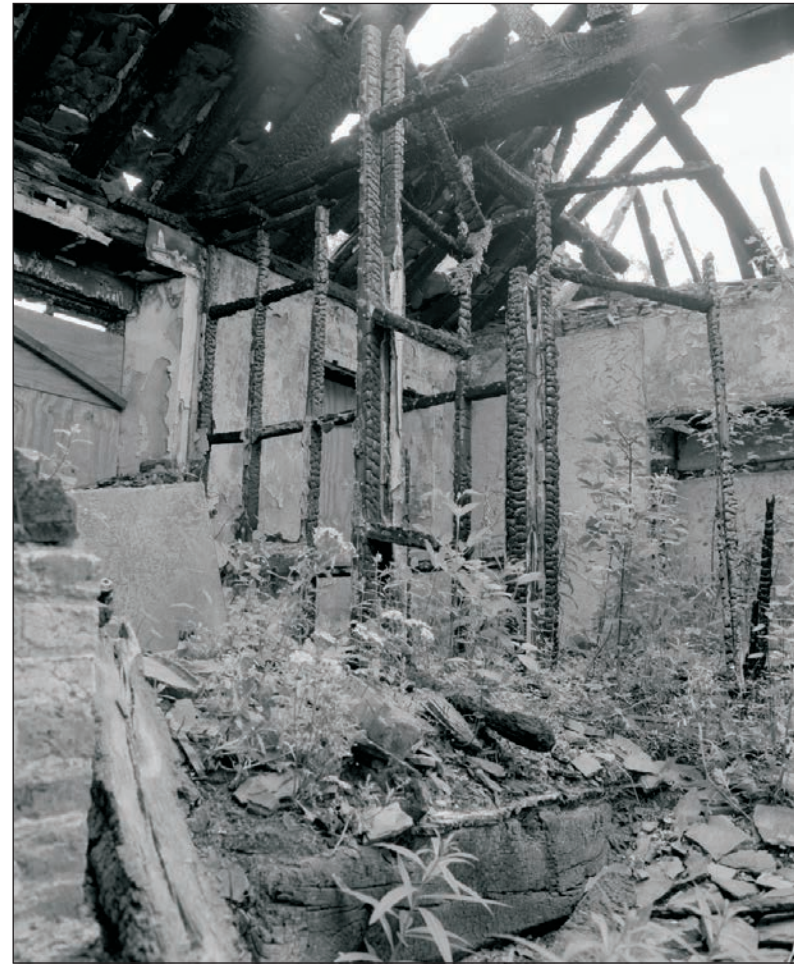
Plate 305: View of rooms F5 and F6, Building 3, from F3, Building 2 (Film 16.01)

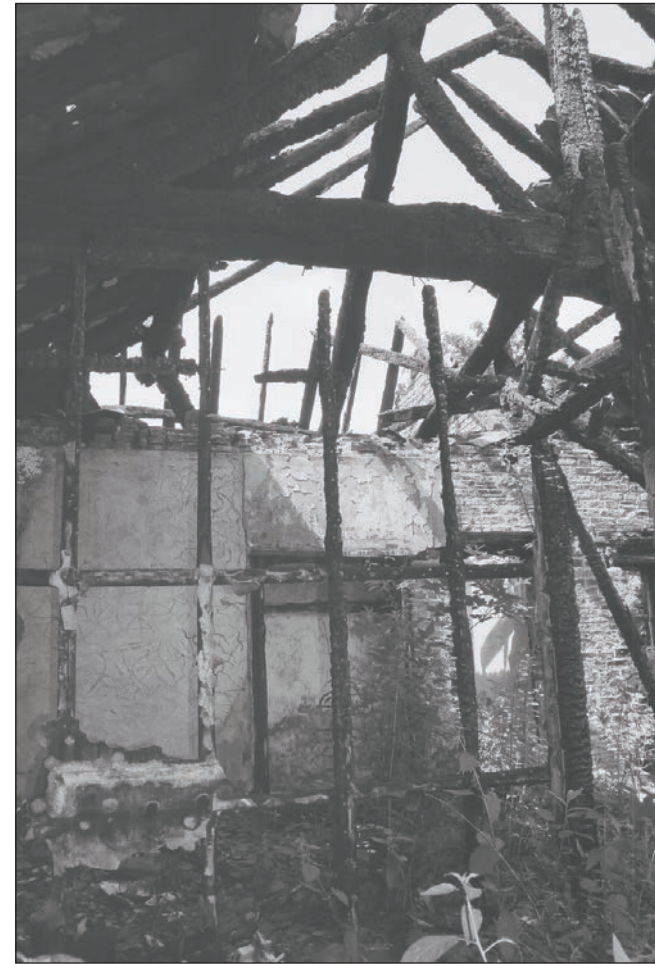
Plate 307: View of rooms F5 and F6, Building 3, from F3, Building 2 (Film 12.24)

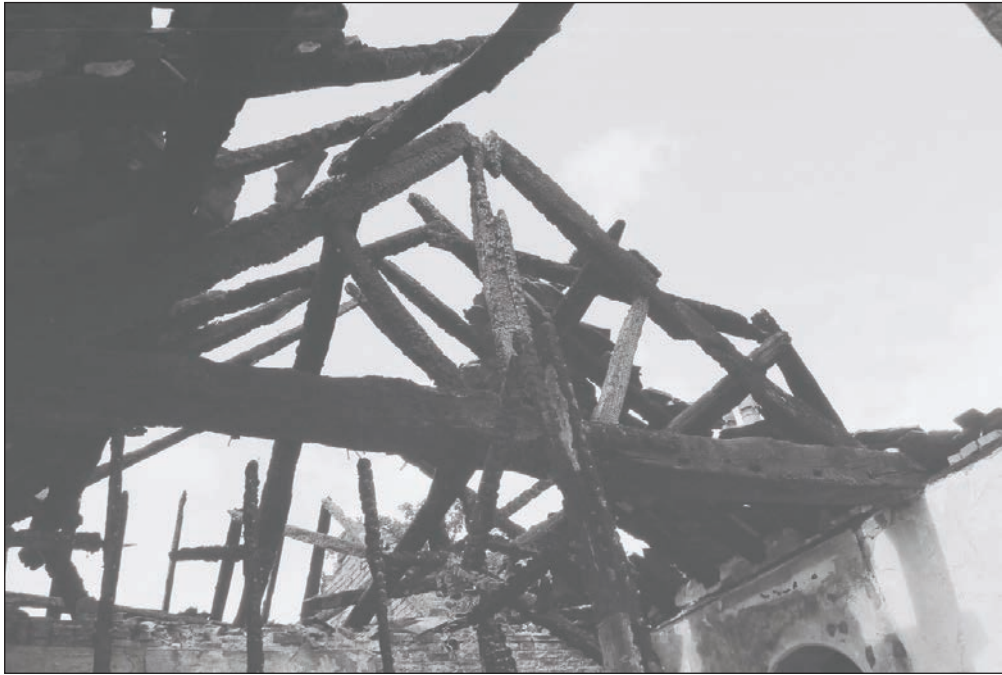
Plate 308: View of timber King-Post roof trusses of Building 3, from F3, Building 2 (Film 12.21)

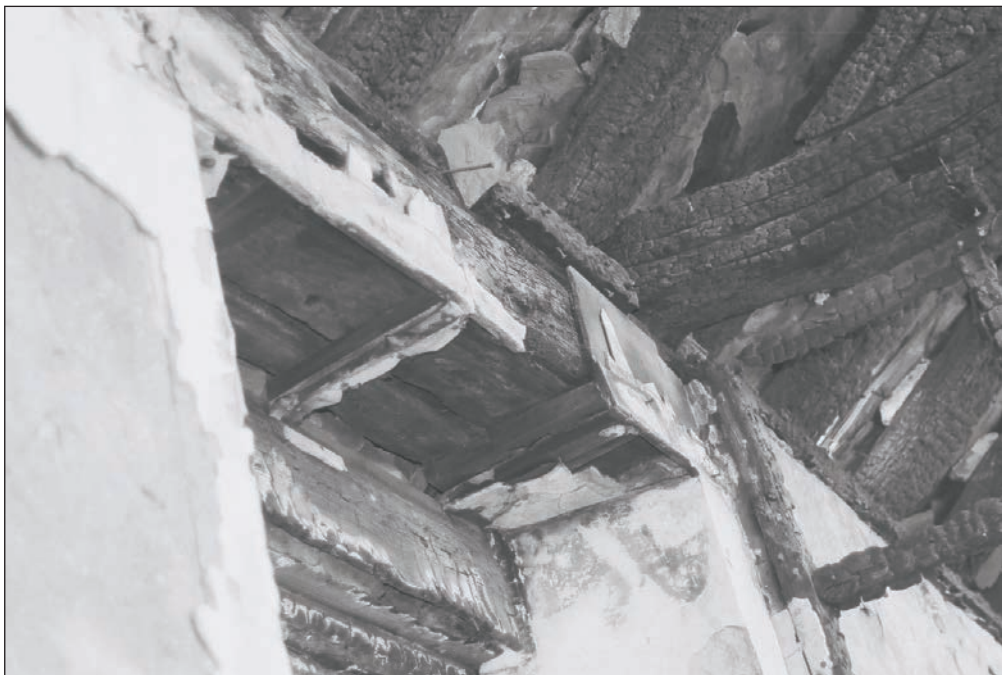
Plate 309: View of joint of window lintel, wall plate, tie beam and principal rafter above room F6, Building 3, from F3, Building 2 (Film 12.23)

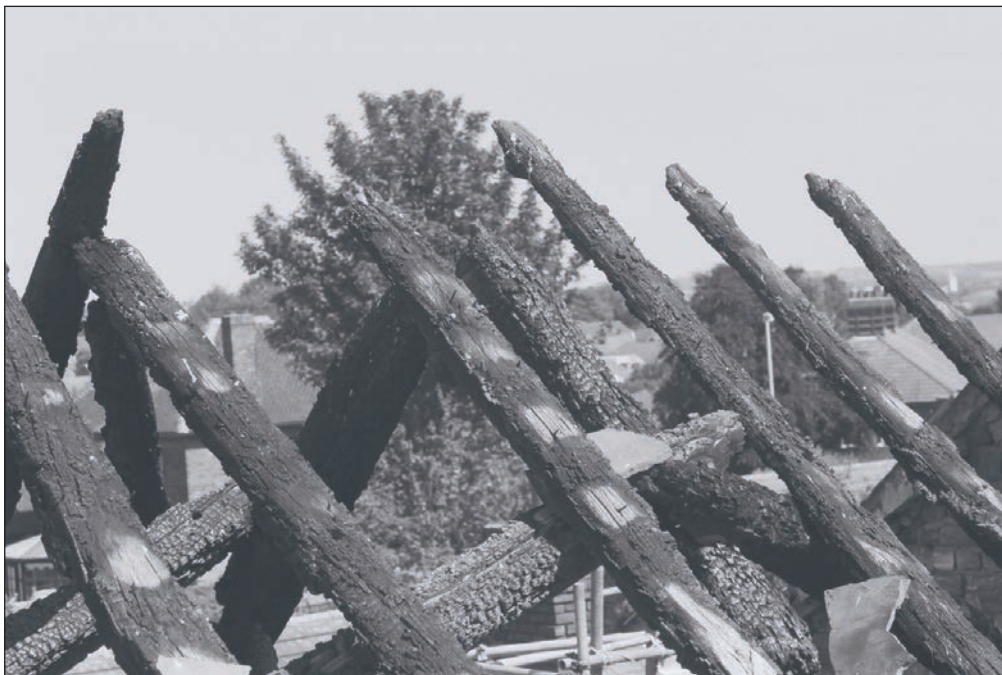
Plate 313: General view of common rafters and ridge of Building 3 (Film 25.07)

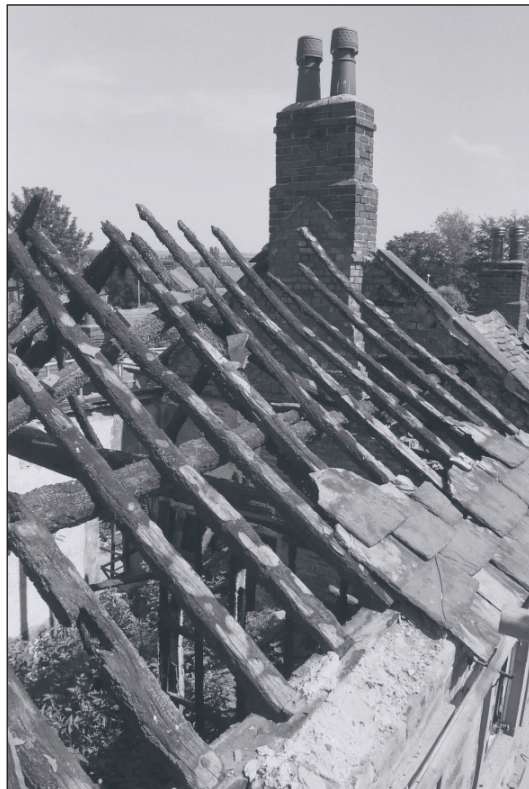
Plate 315: General view of roof timbers, Building 3 (Film 25.11)

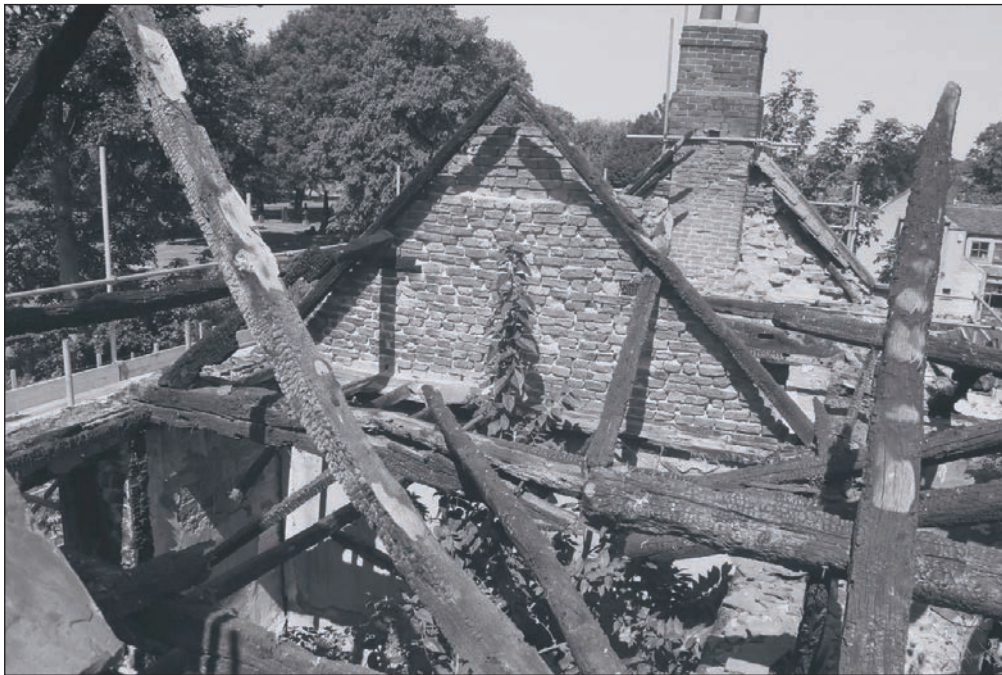
Plate 316: General view of roof timbers, Building 4 (Film 25.12)

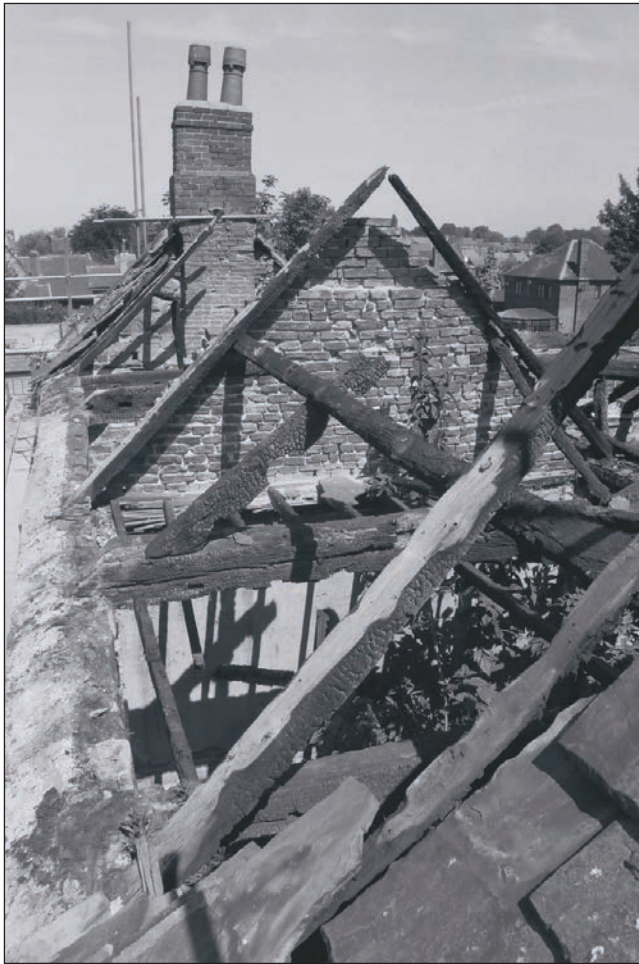
Plate 318: View along wall head, west wall of Building 4 (Film 25.17)

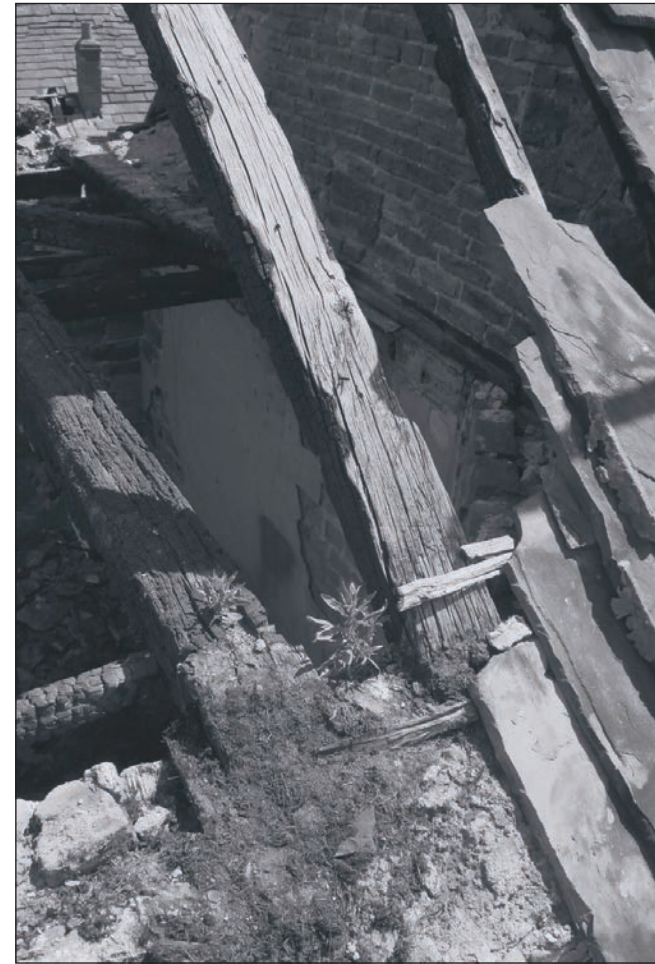
Plate 319: Detail of tie beam and rafter, west wall, Building 4 (Film 25.19)

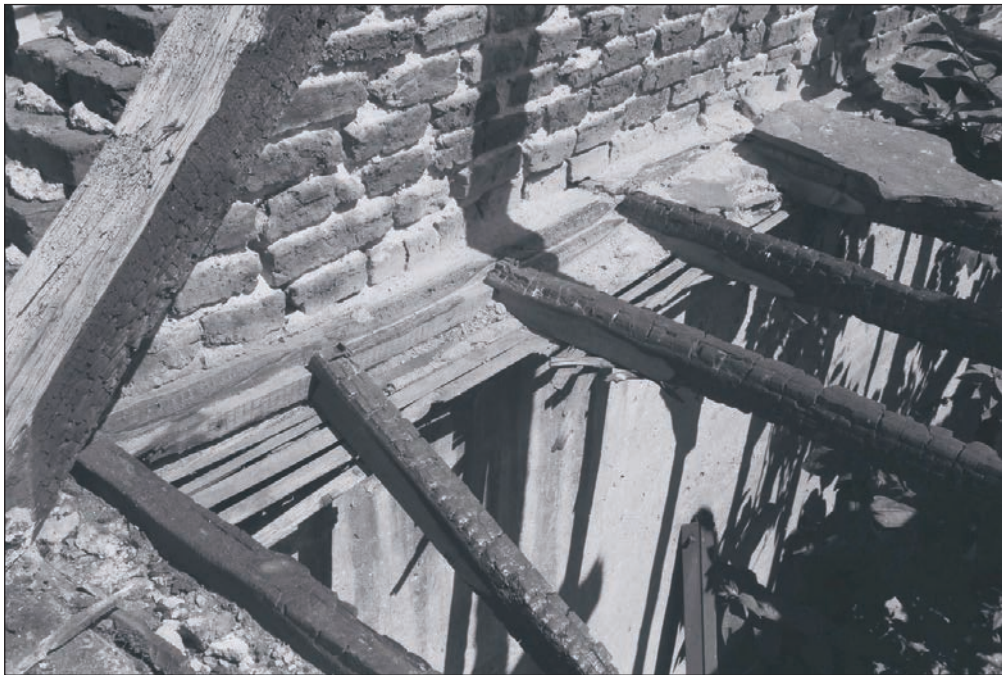
Plate 320: Detail of ceiling joists, south end of Building 4 (Film 25.20)

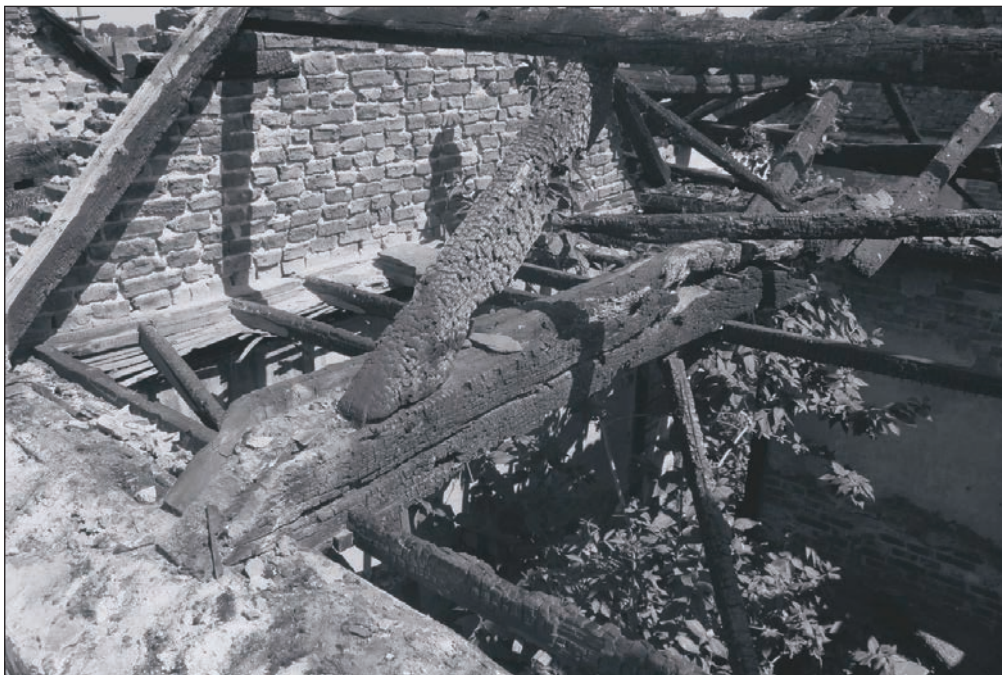
Plate 321: Detail of ceiling joists and tie beam, south end of Building 4 (Film 25.23)

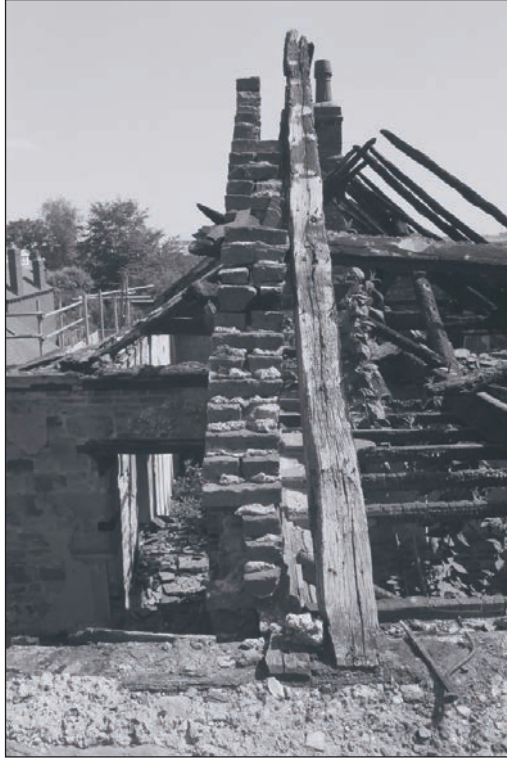
Plate 322: Detail along gable and truss from west wall of Building 4 (Film 25.24)

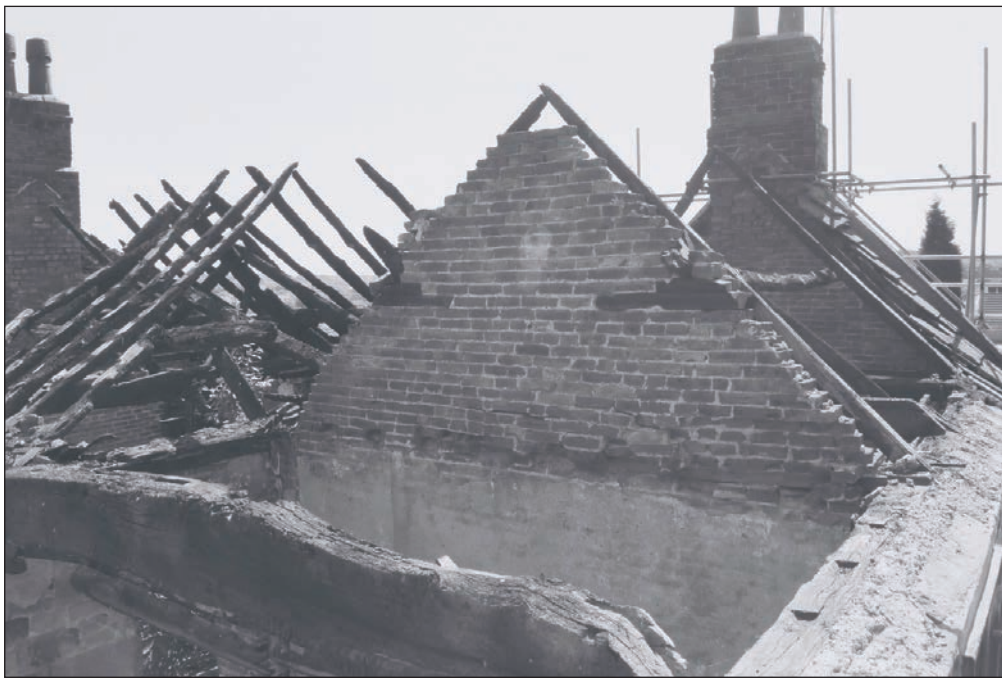
Plate 323: General view of brick gable, Building 4 (Film 25.27)

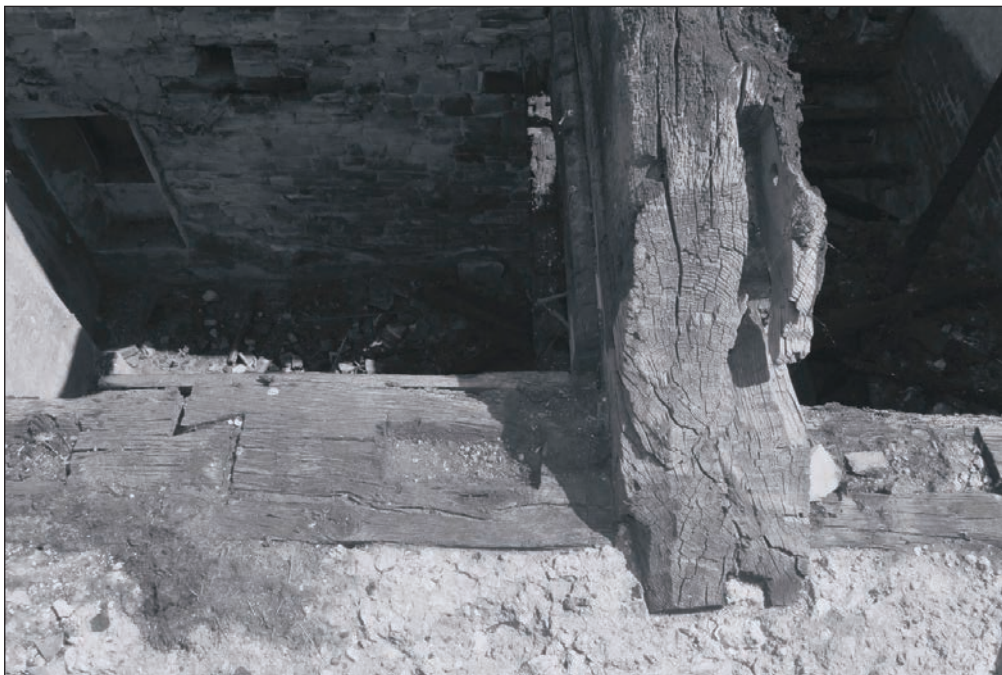
Plate 325: Detail of wall head, west wall of Building 4, showing scarf joint and tie beam (Film 25.30)

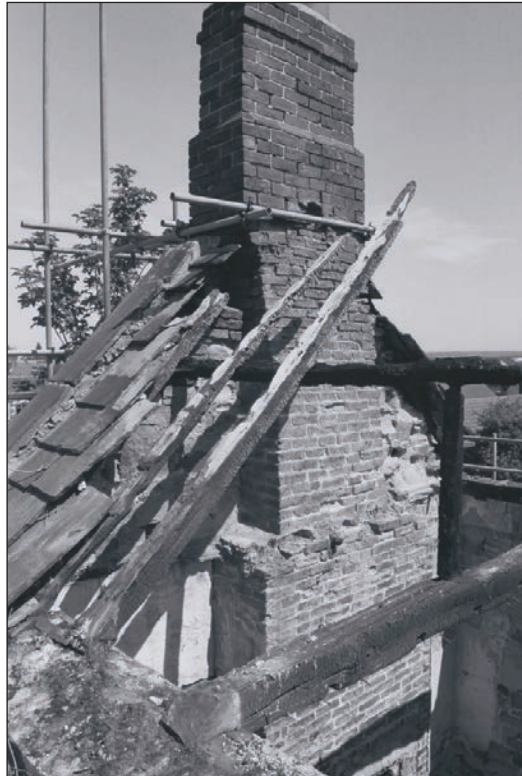
Plate 326: Detail of chimney stack, north end of Building 4 (Film 25.32)

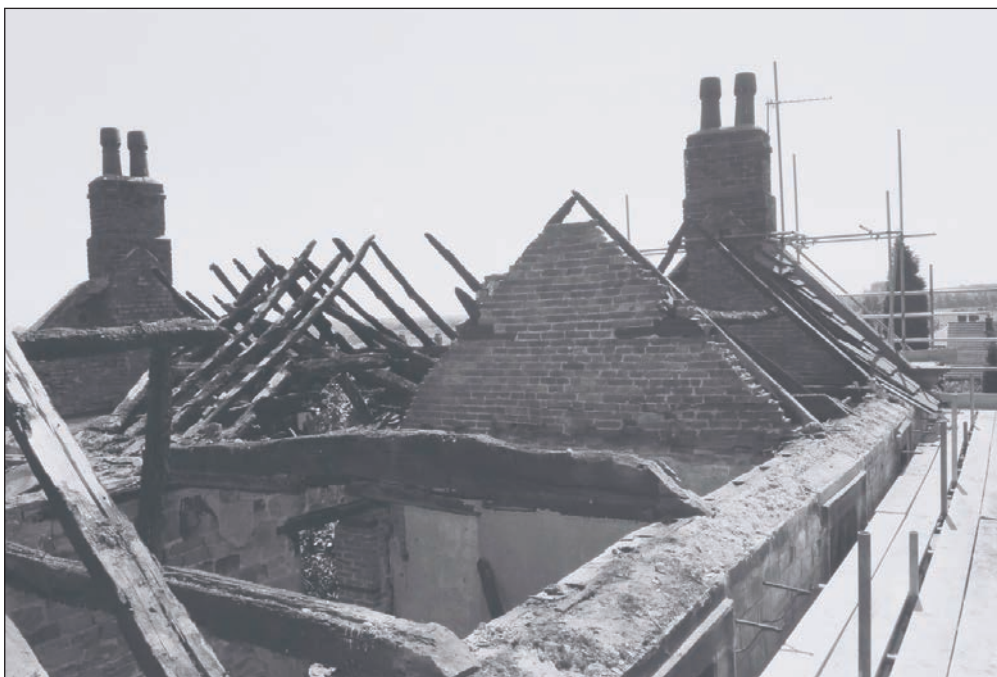
Plate 327: General view along roof of Building 4 (Film 25.35)

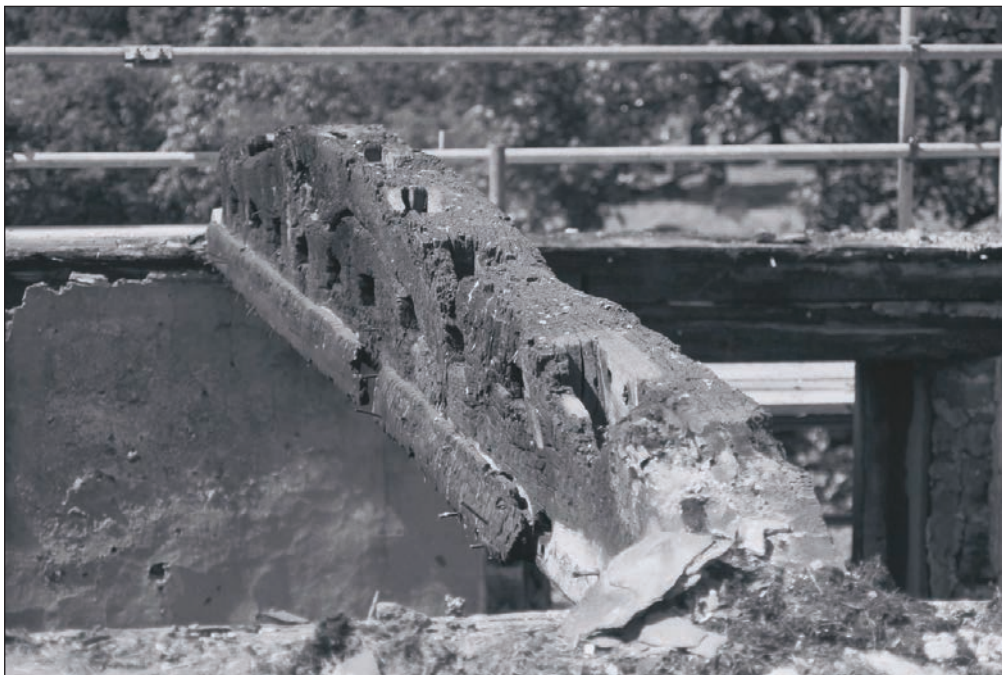
Plate 329: Detail of re-used tie beam, Building 4 (Film 26.02)

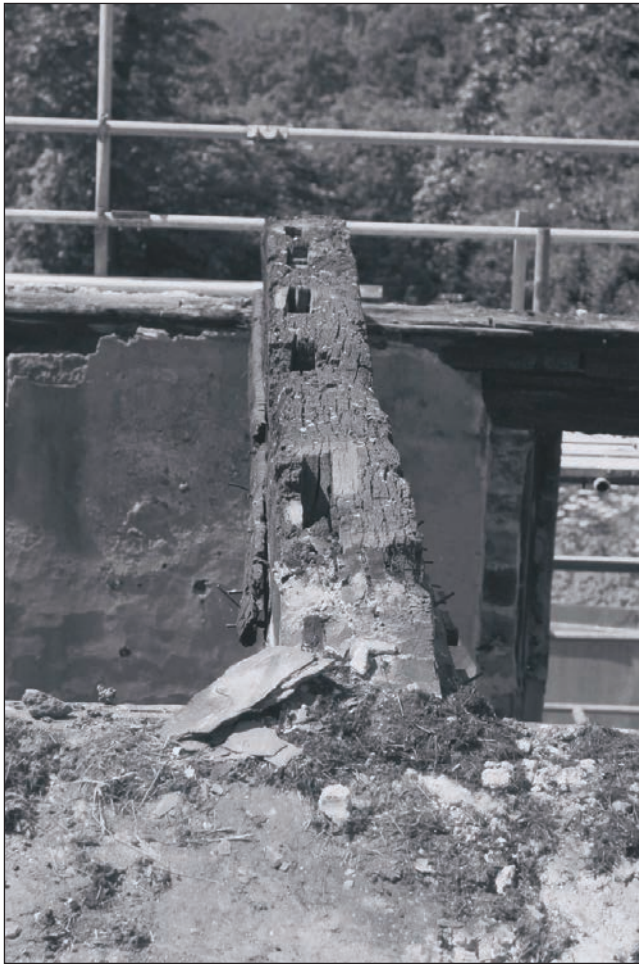
Plate 330: Detail of re-used tie beam, Building 4 (Film 26.04)

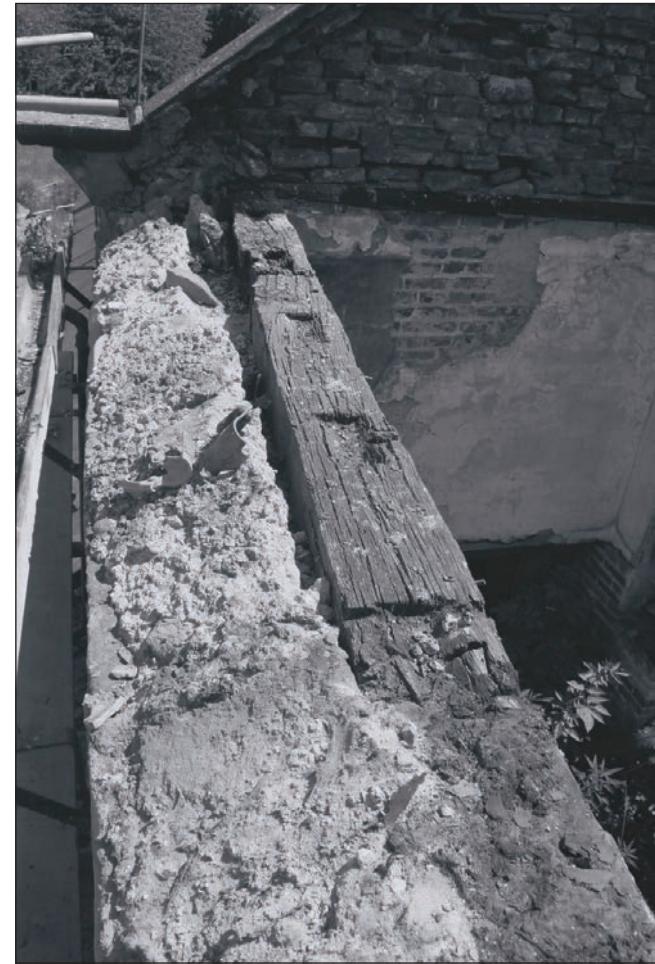
Plate 331: Detail of wall plate, west wall, Building 4 (Film 26.06)

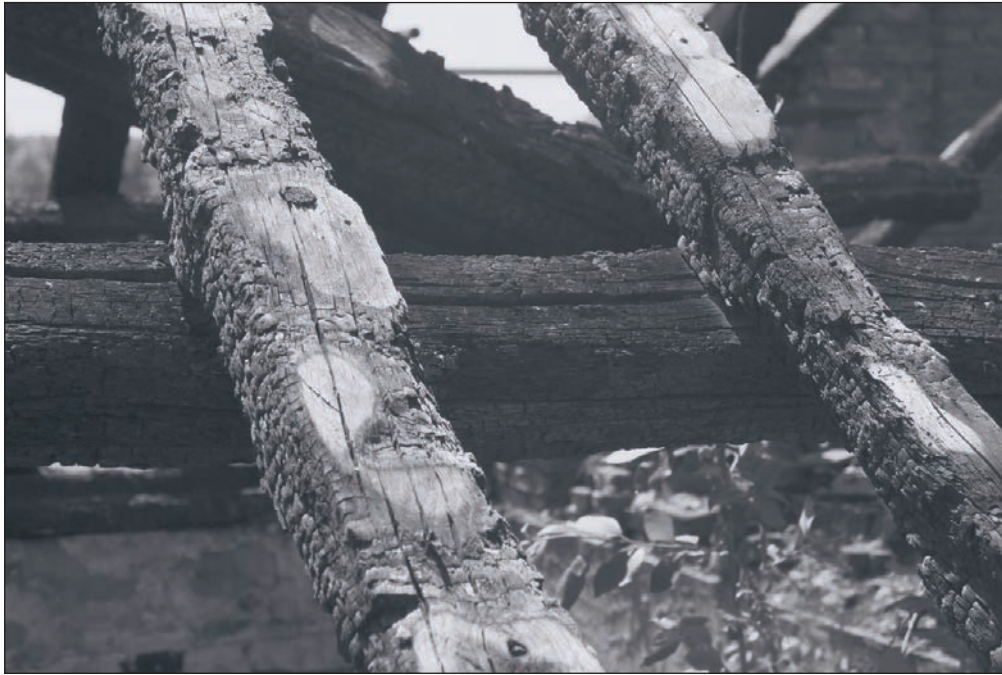
Plate 332: Detail of rafters and pegged purlin, Building 3 (Film 26.08)

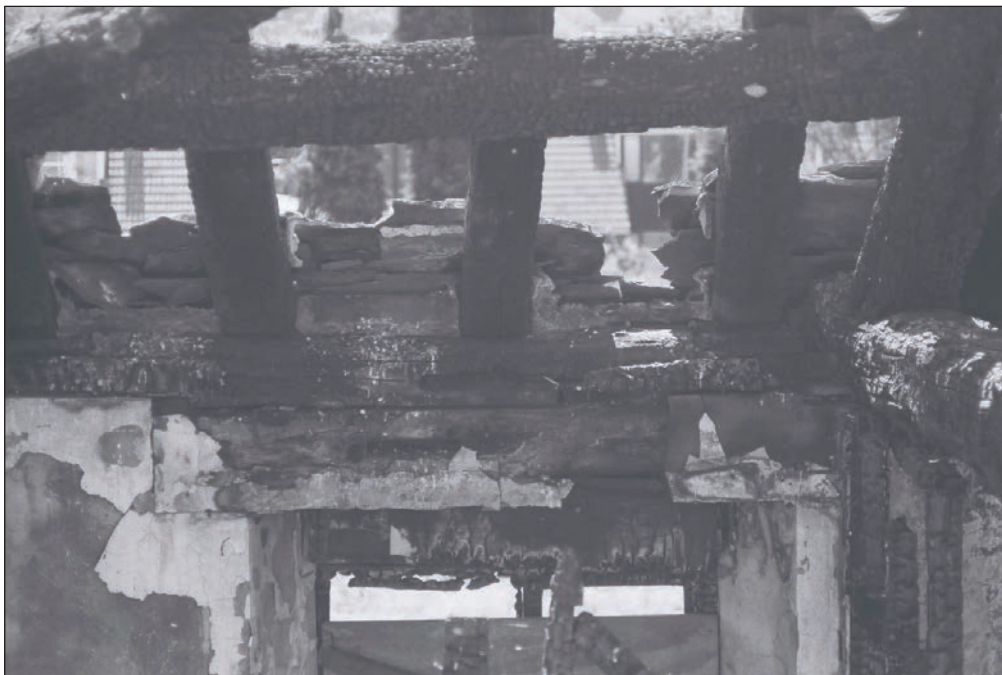
Plate 333: Detail of wall head, south wall of Building 3 (Film 26.10)

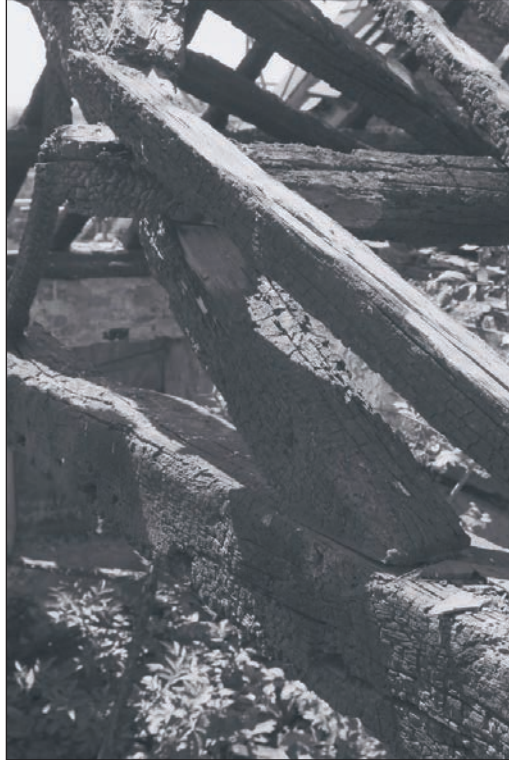
Plate 334: Detail of truss, Building 3 (Film 26.12)

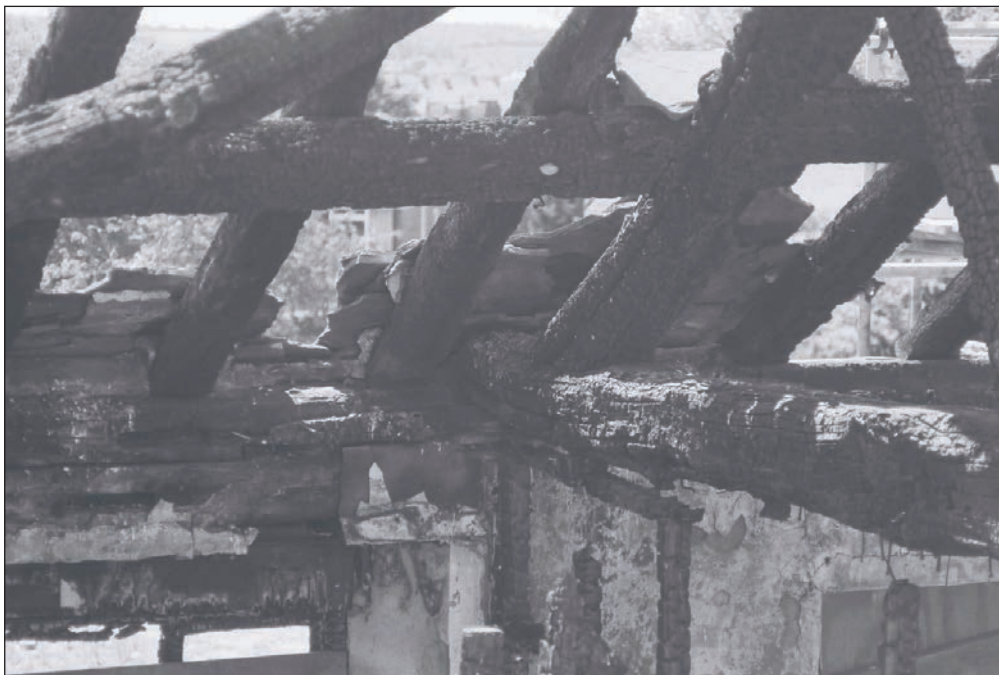
Plate 335: Detail of truss, Building 3 (Film 26.15)

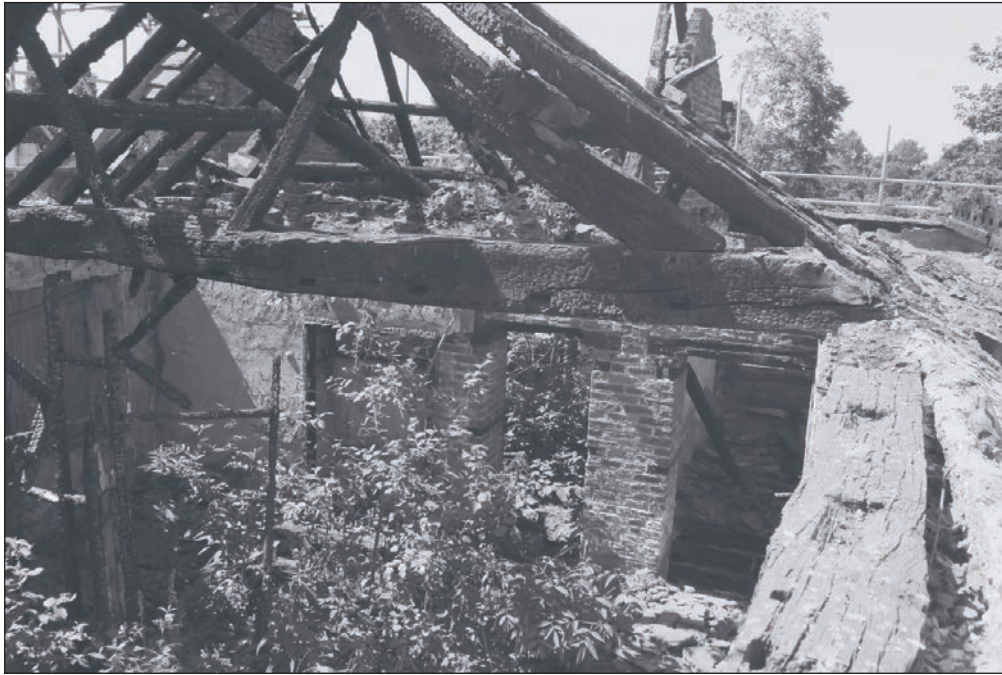
Plate 336: General view of roof timbers, Building 3 (Film 26.17)

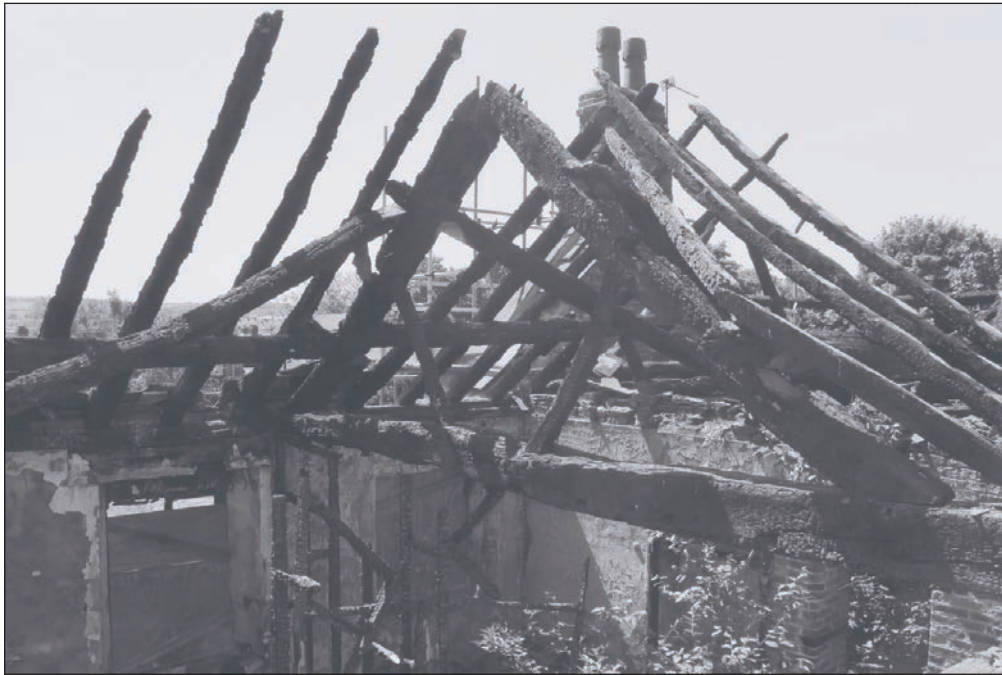
Plate 337: General view of roof timbers, Building 3 (Film 26.19)

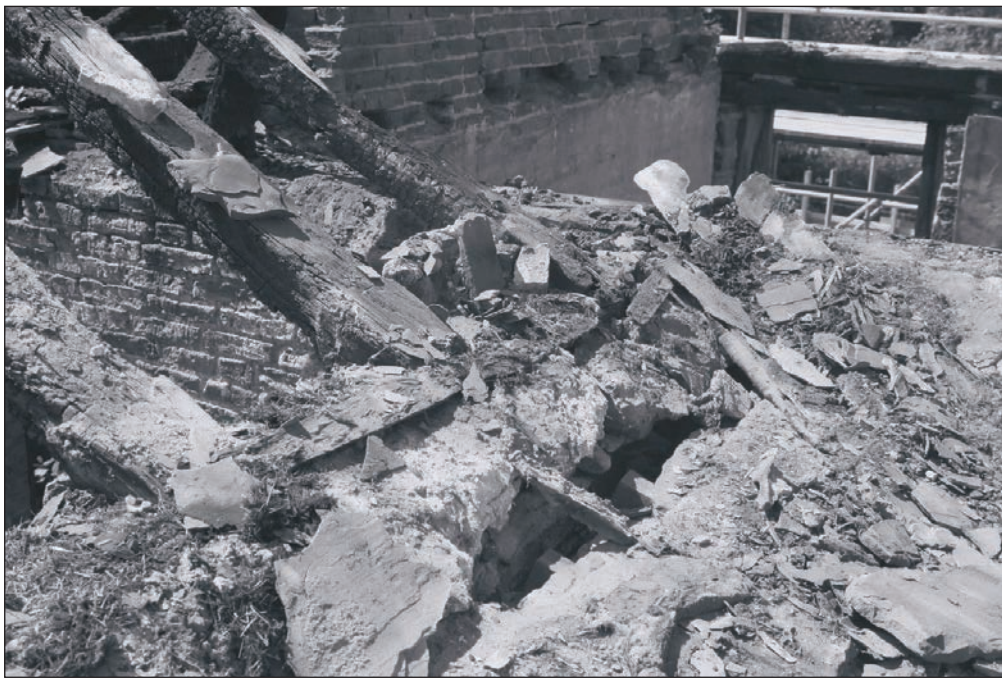
Plate 339: Detail of wall head and rafters, north wall of Building 3 (Film 26.23)

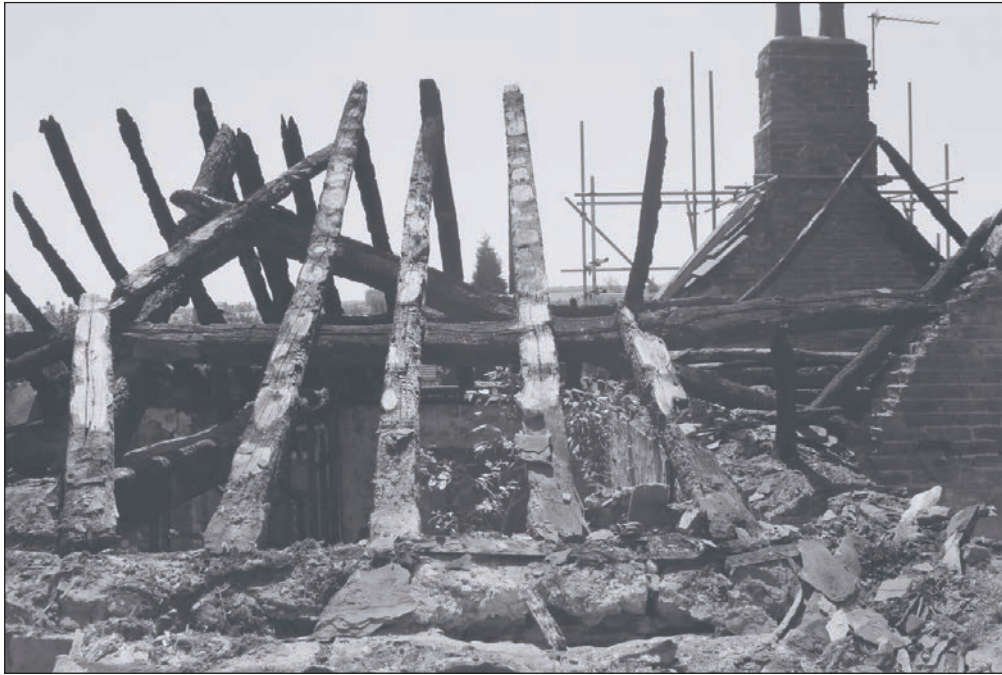
Plate 340: General view of roof timbers, Building 3 (Film 26.24)

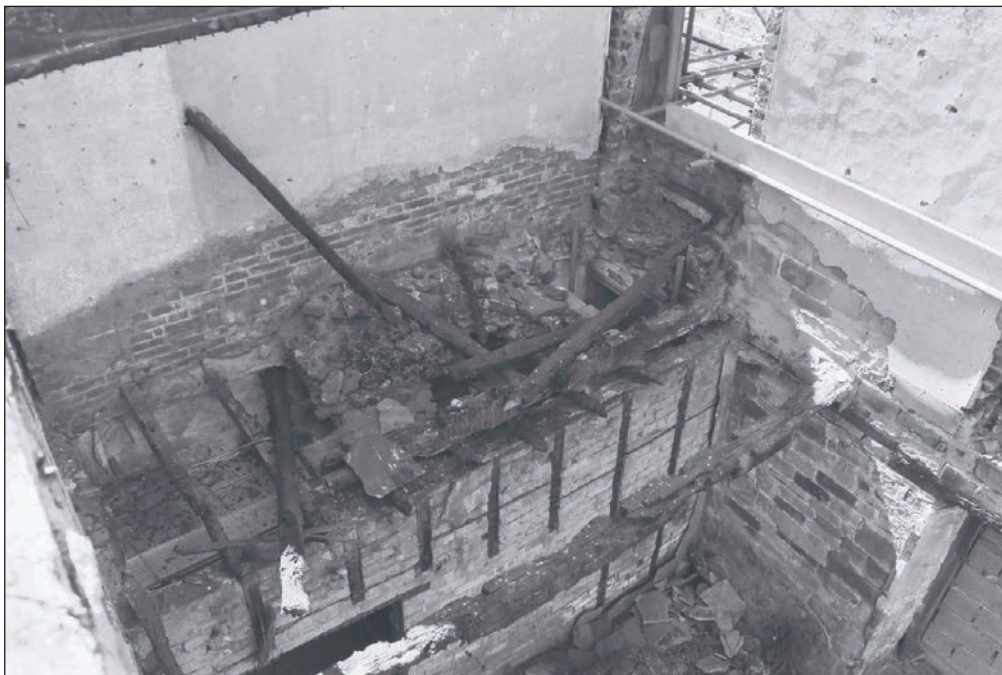
Plate 341: General view of first floor joists (F1), Building 4 (Film 26.27)

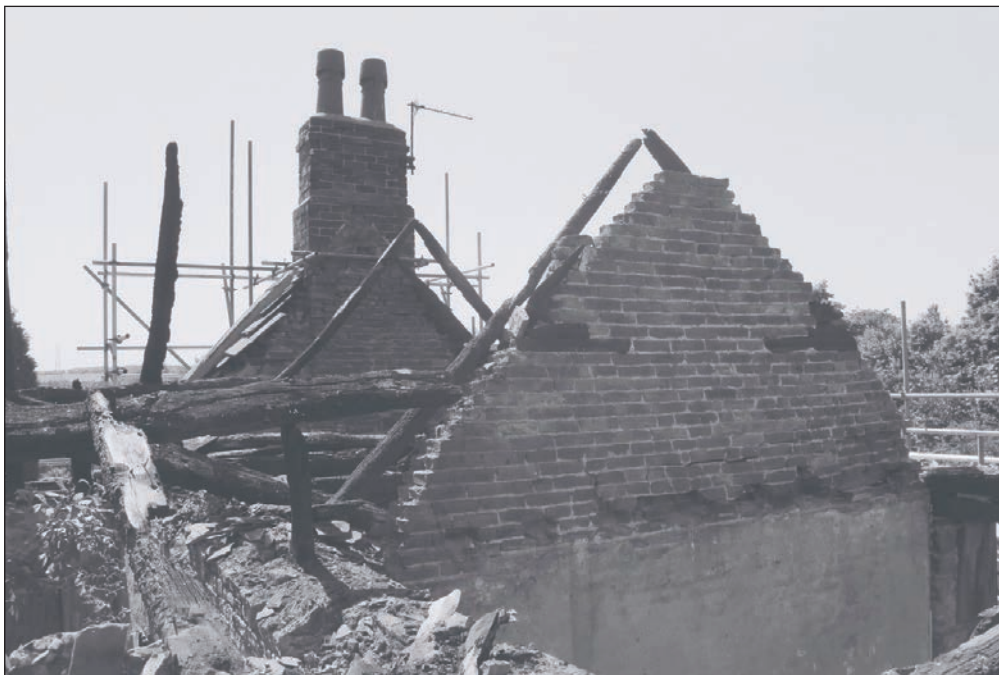
Plate 343: General view of central brick gable, Building 4 (Film 26.31)

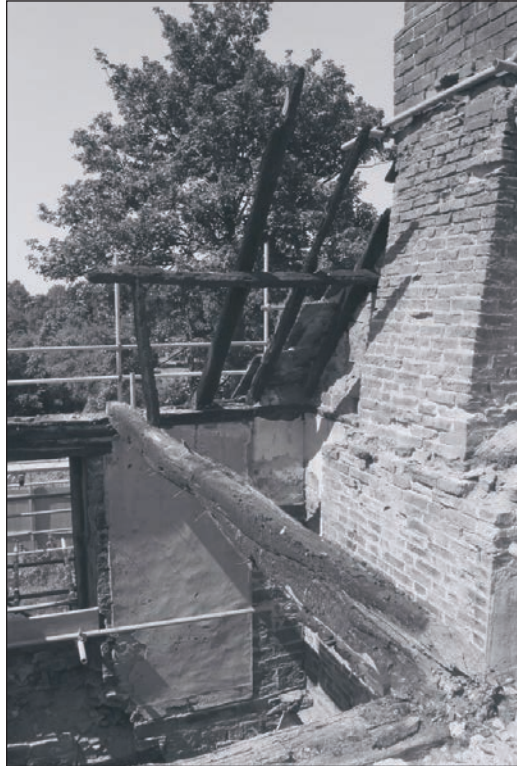
Plate 344: View of chimney stack and tie beam, north gable of Building 4 (Film 26.32)

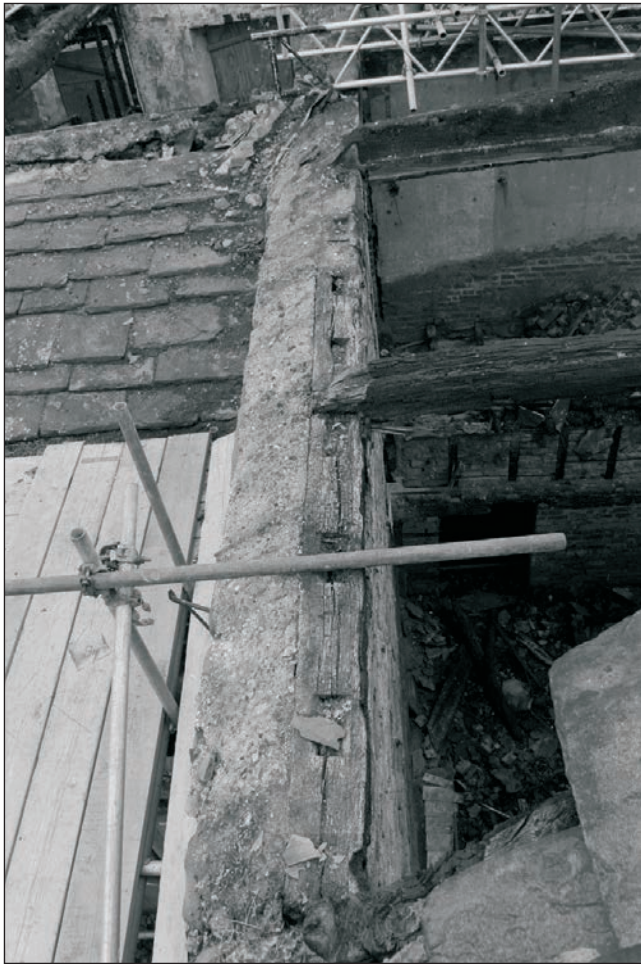
Plate 346: General view of wall head, east wall of building 4 (Film 27.17)
