HANSON HOUSE  
SNYDALE ROAD  
NORMANTON  
WAKEFIELD  
WEST YORKSHIRE

Historic Building Recording

**Planning Application Ref: 07/00704/FUL & 07/00705/LBC**

74352.02\_BDG\_V0\_3

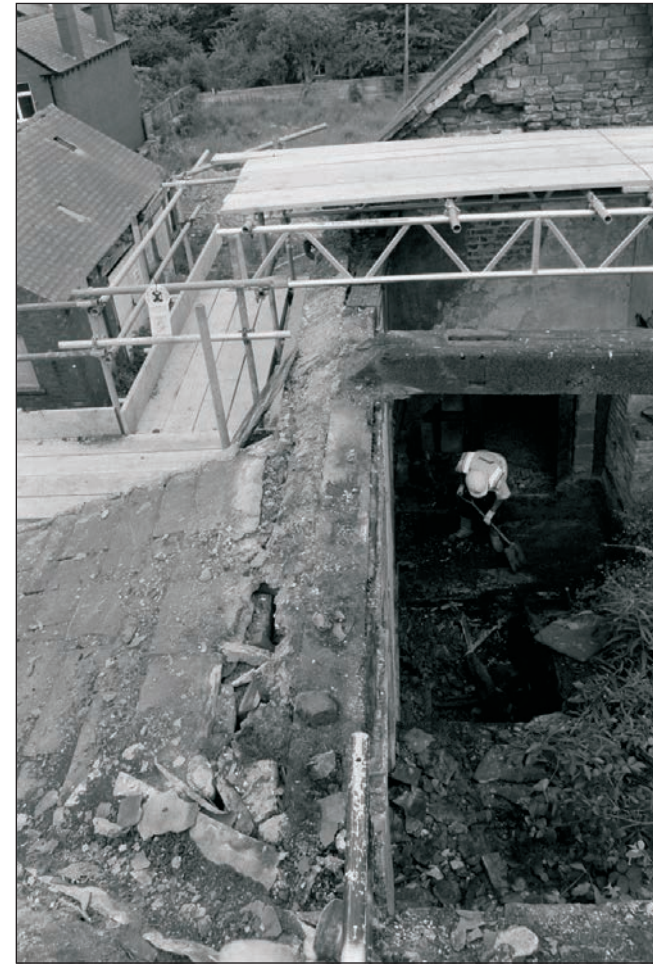
Plate 347: General view along wall head, north wall, Building 3 (Film 27.20)

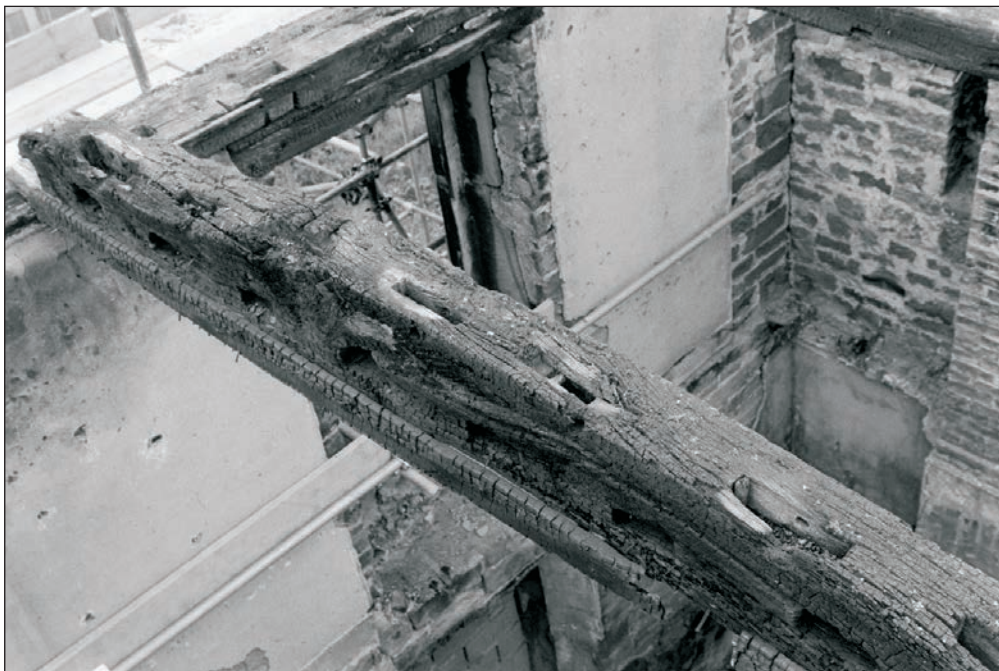
Plate 349: Detail of redundant mortices within tie beam, Building 4 (Film 27.24)

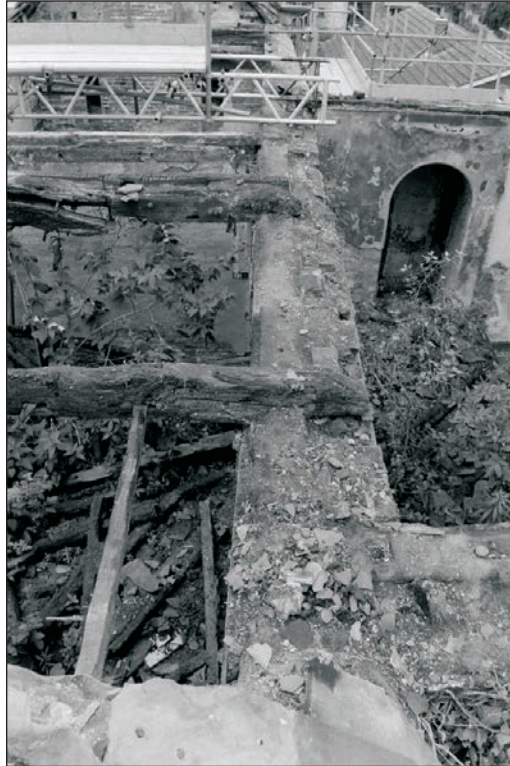
Plate 350: View along wall head, east wall, Building 4 (Film 27.28)

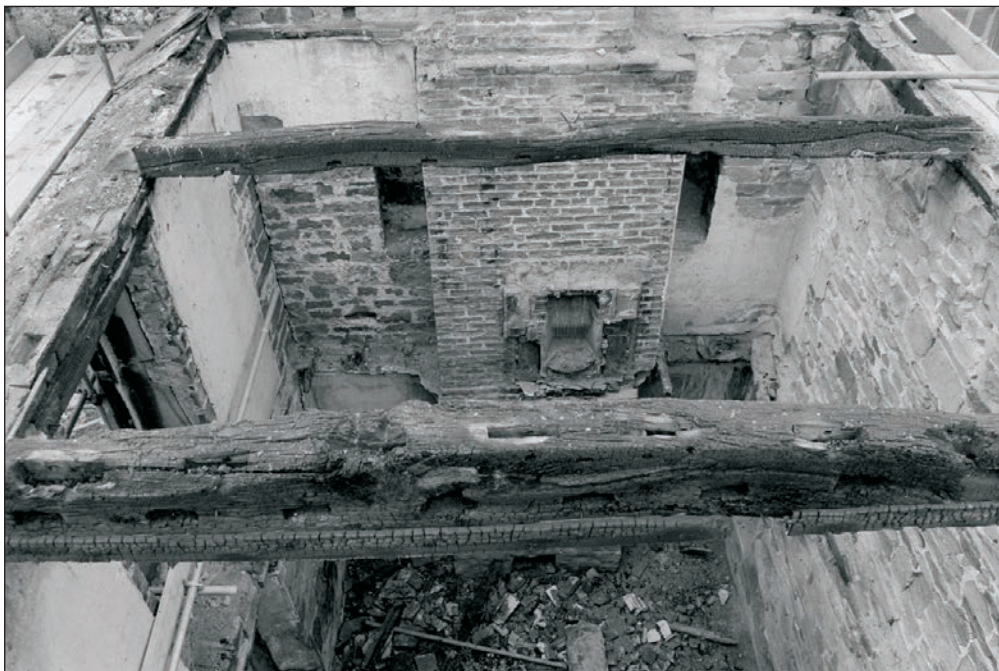
Plate 351: View into former room F1, showing brick chimney breast, flanking windows and tie beams, Building 4 (Film 27.25)

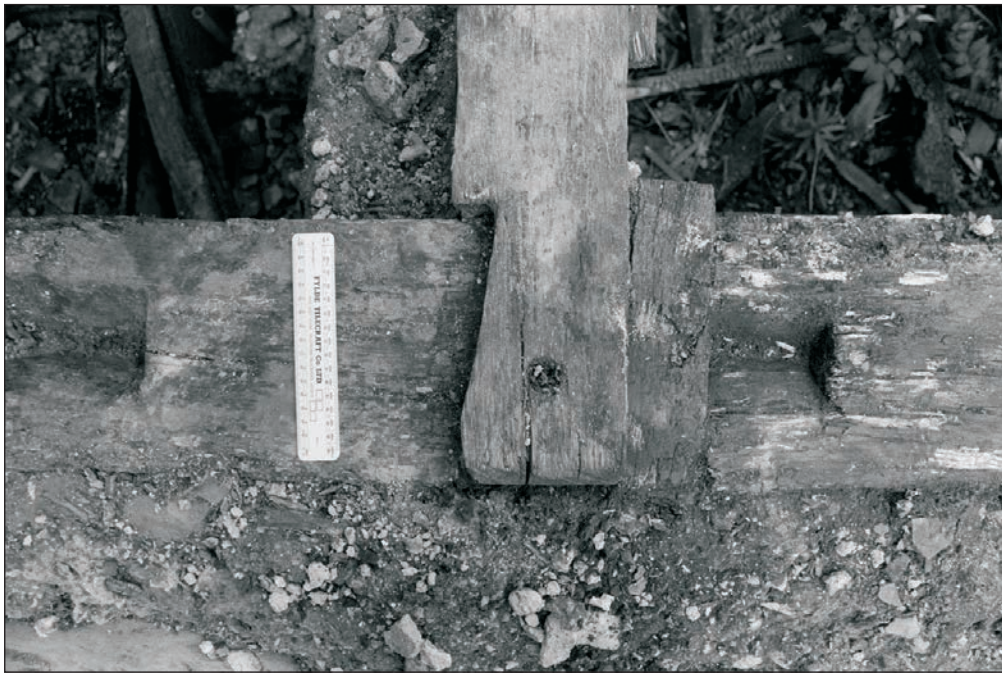
Plate 352: Detail of pegged joint, west wall plate, Building 4 (Film 27.29)

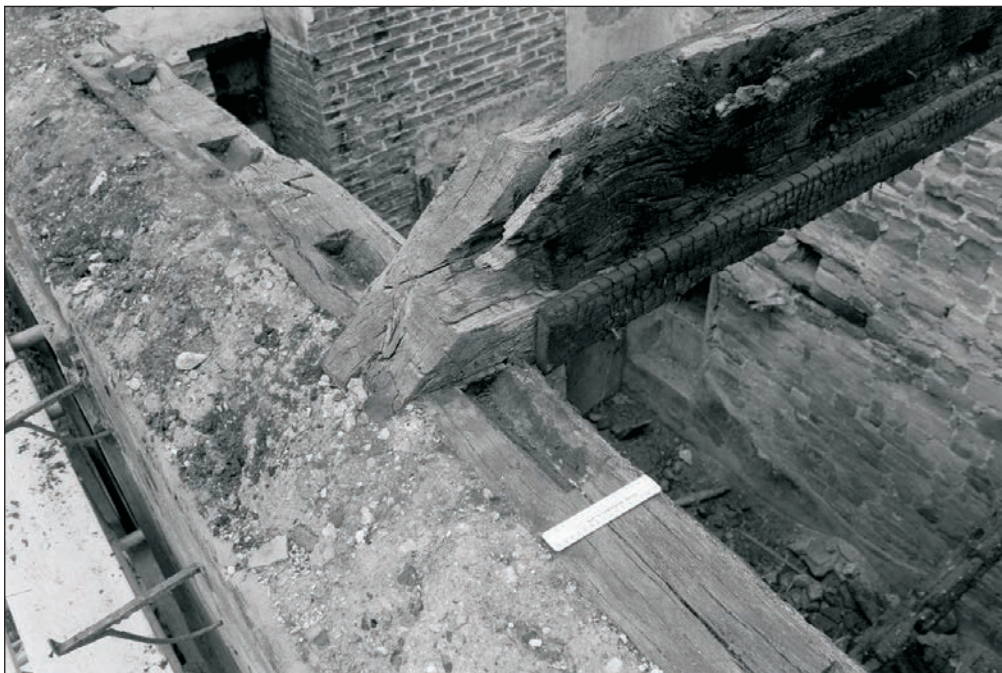
Plate 353: Detail of joint of tie beam and wall plate, west wall, Building 4 (Film 27.31)

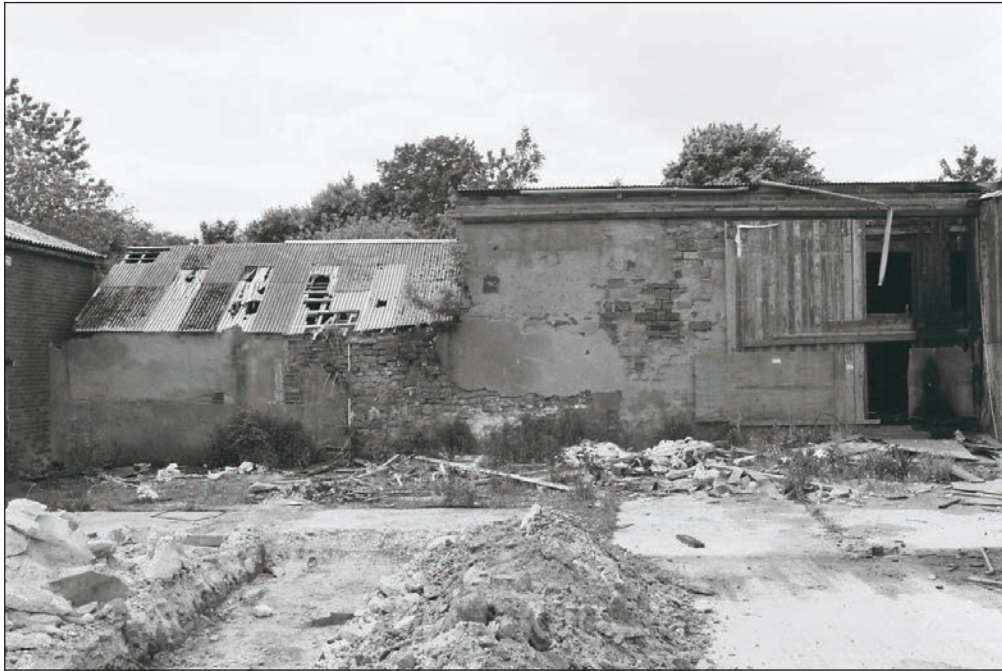
Plate 356: General view of the east elevation of Building 5 (Film 02.27)

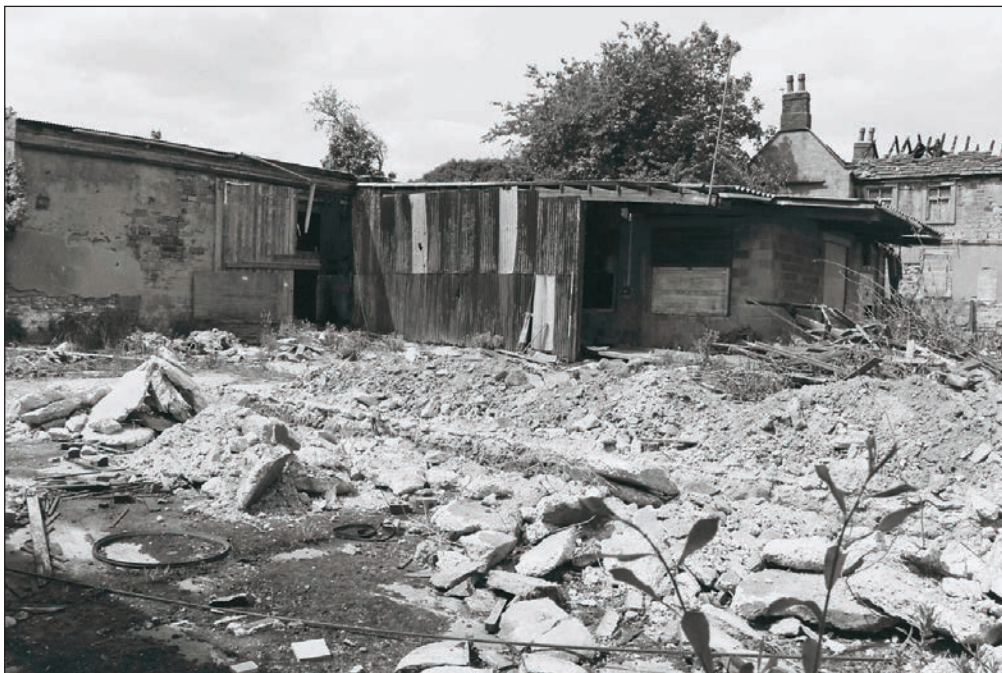
Plate 357: General view of Building 5 looking northwest (Film 02.29)

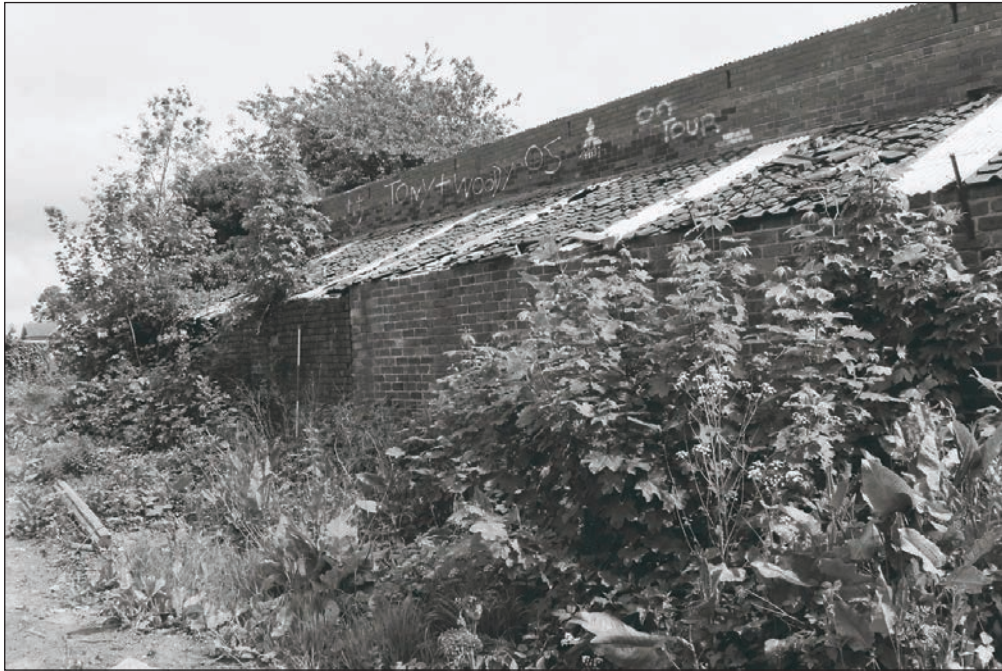
Plate 358: General view of the west elevation of Building 5 (Film 06.26)

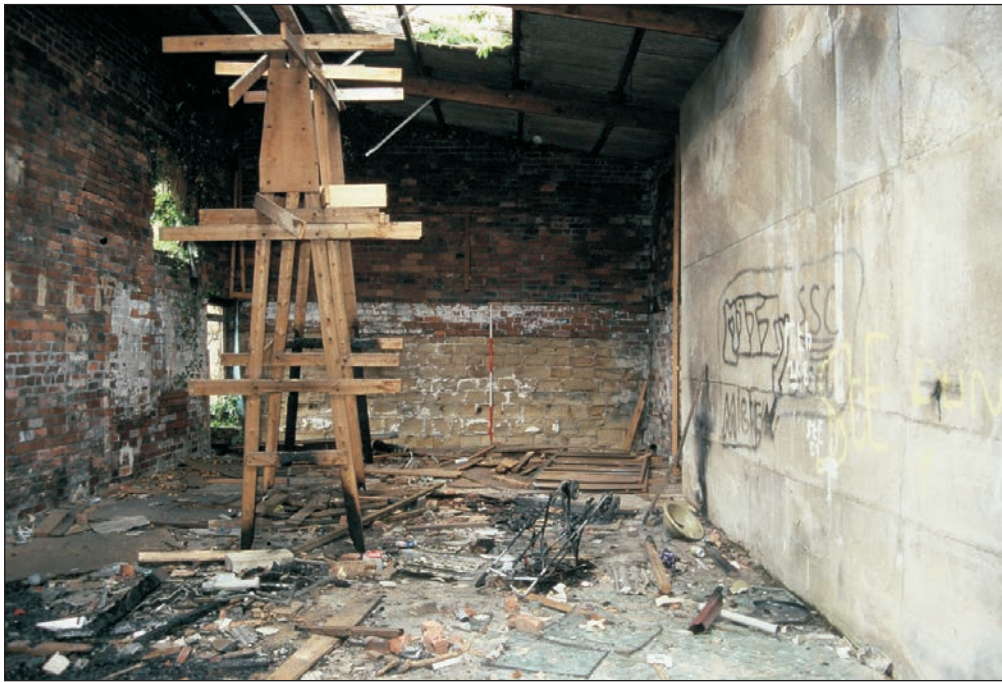
Plate 360: General internal view of Building 5 (Colour Slide 08)

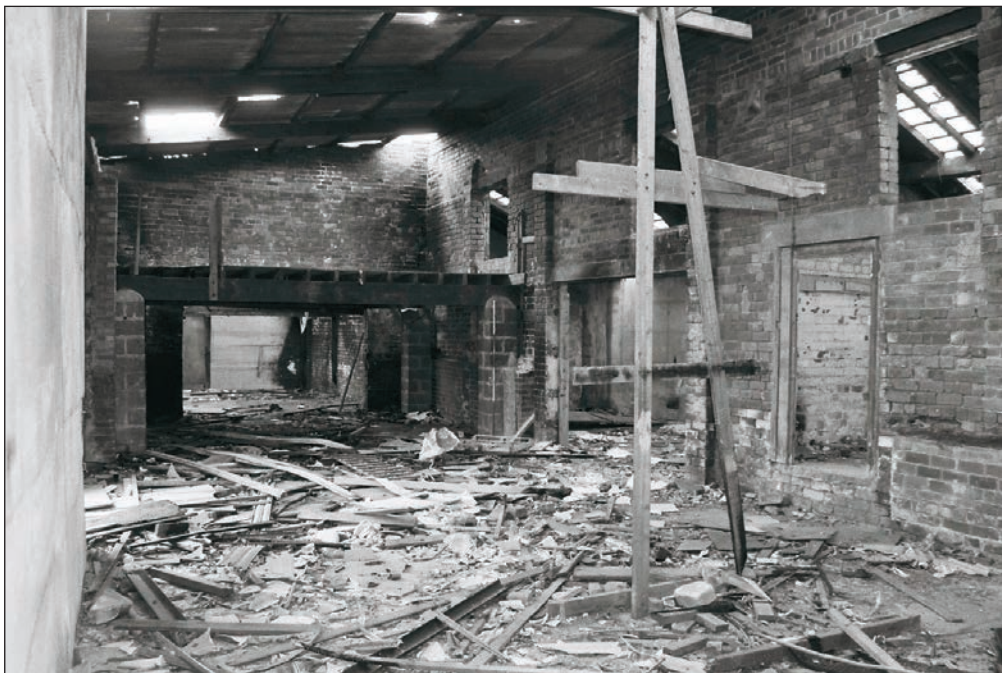
Plate 361: General internal view of Building 5 (Film 06.35)

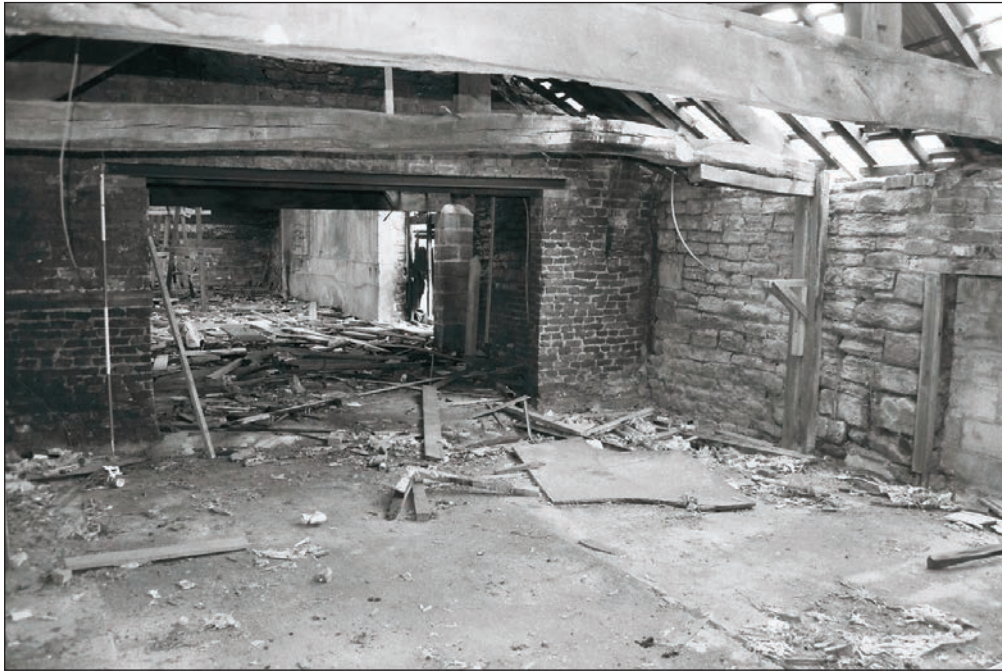
Plate 362: General internal view of Building 5 (Film 06.29)

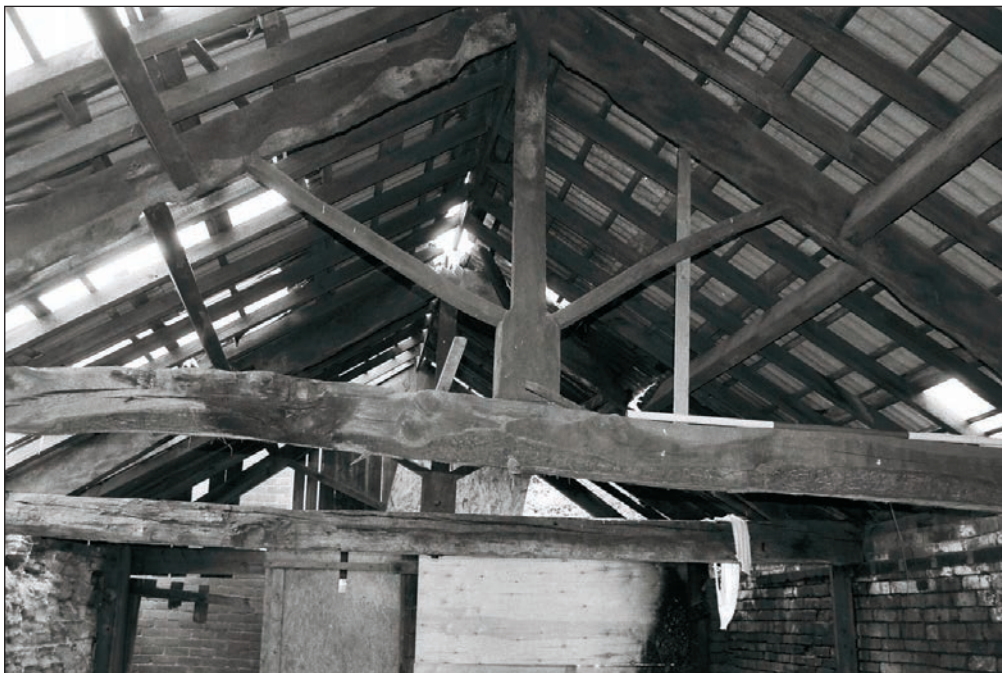
Plate 363: Detail of timber King-Post roof trusses within Building 5 (Film 02.24)

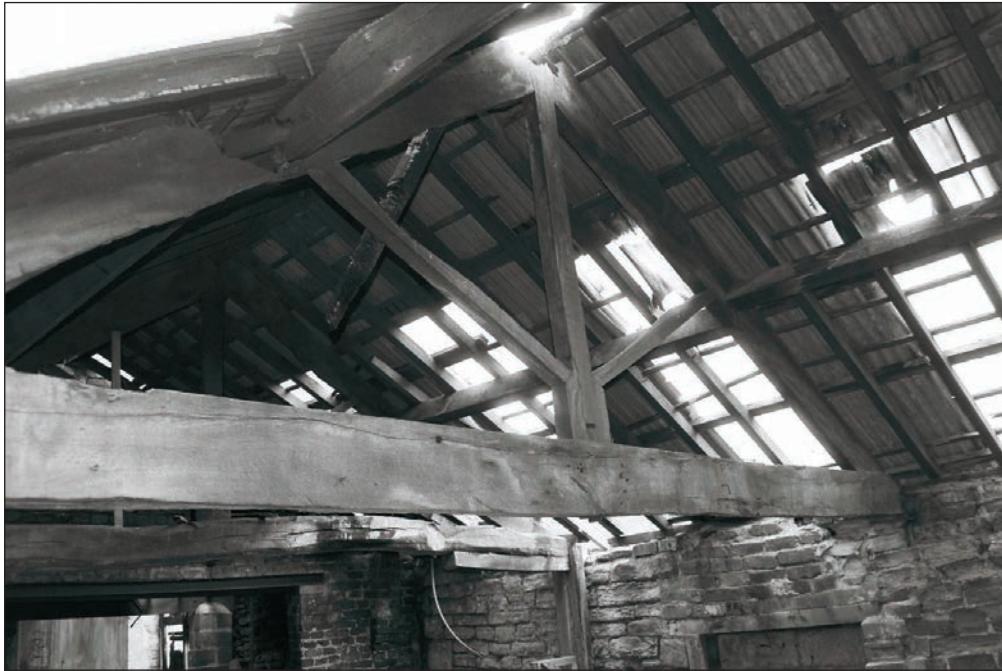
Plate 364: Detail of timber King-Post roof trusses within Building 5 (Film 06.31)

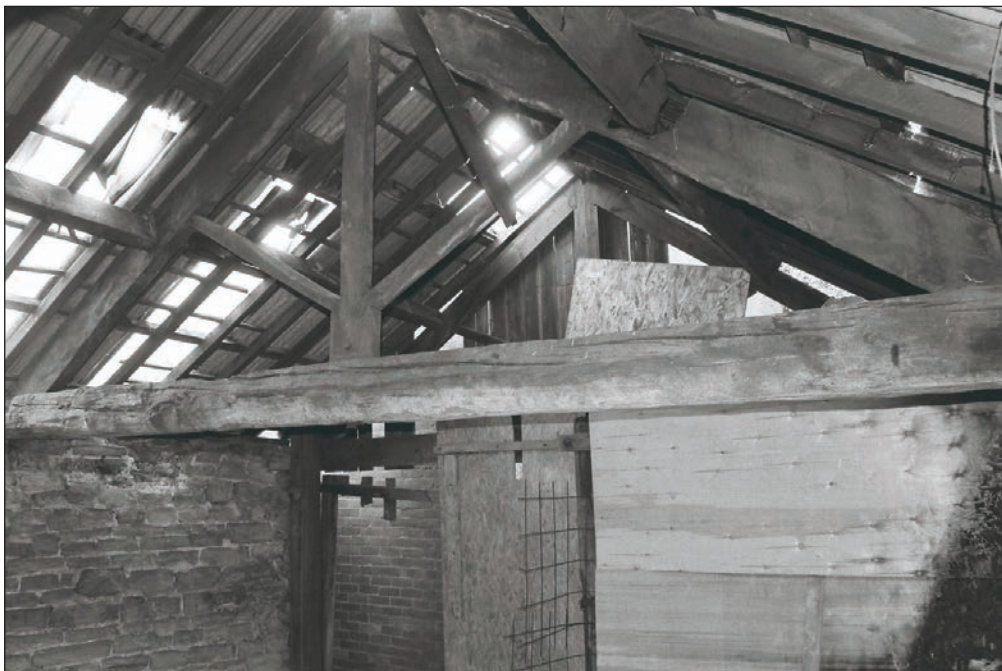
Plate 365: Detail of timber King-Post roof trusses within Building 5 (Film 06.32)

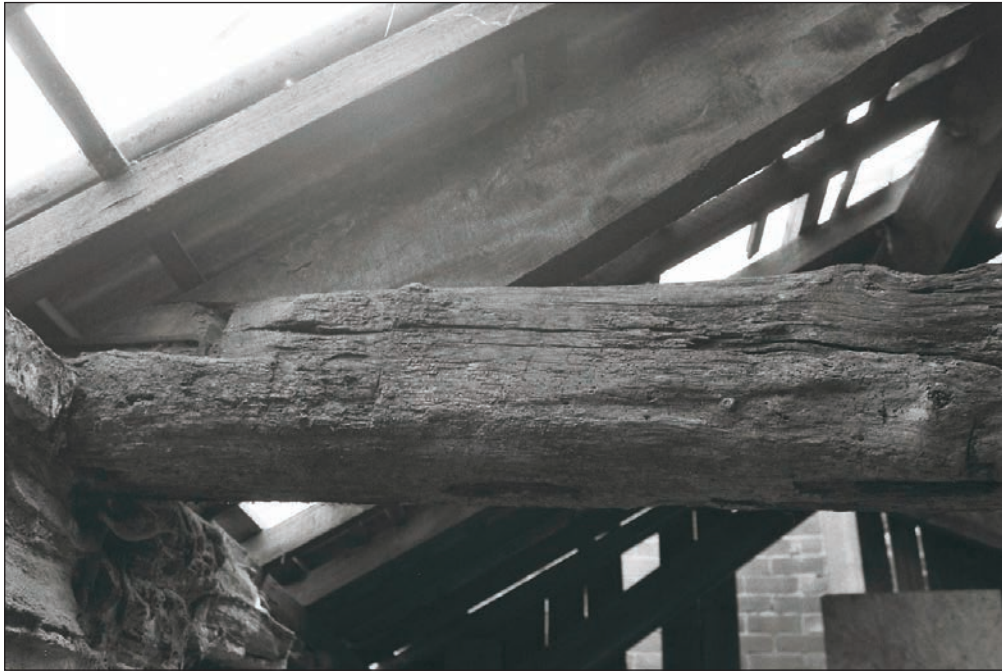
Plate 366: Detail of the joint between the tie beam and principal rafter with wall head, Building 5 (Film 02.22)

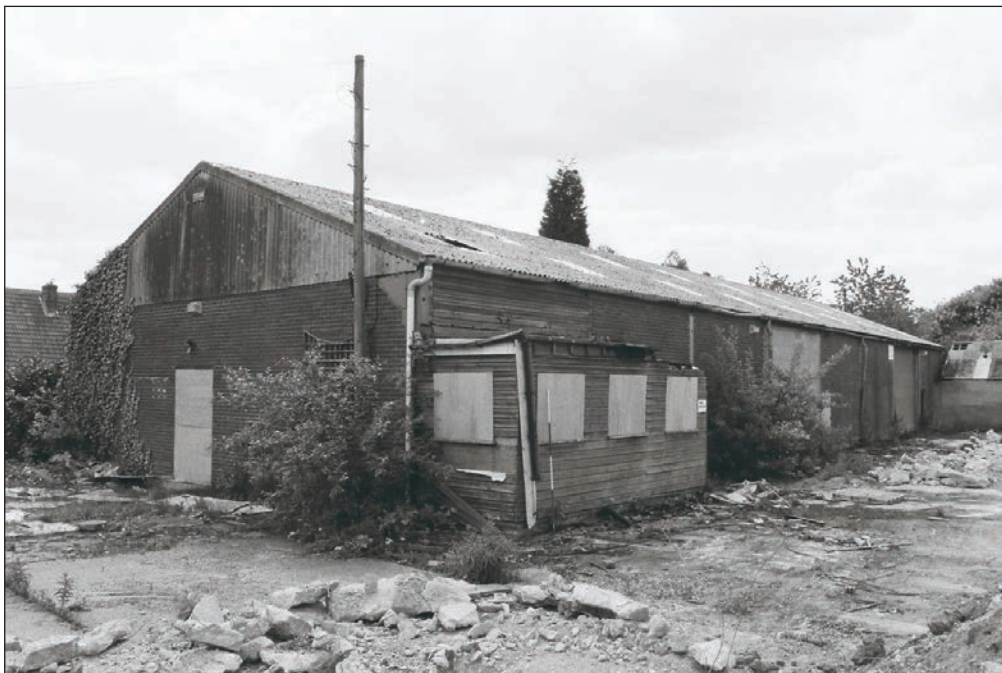
- 5.6.1 At the south of the Site was a large and tall modern brick built building, set on a northeast-southwest orientation (**Figure 9, Plate 367**). This was not subject to any archaeological recording.

Plate 367: General view of Building 6, looking southwest (Film 02.32)

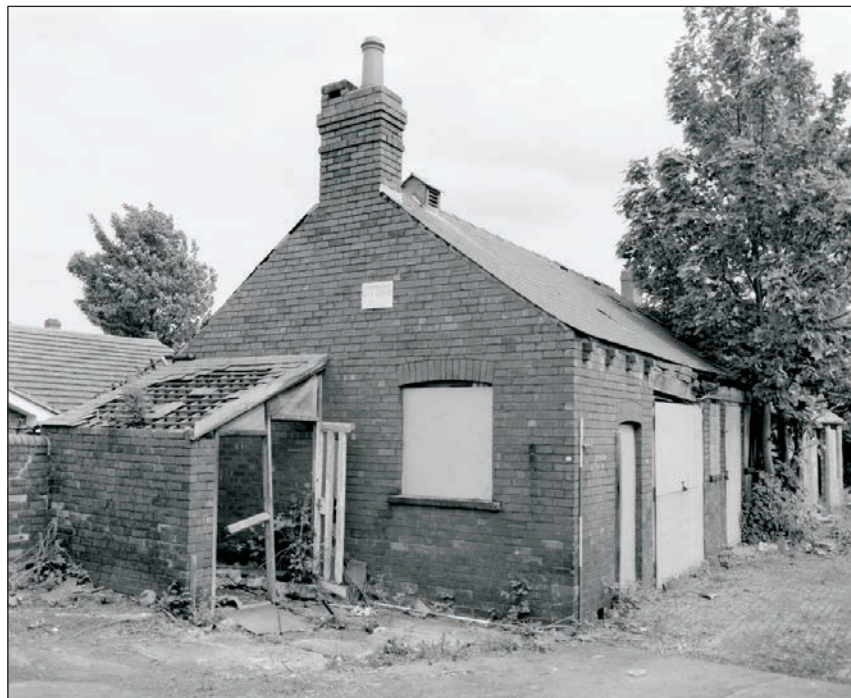
with a slate covering and a chimney within the east gable. A small lean-to was also attached to the east elevation (**Plate 369, 370**). The south elevation contained a large vehicular doorway with an adjacent pedestrian door, and a second doorway to the east with flanking windows (**Plate 368**). Decorative brick dentils along the eaves level of the elevation would have once supported timber guttering. A small timber louvered ridge vent was positioned at the west end of the roof. The building appeared to have two separate internal rooms, one possibly utilised as a small stable (**Plate 371**).

Plate 369: General view of the west and south elevations of Building 7 (Film 08.04)
