Field Farm, Ashby Road Kegworth, Leicestershire

Historic Building Record

Ref: 101406.02
February 2017

Prepared for:
CgMs Consulting
140 London Wall
London
EC2Y 5DN

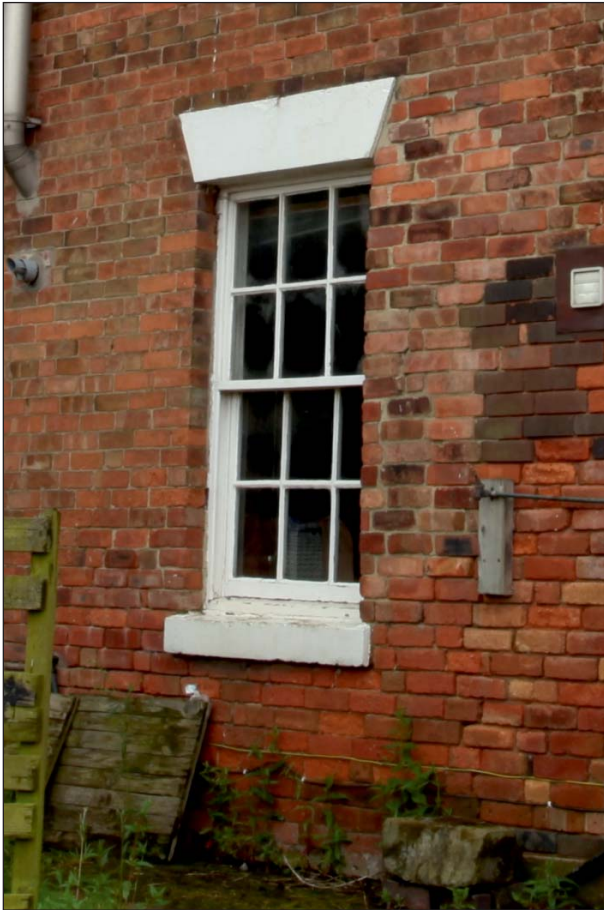
- 6.2.6 The north elevation (Plate 4) of the main house comprises four windows identical in form to those on south elevation and east elevations. The window to F02 has been blocked at an unknown date and those to F04 and G02 have replacement uPVC frames. The window to G06, the utility room, appears to be the only original window that survives within the main house. It is a timber framed sash window, each sash with six panes (Plate 5).

Plate 5: View of the remaining sash window to room G06, Building 1

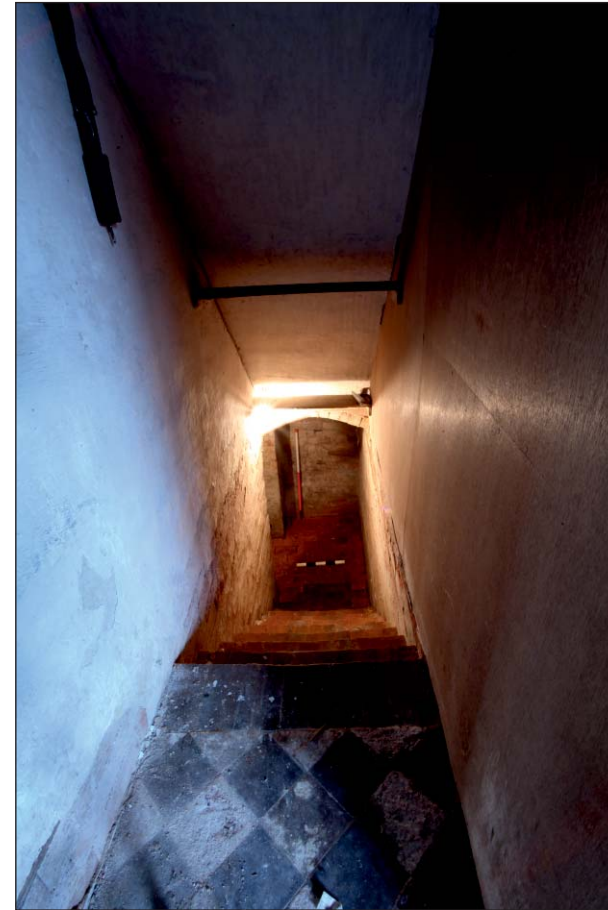
Plate 6: View down basement stairwell, Building 1, showing quarry tiles at the stair head

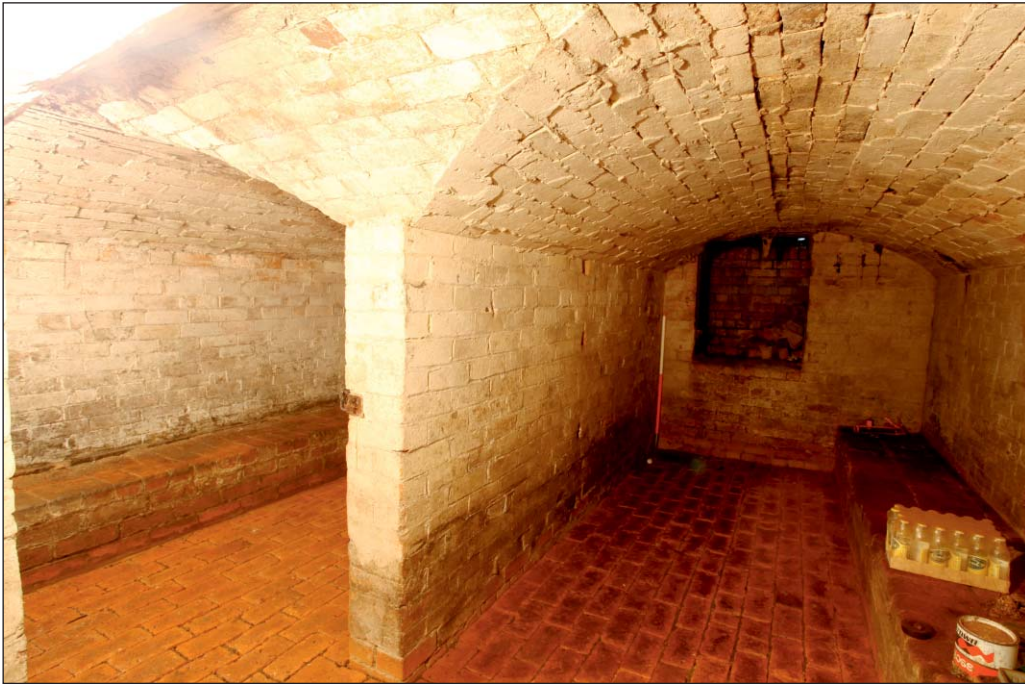
Plate 7: View of vaulted chambers B01 and B02, basement of Building 1

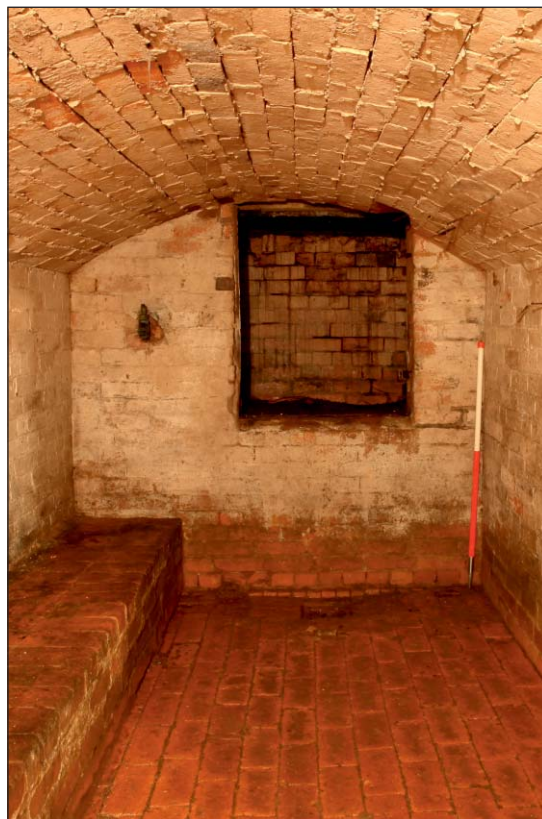
Plate 8: View of the lightwell, drain and tap at the north end of chamber B02, basement of Building 1

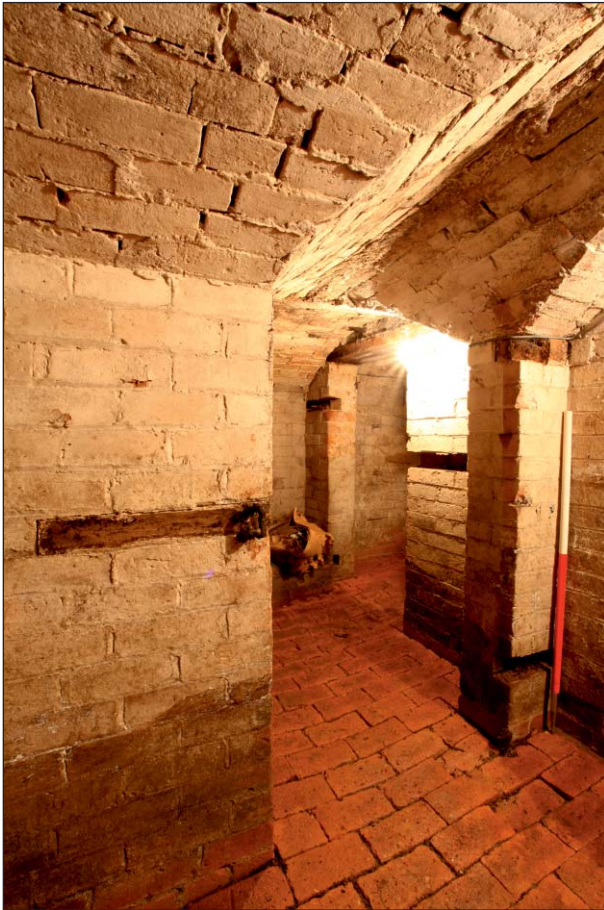
Plate 9: Remnants of door fittings and voids from removed timbers in the door openings within the basement of Building 1

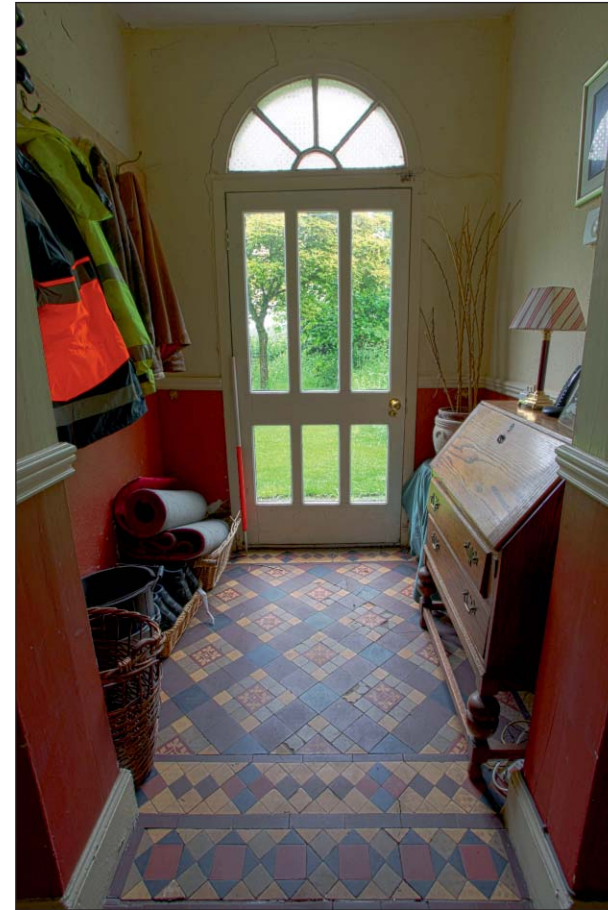
- 6.2.18 On the ground floor the porch (Plate 10) leads from the east into a central hall and stairwell (Plate 11). The porch and hall floor is decorated with mosaic tiles. The straight flight, timber staircase has stick balusters and a moulded newel post and handrail. The hall (G30) and reception rooms either side (G02 and G03; Plates 14-15 and 12-13 respectively) all have original moulded cornices and dado rails. Both reception rooms have fireplaces but these contain modern (late 20th century) replacement surrounds (Plates 12 and 14). Bay windows within G02 and G03 retain their moulded timber frame surrounds (Plate 13) and the north window in room G02 is fitted with timber shutters (Plates 14-15). Each shutter is two-leafed with a simple bead mould and rectangular hinges. The shutters are locked with a metal shutter bar. Internal shutters became standard in the 18th century until the 1840s (Hall 2005, 96), consistent with the late 18th or early 19th century date of the building.

Plate 10: View of porch (G30), Building 1, showing the fanlight door and mosaic floor tiles

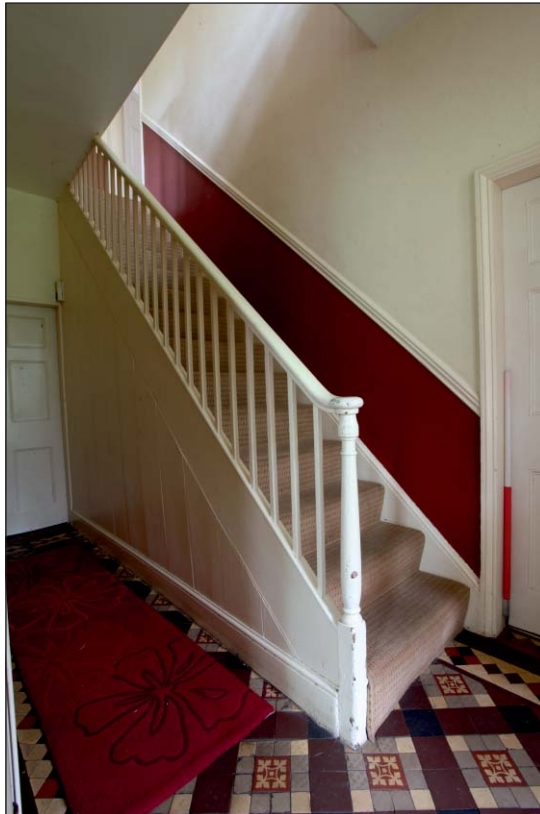
Plate 11: View of hall (G30) and stairwell, Building 1

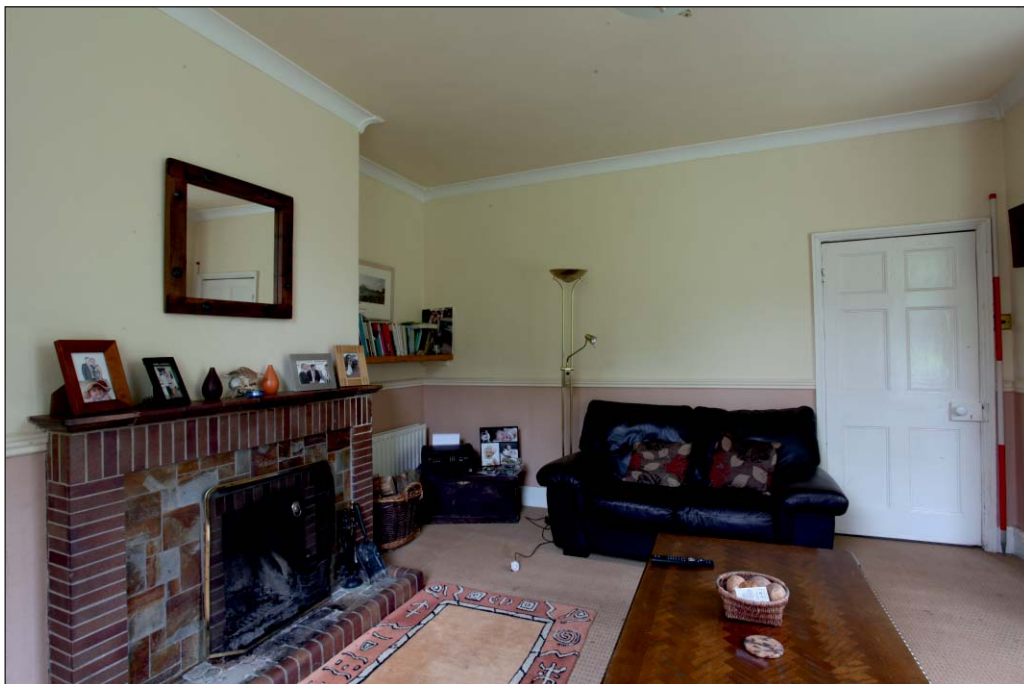
Plate 12: Building 1 reception room G03 viewed from the southeast

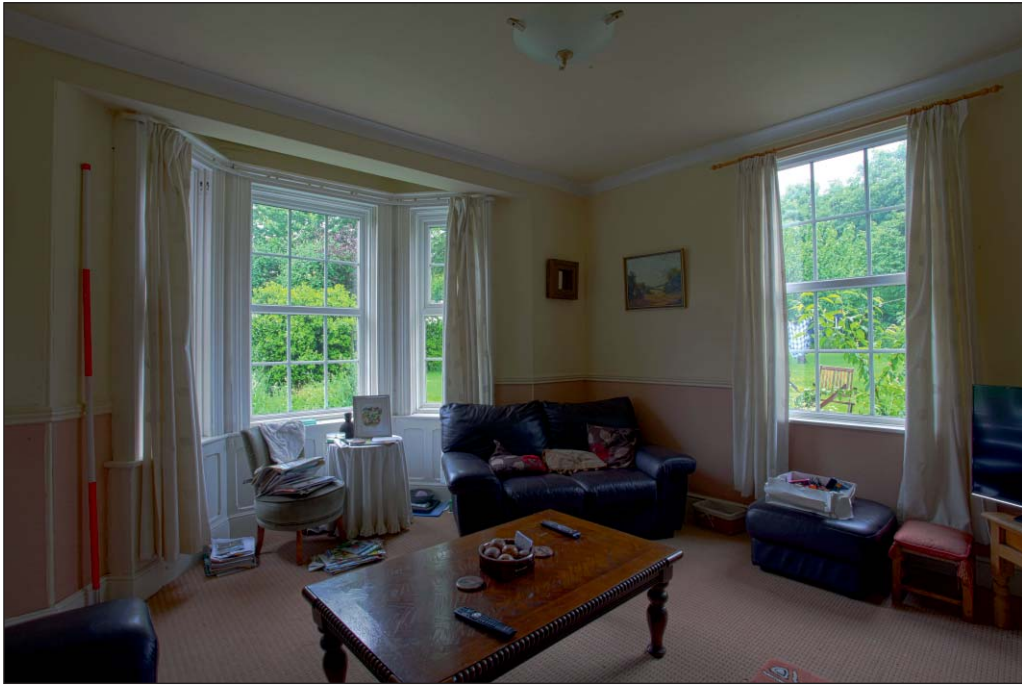
Plate 13: View of reception room G03, Building 1, viewed from the north-west, showing the bay window

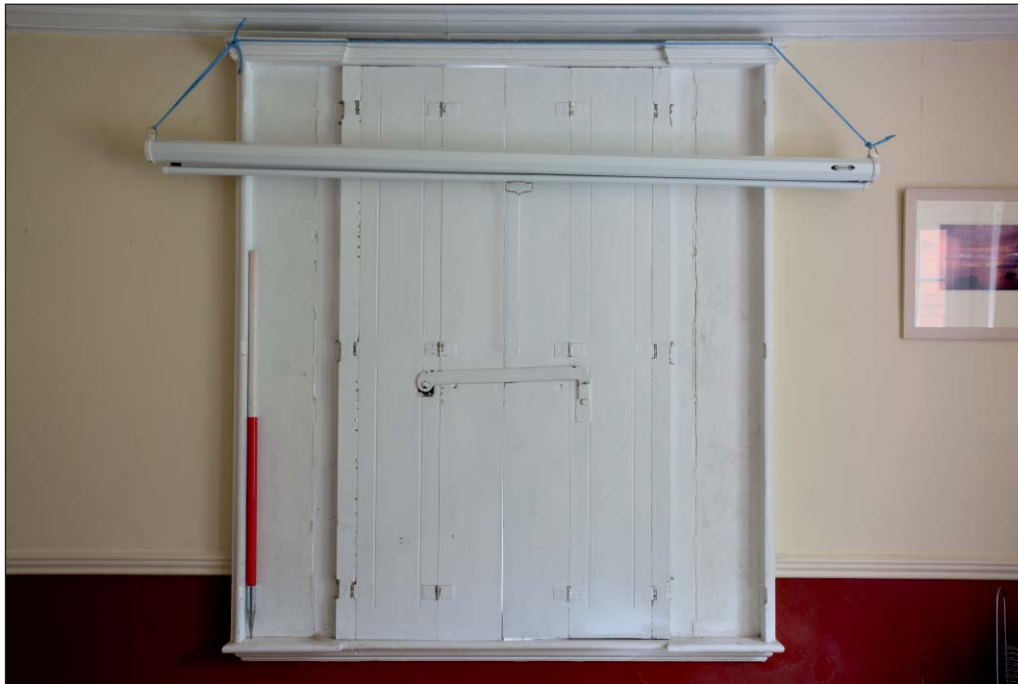
Plate 15: Detail of shuttered window in room G02, Building 1

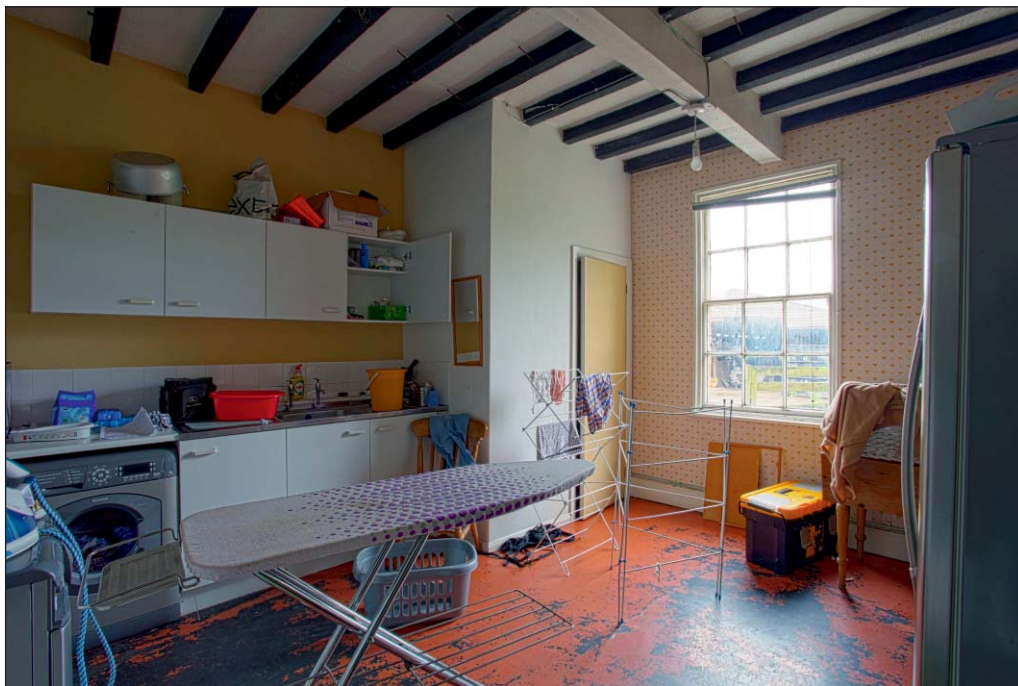
Plate 16: View of utility room G06, Building 1

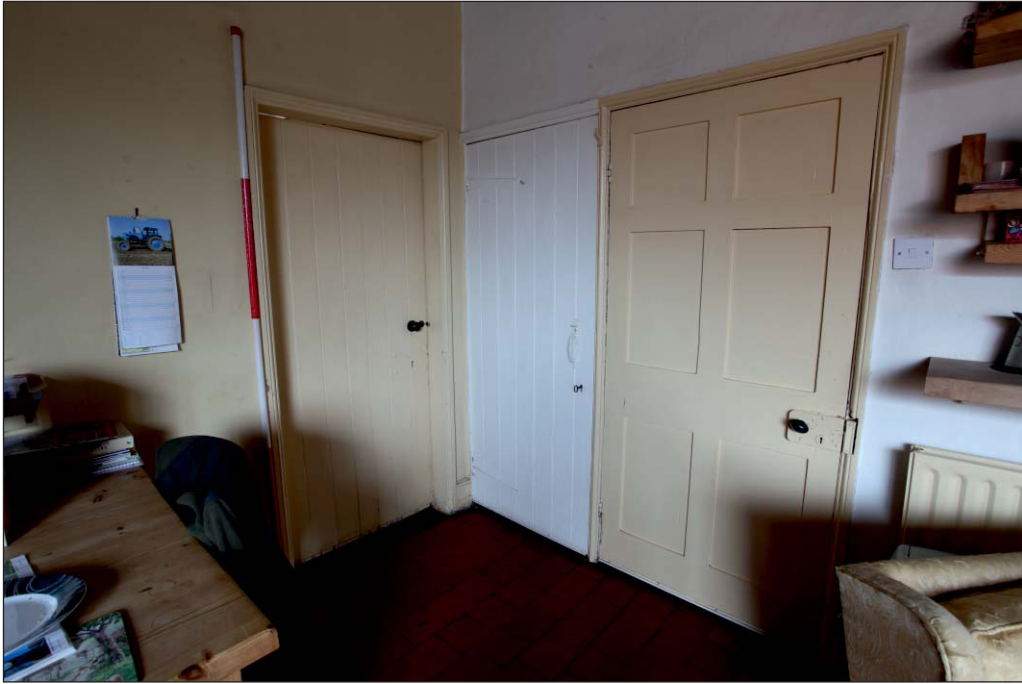
Plate 19: Detail view of the doors in the north-east corner of kitchen G05, Building 1, to illustrate the variety of door types and lock fittings in the building

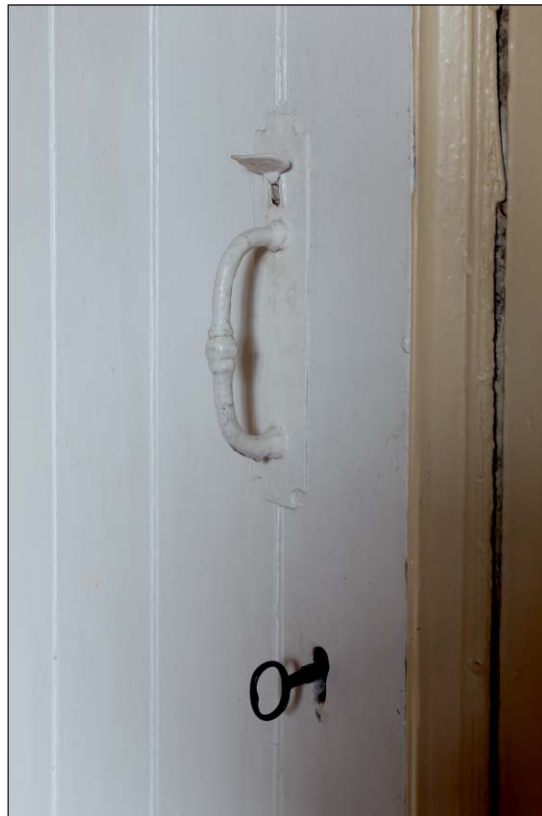
Plate 20: Detail view of basement door handle in G05, Building 1

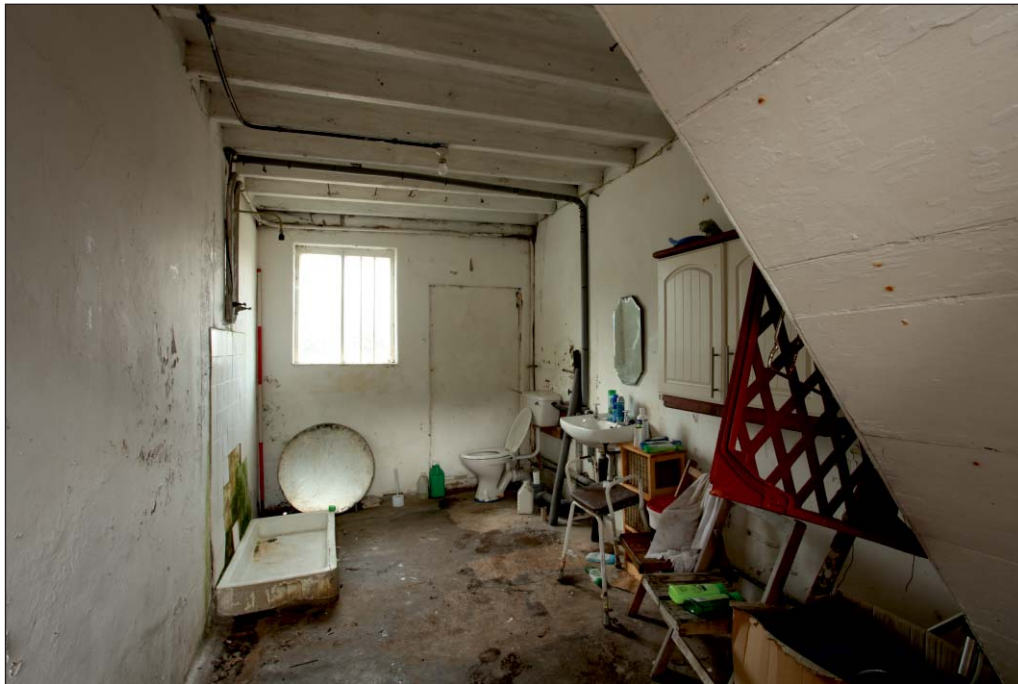
Plate 23: View of G27 in the west wing of Building 1

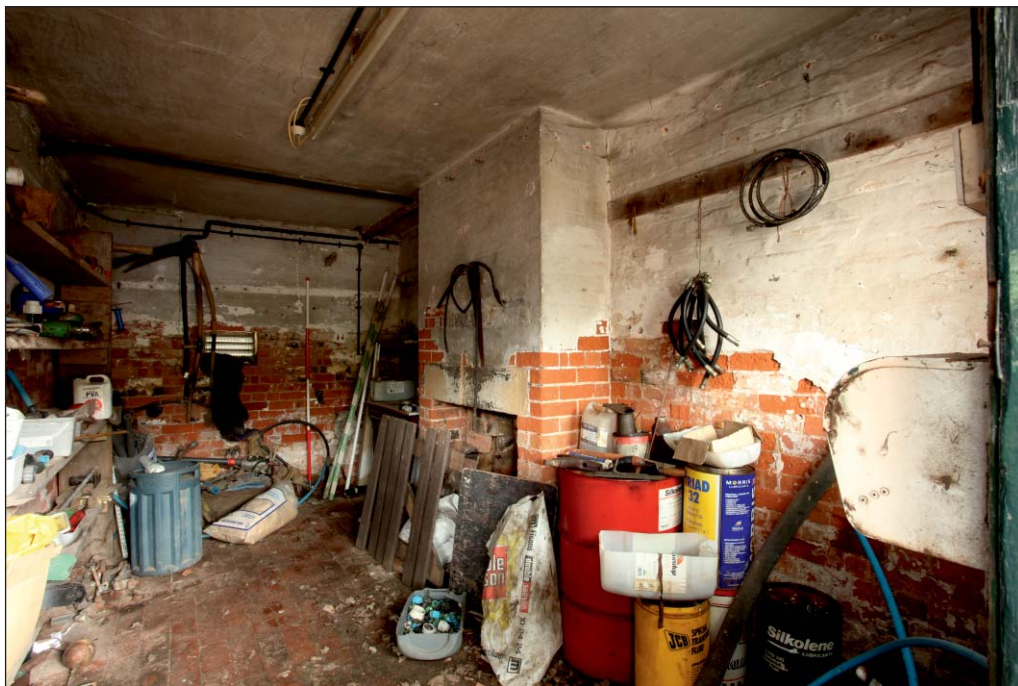
Plate 24: View of G26 in the west wing of Building 1

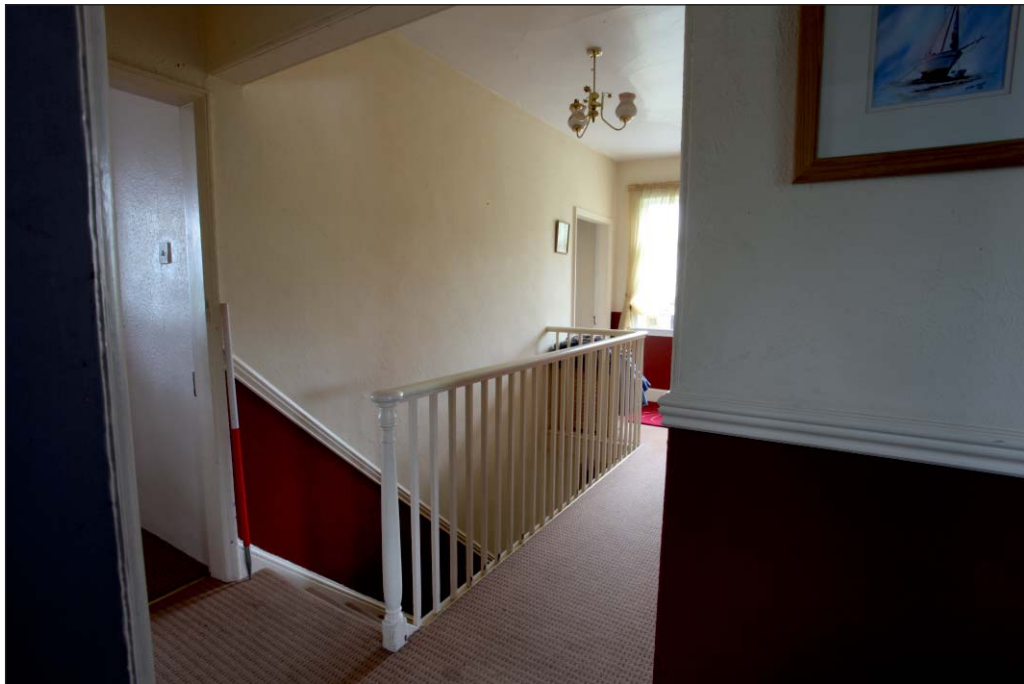
Plate 26: View of stairwell and landing F09, Building 1, from the south-west

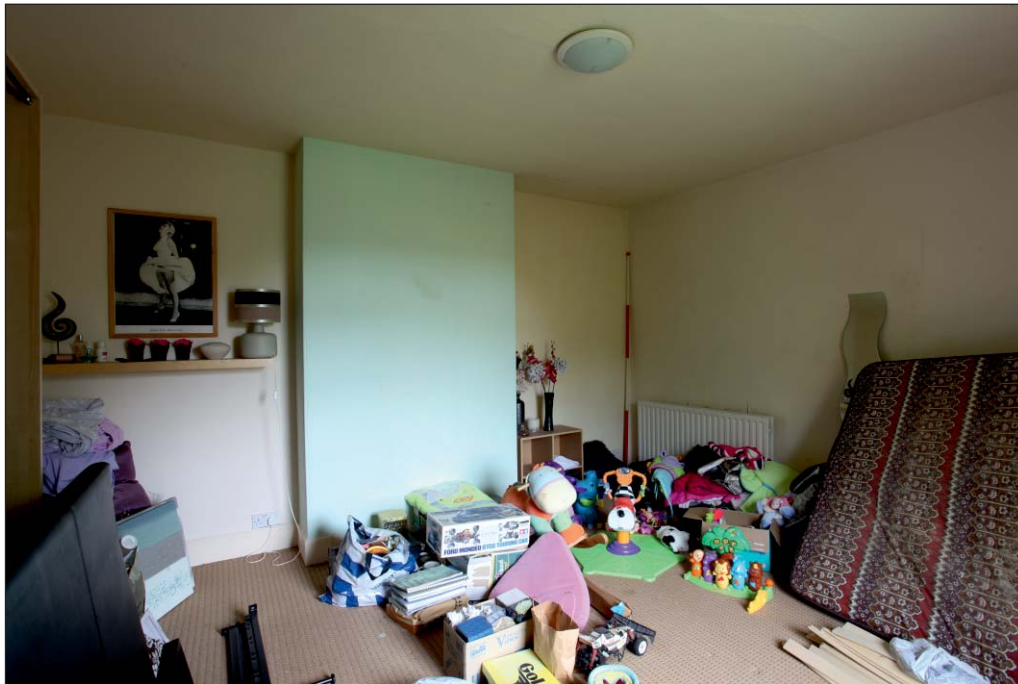
Plate 27: General view of bedroom F01, Building 1, including the wall with a blocked window (right)

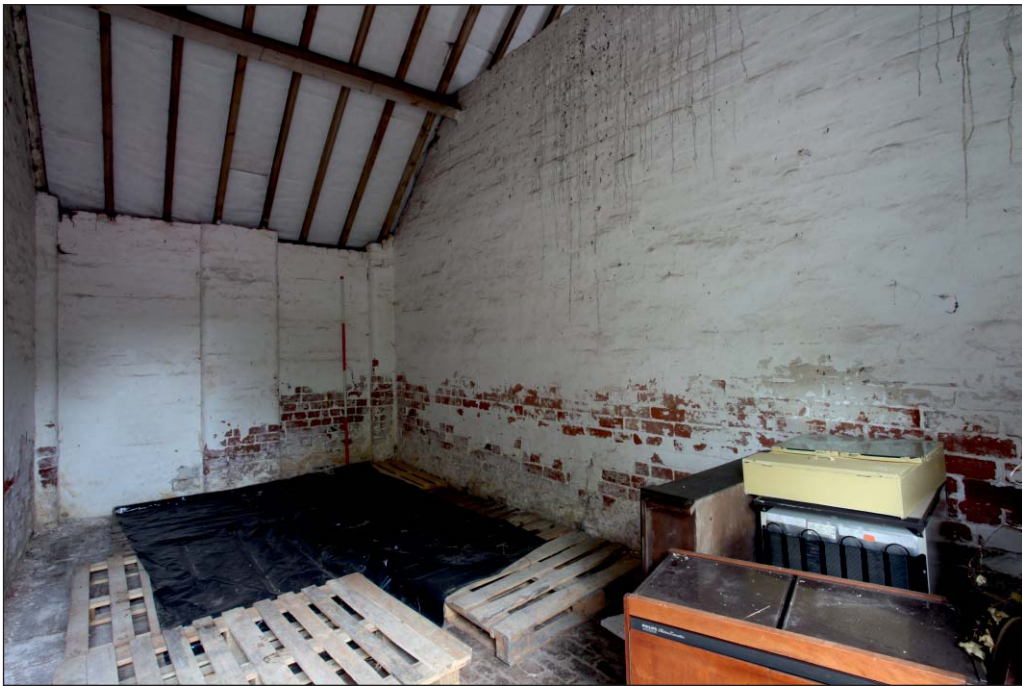
Plate 76: View of G19, Building 6, from the south-east

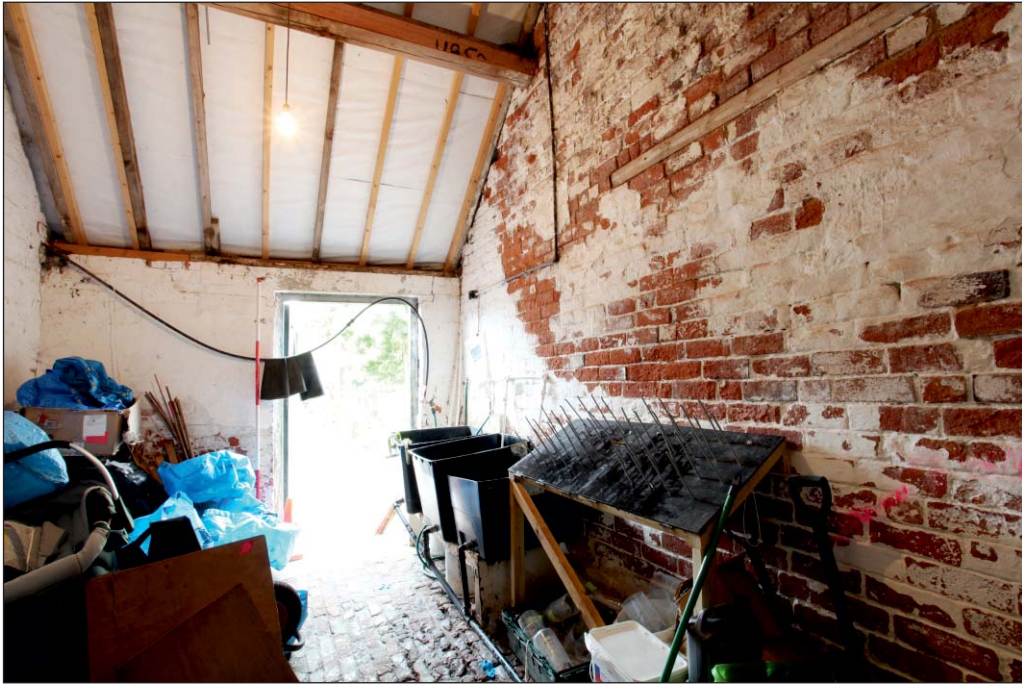
- 6.7.13 G20 (Plate 77) is leased to a local ecology group and contains several tanks and a table with hooks, presumably a drying rack. A drain set in the centre of the floor carries away the waste water from the tanks. Other rooms in Building 6 are used for storage including palettes and furniture. G18 has matting and straw laid on the ground, which suggest it last housed animals, but it appears to have been there some time.

Plate 77: View of G20, Building 6, from the north-west

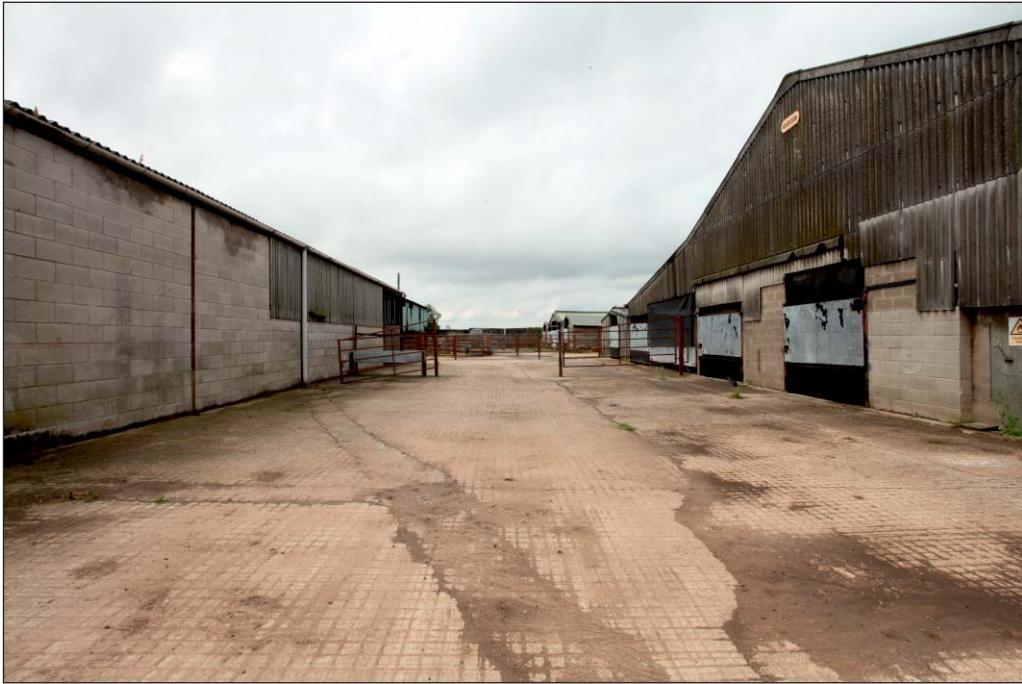
Plate 79: Shed and cow houses to the north and north-west of the farmyard complex, viewed in relation to Building 4 (left)

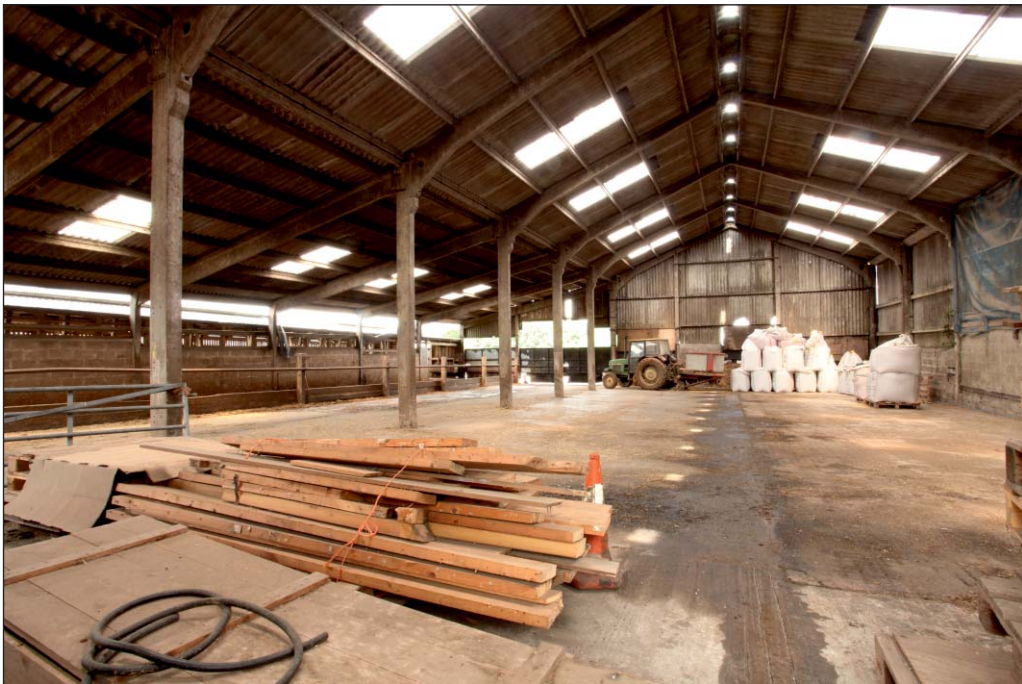
Plate 80: Interior view of the shed to the north of the farmyard complex

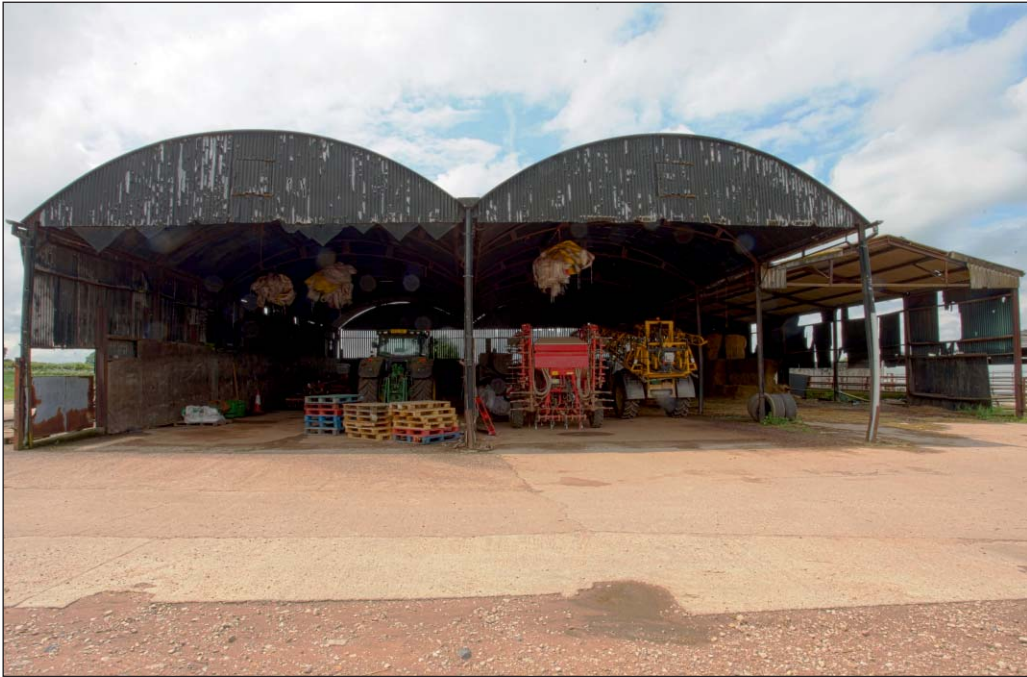
Plate 83: Hay store and vehicle shed to the west of the farmyard complex

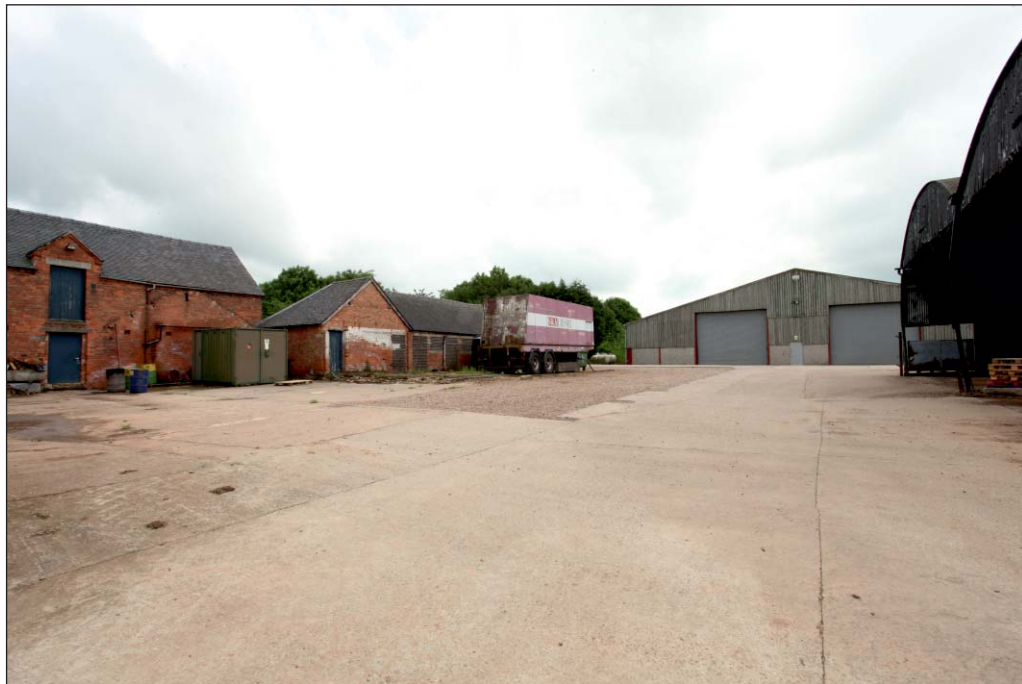
Plate 84: Vehicle shed and granary viewed in relation to Buildings 5 and 6 (left)

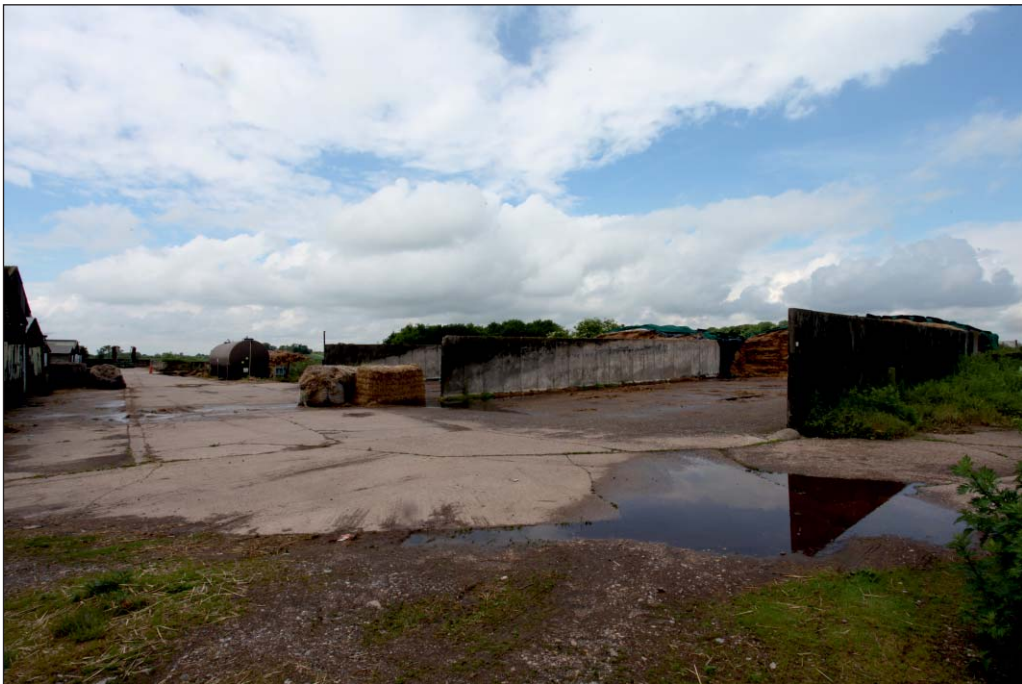
Plate 86: Slurry beds to the north of the farm buildings

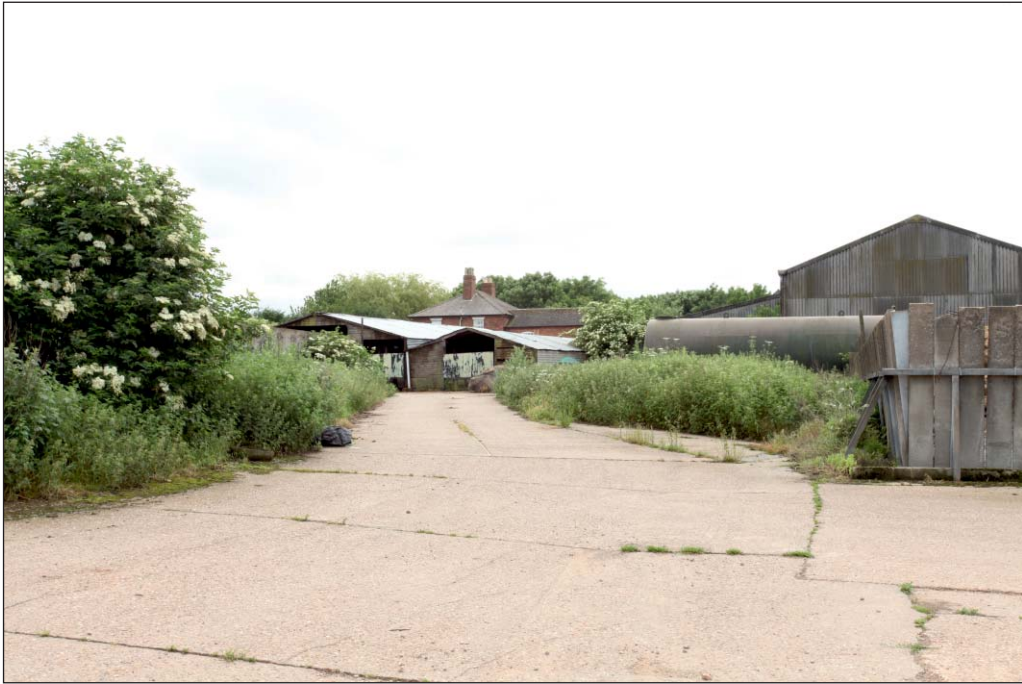
Plate 87: The farmhouse, Building 1, partially visible above farm buildings, viewed from the north
