# IFA2: The Excavation and Recovery of a MKII Fairey Barracuda from the Solent, Hampshire

Marine archaeological technical report

Ref: 202920.13  
January 2020

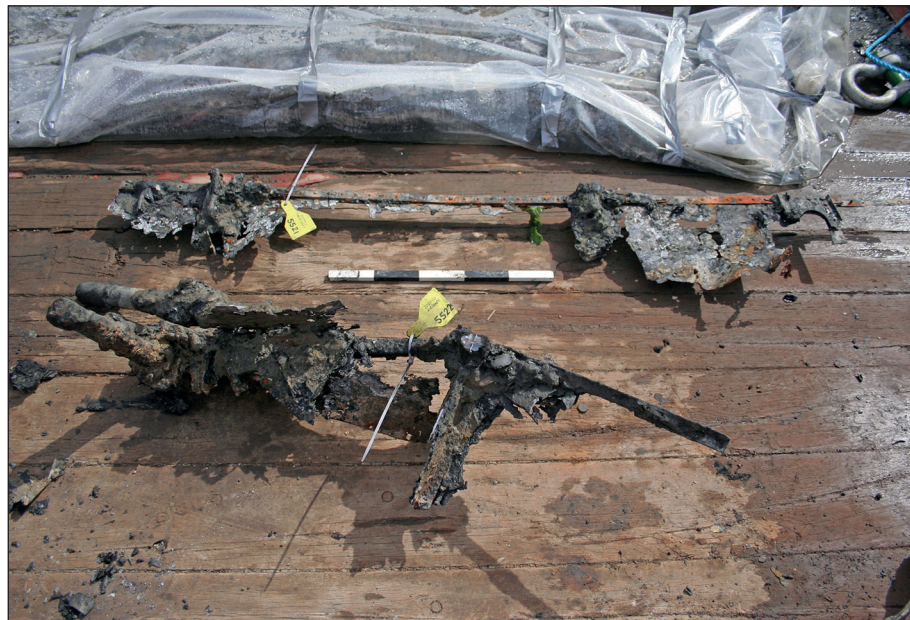
Plate 4: Starboard wing fragment- remains of front spar (5521) and support tubing at the inboard end of the wing (5522)

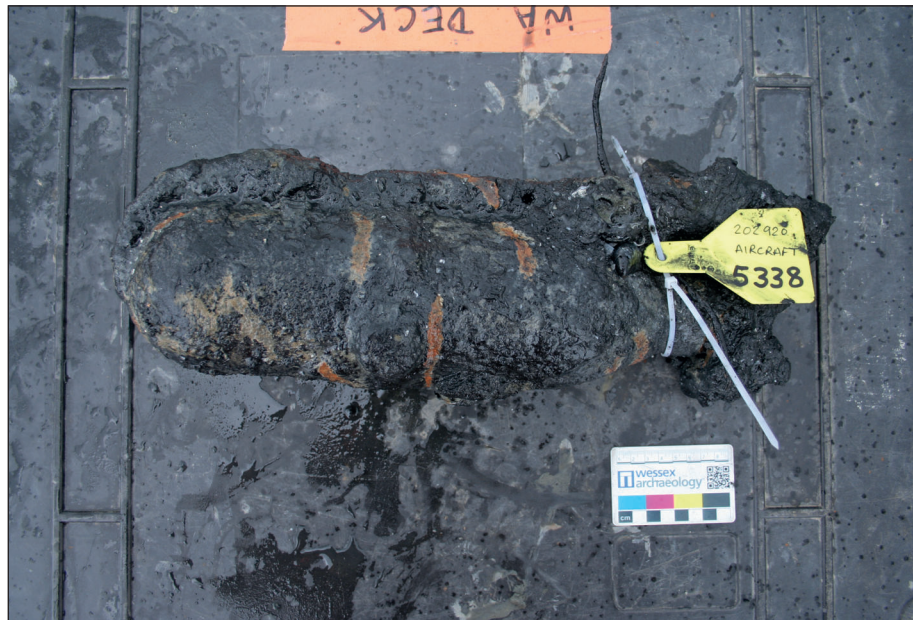
Plate 9: Starboard wing tank fire extinguisher (5338)

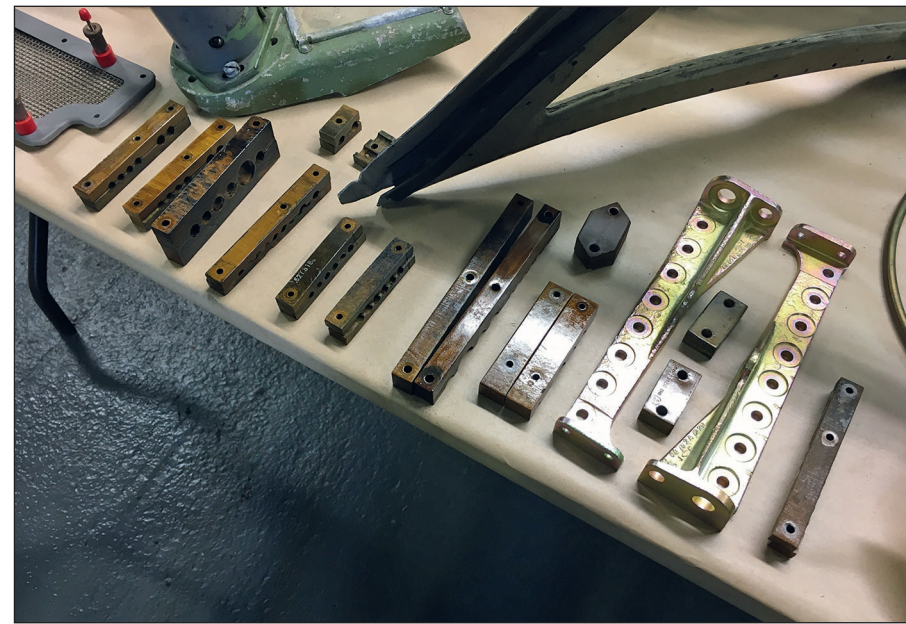
Plate 12: Tufnol and Bakelite blocks, pipe clamps and fittings recovered from the Barracuda and conserved by FAAM © Tony Jupp

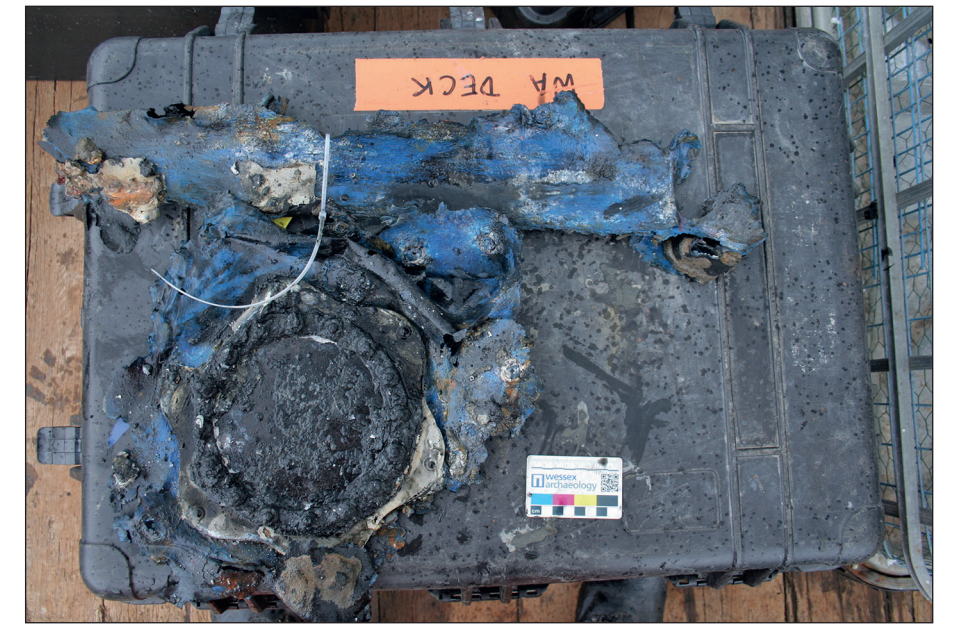
Plate 13: Starboard inboard tank fabric and inlet valve

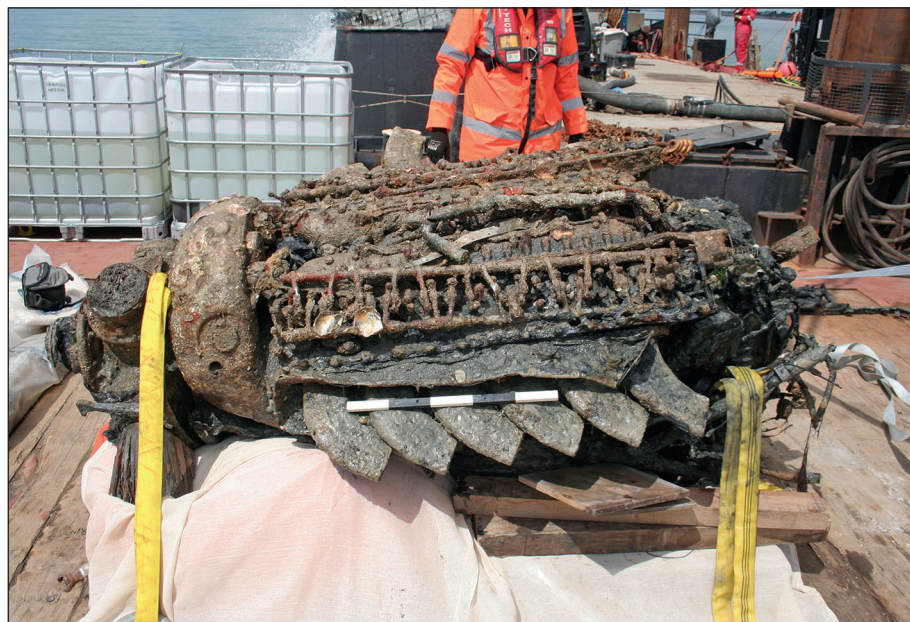
Plate 14: Rolls Royce Merlin 32 engine- port side showing rocker covers and 6 intact exhaust manifolds

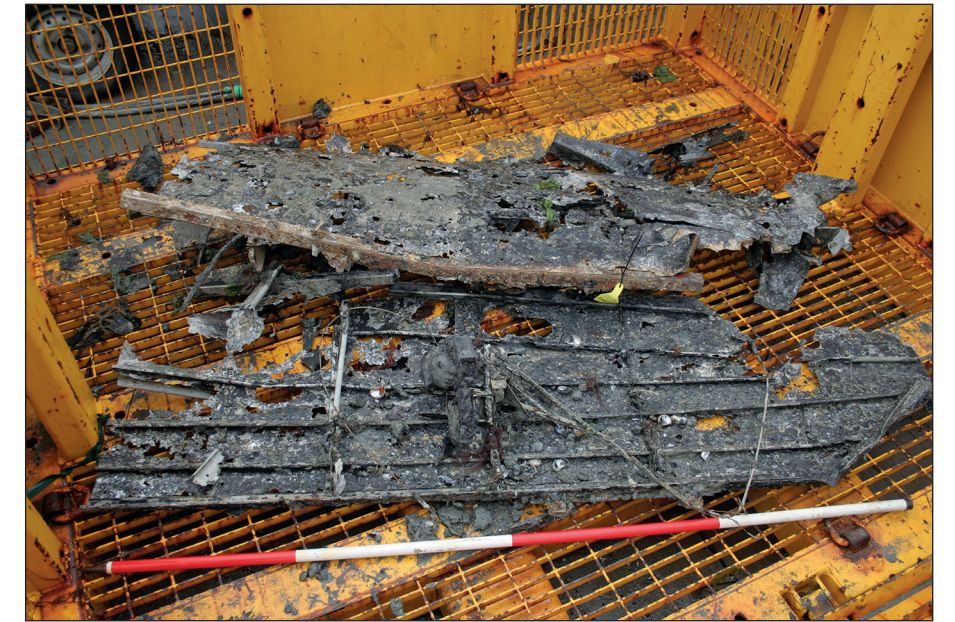
Plate 23: Remains of airframe aft of rear cockpit (front of aircraft to left)

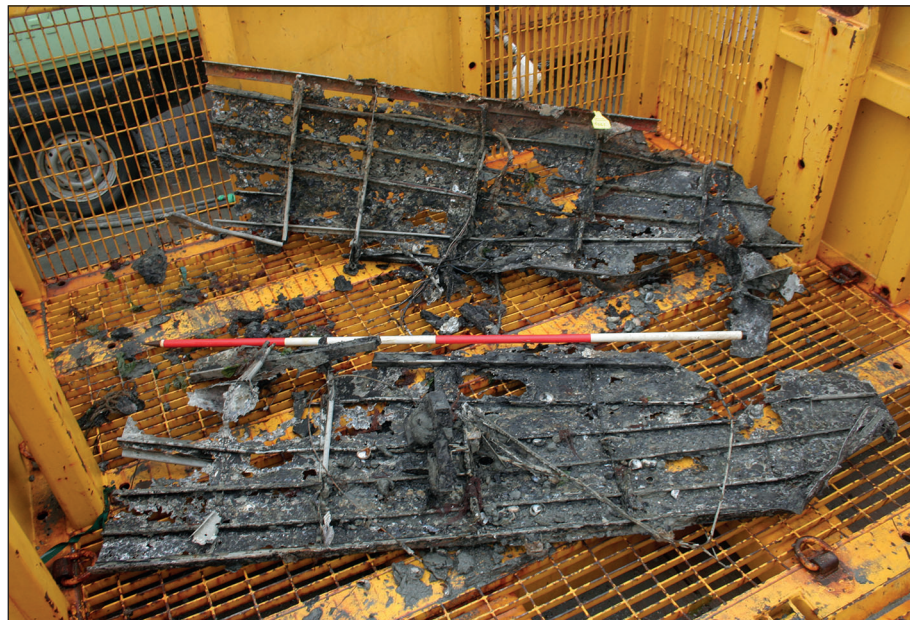
Plate 24: Remains of airframe aft of rear cockpit (front of aircraft to left)

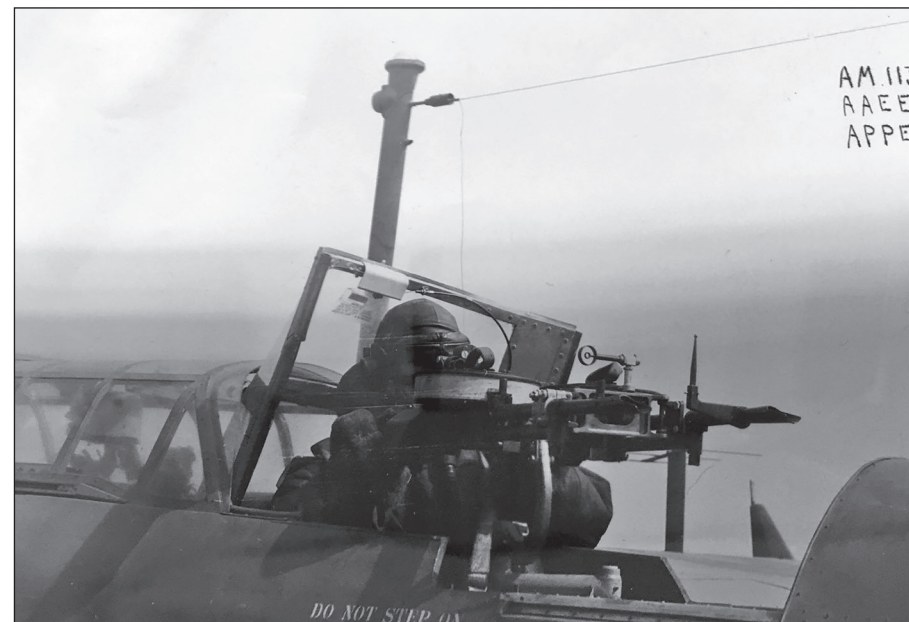
- 3.4.36 The Vickers twin K-guns (**Plate 45**), positioned on an arc-track at the aft end of the TAG cockpit, were the Barracuda's only defensive armament. These guns, designed in 1935, were commonly used in single and twin mounts on aircraft and for light anti-aircraft defence- being particularly favoured by the Long Range Desert Group (the precursor of the SAS) mounted on their jeeps and trucks. They fired .303 ammunition from 60 or 100 round top mounted 'pan' magazines, of which the Barracuda usually carried eight or ten.

Plate 45: TAG with Vickers K Gun showing flat pan magazines on top (National Archives, AVIA18/784)

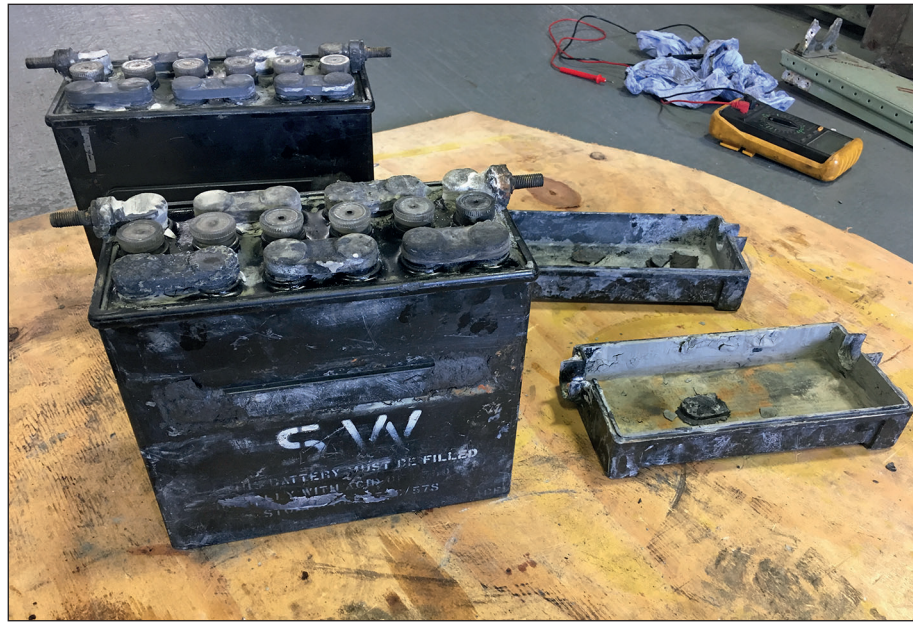
retain 0.7V of charge (**Plate 76**). These batteries were probably manufactured by Nife Batteries of Redditch, who specialised in batteries for aircraft 24V systems ([https://www.gracesguide.co.uk/Nife Batteries](https://www.gracesguide.co.uk/Nife_Batteries) Accessed 06/11/2019)

Plate 76: Batteries after cleaning at FAAM © Tony Jupp
